沙田至中環綫項目工程進展

Progress Update of the Construction of the Shatin to Central Link
(截至2018年12月31日) (As at 31 December 2018)

Legislative Council Panel on Transport

Subcommittee on Matters Relating to Railways

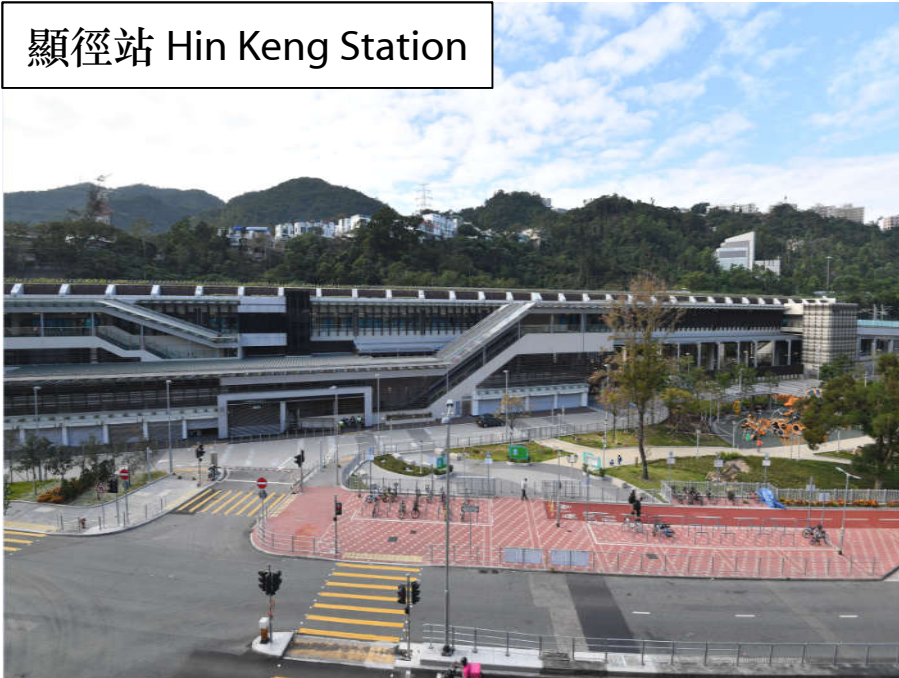
顯徑站 Hin Keng Station

- 顯徑站：車站土木工程、機電、屋宇設備、車站設施及消防裝備等相關法定檢測已完成
Hin Keng Station: Statutory inspections on civil, E&M, building and fire services installation works were completed
- 鑽石山站：所有相關法定檢測工作預計於今年第一季完成
Diamond Hill Station: All statutory inspections are targeted to complete in Q1 2019

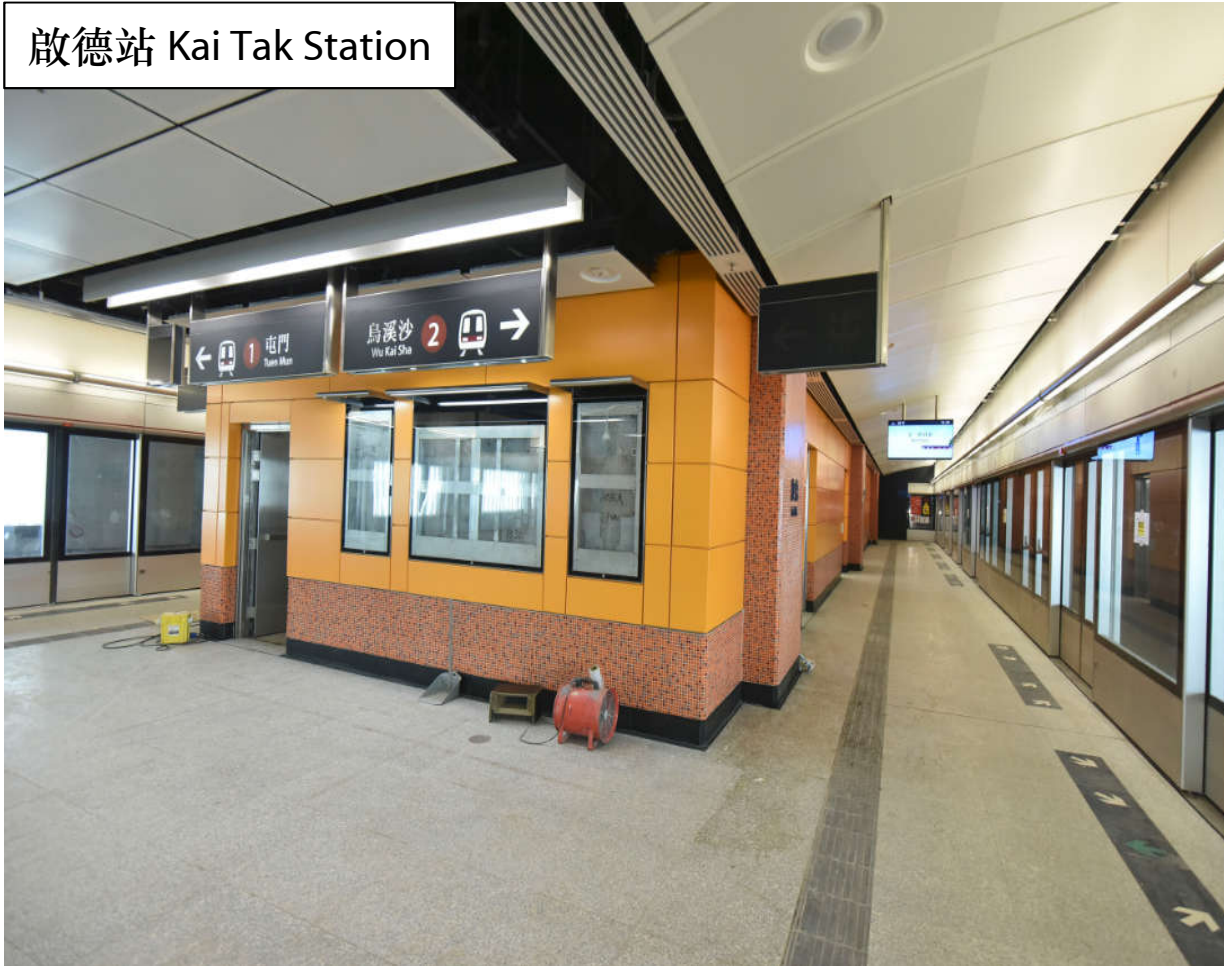
啟德站 Kai Tak Station

- 會繼續於二零一九年第一季進行餘下的法定檢測工作

The remaining statutory inspections will continue in Q1 2019

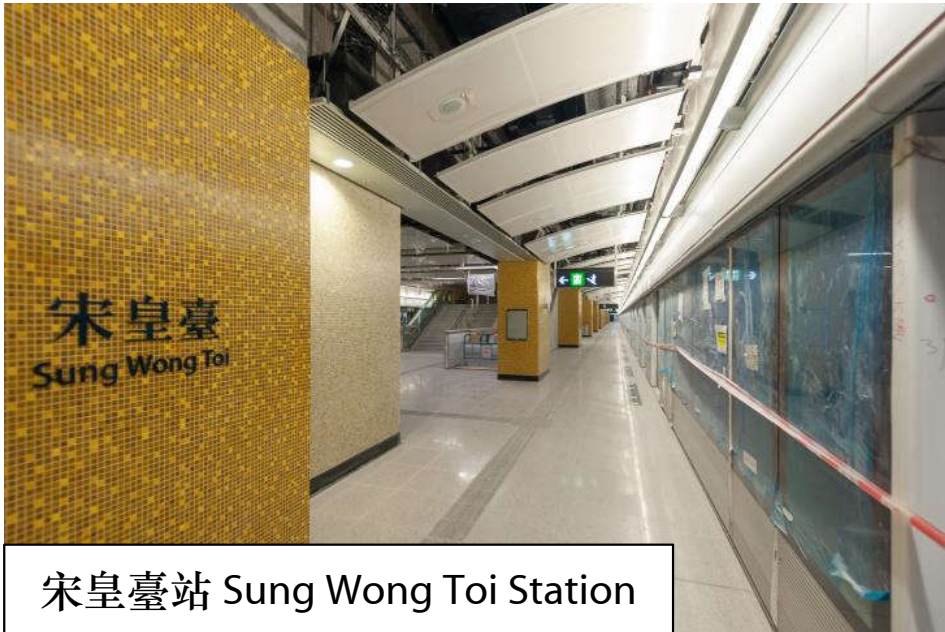
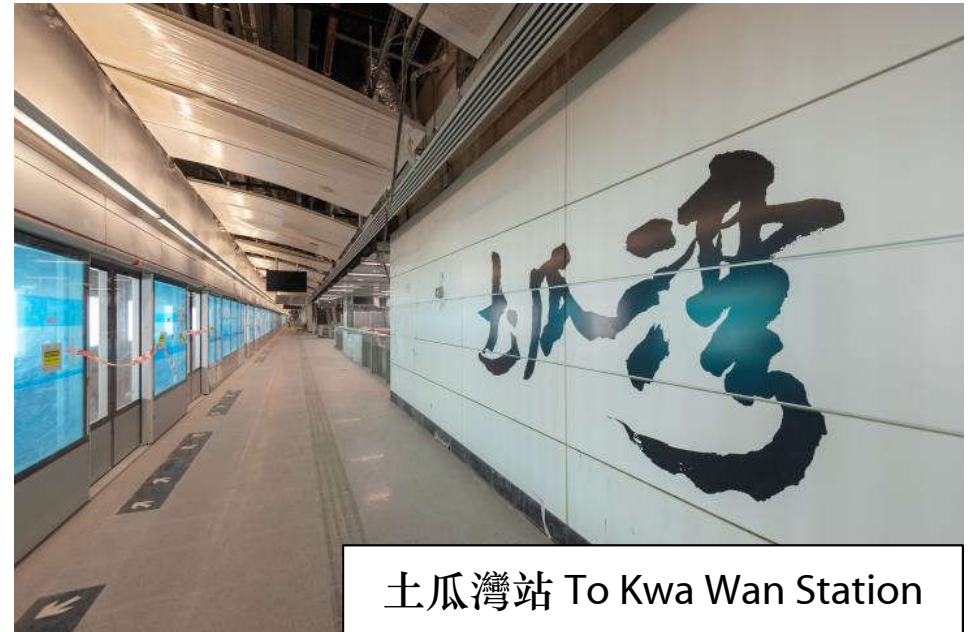
Sung Wong Toi and To Kwa Wan Stations

- 裝修、機電及屋宇裝備工程已大致完成
Fitting out works, E&M and building services works are substantially completed
- 車站已通過消防安全裝置檢測
Fire services inspection was completed

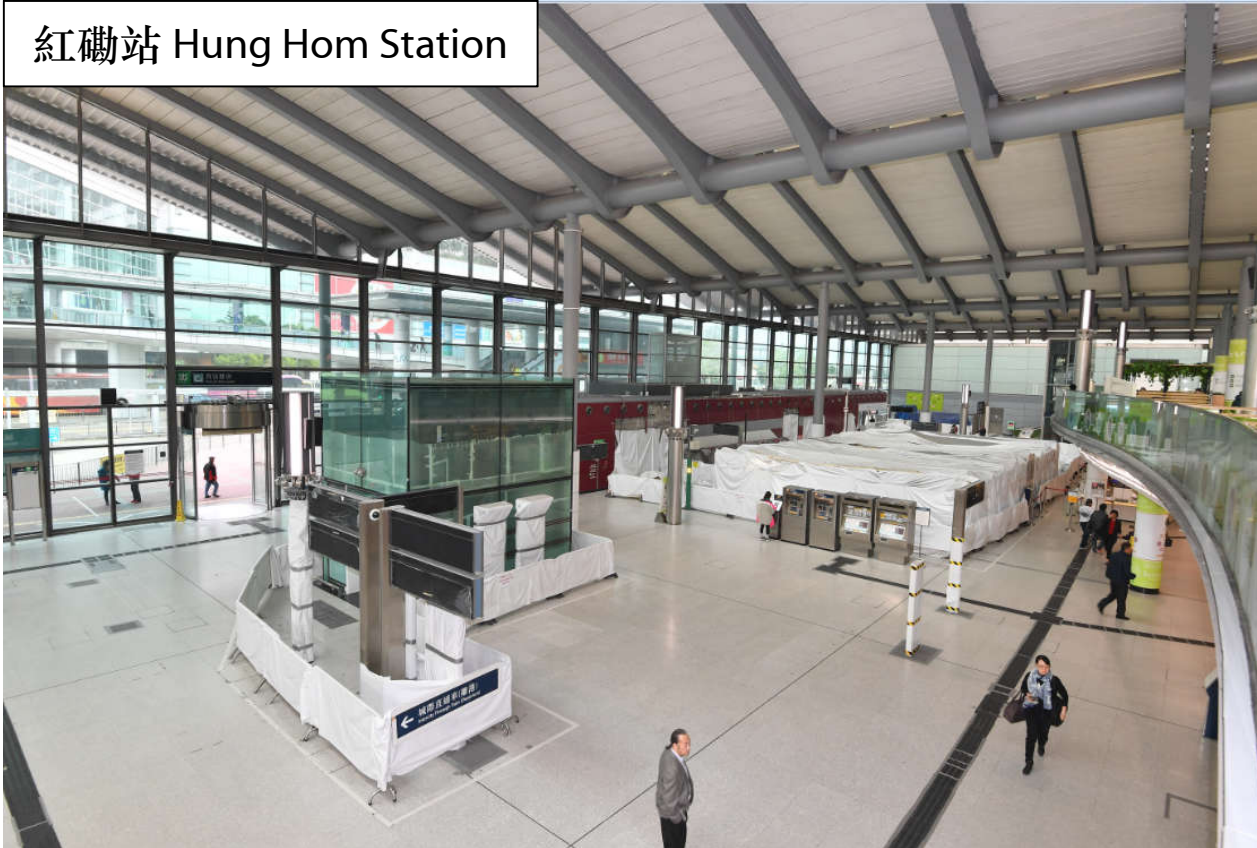
紅磡站 Hung Hom Station

- 車站土木工程、裝修、機電及屋宇裝備工程已大致完成
Civil works, fitting out works, E&M and building services works substantially completed
- 核實工作分階段進行，第二階段的開鑿工作已於二零一八年十二月十日展開
The opening-up works have started since 10 December 2018

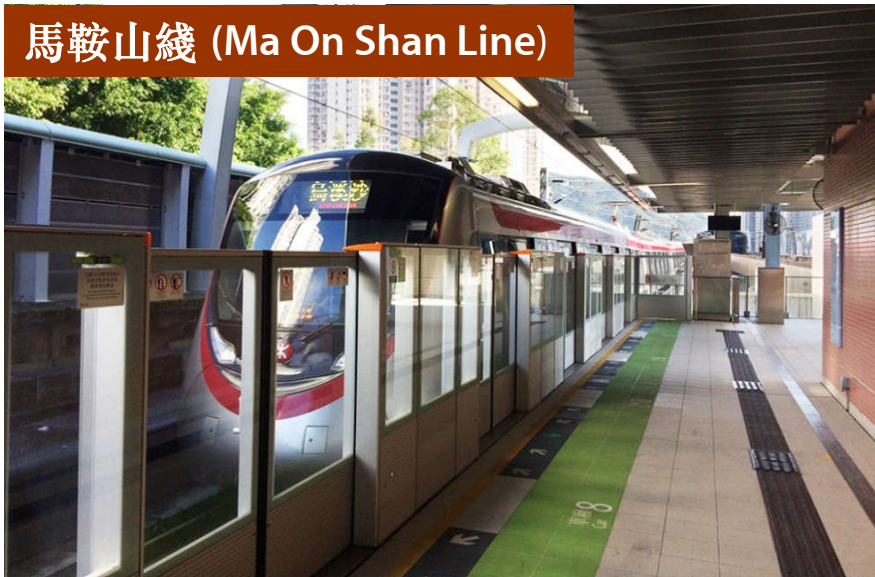
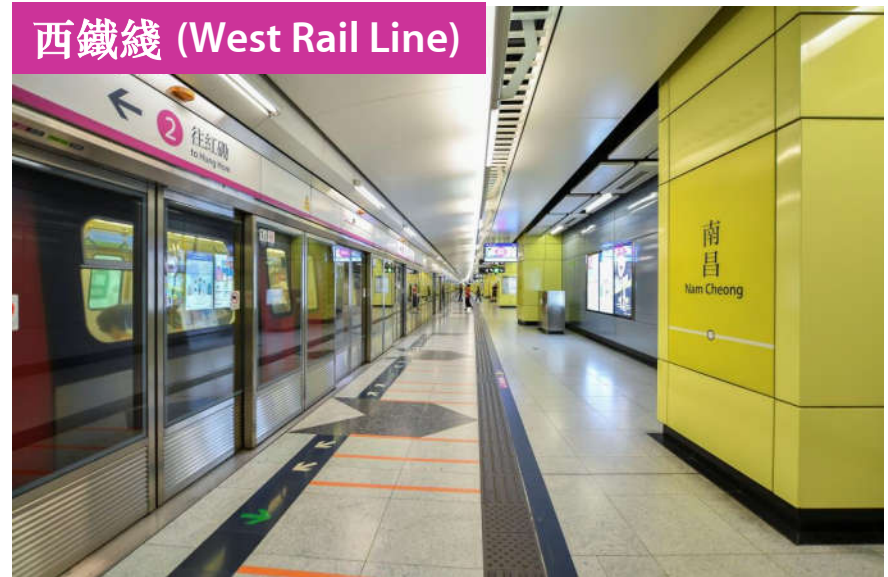
- 全部15列八卡車已投入服務
Full fleet of 15 8-car trains are in service
- 9個車站全部720對自動月台閘門完成安裝
Retrofitting works of 720 pairs of Automatic Platform Gate at 9 stations completed
- 西鐵綫七卡列車於去年5月全面更換成八卡列車
Conversion of all 7-car trains to 8-car trains on the WRL completed in May 2018

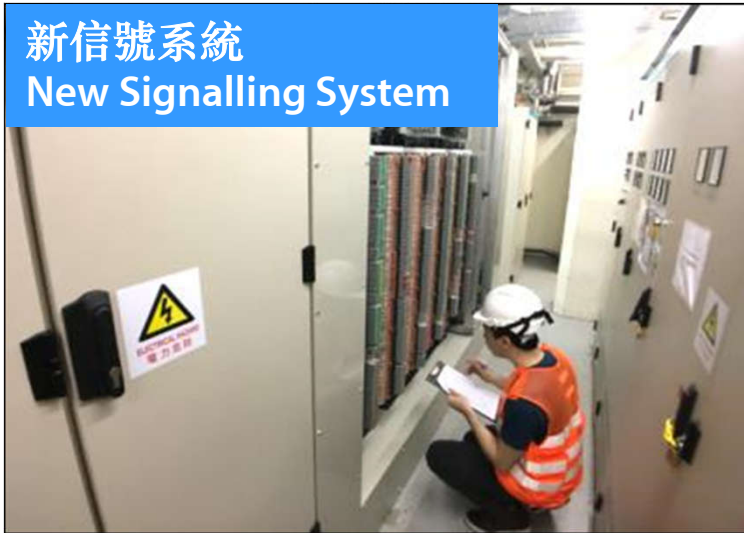
新信號系統
New Signalling System

- 東鐵綫正進行後期重鋪月台地面及修補工程
Floor tiling and defect rectification works at EAL stations are underway
- 信號系統測試已進入最後階段，預計於2019年完成
Final stage of the signalling tests are underway, with completion expected in 2019

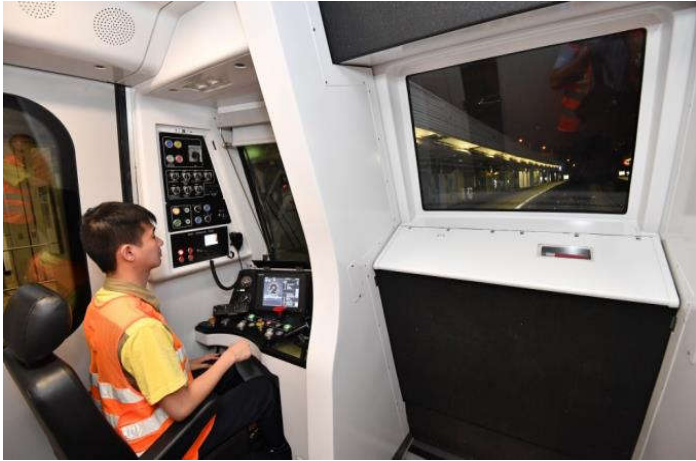
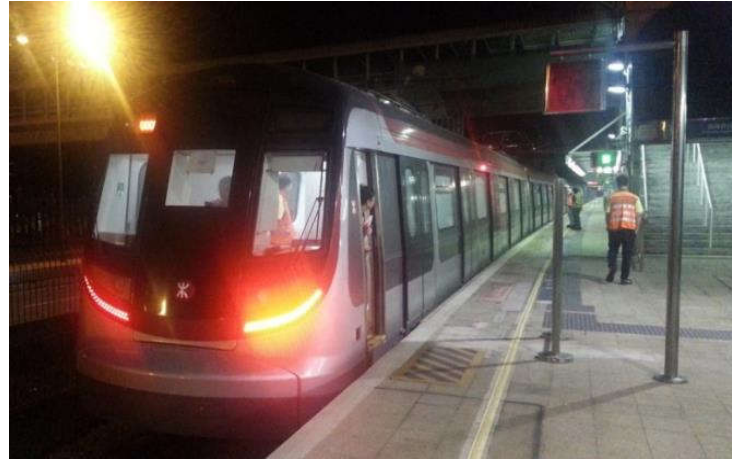
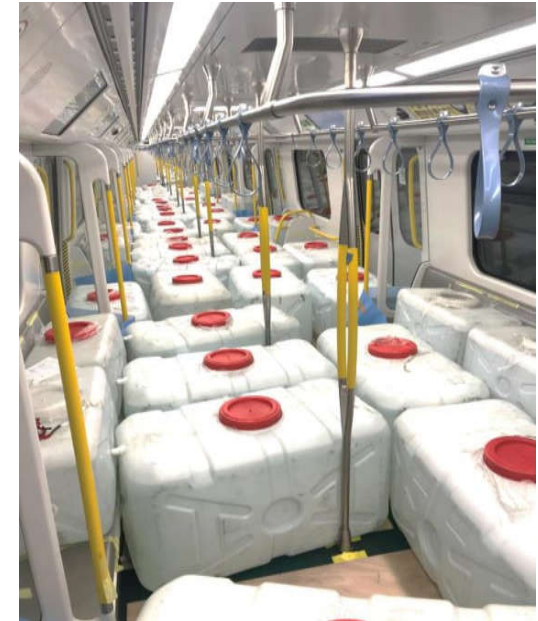
EAL Full-line Train Tests during non-traffic hours

- 為免影響東鐵綫日常列車服務，新信號系統測試只能於晚上非行車時間進行
To avoid impact on day-time train service, signalling tests could only be conducted during non-traffic hours
- 測試期間所發出的聲響或會對較接近鐵路的居民造成不便，會採取適當緩解措施
Mitigation measures would be in place as appropriate to minimise the possible noise impact

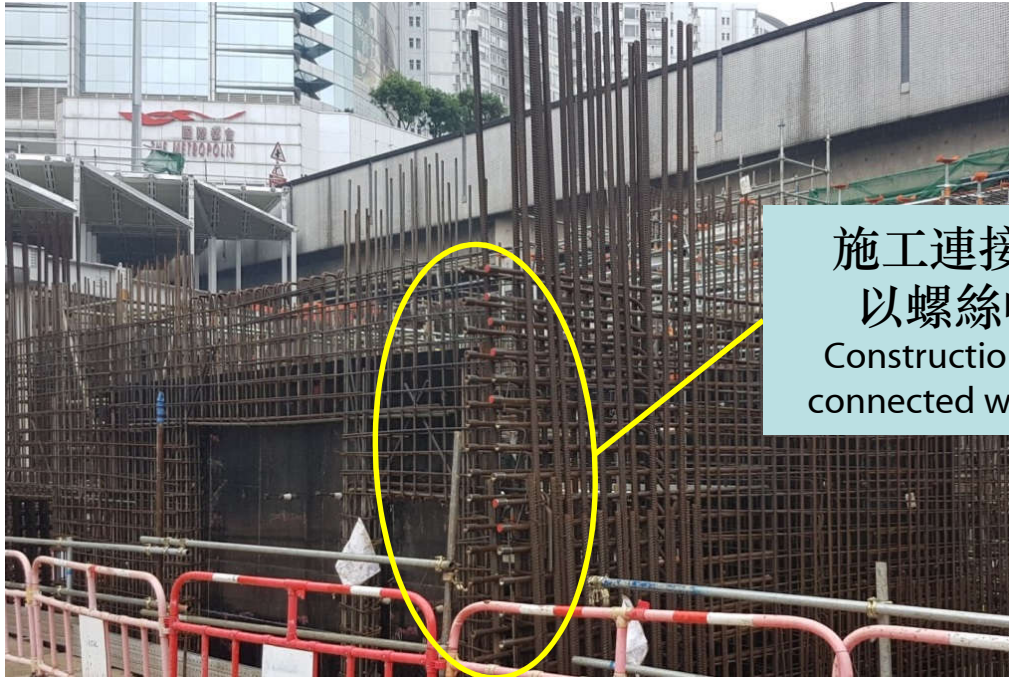
Construction joints

連接隧道牆身
Tunnel wall

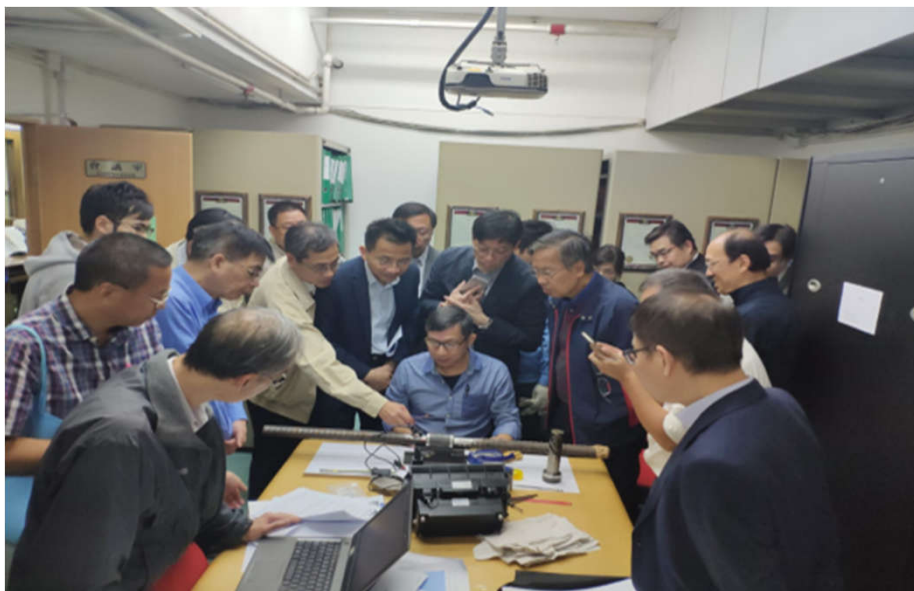
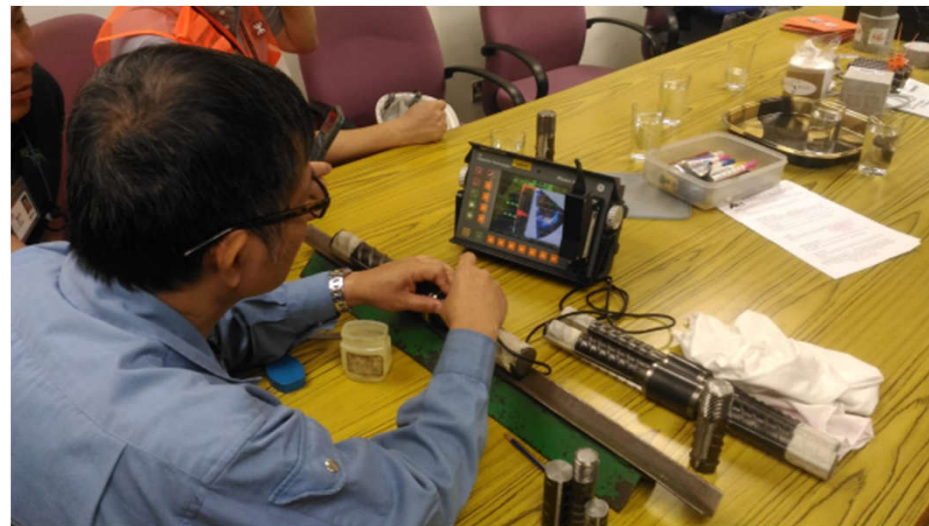
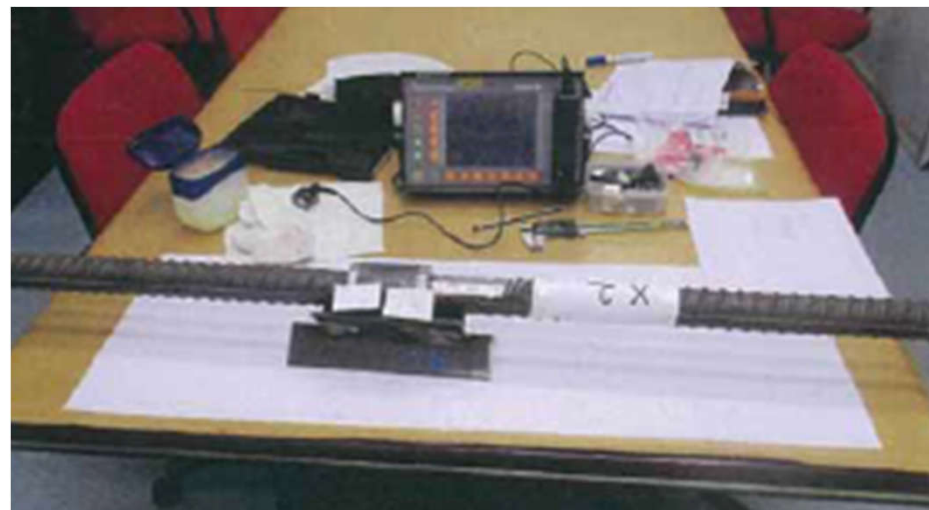
Process of Phased Array Ultrasonic Test (PAUT) – laboratory test

- 在不破壞月台層板的前提下進行螺絲帽接駁質量的檢測工作。
To carry out the verification without damaging the structure of the platform slab
- 在建議非破壞性測試的方式前，已在實驗室及模擬實況反覆測試。政府代表、其專家顧問團及其委聘的學者亦在場見證有關測試。
Before proposing with the non-destructive tests, repeated trials were conducted in laboratory and on-site. Government representatives, its expert adviser team and their engaged academics also witnessed the tests
- 全面評估策略建議（包括非破壞性測試）獲政府同意及接納。
The holistic proposal including the non-destructive test was submitted to and accepted by the Government

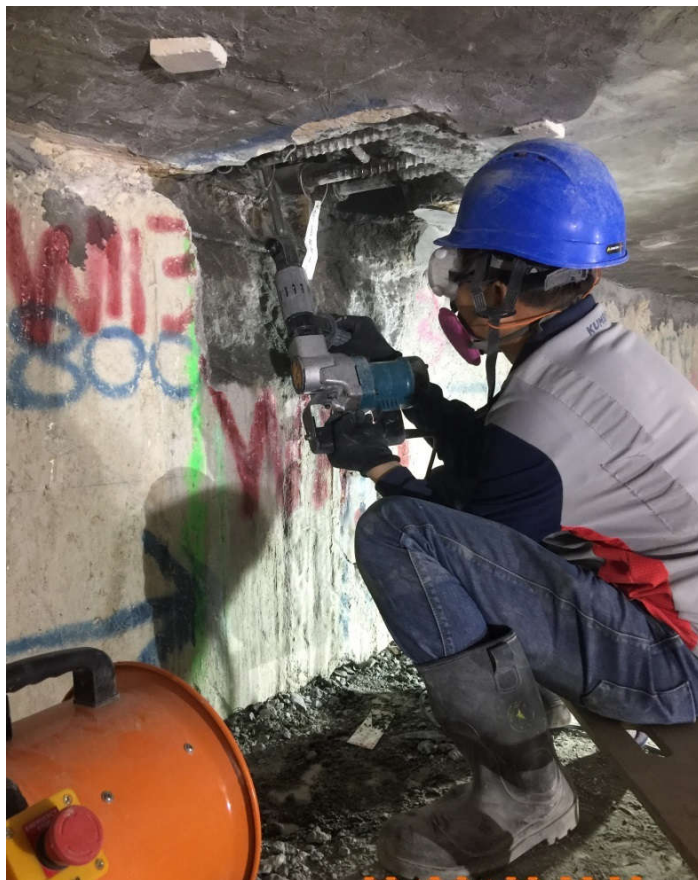
Process of Phased Array Ultrasonic Test (PAUT) – On-site test

開鑿石屎以露出鋼筋及螺絲帽
Open up concrete to expose couplers
and steel bars

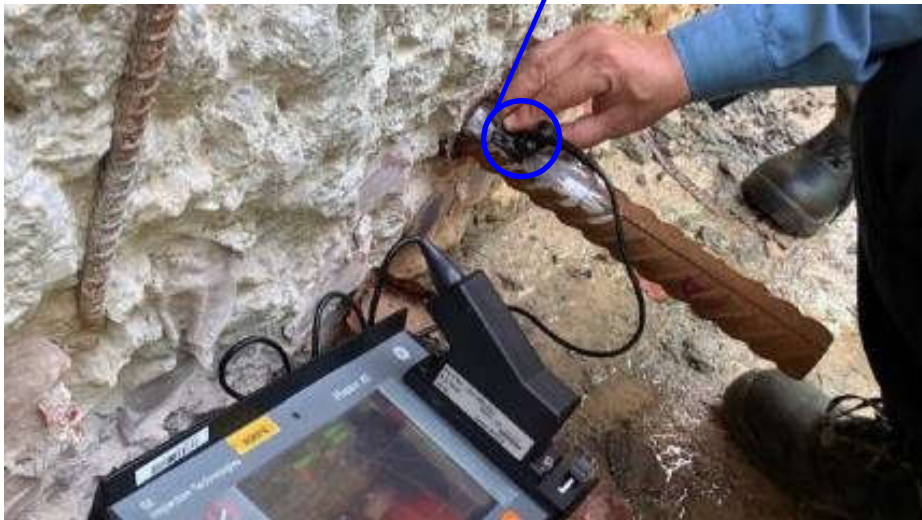
探測器
Probe

將探測器放上鋼筋接觸面
Put the detector on the steel bar surface
