**Legislative Council  
Panel on Environmental Affairs**

**The Trial of Alternative-fuelled Light Buses**

# Report of the Alternative Fuel Light Bus Trial

Monitoring Committee of the Alternative Fuel Light Bus Trial  
June, 2001

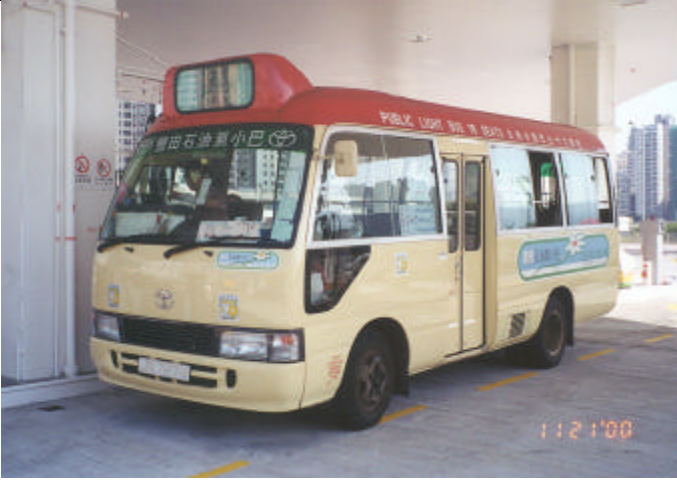
車廠 Make	Toyota

型號 Model	Coaster (LPG)	
引擎類別 Engine Type	直列 4 汽缸 4-cylinder, in-line	
汽缸容積 (公升) Cylinder Capacity (L)	4.104	
最大馬力 Max. Power	85 kW @ 3600 rpm	
最大扭力 Max. Torque	306 Nm @ 1600 rpm	
石油氣缸容積 (公升) LPG Tank Capacity (L)	90

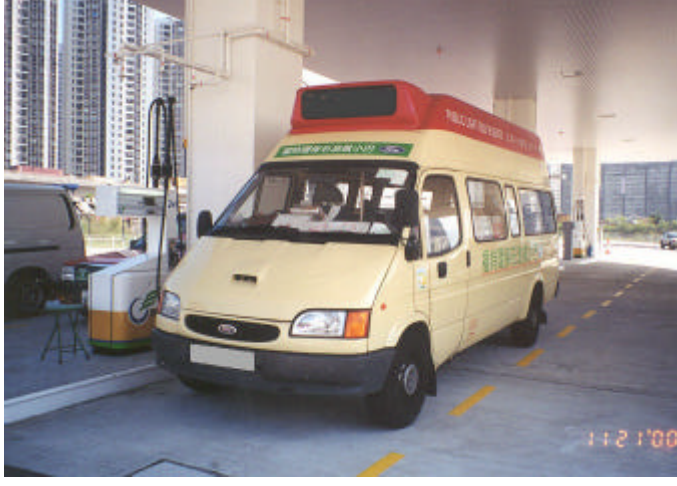
車廠 Make	Ford

型號 Model	Transit (LPG)	
引擎類別 Engine Type	直列 4 汽缸 4-cylinder, in-line	
汽缸容積 (公升) Cylinder Capacity (L)	1.998	
最大馬力 Max. Power	84 kW @ 5500 rpm	
最大扭力 Max. Torque	170 Nm @ 2700 rpm	
石油氣缸容積 (公升) LPG Tank Capacity (L)	116

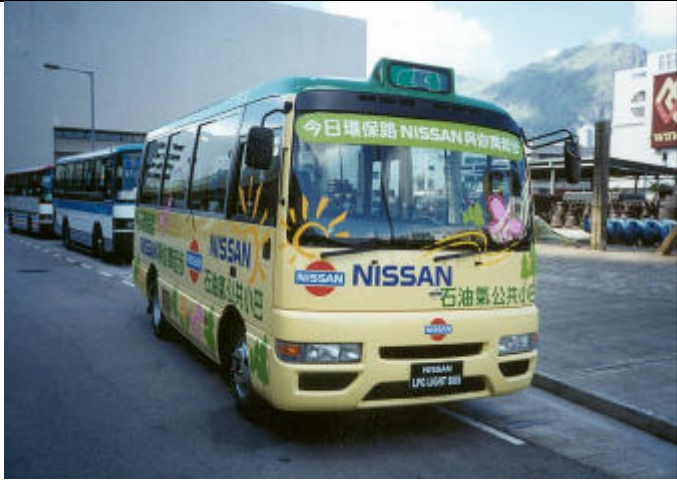
車廠 Make	Nissan

型號 Model	Civilian	
引擎類別 Engine Type	直列 6 汽缸 6-cylinder, in-line	
汽缸容積 (公升) Cylinder Capacity (L)	4.169	
最大馬力 Max. Power	90 kW @ 3600 rpm	
最大扭力 Max. Torque	270 Nm @ 2000 rpm	
石油氣缸容積 (公升) LPG Tank Capacity (L)	126.5
