2012年11月27日會議
討論文件

立法會發展事務委員會
有關保存在地盤發現的歷史遺跡的政策和事宜

港鐵在金鐘夏慤花園工程地盤發現歷史遺蹟

港鐵在金鐘夏慤花園工程地盤所發現的遺蹟的相片

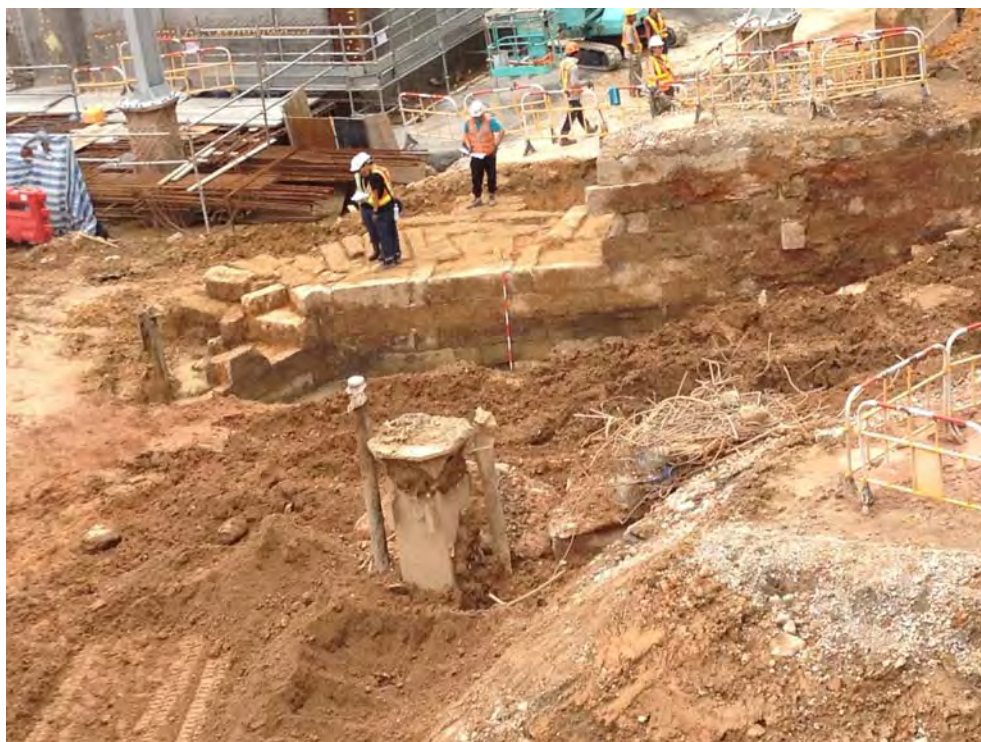
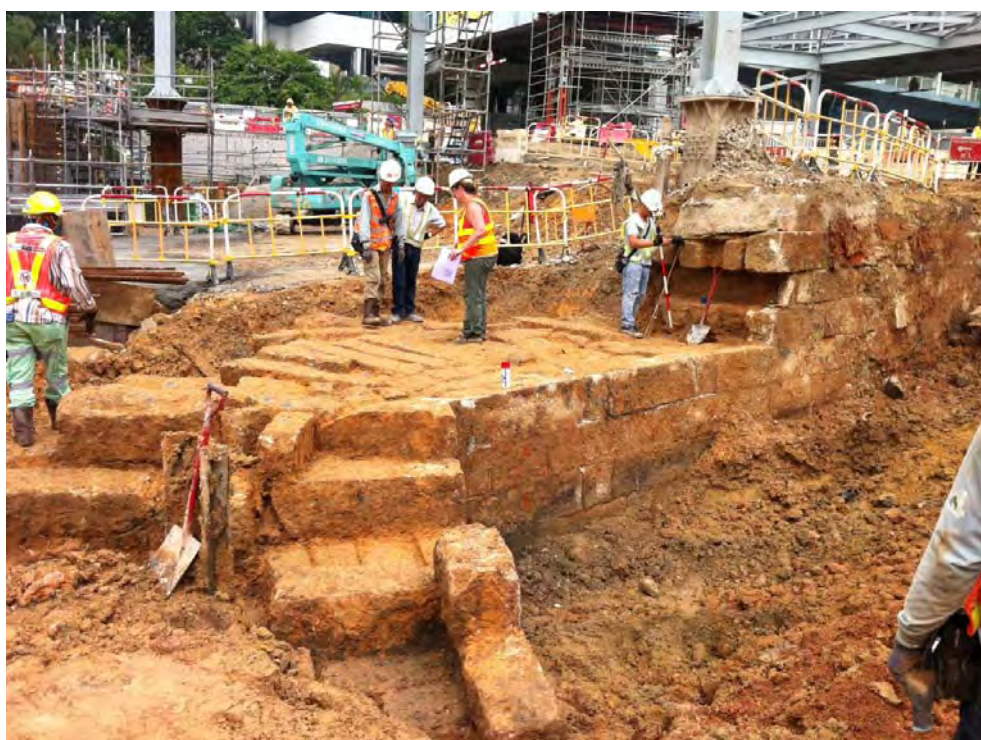
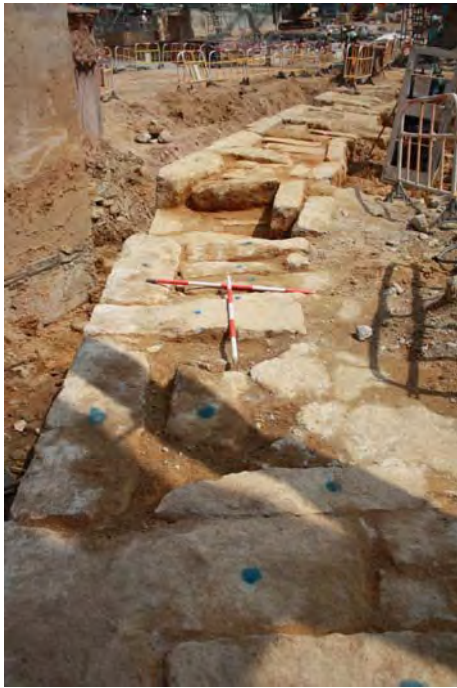
時間	有關事項
2010年10月	根據獲批准的南港島線(東段)工程環評報告建議，港鐵須在夏慤花園工地施工期間，委聘考古學家進行考古觀察。
2011年5月	根據《古蹟條例》，港鐵委聘的考古學家（該考古學家曾多次參與香港的考古發掘）就有關考古工作向古物事務監督轄下的古蹟辦遞交牌照申請，列出考古觀察的操作安排(包括進行考古挖掘的範圍和方法，以及如有發現，會通知古蹟辦)。經古蹟辦審核，並獲得古諮會的支持下，古物事務監督向申請人發出牌照。
2011年6月	港鐵委聘的考古學家通知古蹟辦在夏慤花園工地開始進行考古觀察。期間，古蹟辦與港鐵委聘的考古學家保持溝通以了解最新情況。
2012年9月25日	古蹟辦接獲港鐵委聘的考古學家通報發現遺跡（相片見 <u>附件B</u> ）。此通報是根據考古工作牌照的有關條款發出(即規定考古觀察須按牌照申請人在申請牌照時所提交的資料進行；而有關申請資料述明申請人如發現構築物遺跡須通知古蹟辦)。
2012年9月26日	古蹟辦派內部具專業考古學訓練的博物館館長職系人員（“古蹟辦專業人員”）實地視察及與港鐵委聘的考古學家討論，雙方均認為被發現的建築構件並不是威靈頓炮台的一部分，而是十九世紀中期的海堤的一小部分，並且海堤已受到早年多次工程所破壞。
2012年10月上旬	港鐵委聘的考古學家指出由於所發現的遺跡是殘存海堤，海堤亦已受到早年多次工程所破壞，遺跡文物價值相對不高，且位於金鐘站擴建工程施工的主要位置，不宜原址保存，並建議以詳細紀錄的方法，包括利用照片、繪圖及

時間	有關事項
	文字方式紀錄。此建議是根據考古工作牌照的有關條款提出(即規定考古觀察須按牌照申請人在申請牌照時所提交的資料進行;而有關申請資料述明申請人須就發現的物品的跟進工作徵詢古蹟辦及取得其同意)。古蹟辦經研究後,同意上述處理方法,並建議將部分海堤的石塊保存下來,日後再利用及作適當詮釋。港鐵接納古蹟辦的建議,並已將狀況良好的石塊妥為存放。
2012年10月18日	古蹟辦專業人員再次實地視察,確定未有更多遺跡發現。

9. 目前,有關考古觀察的工作仍在進行。港鐵委聘的考古學家會於**2013**年中南港島線(東段)考古工作完成後,把詳細報告提交古蹟辦。一如其他考古發現的安排,古蹟辦會向古諮會匯報相關發現。雖然,於金鐘夏慤花園發現的遺跡只為殘存海堤,文物價值相對不高,但鑑於公眾對是次發現的關注,古蹟辦於**2012**年**11**月**1**日已安排古諮會成員到港鐵工地現場視察。此外,古蹟辦亦安排了香港大學房地產及建設系專門研究香港採石業歷史的潘新華教授和其研究團隊的馬冠堯工程師,以及香港浸會大學歷史系研究軍事歷史的研究助理教授鄭智文博士到工地視察,進一步認定遺跡為殘存海堤,而不是炮台遺跡。
