WWF-Hong Kong

**RE: Investigation into Government control measures
against illegal land filling and fly-tipping activities on private land**

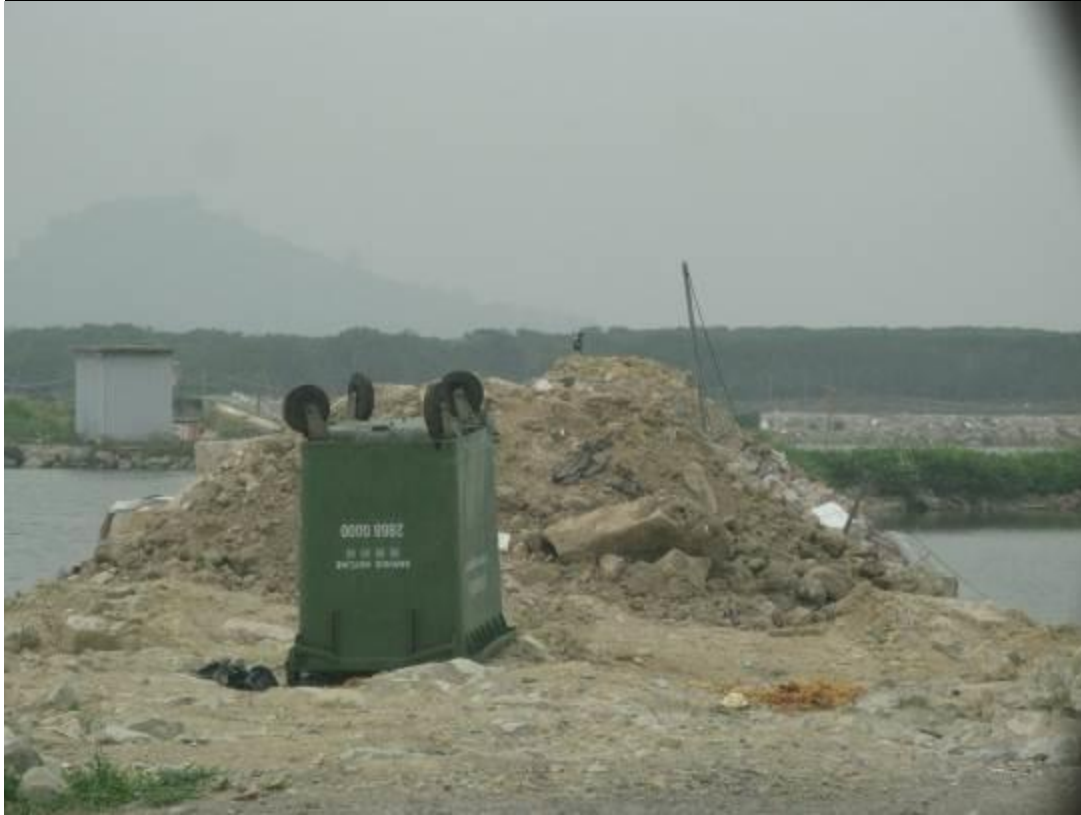
Fig 1 Illegal dumping activities at a Deep Bays fish pond (photo taken on 20 Feb 2013)

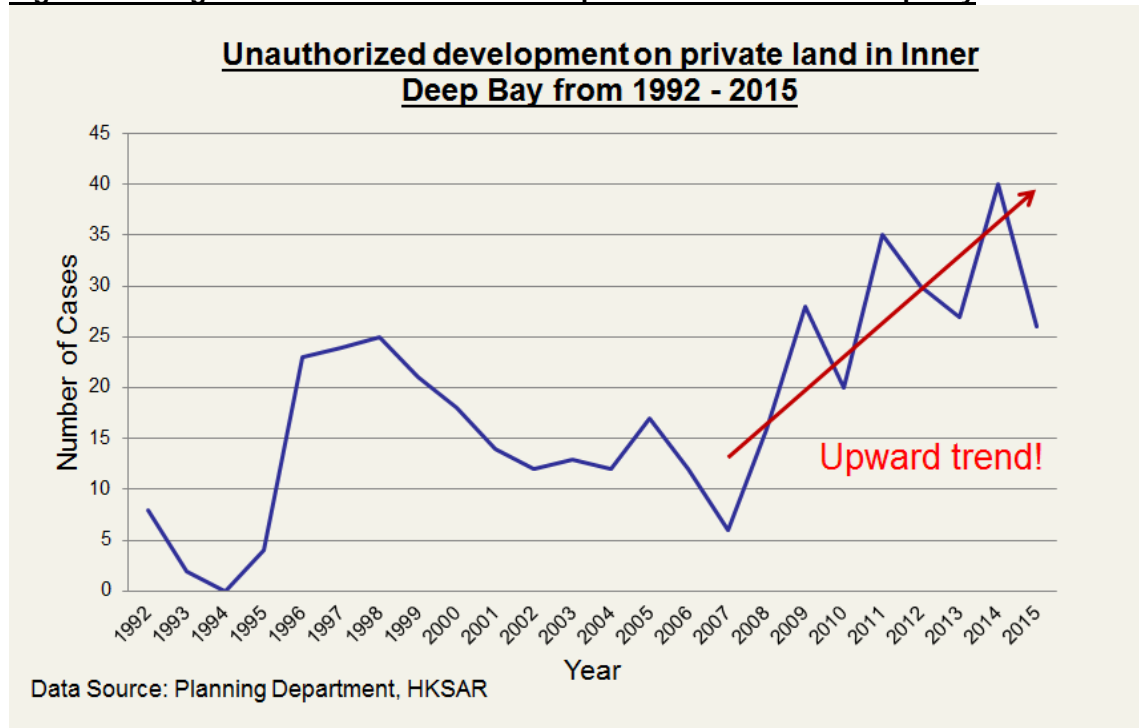
We are concerned that records even for areas that are regulated by statutory land use plans, show a rise in illegal dumping activities. Of particular concern to WWF are both the fish ponds of the Inner Deep Bay, which together with other wetland habitats in Mai Po, support tens of thousands of migratory water birds and are of international significance. Even though these fish ponds receive additional protection from private development by the Town Planning Board Guidelines 12c, unauthorized developments involving land and/or pond filling, land formation and waste dumping frequently occur (Fig 2).

Fig 2 The rising trend of unauthorised development cases in Inner Deep Bay

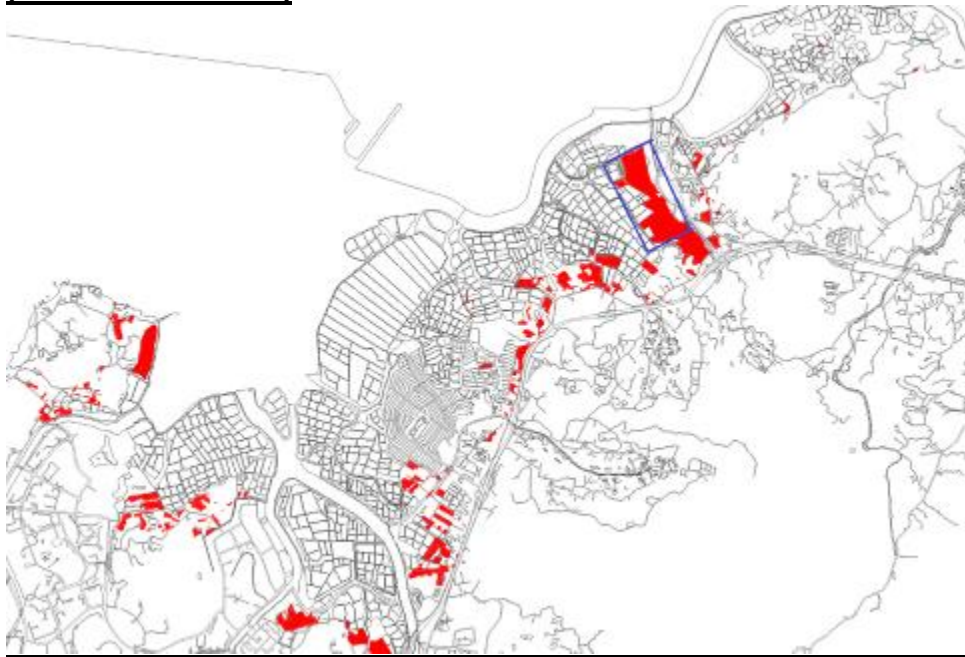
WWF's Deep Bay Unauthorized Development Report⁶ (the Deep Bay Report) shows over the last 25 years there were 435 unauthorized development cases with 153 ha of affected private land found to be within the Wetland Conservation Area and Wetland Buffer Areas of Inner Deep Bay (Fig 3). One particular example of degradation of ecologically important land is an area along Tun Yu Road in San Tin, with over 10 unauthorized development cases occupying an area larger than 15 soccer fields (the blue box in Fig 3).

Fig 3 Locations of the 435 unauthorised development cases in Inner Deep Bay (shown in red areas)

Note: The affected area at Tun Yue Road is marked with blue outline
Data source: Planning Department, HKSAR

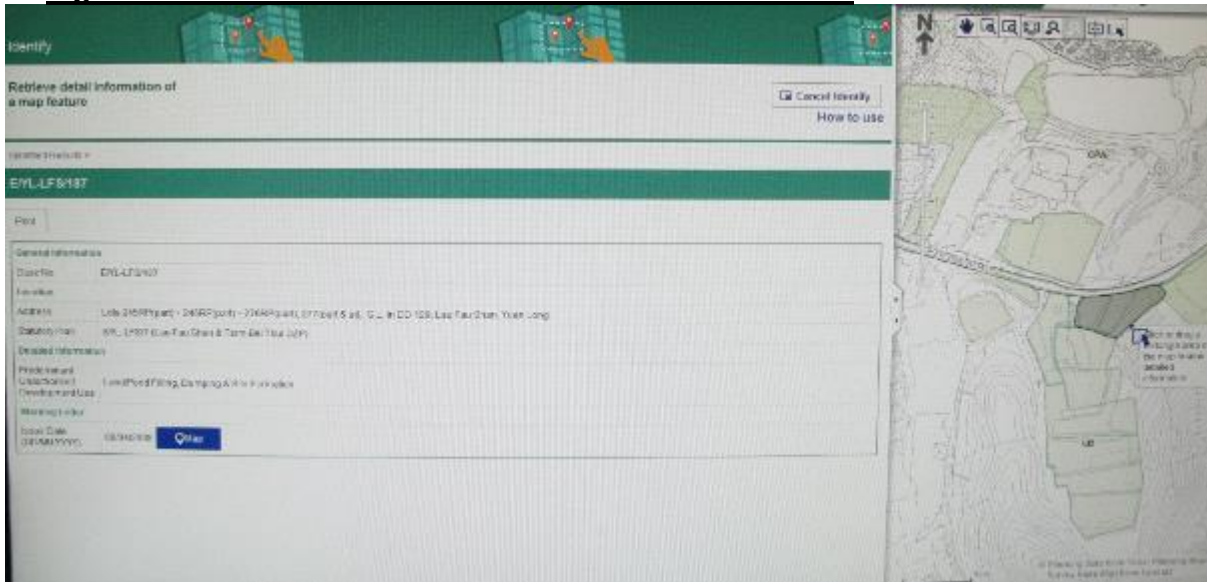
Our Deep Bay Report also shows that in only 55% of the pond filling cases were persons required to reinstate land back to fish ponds. This can result in a net loss of important wetland habitat close to the Inner Deep Bay Mai Po Ramsar Site. There was a pond filling and site formation case (E/YL-ST/002) at Mai Po Lung in which PlanD issued compliance notice to the recipient without the requirement of reinstatement. This apparently resulted in further unauthorized developments and changes in land use in the subsequent 15 years with more enforcement cases (E/YL-ST/147 and E/YL-ST/239). By not requiring offenders to reinstate land back to ponds to redress ecological degradation, there is not enough deterrent and such practice may encourage further illegal dumping. There are a number of other cases where illegal pond filling led to further encroachment to the surrounding ponds and land (e.g. E/YL-LFS/187, Fig 4a, 4b, 4c, and adjoining 6 cases).

Fig 4a Enforcement Information of the E/YL-LFS/187 case

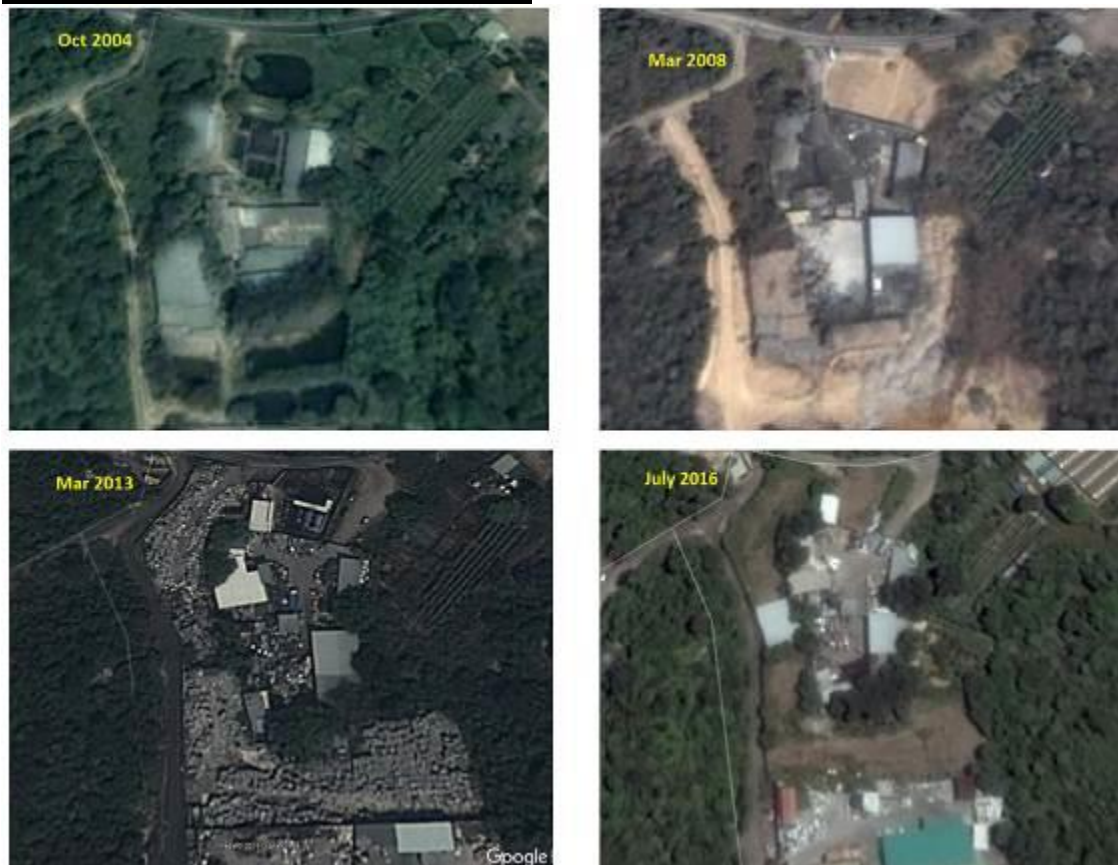
Fig 4b Unauthorised development and landscape change continued in the general area of the E/YL-LFS/187 case

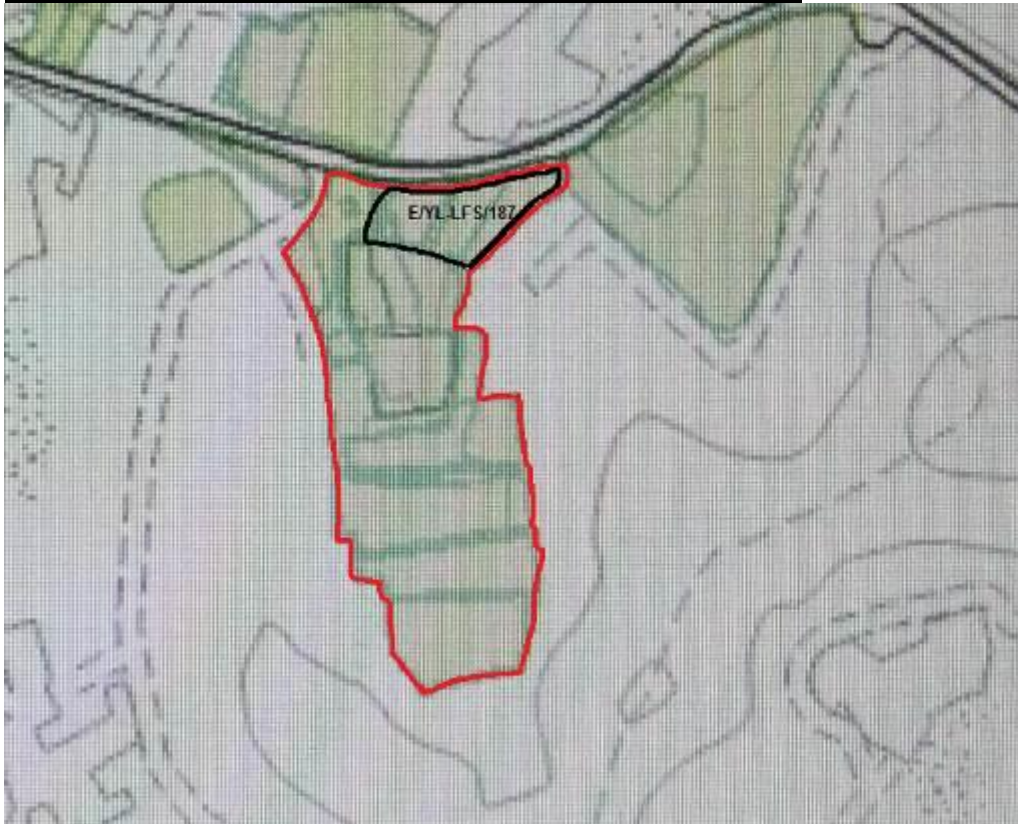
Fig 4c Subsequent to the E/YL-LFS/187 case, over 15 unauthorized development cases had been enforced in the adjoining area (within the red outline)

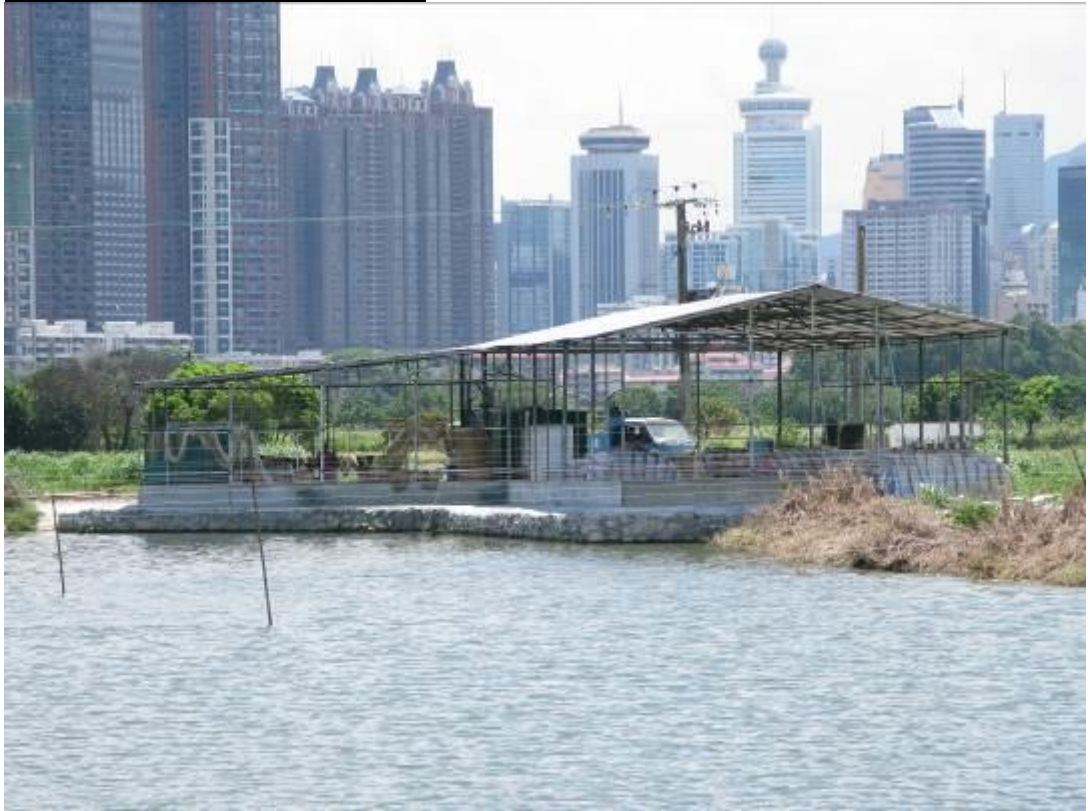
Even when a reinstatement notice is given, it may take a long time to resolve. The pond filling case E/NE-MTL/003 at Hoo Hok Wai “Conservation (1)” zone happened in 2015 (Fig 5a). The reinstatement notice stipulated the recipient “*to remove all fill materials (including concrete) deposited in the pond...*” and the notice has expired on 21 Oct 2015 (Fig 5b and 5c) but the structure built on the filled area remains along the pond edge.

Fig 5a Unauthorised development in the E/NE-MTL/003 case at Hoo Hok Wai (photo taken on 19 June 2015)

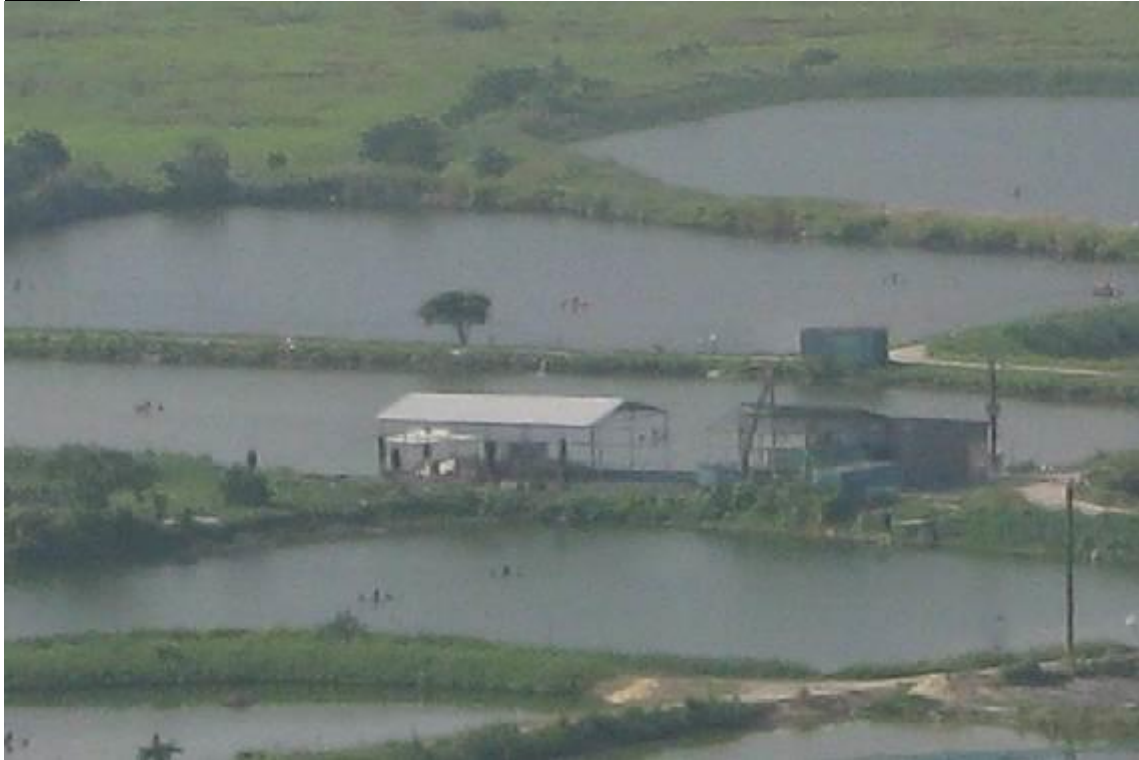
Fig 5c The emergent structure remains in the pond, only the roof that encroached into the Government land has been removed (photo taken on 19 June 2015)

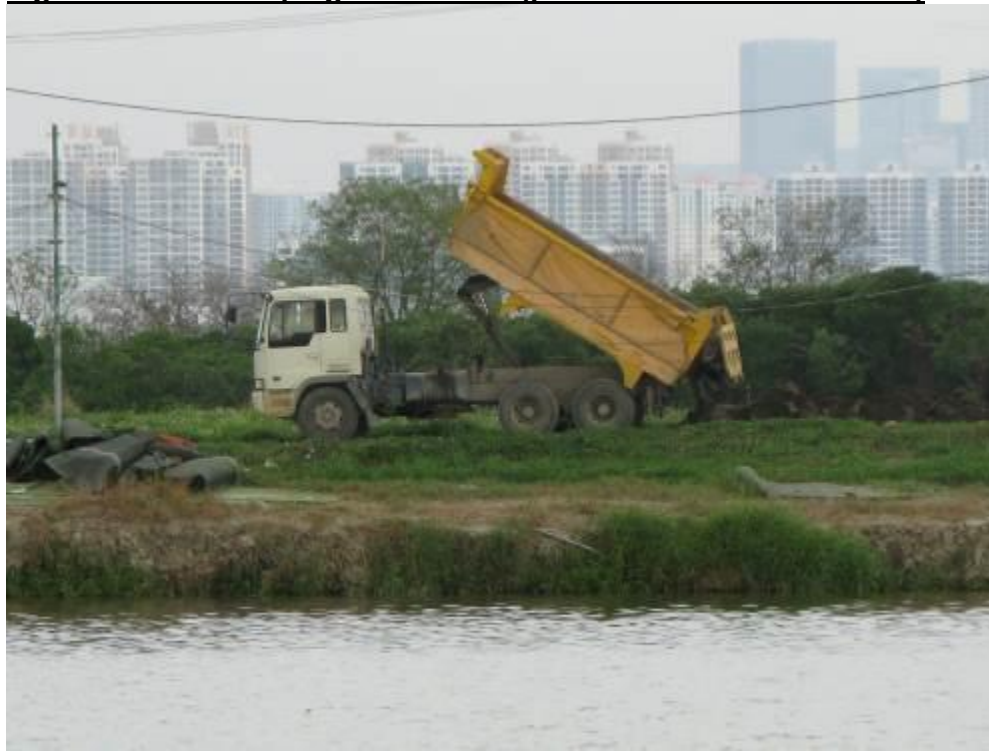
Fig 8b A truck dumping at Lut Chau (photo taken on 19 Mar 2013)

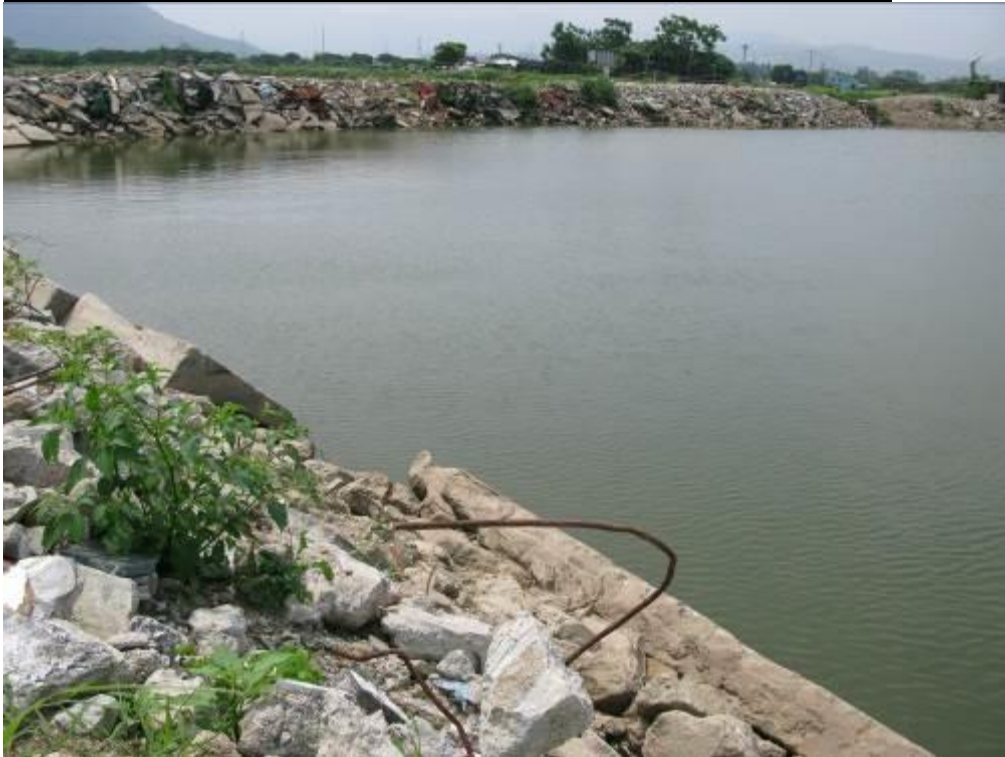
AFCD wardens patrol many areas of ecological importance and can be an effective frontline force to respond to complaints of suspected illegal dumping. In the case of some fish pond operators introducing construction and demolition (C&D) waste in Deep Bay fish ponds, AFCD has so far found this to be a common practice conducted by fish farmers to facilitate transportation of feed, harvest and equipment. (Fig 9a). These commercial fish ponds naturally attract feeding migratory water birds and the concern is that continued practice introducing quantities of C&D waste may unnecessarily degrade fish pond habitat, affecting the health of the fish on which both people and migratory water birds feed. Government should carefully monitor the practices of commercial ponds and conduct testing to ensure the health of fish for human consumption (Fig 9b).

Fig 9b Dumping of C&D waste at a fish pond that has joined AFCD's accredited fish farm scheme (photo taken on 12 May 2016)

- The government should help the fish pond operators to locate sources/suppliers of environmental friendly material for the fish pond operators to use in strengthening their pond bunds rather than use C&D waste. The health of fish produced and available for human consumption at fish po RE should be subject to testing for health safety.

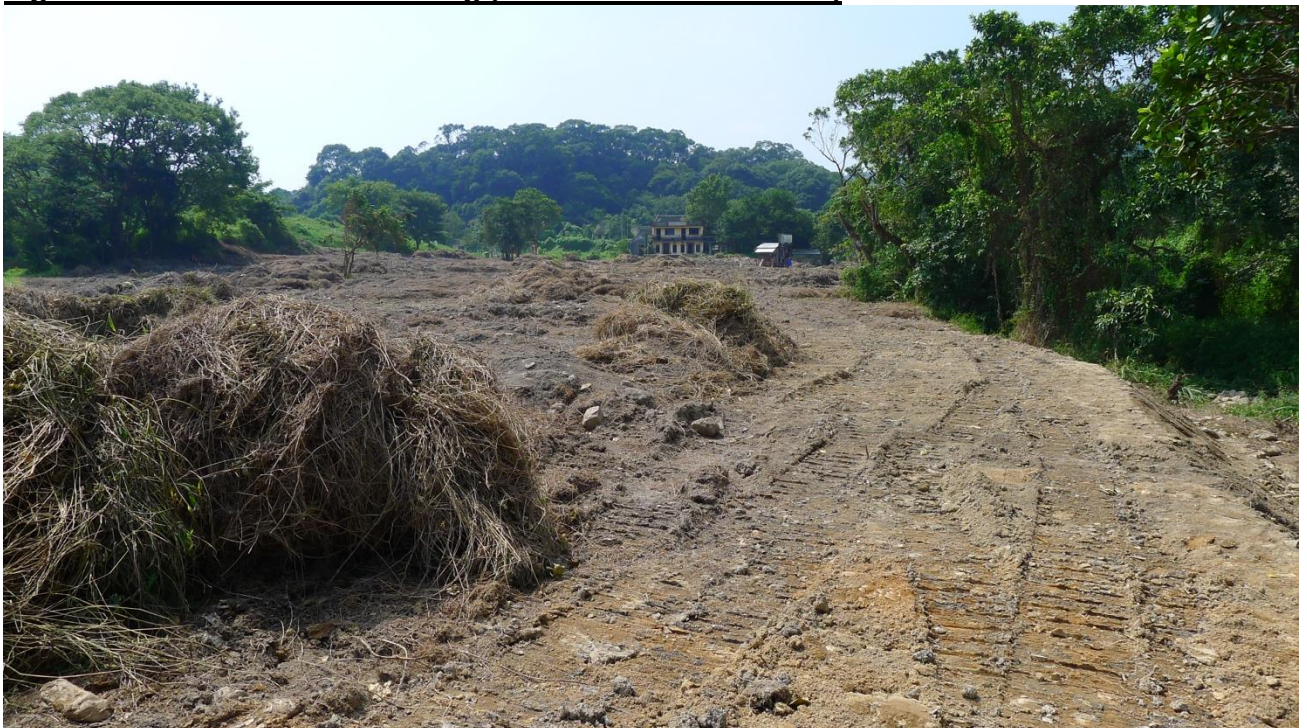
Fig 10 Destruction of Sha Lo Tung (Photo taken in Oct 2015)

- Ecologically-important enclaves even those with private land rights should be incorporated into country parks for proper protection. This should also apply to those important enclaves that are already covered by statutory land use plans such as Sha Lo Tung and Tai Ho.
- AFCD needs to expedite the process of incorporating enclaves into the country parks, if they meet the criteria adopted in May 2011¹¹ by producing a clear timetable for their incorporation.
