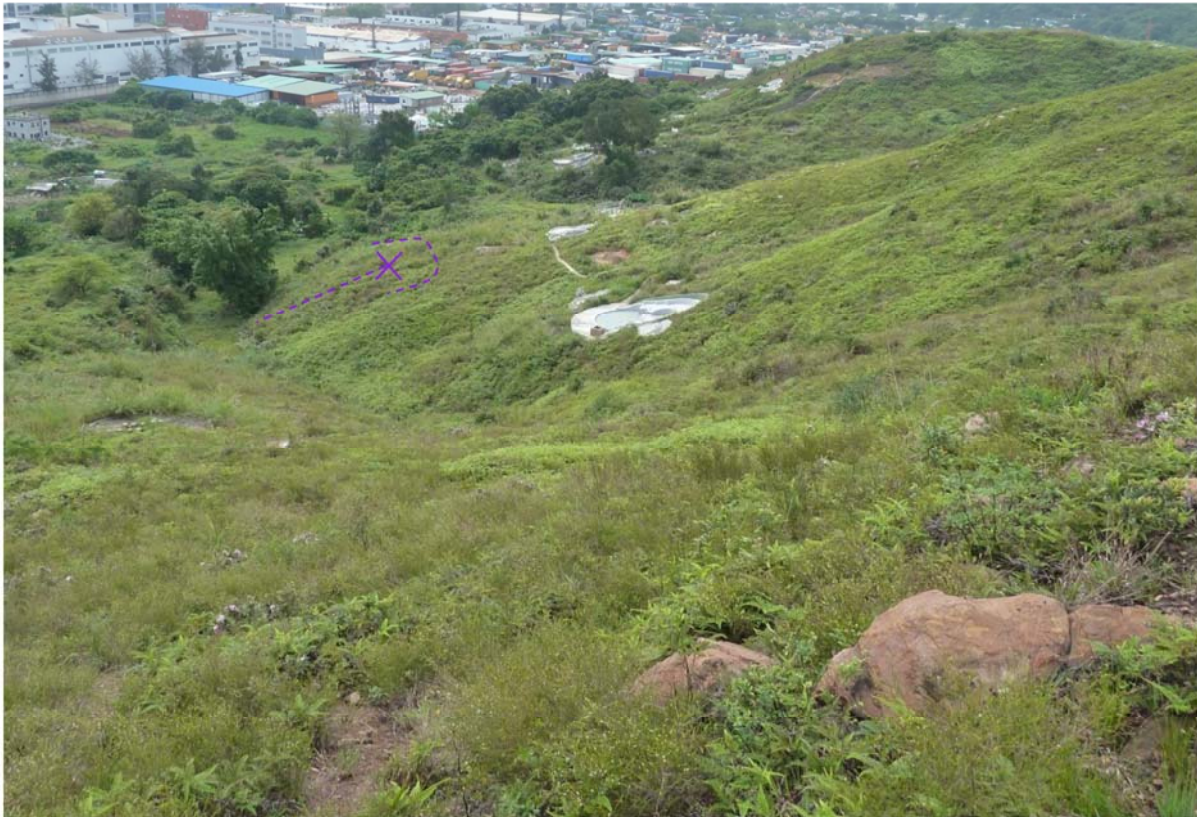
Photo above: Re-vegetated landslide scar is at the hillslope.

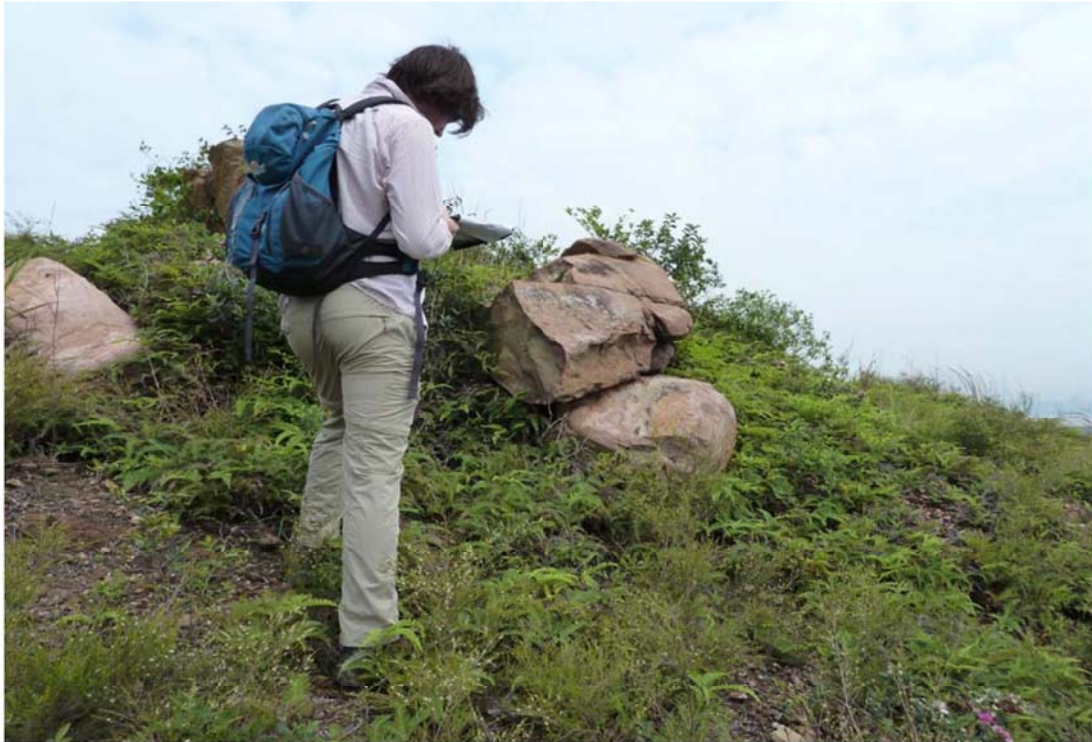
Photo 1: Angular boulder is in good contact of soil and stacking on top of another boulder.

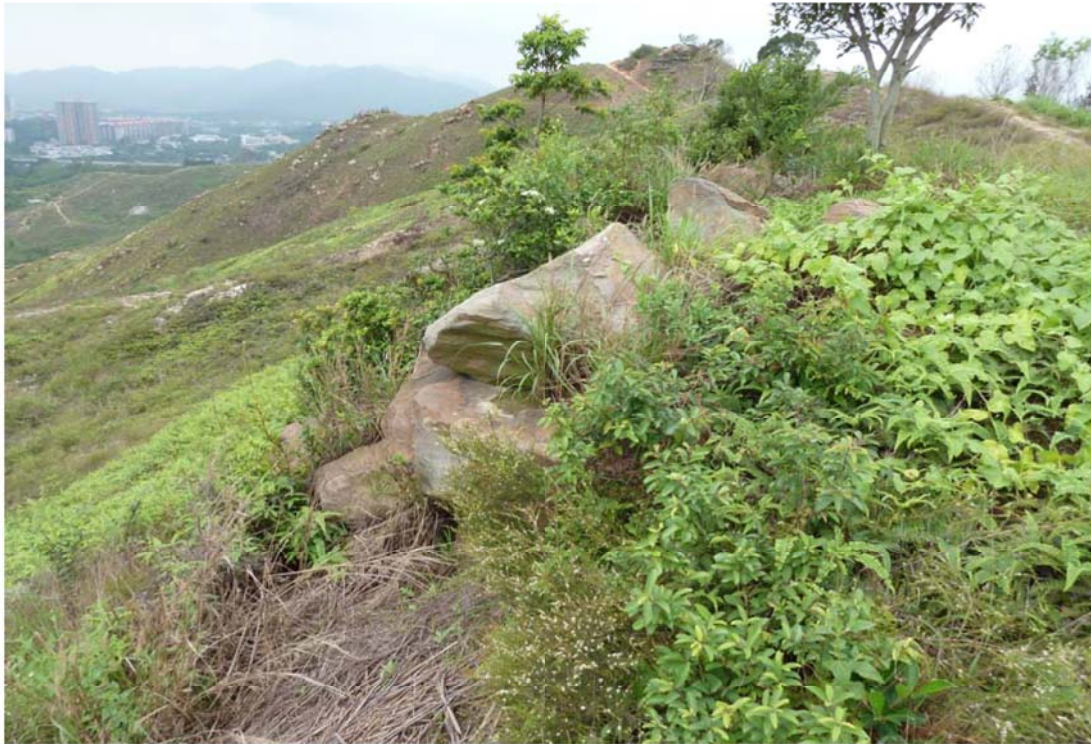
Photo 1: Sub-angular boulder cluster was observed at hilltop.

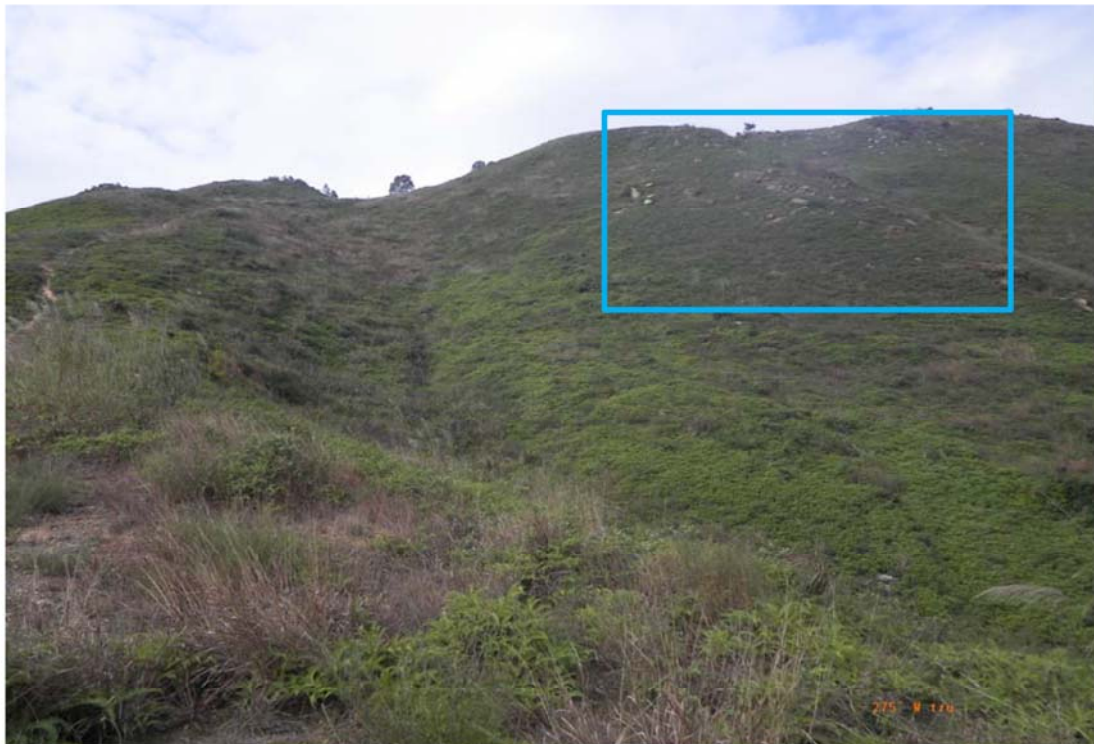
Photo 1: Sub-angular boulder cluster on ridgeline was observed.

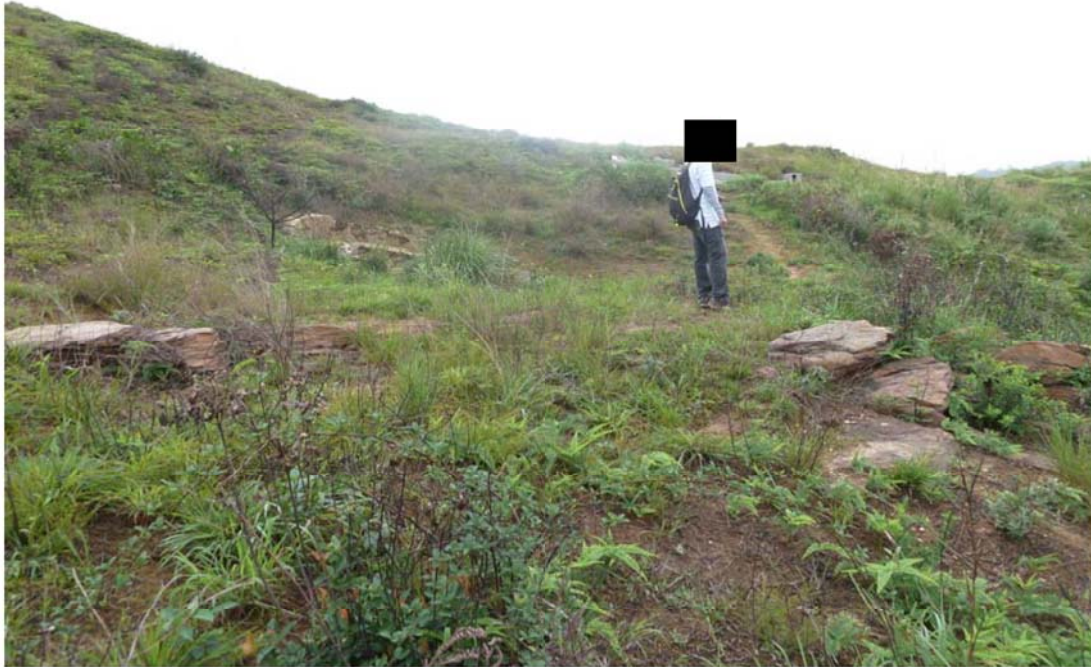
Photo 1: Sub-angular boulder cluster was observed.

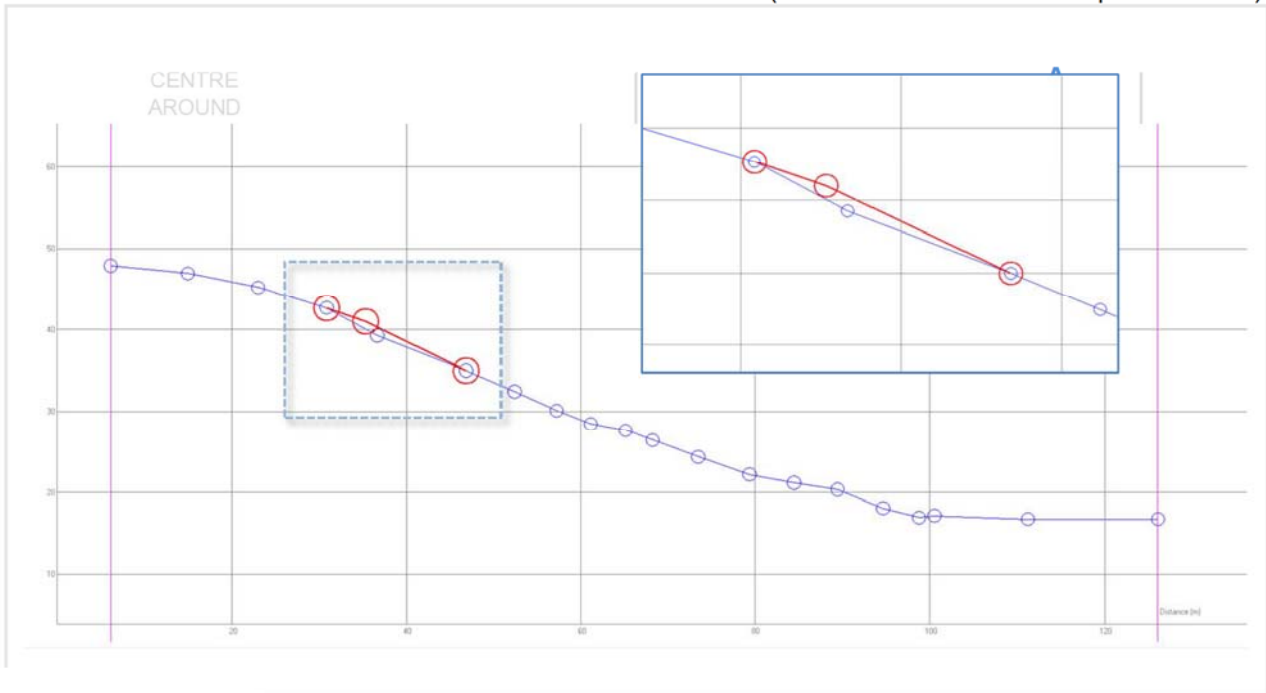
Failure ID	F-AB1	Estimated Source Volume	100.00 m ³
Hazard Type	OHL	Estimated Entrainment Volume	0 m ³

SECTIONAL PROFILE

Rheology	Unit Weight (kN/m ³)	Friction Angle (°)	Pore Pressure Coefficient	Friction Coefficient	Turbulence Coefficient	Internal Angle of Friction (°)	Erosion Depth (m)	
							Min	Max
Voellmy	20	25	-	-	-	35	0	0
