**LegCo Joint Subcommittee to Monitor the Implementation of
the West Kowloon Cultural District Project**

**Update on the Construction of L1 and L2 Works Contracts
for the Lyric Theatre Complex and the Extended Basement**

25 November 2019

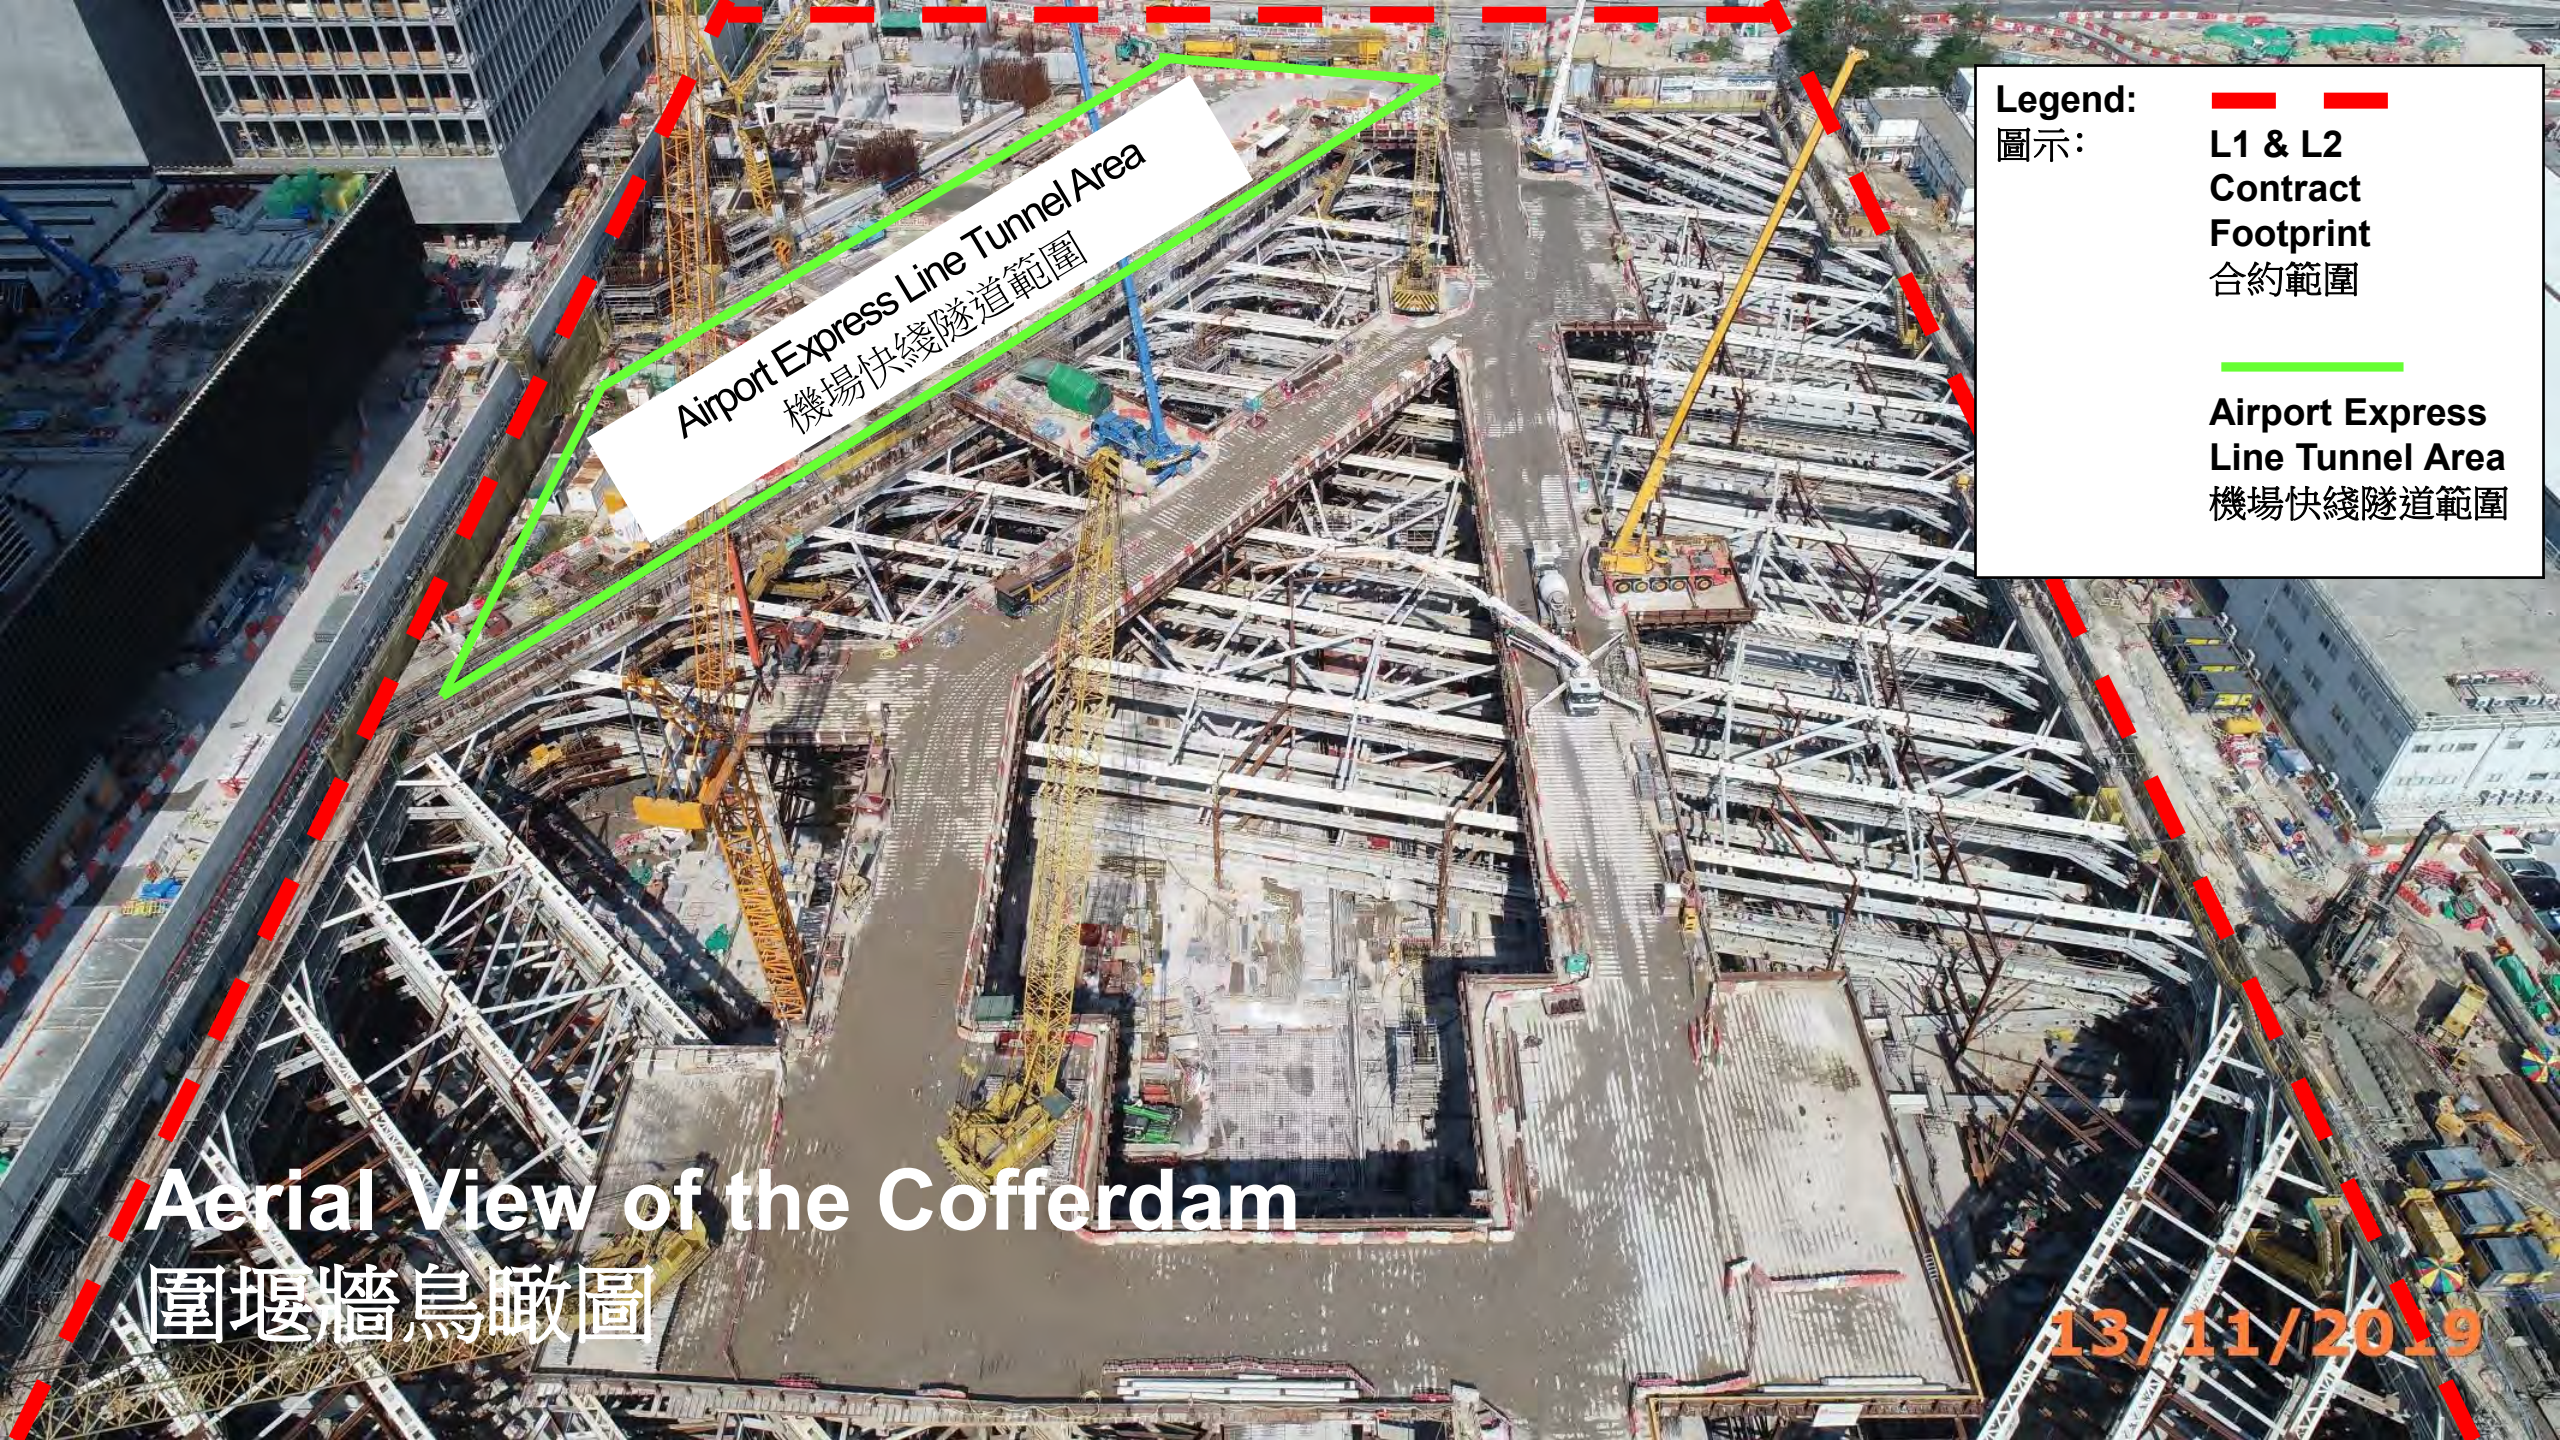
Aerial View of the Cofferdam
圍堰牆鳥瞰圖

Airport Express Line Tunnel Area
機場快綫隧道範圍

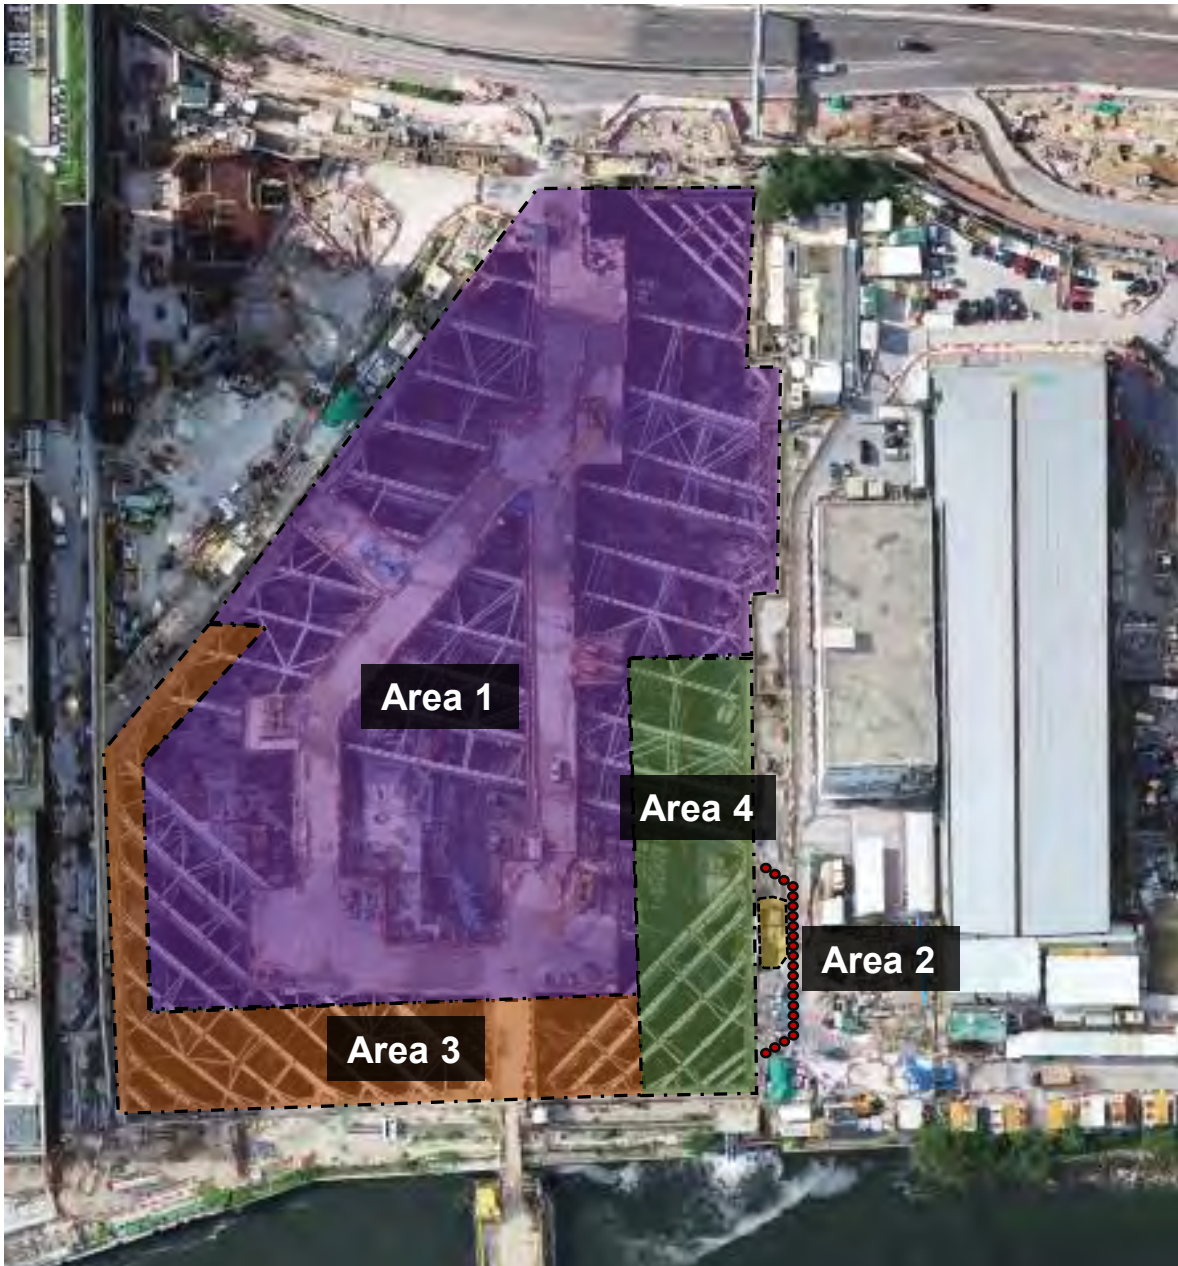
Area 範圍 1:

- Stage 1 BD submission approved on 23 August 2019
於2019年8月23日獲屋宇署批核階段 1申請
- Basement works restart
地庫工程重新展開
- Removal of northern S4 struts will follow.
拆卸北面S4支撐杆將緊接進行

Area 範圍 2:

- Stage 2 BD submission approved on
20 September 2019
於2019年9月20日獲屋宇署批核階段 2申請
- Clutch pipe pile works in progress, completion on
6 December 2019.
互扣式管樁牆工程進行中，預計2019年12月6日完成

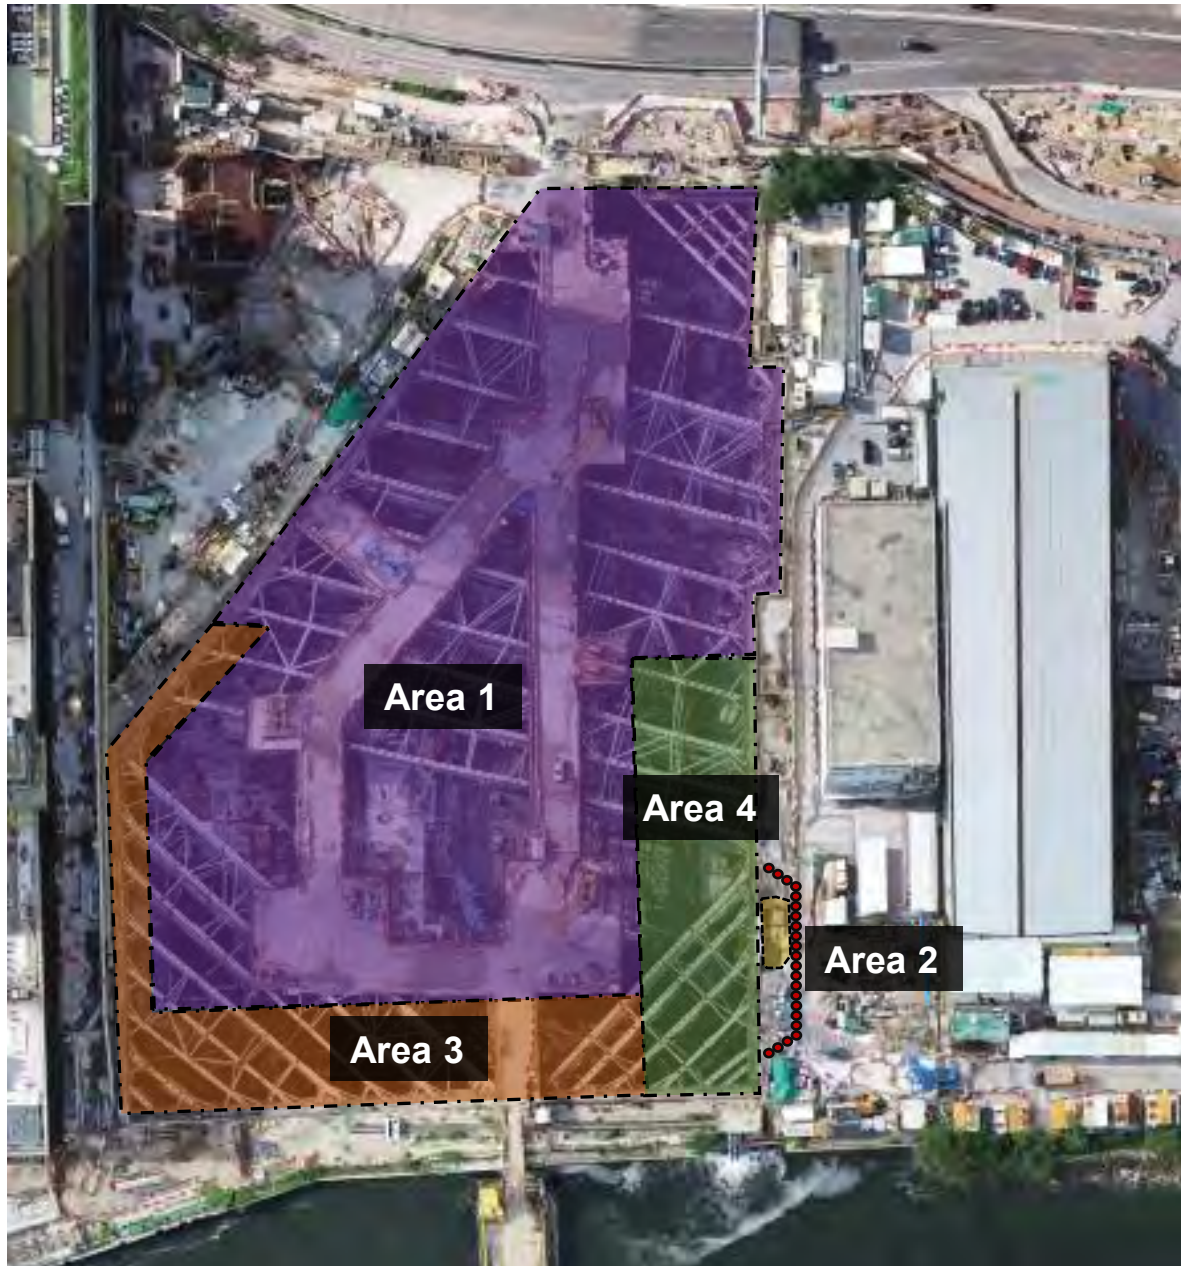
Area 範圍 3:

- Stage 3 BD submission approved on 30 October 2019, allowing strutting and excavation to commence.
於2019年10月30日獲屋宇署批核階段 3 申請，容許架設支撐杆和挖掘工程展開
- ELS Installation in progress.
側向支撐工程正在安裝中
- Excavation of the west and south berms commence by 25 November 2019.
西邊和南邊泥台的挖掘工程在2019年11月25日展開

Area 範圍 4:

- In final discussion with Buildings Department regarding the Incident Investigation Report
正就事件的調查報告，與屋宇署進行最後階段商討
- **Basement works on HOLD until**
地庫工程暫停直至
 - i) Completion of clutch pipe pile works
完成互扣式管樁牆工程
 - ii) BD acceptance of the Investigation Report
屋宇署接納調查報告
 - iii) BD approval of the ELS design review submission
屋宇署批核檢視後的挖掘側向支撐工程設計

- For Area 4 works to proceed
範圍 4 復工前提為
 - BA14 for clutch pipe-pile wall (anticipated end November 2019)
互扣式管樁牆工程BA14 表格獲批(預料於2019年11月底)
 - Acknowledgement of Investigation Report (anticipated early December 2019)
調查報告獲接納(預料於2019年12月初)

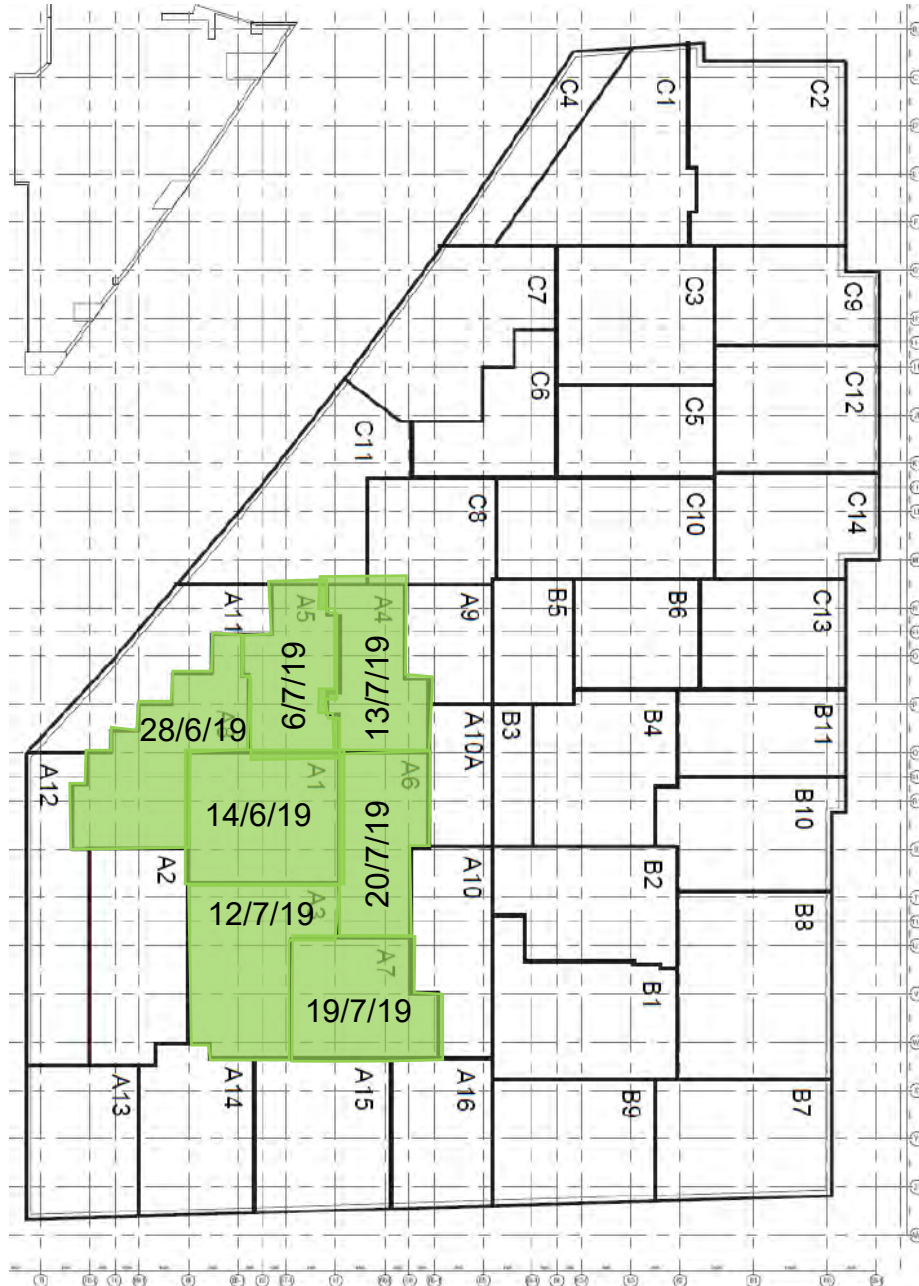
L1 Pile Caps and Foundation Slabs Construction

Concreting Completed
完成混凝土澆灌
