**Final Report of the Investigation into the incident
that occurred on 5 September 2002
at North Point Station of the Tseung Kwan O Line**

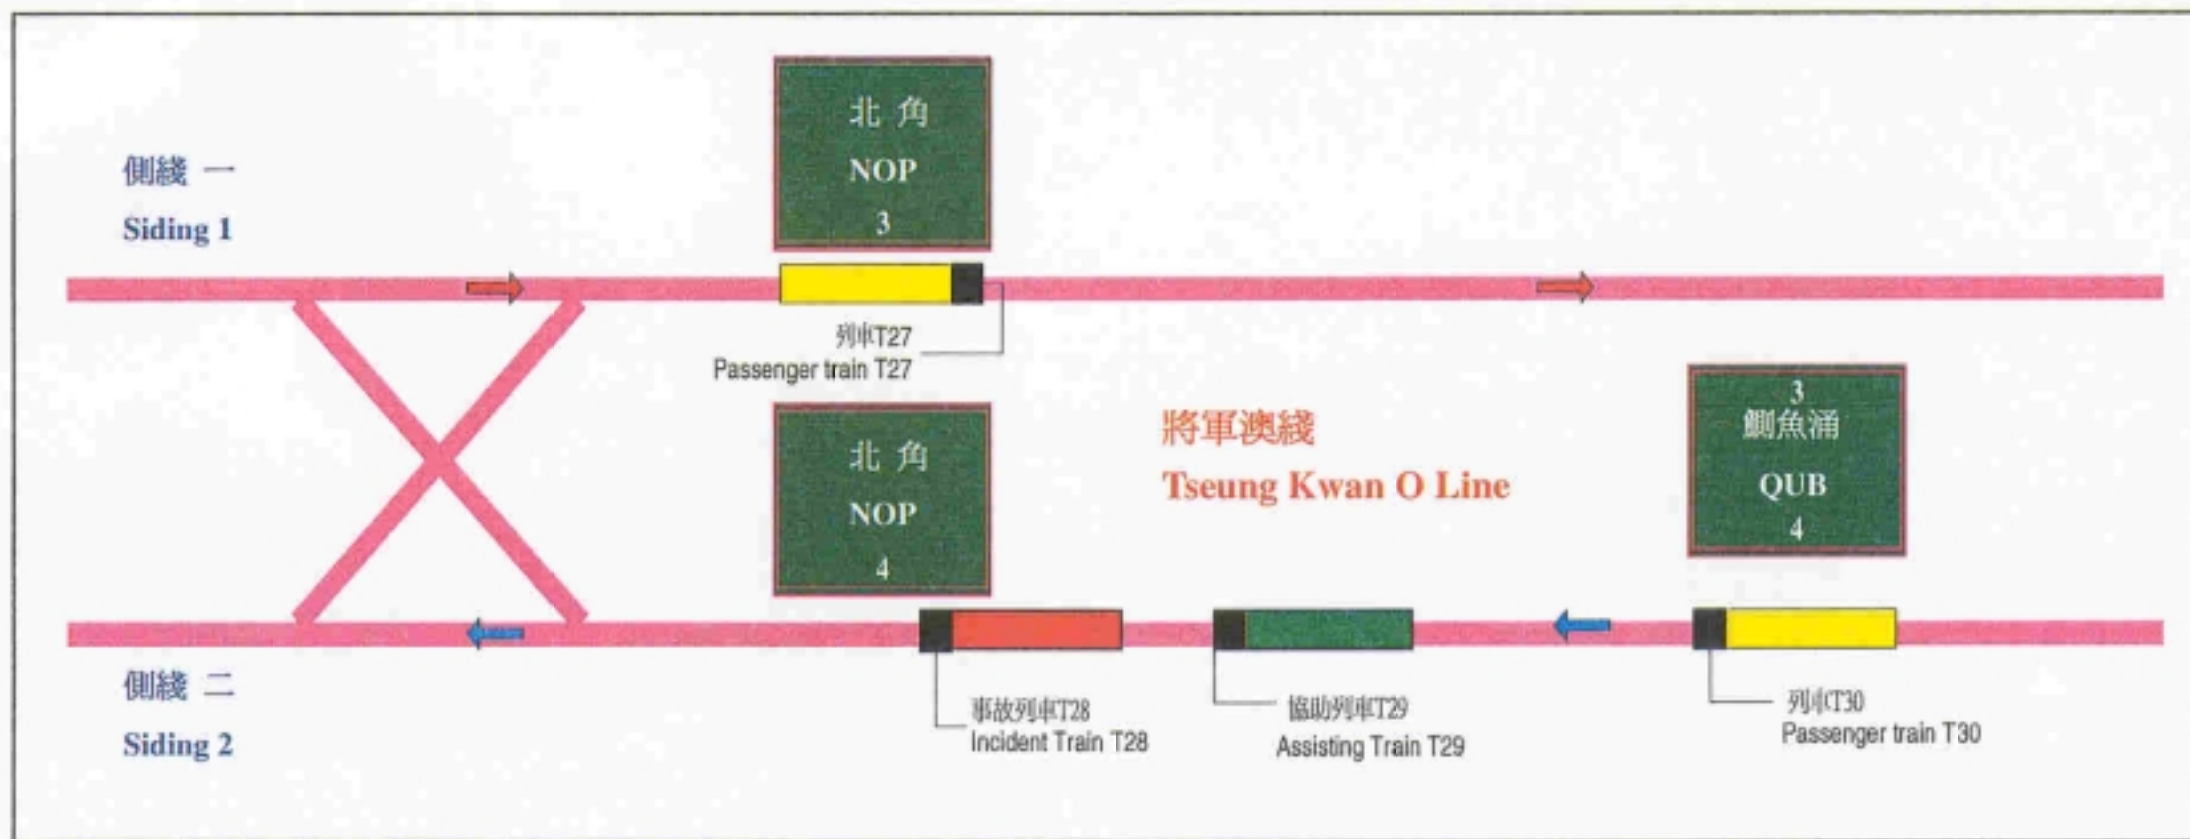
Diagram 1: Layout of the Incident Site at North Point

2. On Thursday, 5 September 2002, a service disruption occurred on the Tseung Kwan O Line. As Passenger train T28, running from Po Lam Station to North Point Station, with passengers on board, entered platform 4 at the North Point Station at 0838 hrs, the train was brought to a stop with only the first 2-cars in the platform (see Diagram 1).
