**Legislative Council**

**Panel on Development**

**DEFORMATION OF ROAD SURFACES ON BRIDGES**

## Deformation of Road Surfaces on Bridges

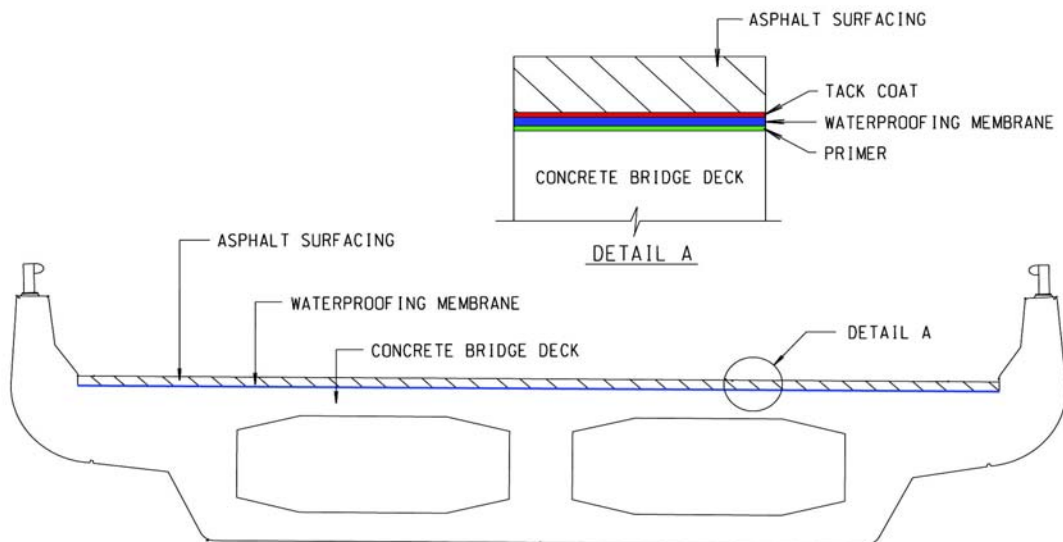
Figure 1 – Typical cross section of asphalt surfacing and bridge deck waterproofing membrane on a concrete bridge

reinforcement and stressed steel tendons inside the bridge, corrosion protection measures were adopted in these bridges. As an added line of defence, a waterproofing membrane was applied on the bridge deck surface. A layer of tack coat was applied to provide adhesion between the asphalt surfacing and the membrane. A typical cross section of a bridge deck of such construction is shown in Figure 1.

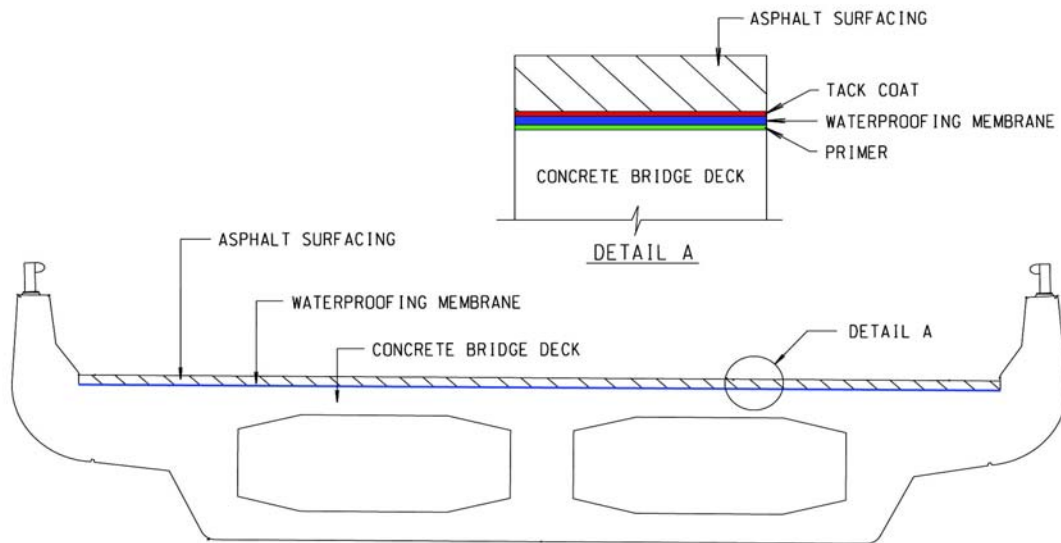
Figure 1 – Typical cross section of asphalt surfacing and bridge deck waterproofing membrane on a concrete bridge

4. A number of measures are used to prevent such corrosion. The steel tendons are encased in sheaths and grout is injected into the sheaths to fill up the space around the steel tendons. The reinforcements are embedded to sufficient depth in the concrete to prevent attack of corrosive materials seeping through shrinkage cracks at the concrete surface. The construction joints between segments are sealed with epoxy resin to prevent seepage of water. Above these corrosion protection measures, some bridge designers consider that a waterproofing layer should be provided before the asphalt surfacing is laid so that an added line of defence against corrosion can be provided. Figure 1 in the Appendix shows a typical cross section of a bridge deck with waterproofing membrane and asphalt surfacing.

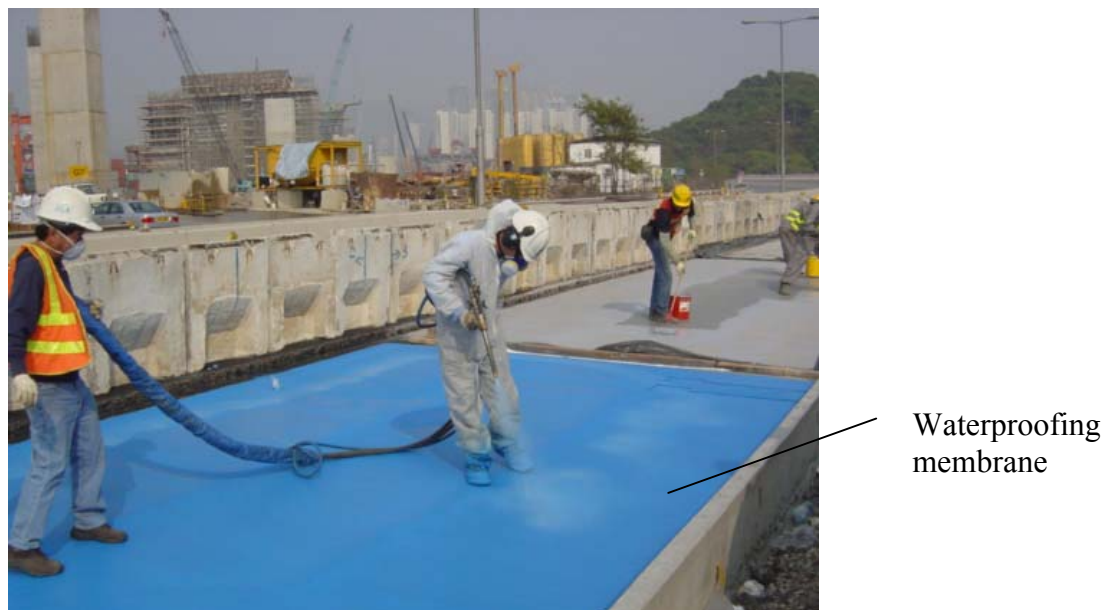
Figure 4 – Construction of trial panels of waterproofing systems under the Ngong Shuen Chau Viaduct Contract

18. A site trial consisting of seven trial panels was also conducted at a newly diverted at-grade section of Container Port Road South under the NSCV Contract. The purpose of the trial was to demonstrate the on-site application method of the waterproofing membranes, and to assess the long term adhesion performance of the waterproofing membranes to the concrete deck and the asphalt surfacing under real life traffic loading. The trial panels were constructed with the three waterproofing membranes proposed under the contract, with different asphalt surfacing thicknesses ranging from 50 mm to 120 mm (excluding friction course thickness) and different drainage conditions. Strain gauges connected to computers were installed in the asphalt surfacing to obtain field measurement data related to deformations. Figure 4 in the Appendix shows the construction of the trial panels under the NSCV contract and Figure 5 shows the computer installations. Trial panels were also constructed in two other contemporary bridge contracts to assess the site performance of other tack coat and polymer waterproofing membrane systems.

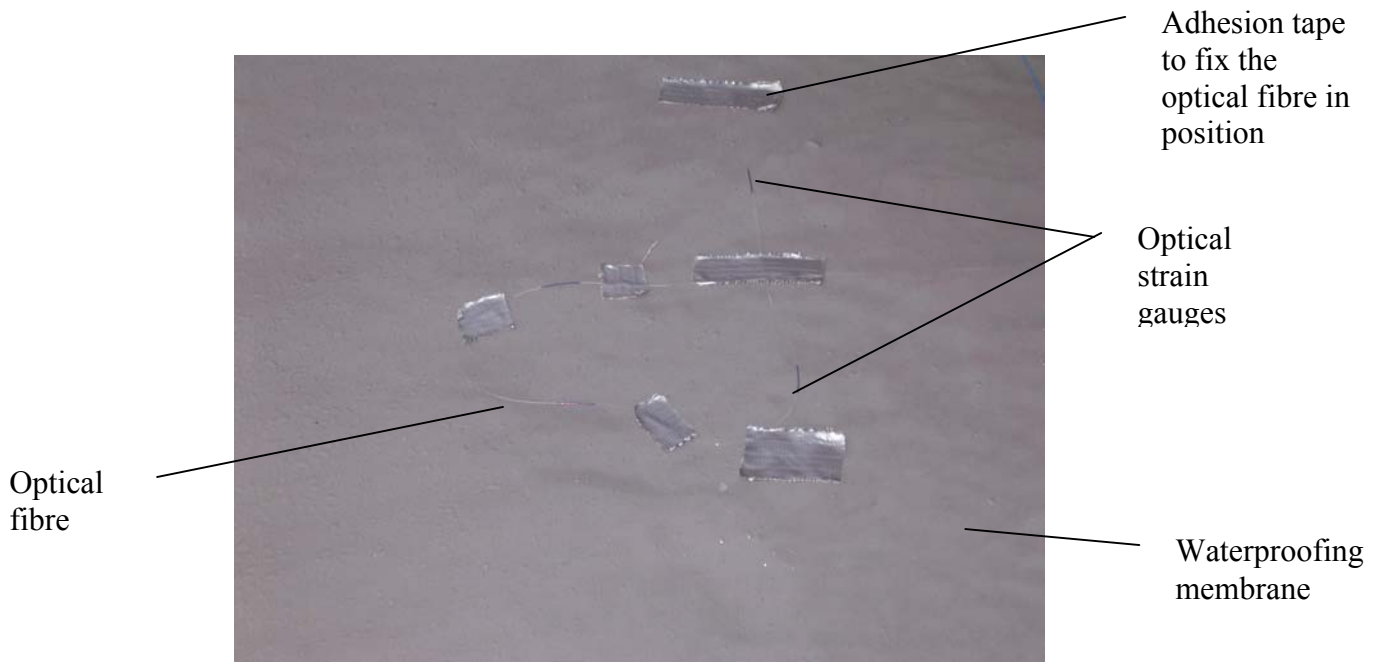
Figure 7 – Optical strain gauges installed on a waterproofing membrane trial panel on a bridge deck of Yuen Long Highway

22. Despite the useful information obtained in the NSCV research, it was not possible, with the equipment installed, to derive the actual stresses at the waterproofing membrane so as to decide whether the required adhesion strengths between the asphalt surfacing and the waterproofing membrane specified in the contract are adequate or over-provided. In order to investigate the actual stresses experienced by the waterproofing membrane, further trial panels with optical strain gauges embedded into the waterproofing membranes were constructed on a concrete bridge deck with an asphalt surfacing thickness of 100 mm in Yuen Long Highway in February 2006. Figure 7 in the Appendix shows the optical strain gauges installed on a waterproofing membrane.
