Report of the Commission of Inquiry into
the Collision of Vessels near Lamma Island on
1 October 2012

(The Redacted Version)

The Honourable Mr Justice Michael Lunn, JA
Mr Benjamin Tang, GBS, JP

April 2013

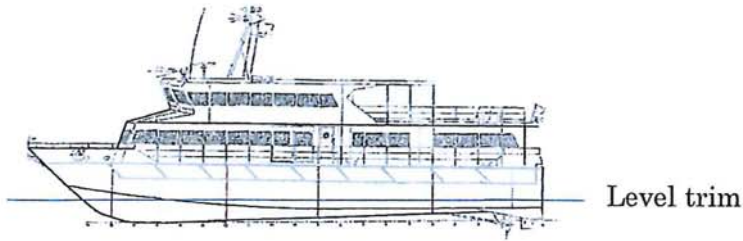
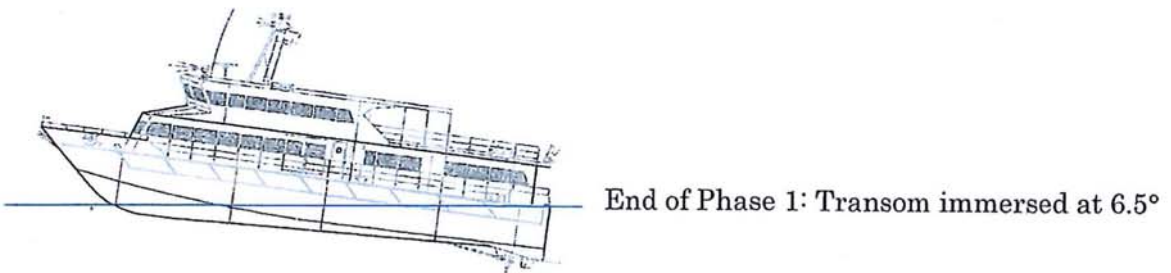
Angles assumed by the Lamma IV after sinking

End of Phase 2: Transom in contact with sea bed.

End of Phase 2a: Vessel settles into the mud on the sea bed.

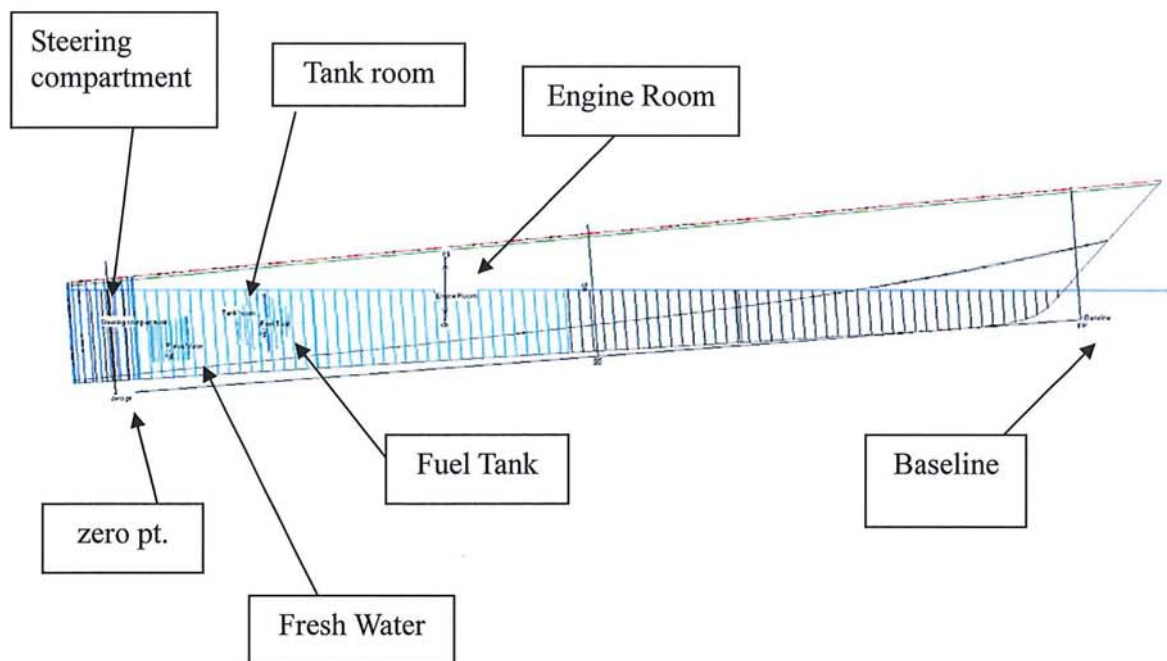
Two-compartment Damage – Engine room and Tank room

Note that the stern is almost submerged, but the vessel remains afloat
