**Final Report of
Stray Dog Incident on 20 August 2014**

Operations Manager – WRL & LR

Date: 11 December 2014

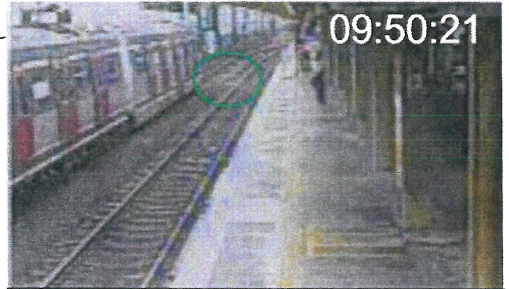
<p>09:50:21</p> <p>P2 pointing at tailwall (~10th car)</p> <p>The dog moved to 6-foot space</p>
0951	A BIU staff at Up platform noticed a dog on SHS platform tracks. He immediately operated PEP. Subsequently, SHS Down PSB staff and SC operated PEP and ESS respectively.	<p>3 BIU staff rushed to the Down platform to assist after hearing a call on the BIU radio.</p>

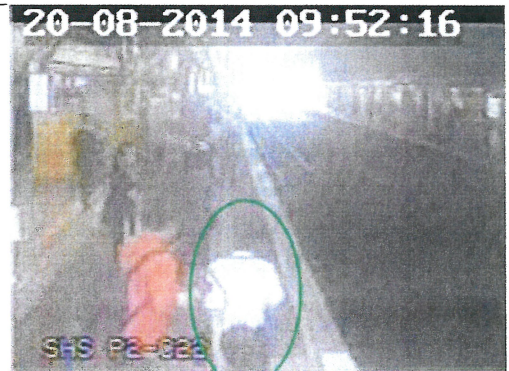
<p>20-08-2014 09:52:16</p> <p>SHS P2-822</p> <p>P2 pointing at headwall (~6th car)</p> <p>The 3rd BIU staff appeared</p>
0952	TC noticed the PEP operations and informed all EAL TCap via IRS of the activation of the PEP at SHS.	<ul style="list-style-type: none"> Up Line train M143 came a halt after passing Signal S2403 Down Line train M178 from LOW stopped at Signal S2412 Down Line train M180 from LMC stopped at Signal S2406

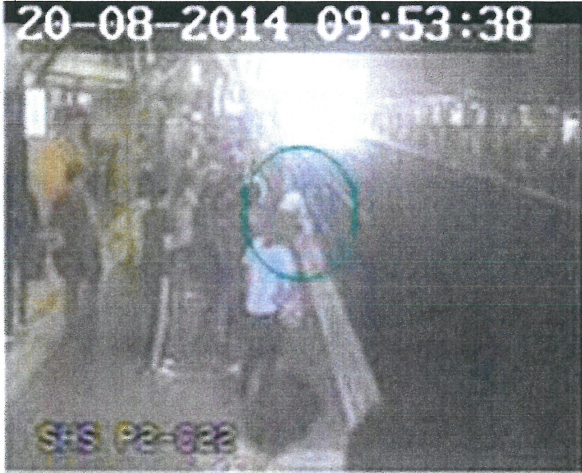
<p>20-08-2014 09:53:38</p> <p>SHS P2-822</p> <p>P2 pointing at headwall (~6th car)</p> <p>A person (suspected to be BIU staff) tried to save the dog</p>
0955	CC advised station staff to go down to the track to handle the dog. TC authorised track access.

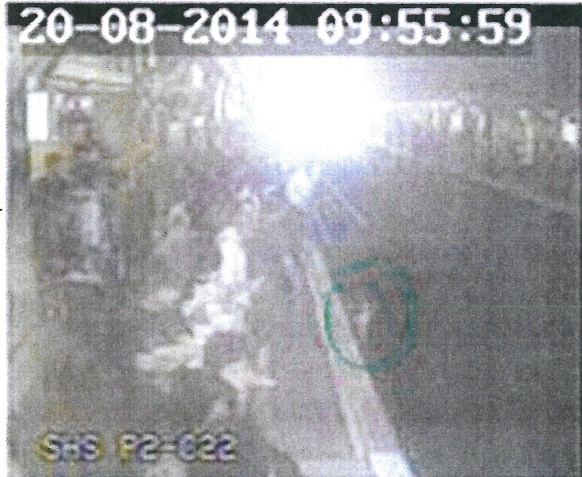
<p>20-08-2014 09:55:59</p> <p>SHS P2-822</p> <p>P2 pointing at headwall (~6th car)</p> <p>The dog came out from the coping stone</p>

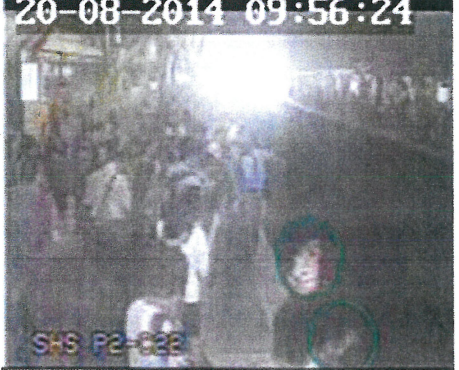
<p>P2 pointing at headwall (~6th car)</p> <p>The staff walked with the dog to the tailwall direction</p>
095653	As requested by TC, both staff returned to Down platform.	The dog was at about 8th car position on Down track.

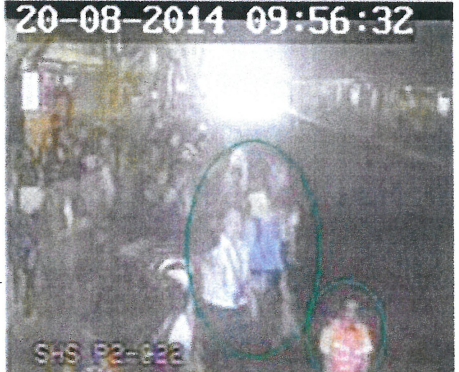
<p>P2 pointing at headwall (~6th car)</p>
0956	BIU commander on platform made a further attempt to pull the dog but was advised by station staff on the hazard of being bitten by the dog.	Another BIU staff had already been bitten by the dog earlier.

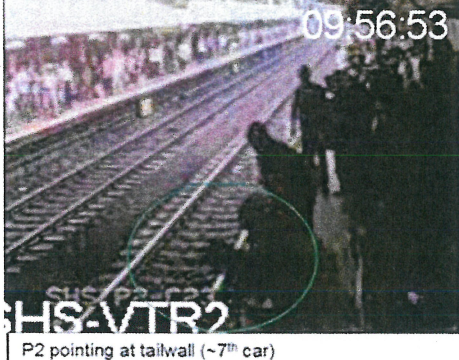
<p>P2 pointing at tailwall (~7th car)</p> <p>The second staff was pulled up as well</p>
0957	TC requested station staff to reset all PEP and ESS.

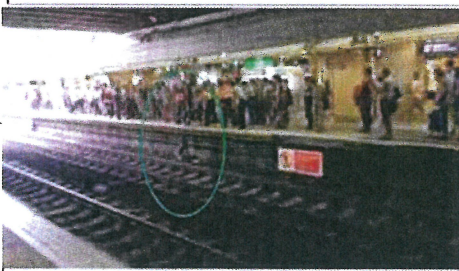
<p>P2 pointing at headwall (~6th car)</p> <p>BIU commander tried to pull the dog but advised by staff about the possible biting</p>

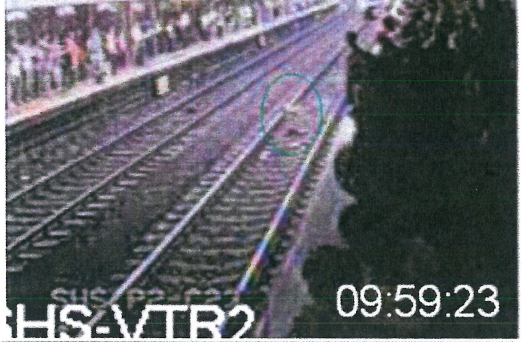
<p>09:59:23 SHS-VTR2</p> <p>P2 pointing at tailwall (~7th car) A down line train arrived, the dog crossed to up track</p>
0959	TC instructed TCap/M143 (Up Line train) to work the train in cautious speed and conduct track check. TCap/M143 noticed the dog lingered in the area between the underside of the platform and the track and sounded the horn once. The dog moved to Down track in front of the Down train.

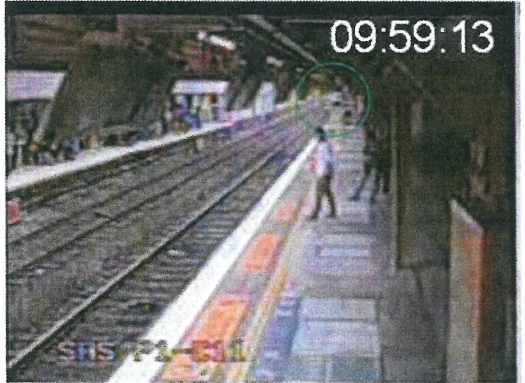
<p>09:59:13 SHS-P1-C11</p> <p>P1 pointing at tailwall (~11th car) An up train was coming</p>
1000	Both trains (M178 and M143) carried out platform duty at SHS.	
1001	After platform duty, TCap/M178 saw the dog in SHS Down trackside, he then worked the train in ATP mode with cautious speed. Later he saw the dog walking towards FAN along the bush at a distance from the track. He reported this sighting to TC and confirmed to TC that his train would not hit the dog.

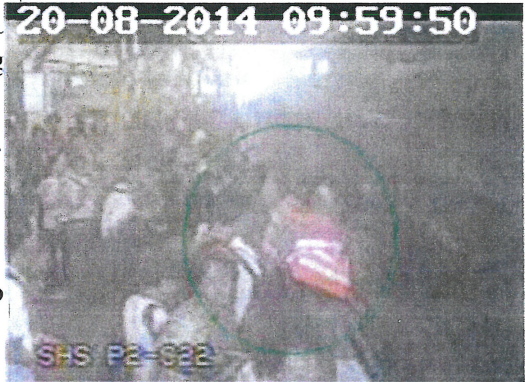
<p>20-08-2014 09:59:50 SHS-P2-G22</p> <p>P2 pointing at headwall (~6th car) Both up and down trains arrived, staff walked along the platform</p>

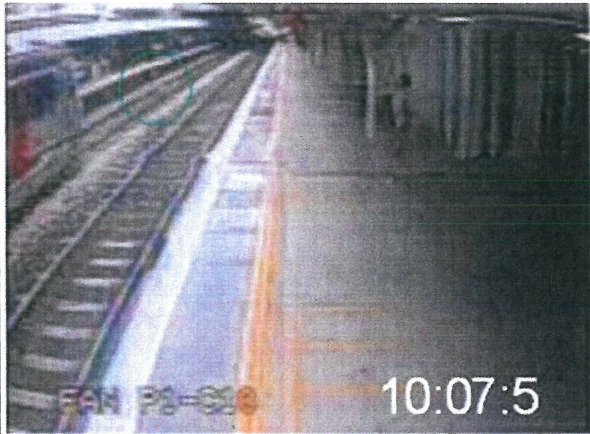
<p>10:07:50</p> <p>P1 pointing at tailwall (~8th car)</p> <p>A down train was running after the dog and decelerating</p>
1008	A passenger reported to FAN Up PSB staff about the presence of the dog. The staff rushed out from PSB and saw the dog on Up platform track. At the same moment, a MTT train P705 arrived at FAN Up. The PSB staff immediately applied danger hand signal to stop the approaching MTT.

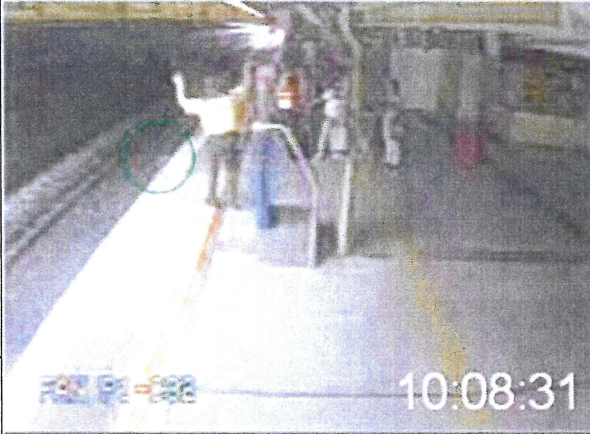
<p>10:08:31</p> <p>P1 pointing at tailwall (~10th car)</p> <p>The PS started waving his hands vigorously</p>
100859	MTT stopped at the 2nd car position of FAN Up platform. FAN staff informed TC that a dog was spotted on platform track before the MTT arrived.	
1009	TC called TCap/M182 (Down Line train) who was carrying out platform duty at FAN if she saw the dog. She replied that the dog had run to Up platform track when her train moved into platform. TC requested her to operate the train

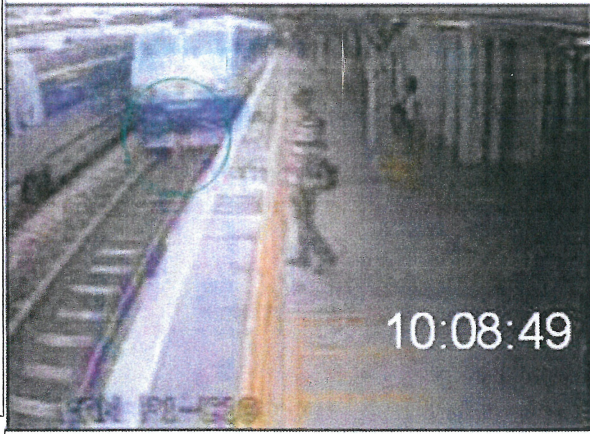
<p>10:08:49</p> <p>P1 pointing at tailwall (~8th car)</p> <p>The dog was close to MTT</p>

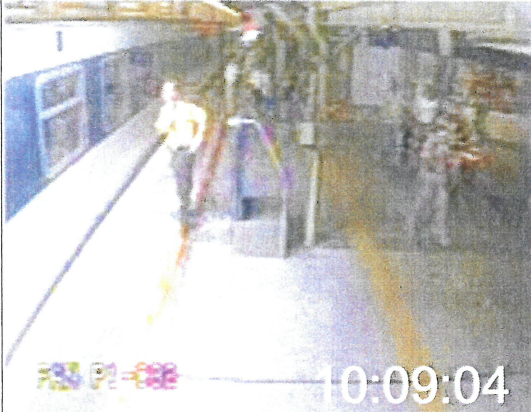
P1 pointing at tailwall (~10 th car)
The PS listened to the radio
