Technical Investigation of the Escalator Incident at Langham Place

**Technical Investigation Report on
Escalator Incident at Langham Place,
Mong Kok, Kowloon**

Date of Incident: 25 March 2017
事故日期：2017年3月25日

Issued Date: 9 June 2017
出版日期：2017年6月9日

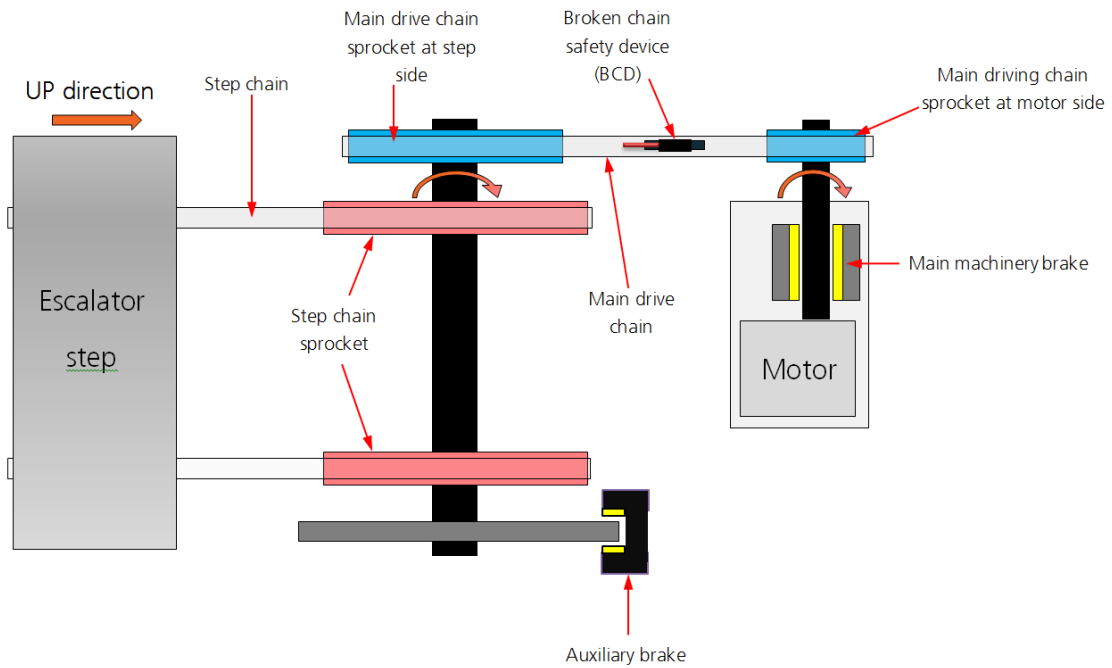
Figure 1a: Schematic diagram of an escalator drive system

3.1 The escalator was driven by two traction machines with two alternating current (AC) three-phase induction motors. Mechanical power from the traction machine sprocket is transferred to the step side sprocket via the main drive chain. For the basic structure of an escalator, please refer to Appendix 1. For illustration of the drive system, please refer to Figures 1a and 1b.

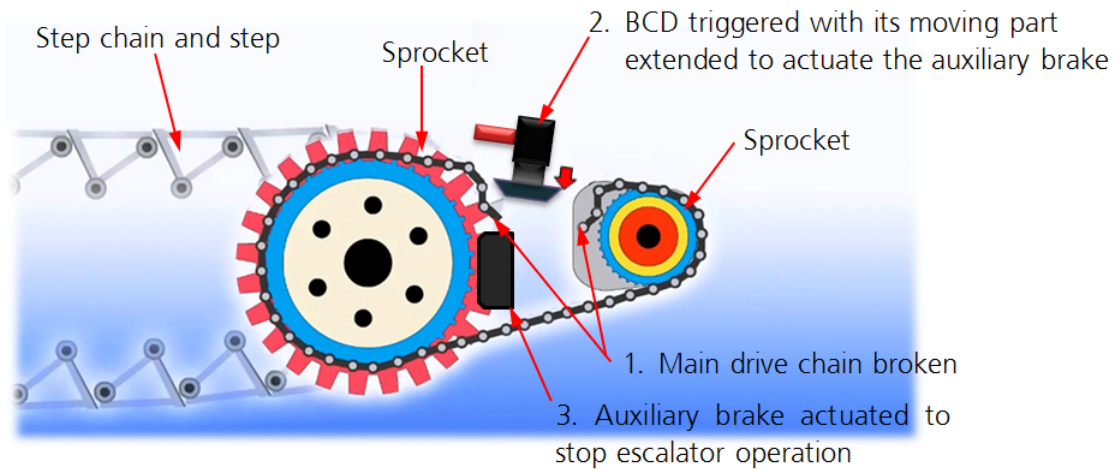
Figure 2a: Design to protect against main drive chain failure

5.2 Under normal circumstance, the breakage and/or excessive elongation of the main drive chain are continuously monitored by the broken chain safety device (BCD, Figures 1 and 3 refer). In case of breakage or excessive elongation of the main drive chain, the BCD will be triggered and will send a signal to activate the auxiliary brake to stop the moving escalator (Figure 2a refers). In this incident, upon breakage of the main drive chain, the BCD failed to detect the chain breakage and the auxiliary brake was not activated to stop the moving escalator (Figure 2b refers).
