**Legislative Council Panel on Transport
Subcommittee on Matters Relating to Railways**

**Shatin to Central Link
Incidents relating to the works at
To Kwa Wan Station and Exhibition Centre Station**

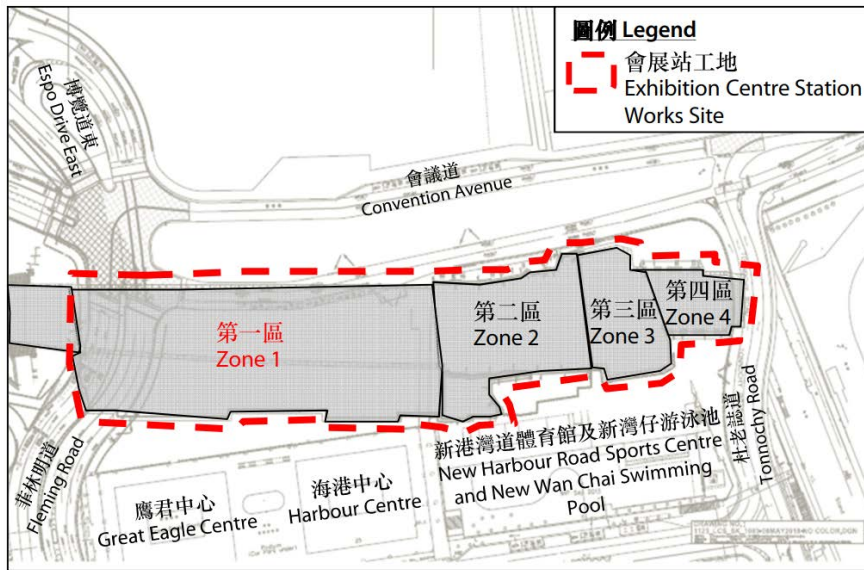
Figure 1 – Zoning layout of EXC

4. The works site for EXC is divided into 4 zones namely Zone 1, Zone 2, Zone 3 and Zone 4 as shown in **Figure 1**.

6. The Contractor has been installing the temporary steel strutting in accordance with the contractual requirements from first to fourth layers. On 9 May 2018, the Corporation observed a localised over-excavation by approximately a few metres lower than the allowable depth of -19.5mPD level during rock breaking without installation of the fifth and final layer of temporary steel strut.

8. On 4 June 2018, the Corporation observed another localised over-excavation lower than the allowable depth of -19.5mPD level during the rock breaking in Zone 1. The Corporation then issued another NCR to the Contractor on 11 June 2018. Backfilling works at this localised area were completed in early July 2018 and targeted to complete the installation of the required struts at level 5 by August 2018.

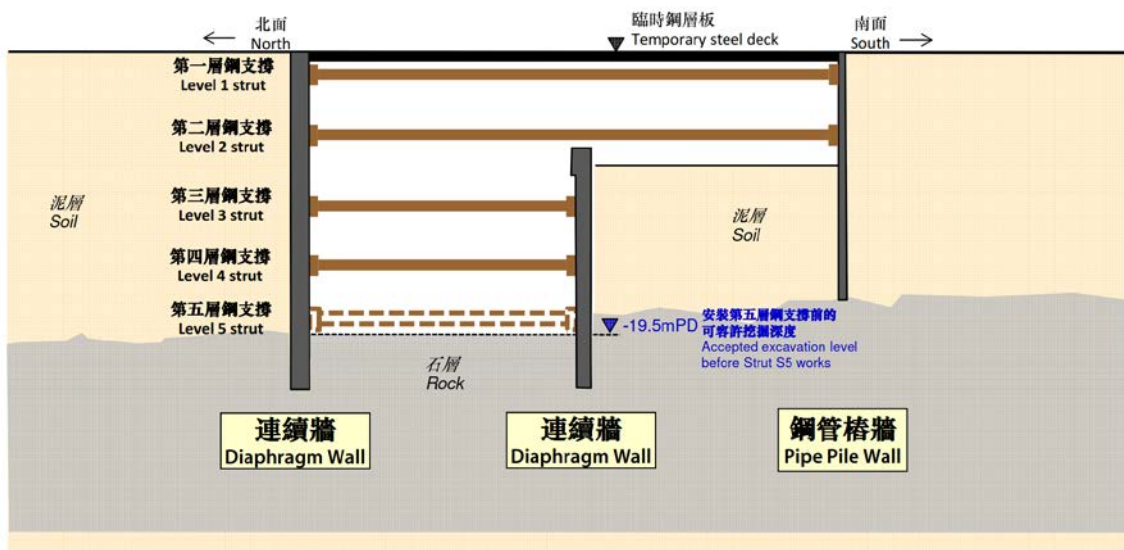
Figure 2 – Cross section of EXC – excavation and installation of temporary steel strutting

5. Construction sequence involving progressive excavation and Excavation Lateral Support (“ELS”) works (installation of temporary steel strutting) was accepted by relevant Government departments in June 2017 allowing bulk excavation at Zone 1 to commence in July 2017. According to this accepted construction sequence, excavation works take place in between diaphragm walls and temporary steel strutting is erected at specified intervals as the excavation goes deeper to form the ELS system to support the excavation. There are five layers of temporary steel struts in Zone 1, the approved construction sequence allowed excavation to proceed to -19.5 mPD prior to installing the 5th layer of struts, as illustrated in Figure 2 below.

Corporation. The design check confirms that the diaphragm wall and existing ELS shoring system are within their structural capacity and that they are in a stable condition. The Contractor's Independent Checking Engineer ("ICE") also certified that the design check by the Contractor's designer is satisfactory prior to issue to the Corporation. The RGE team of engineers also reviewed and certified the design check as satisfactory. The Corporation delivered the design check report, ICE certificate with RGE/CP endorsement to the relevant government department on 20 June 2018.
