**Legislative Council Panel on Transport
Subcommittee on Matters Relating to Railways**

**Incident of the new signalling system testing on
Tsuen Wan Line on 18 March 2019**

(Information Paper)

**Investigation Report on
Incident of the New Signalling System Testing on
MTR Tsuen Wan Line**

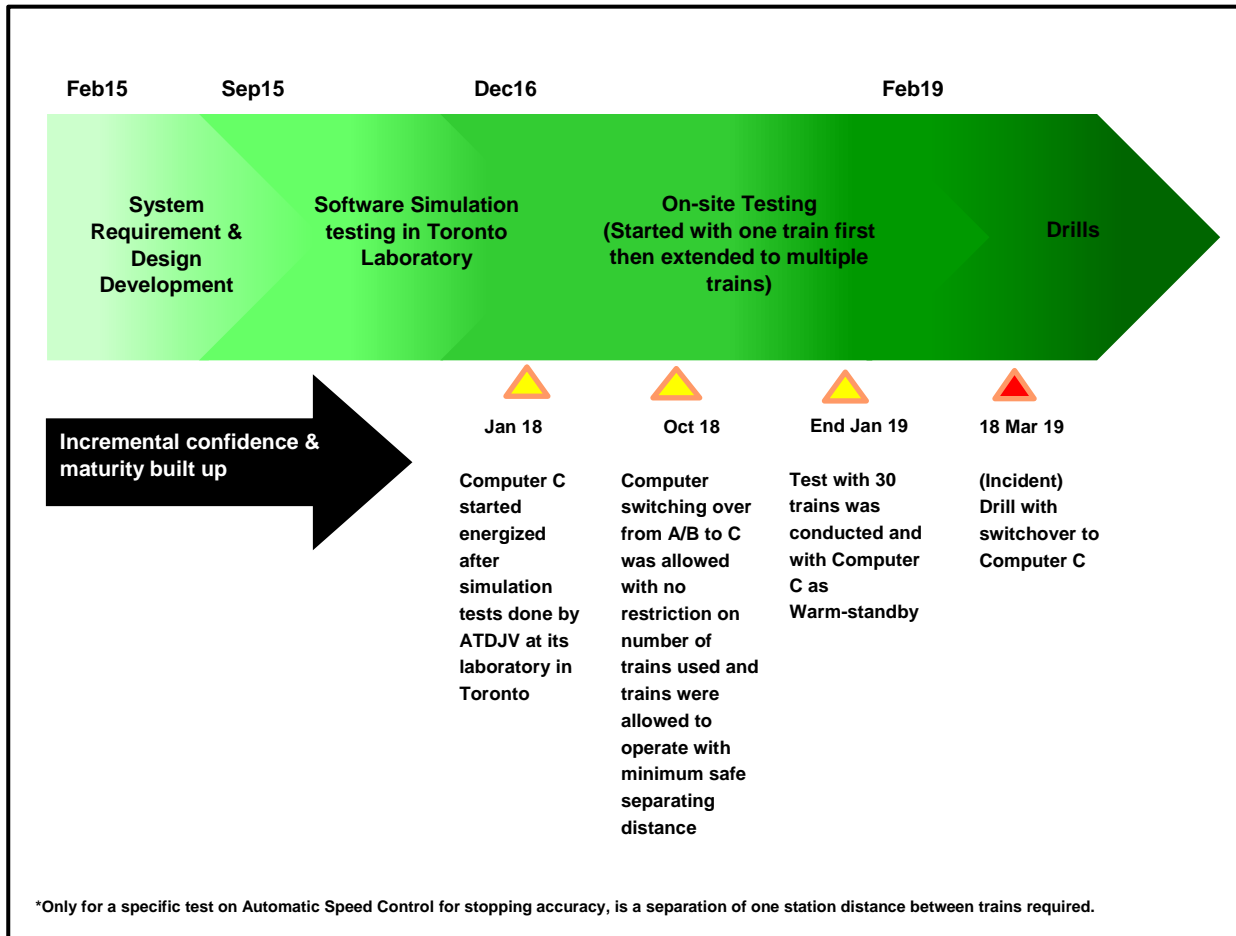
Overall Programme of Simulations and Testing

1. ATDJV started on-site train testing during non-traffic hours on TWL in December 2016 and the scope of test was progressively extended from one train to multiple trains.
2. In January 2018, Computer C started to be energized as Warm-standby after simulation tests done by ATDJV at its laboratory in Toronto.
3. From 15 October 2018 onwards, in accordance with the safety documentation issued by ATDJV, computer switching over from A/B to C was allowed with no restriction on the number of trains used

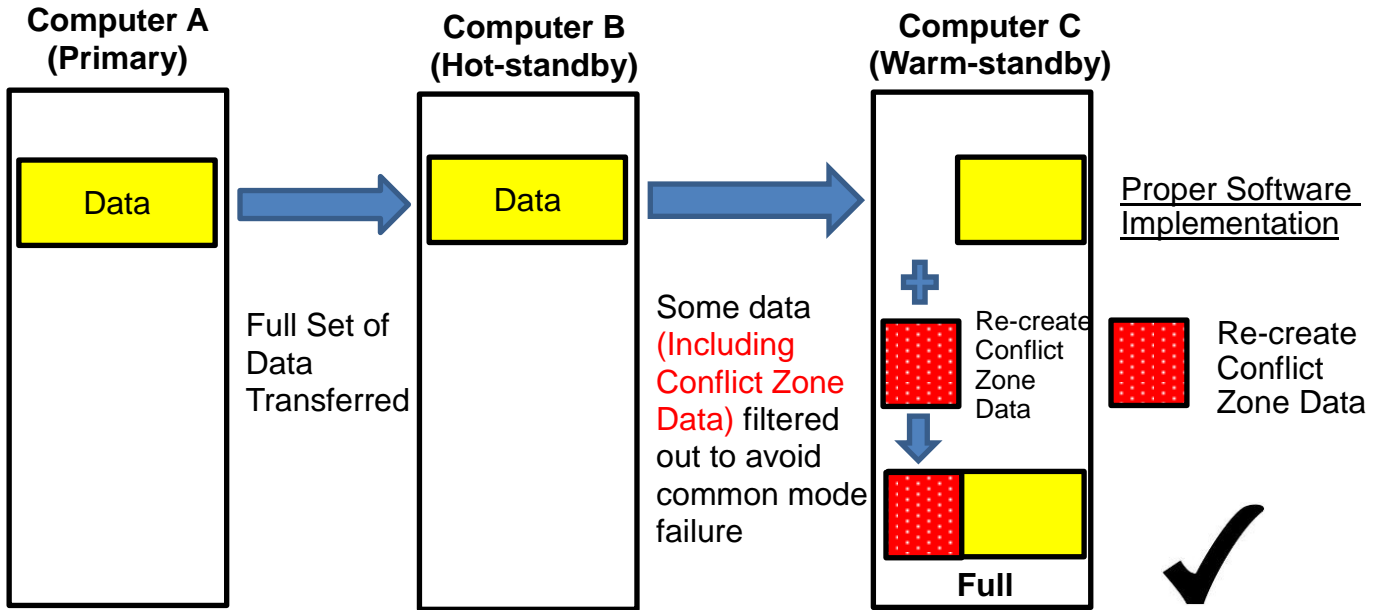
Design Intention developed by ATDJV

What Happened :

Software Implementation Errors resulted into an unknown software issue

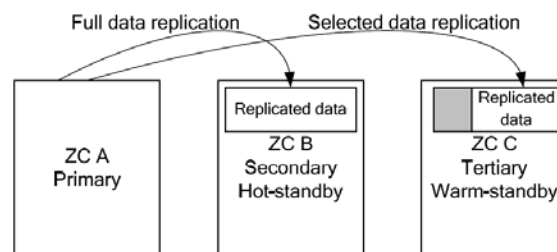
Figure 4: Design functions of the three ZCs

3.4 To further enhance the availability of the signalling system, the new signalling system of the Tsuen Wan Line has adopted a three-ZC configuration for train control, namely primary ZC A (ZC-A), secondary ZC B (ZC-B) and tertiary ZC C (ZC-C). This is a unique and non-standard design among its standard signalling system products of the supplier. The respective functions of the different ZCs are as follows (Figure 4):

- (a) Primary ZC-A is the active ZC of the system for train control in the designated track section;
- (b) Secondary ZC-B is the hot-standby ZC, which synchronises with ZC-A at all times and takes over ZC-A for train control as primary ZC when ZC-A fails;
- (c) Tertiary ZC-C is the warm-standby ZC and takes over ZC-A and ZC-B as the active ZC when both ZC-A and ZC-B fail at the same time. To avoid common mode failure⁴, part of ZC-C's data is not synchronised with ZC-A and ZC-B, which would be re-created in ZC-C upon taking over as the active ZC.

The addition of ZC-C in the new signalling system as warm-standby is a new design and its switch-over mode is more sophisticated than that of conventional design which adopts only two ZCs as active and hot-standby configurations.

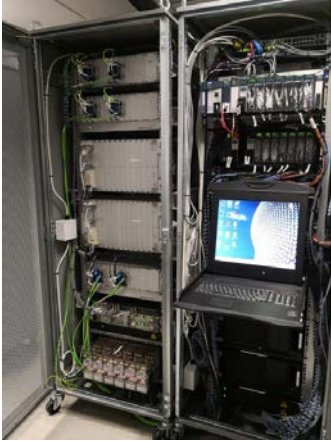
Figure 9: Simulator in Ho Man Tin Station

Simulation tests (Figures 9 and 10) were conducted at Ho Man Tin Station by using the ZCs and VOBCs of the incident trains with the same location and conditions of the incident, with a view to ascertaining whether the incident was caused by the incident ZCs and VOBCs. According to the results of the simulations, the same incident would happen by using the incident ZCs and VOBCs in the simulator.

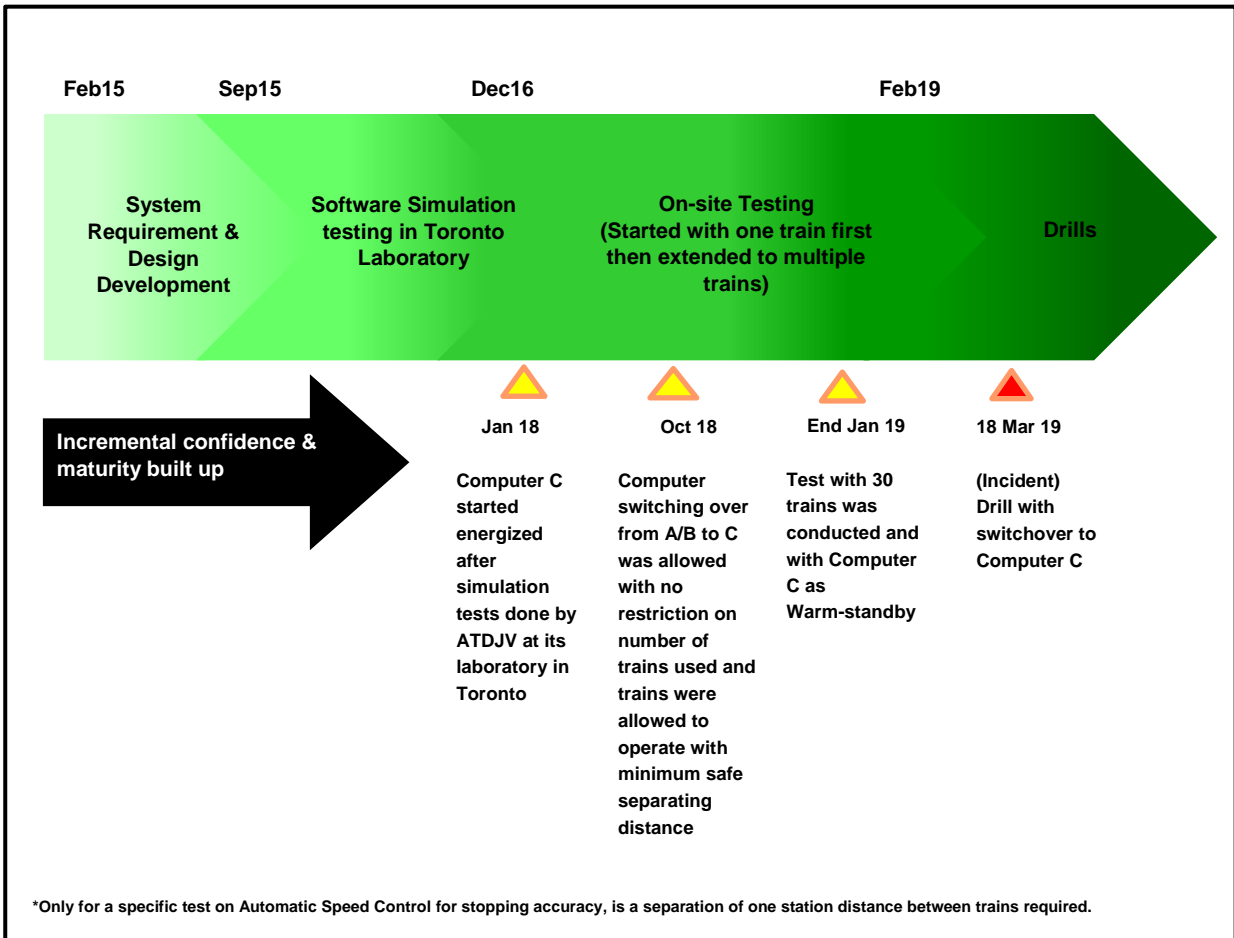
Overall Programme of Simulations and Testing

1. ATDJV started on-site train testing during non-traffic hours on TWL in December 2016 and the scope of test was progressively extended from one train to multiple trains.
2. In January 2018, Computer C started to be energized as Warm-standby after simulation tests done by ATDJV at its laboratory in Toronto.
3. From 15 October 2018 onwards, in accordance with the safety documentation issued by ATDJV, computer switching over from A/B to C was allowed with no restriction on the number of trains used
