Derailment Incident at Hung Hom Station on East Rail Line (17 Sept 2019)

Legislative Council
Subcommittee on Matters Relating to Railways

5 May 2020

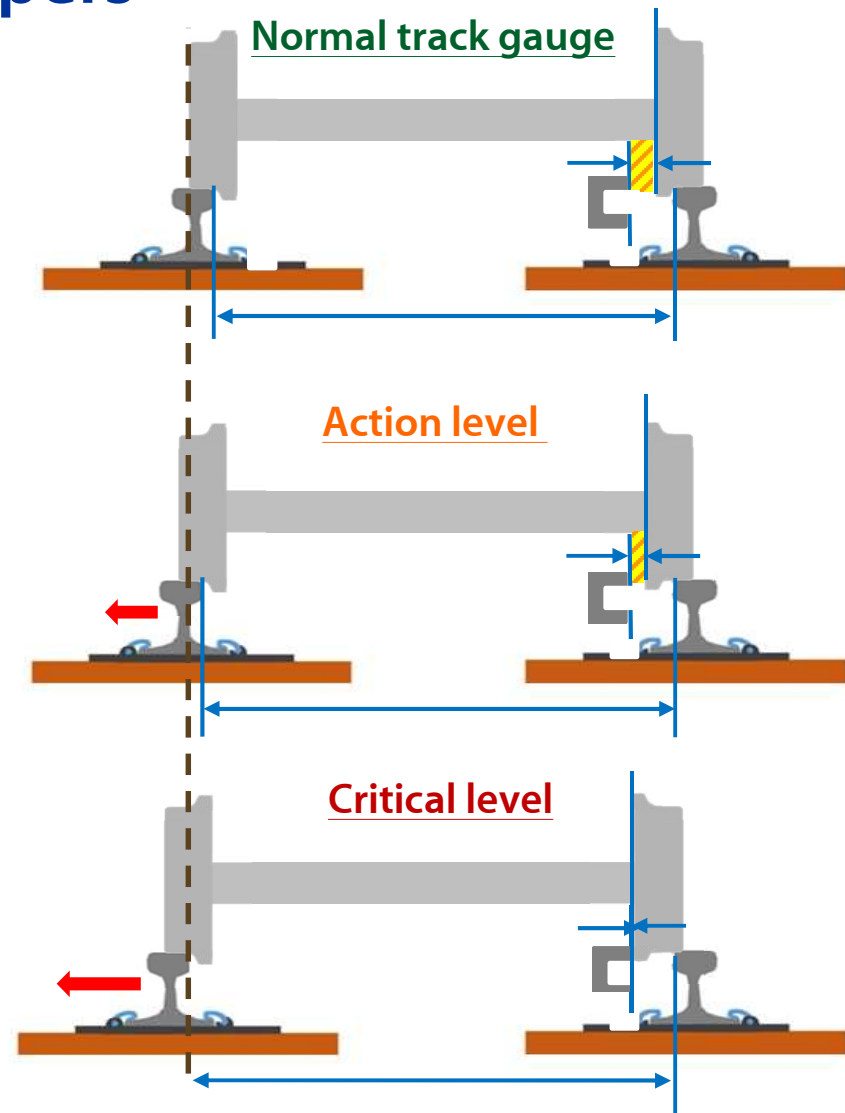
Incident cause - Knowledge Gap of Interaction between the two types of sleepers

Knowledge gap – lack of informed judgment on the scope, timeliness and effectiveness of remedial measures to correct track gauge

Reliance on experience – follow up actions not carried out strictly in accordance with procedures

Situation not timely escalated
