# West Rail Fire Incident

**Legislative Council – Panel on Transport  
Subcommittee on Matters Relating to Railways  
4 May 2007**

# Forensic Examination of the Failed Transformer

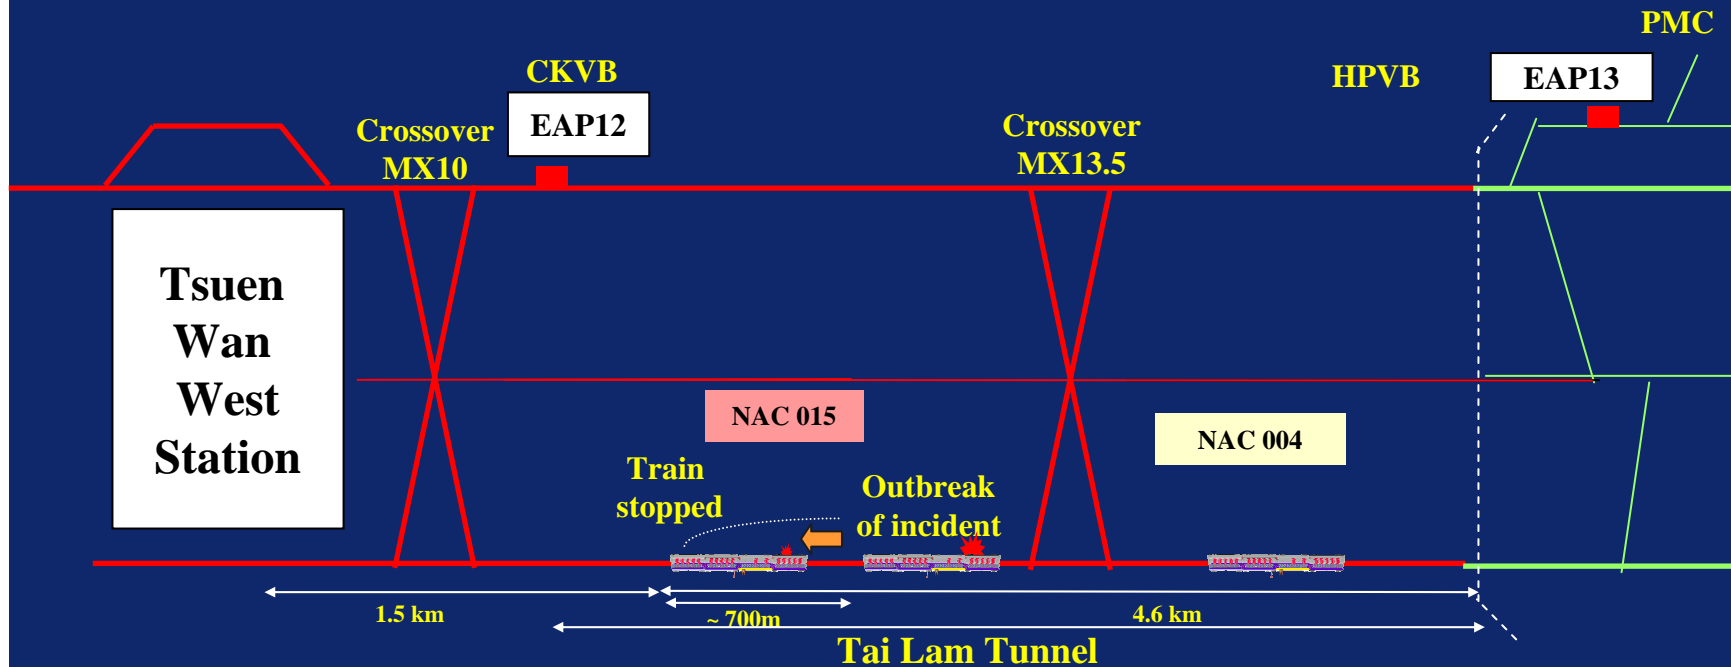
# Outbreak of Incident

09:17 OCC reported train/ tunnel status to FSD	OCC confirmed train location and fire status	09:15 all train doors opened. Driver/KCR staff directed passengers to TWW station	OCC cleared up track & authorized evacuation	OCC operated TVS & instructed TWW to switch on tunnel lights	Driver stopped the train	Driver received calls from passengers & observed smoke at rear cars through in-cab CCTV	Loss of traction power	09:13 bang sound heard by Driver  Automatic fire alarm sent to FSD
--	--	--	--	--	--------------------------	---	------------------------	---

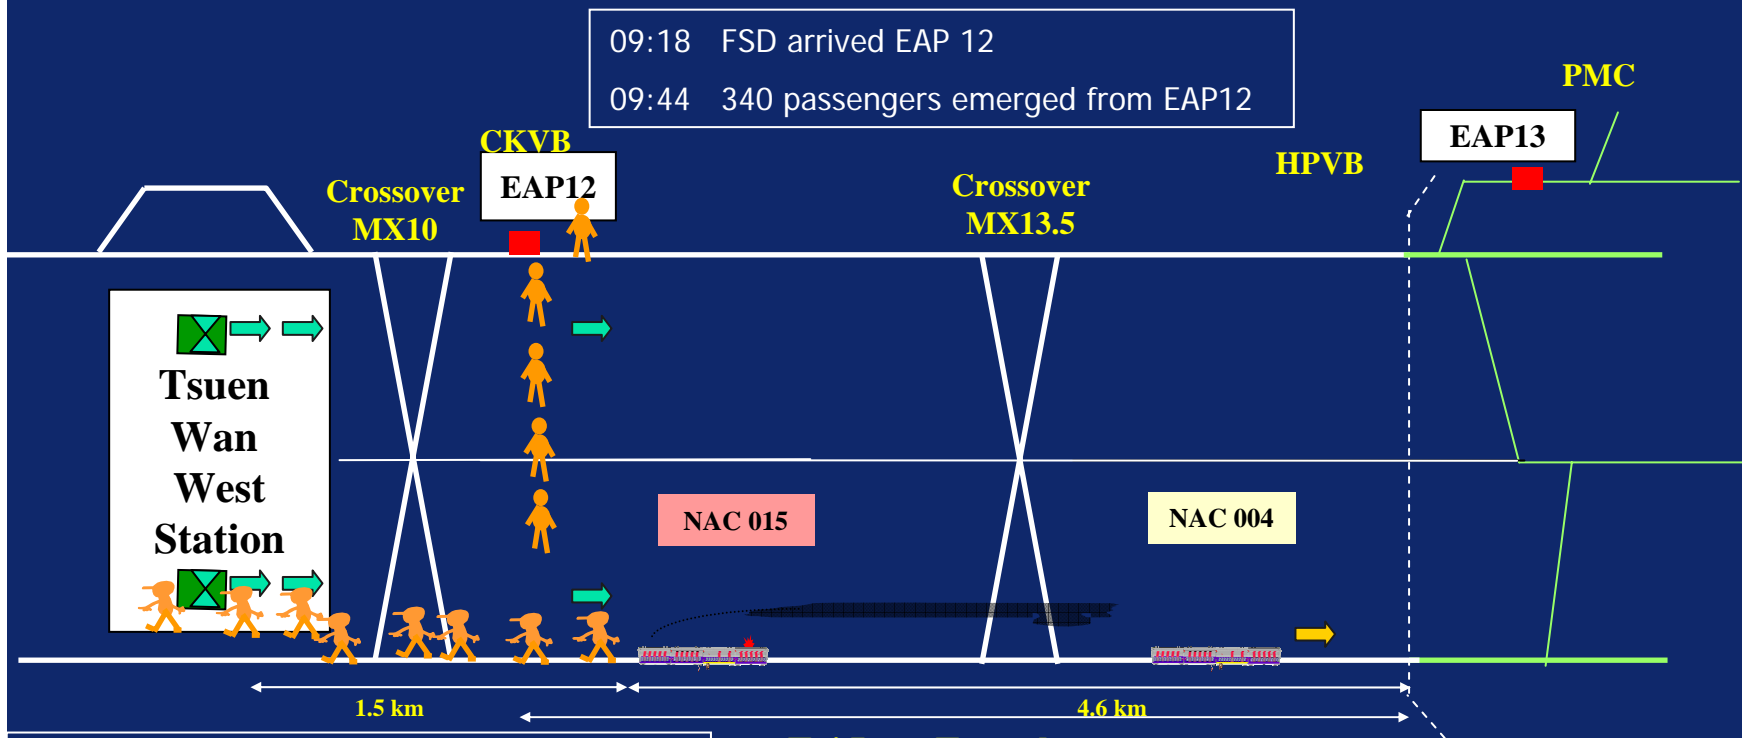
# Evacuation

09:18 FSD arrived EAP 12  
 09:44 340 passengers emerged from EAP12

09:26 All passengers detrained and walked towards TWW as directed  
 09:45 626 passengers had reached TWW platform, and FSD arrived at incident train fire

09:47 Re-energized overhead line for NAC004 to leave tunnel  
 09:54 Switched off traction supply  
 09:55 FSD started to put out fire by water
