#### **Follow-up to the meeting on 27 February 2012 “Breakdown of Ngong Ping 360 ropeway occurring in December 2011 and January 2012”**

**Ngong Ping 360 Ropeway**  
**Incident occurred on 25 January 2012**  
**Report of Investigation**

**Electrical and Mechanical Services Department**  
**3 April 2012**

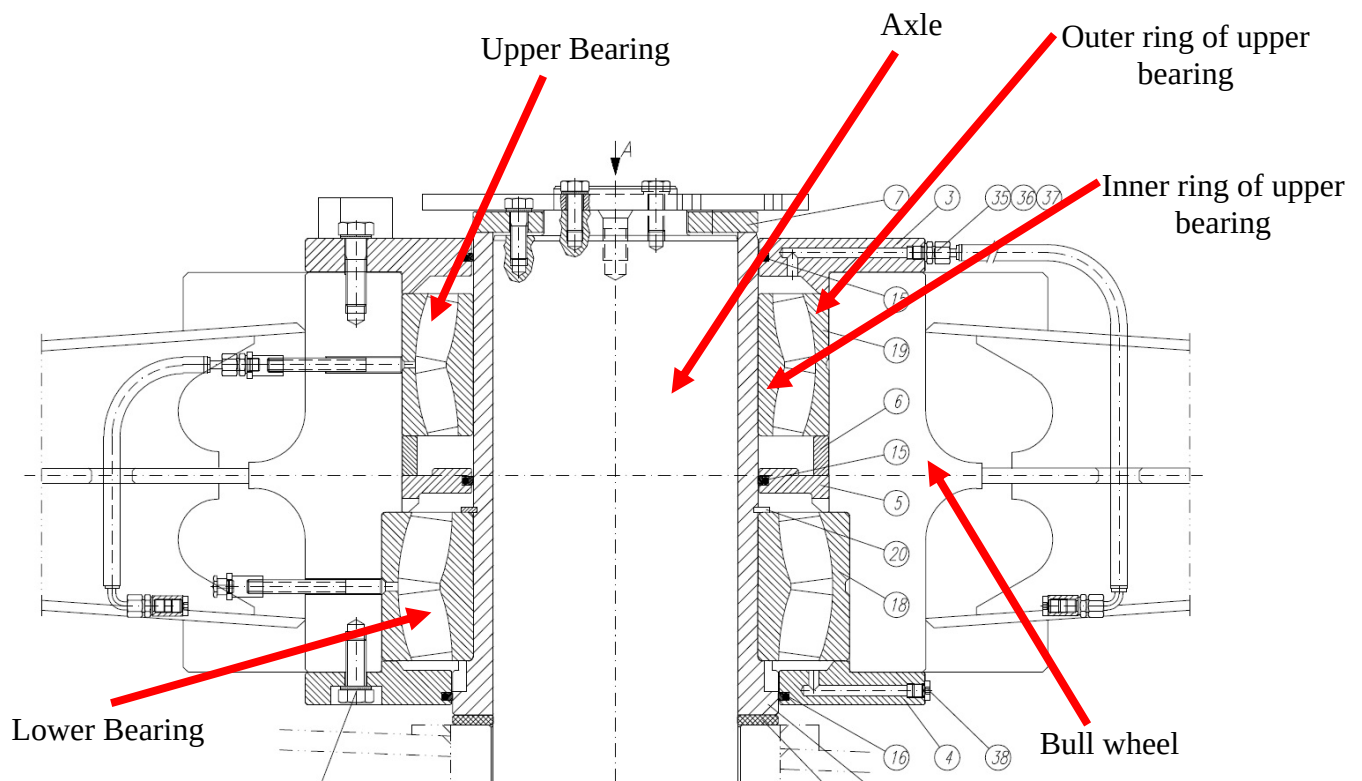
Figure 1 : Configuration of a typical bull wheel of the Ngong Ping 360 Ropeway

used to drive and guide the haul ropes in Section I and Section II. Two bearings (upper and lower) (see Figure 1) are used in each bull wheel to connect the bull wheel to its shaft. Among the numerous protective devices (more than 1,000) installed to ensure safe operation of the Ropeway, position sensor is installed adjacent to each bull wheel to stop the ropeway operation when there is any abnormal vibration in any of the bull wheels. A schematic diagram of the Ropeway is given in Figure 2 below.
