## **CKR – Kai Tak**

Central Kowloon Route -  
Design and Construction

Tree Assessment Schedule - Kai Tak Area (Trees under AFCD to Provide Expert Advice)

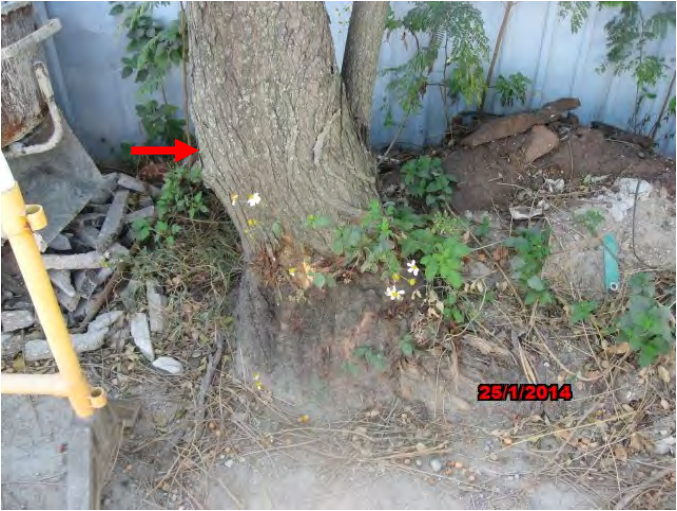
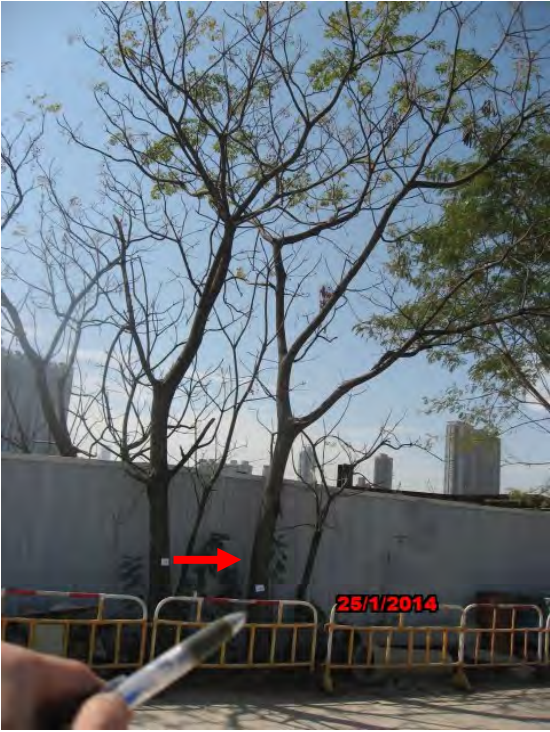
KT/T3_1 (Fell) Scientific Name: <i>Melia azedarach</i>	KT/T3_2 Next to concrete pavement	KT/T4_1 (Fell) Scientific Name: <i>Melia azedarach</i>	KT/T4_2 Dead branches

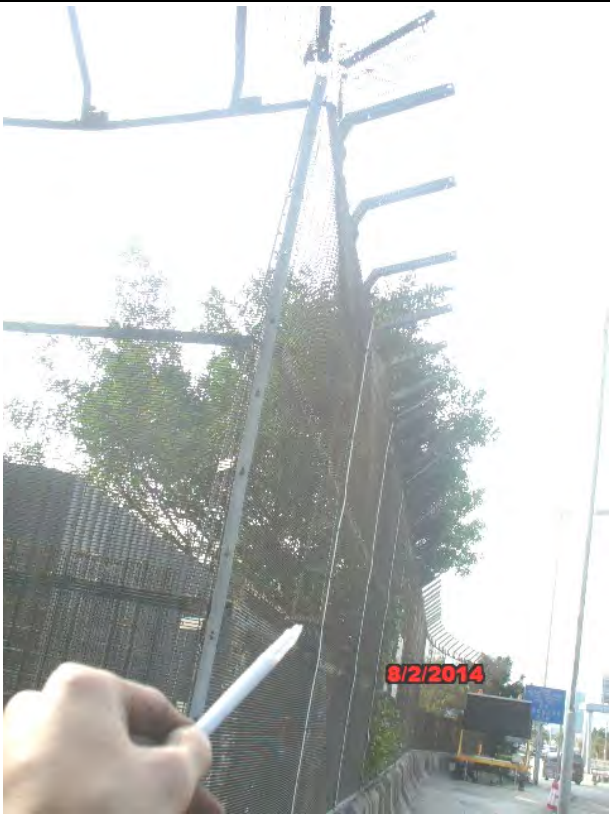
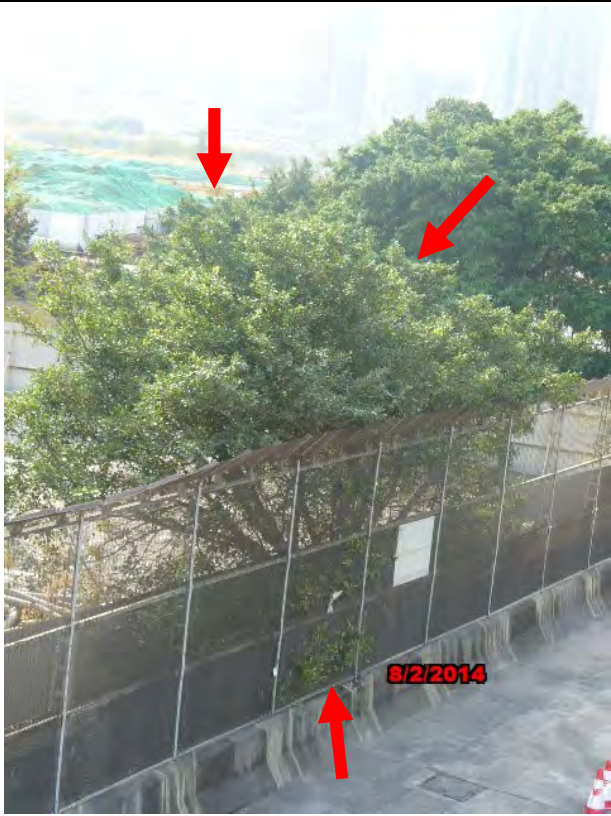
KT/T7_1 (Fell) Scientific Name: <i>Melia azedarach</i>	KT/T7_2 No foliage at time of survey	KT/T7_3 Close to fence

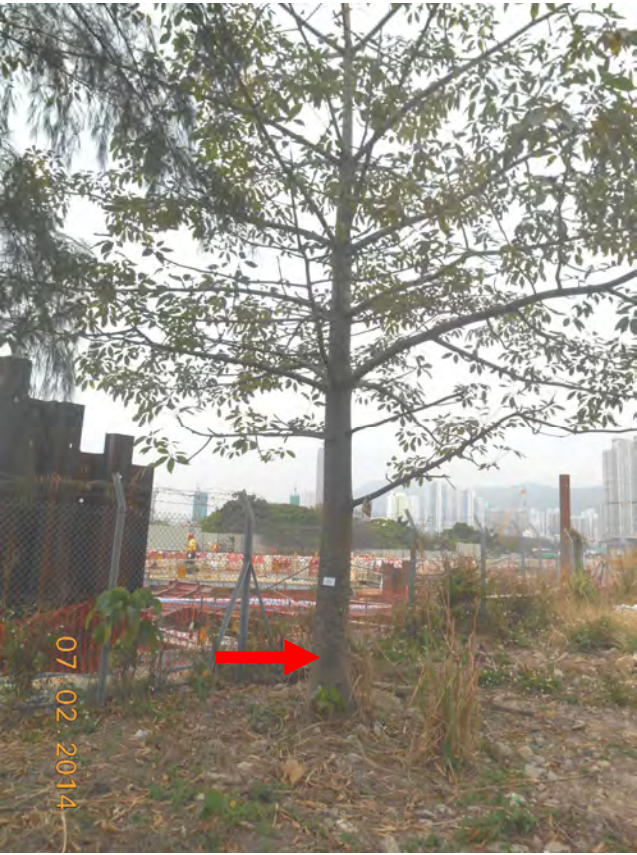
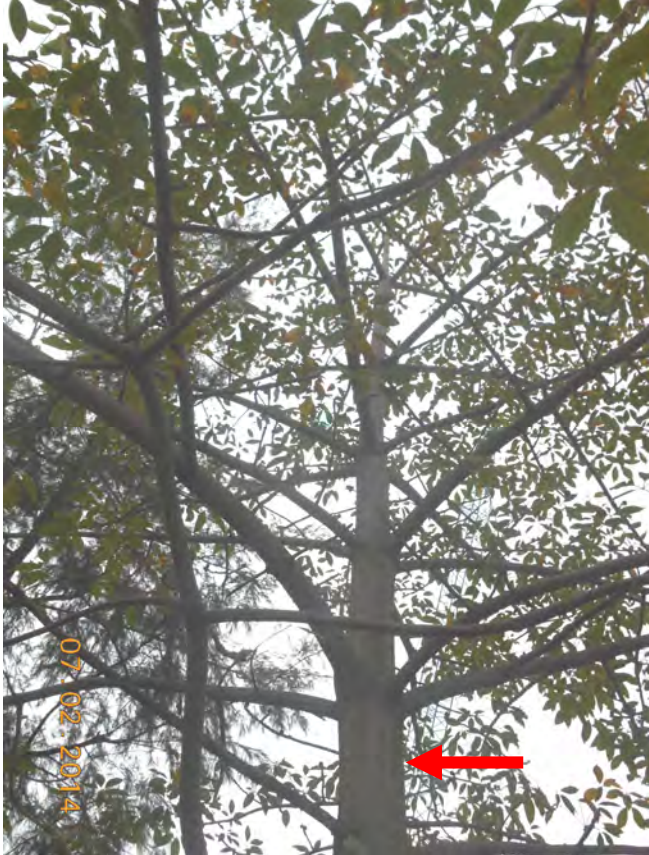
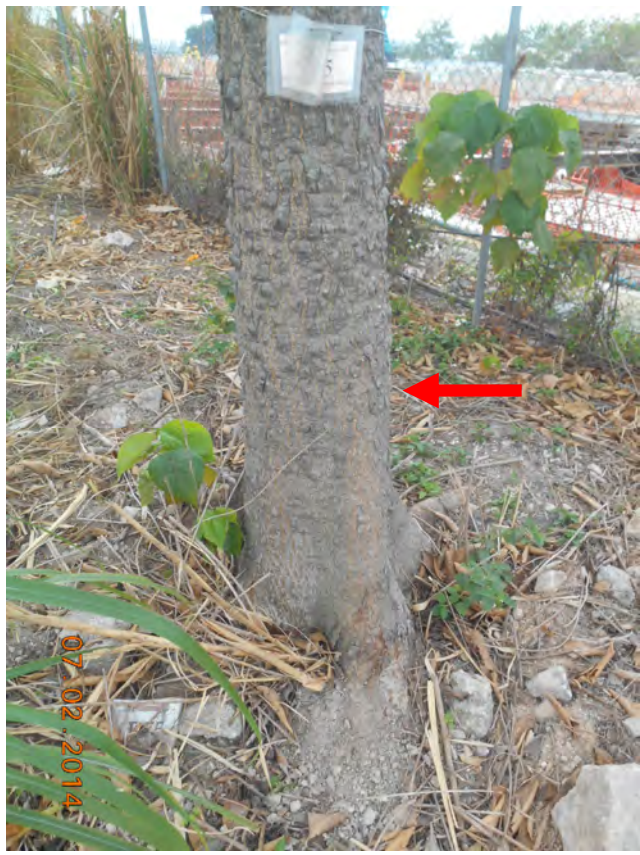
KT/T238_1 (Fell) Scientific Name: <i>Ficus microcarpa</i>	KT/T238_2 Next to concrete footing and pavement

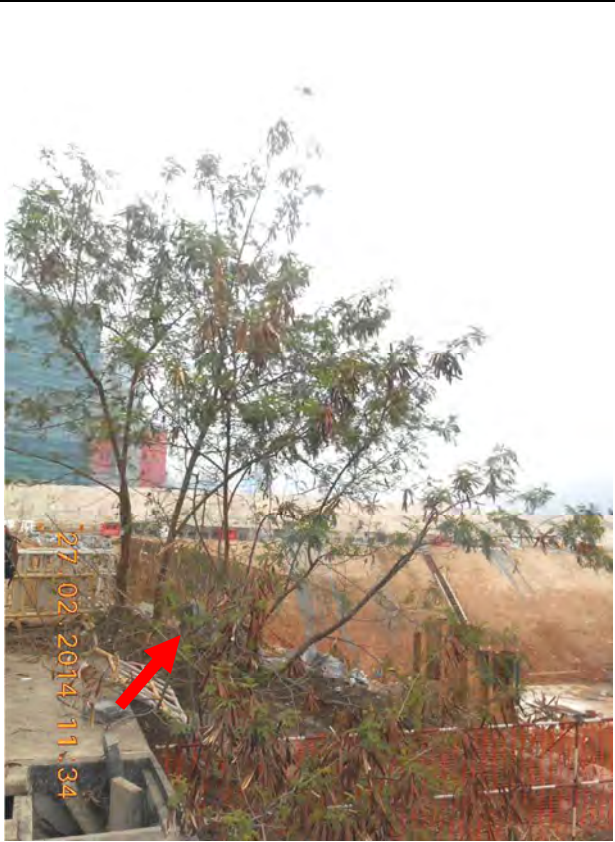
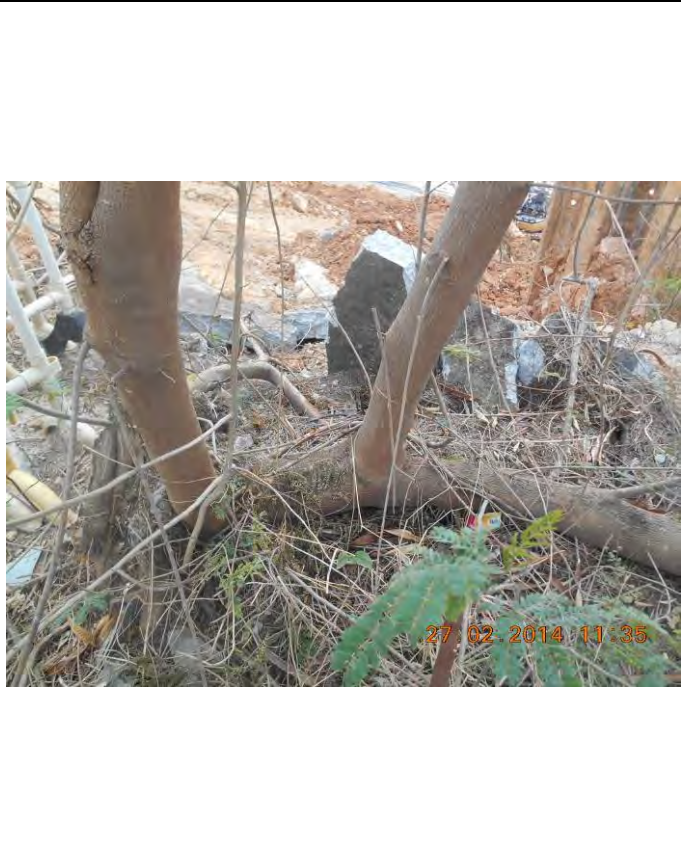
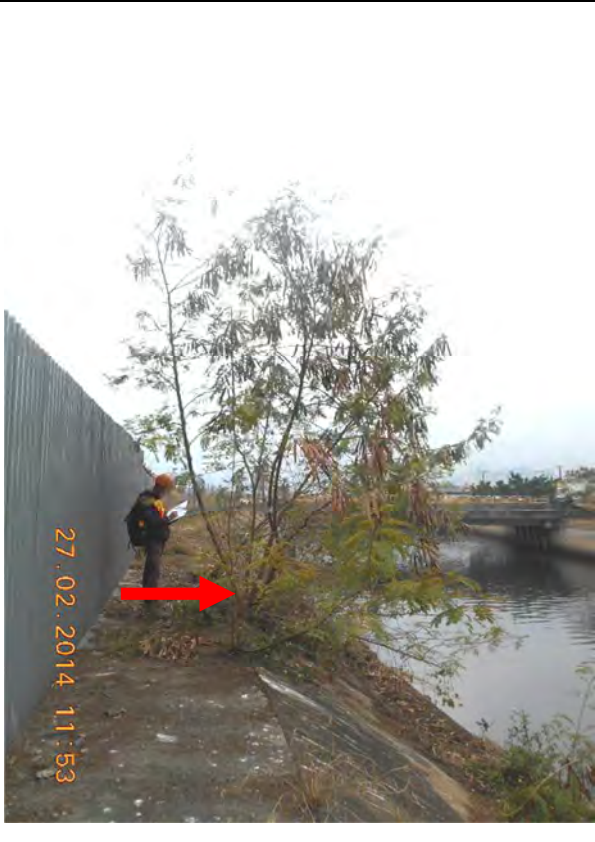
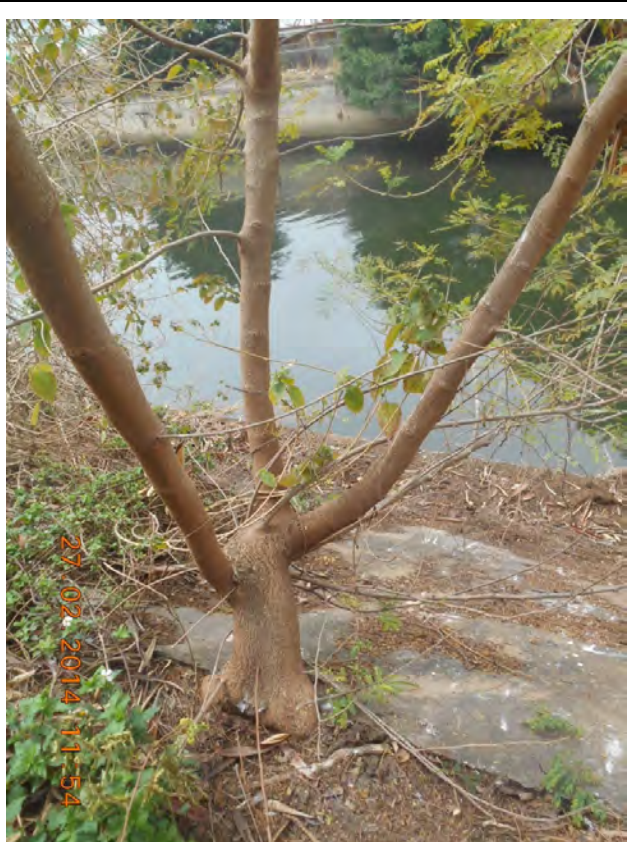
KT/T481_1 (Retain) Scientific Name: <i>Aleurites moluccana</i>	KT/T481_2 Large wound on trunk base

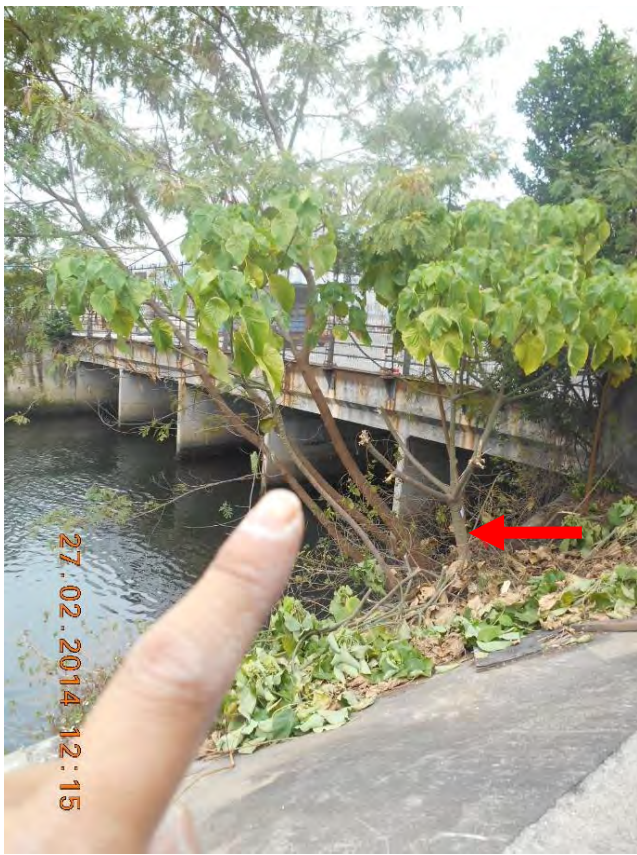
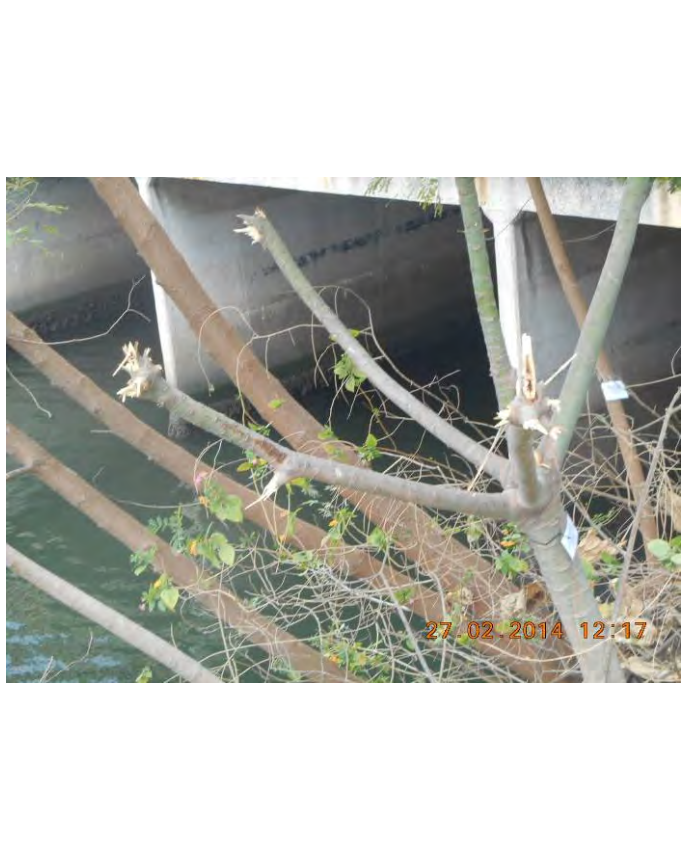
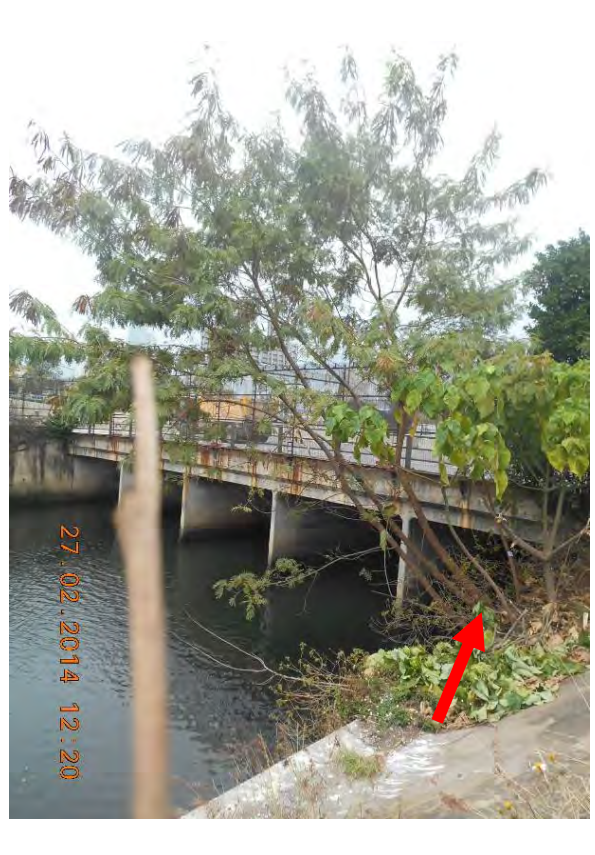
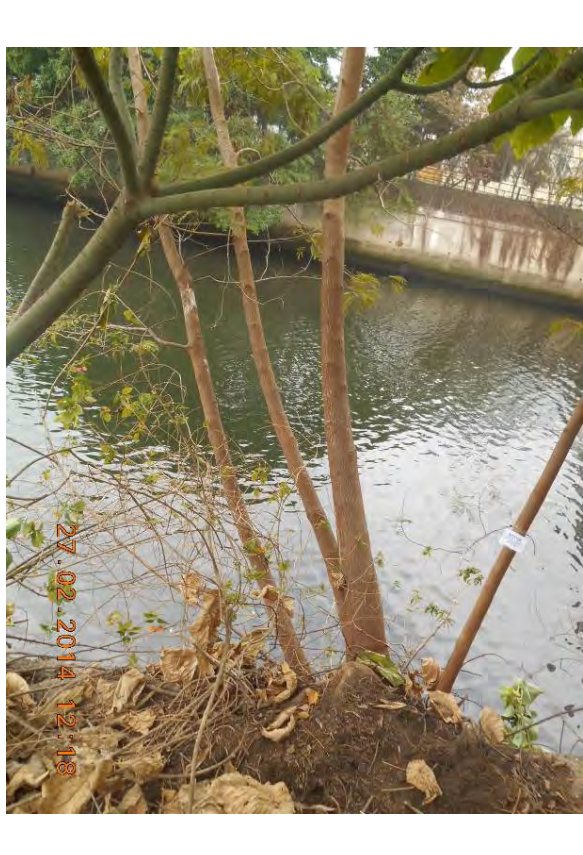
KT/T577_1 (Retain) <i>Macaranga tanarius</i> var. <i>tomentosa</i>	KT/T577_2 Broken branches	KT/T578_1 (Retain) Scientific Name: <i>Leucaena leucocephala</i>	KT/T578_2 Multi-trunk

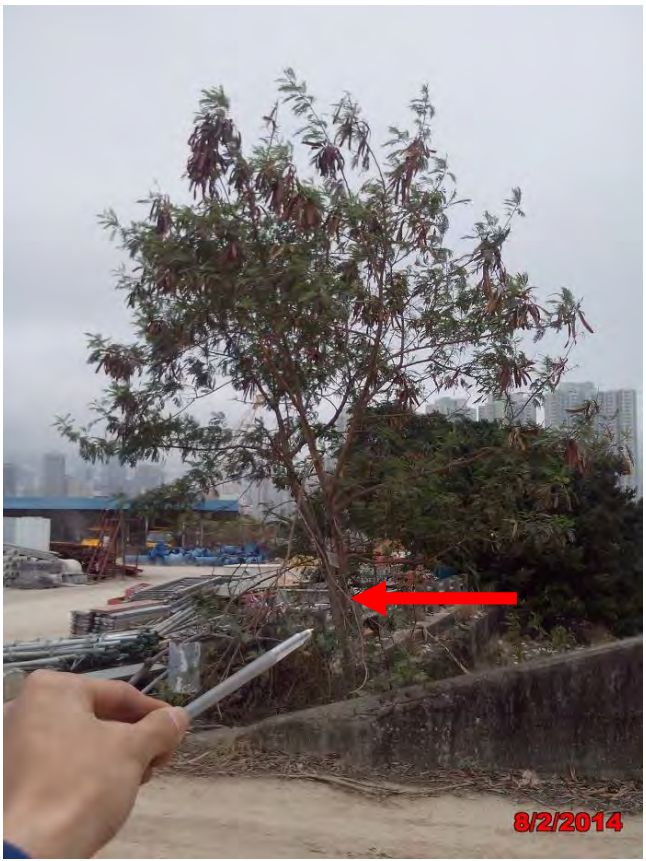
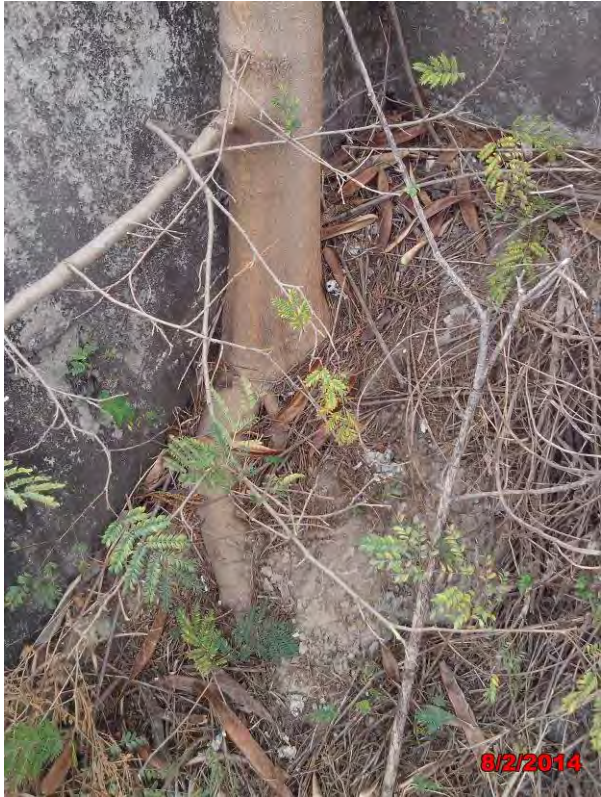
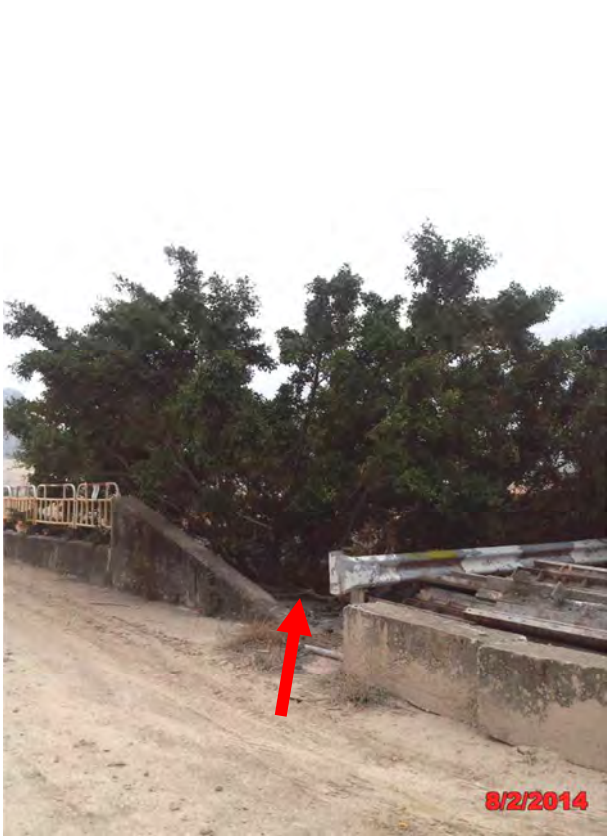
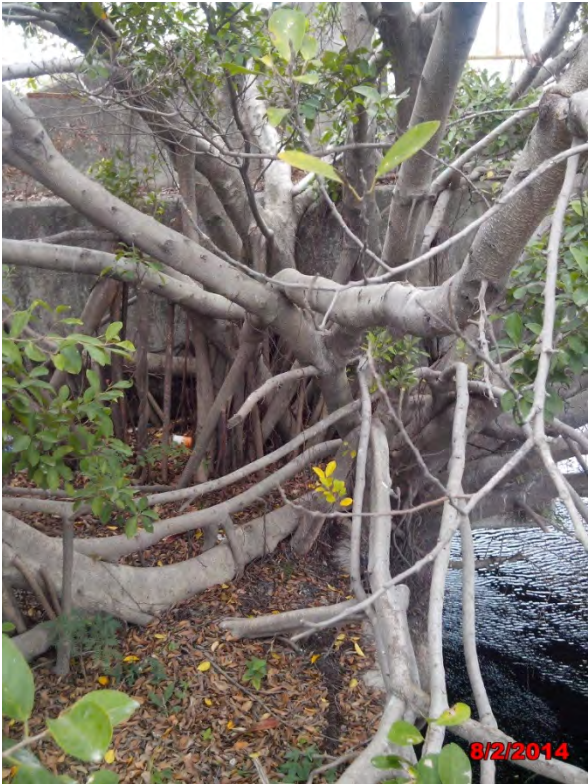
<div>KT/T581_1 Retain</div> <div>Scientific Name: <i>Leucaena leucocephala</i></div>	<div>KT/T581_2</div> <div>Next to concrete structure</div>	<div>KT/T582_1 (Fell)</div> <div>Scientific Name: <i>Ficus microcarpa</i></div>	<div>KT/T582_2</div> <div>Trunk sprangling on concrete structure</div>

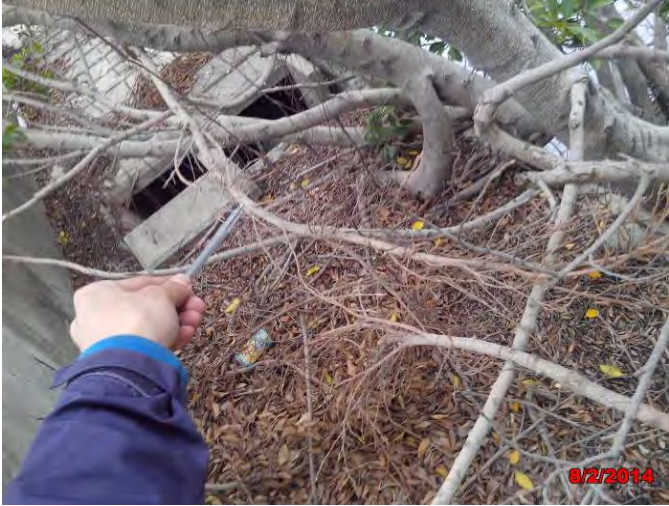
<div>KT/T582_3</div> <div>Trunk sprangling on concrete structure</div>	<div>KT/T582_4</div> <div>Next to concrete structure</div>

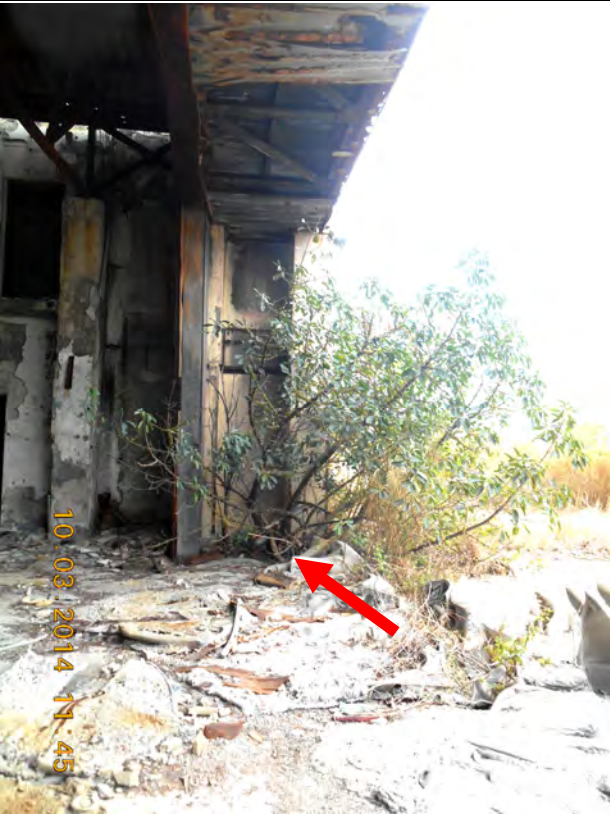
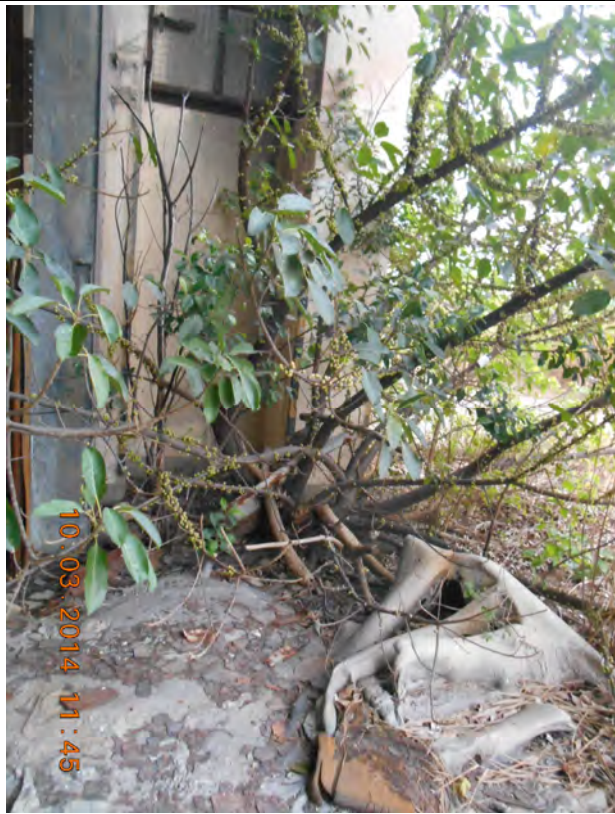
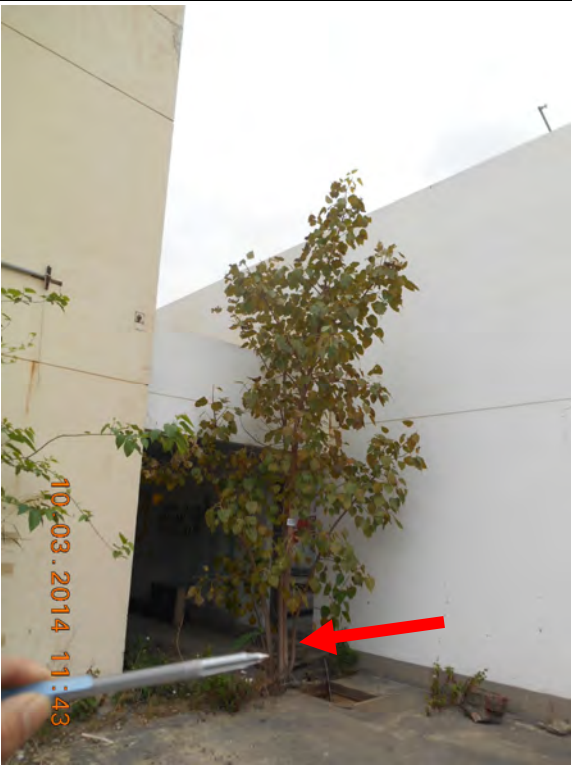
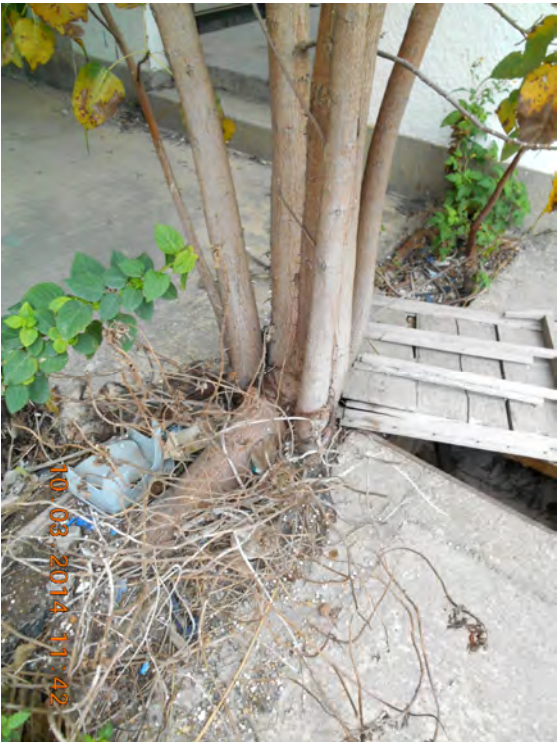
KT/T623_1 (Retain) Scientific Name: <i>Ficus subpisocarpa</i>	KT/T623_2 Multi-trunk; Next to building	KT/T624_1 (Retain) Scientific Name: <i>Ficus religiosa</i>	KT/T624_2 Rooted from concrete crevice

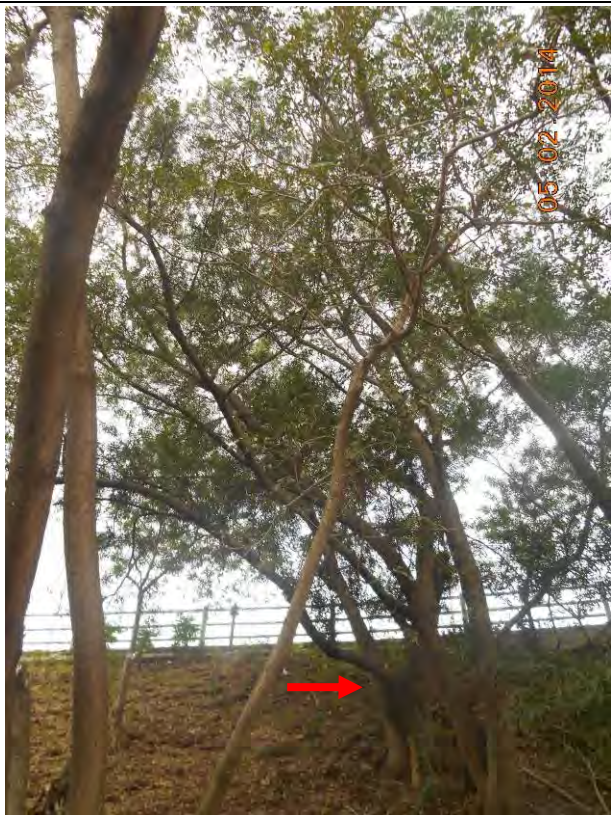
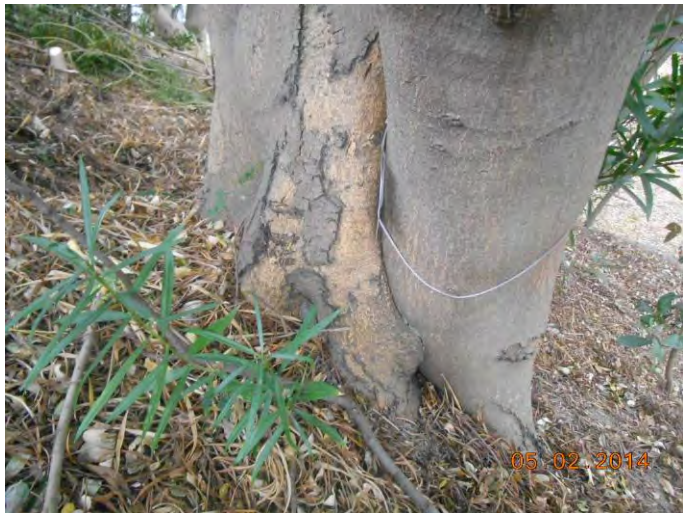
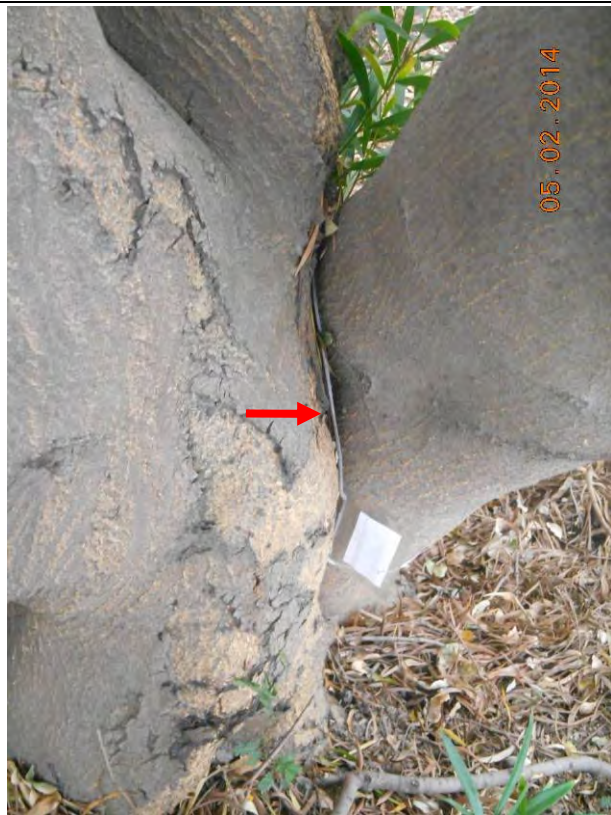
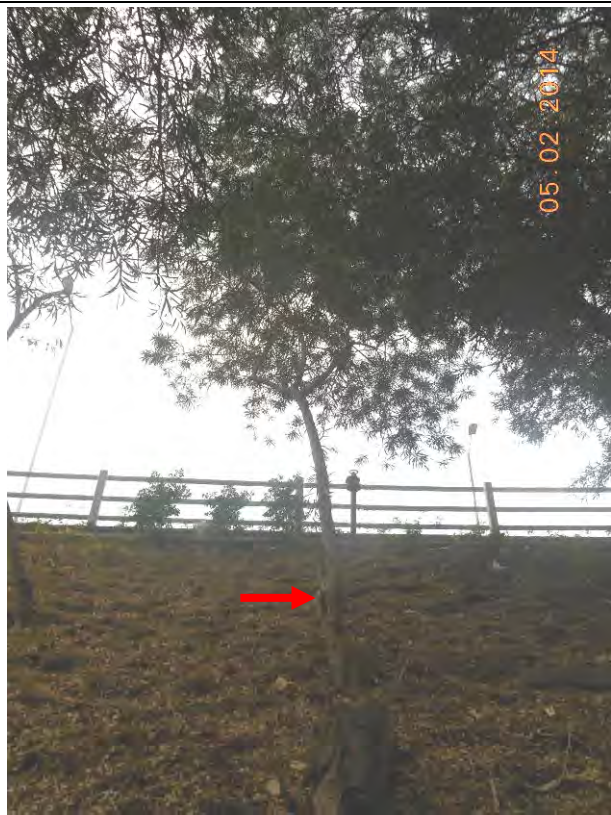
KT/T122_3	KT/T123_1 (Fell) Scientific Name: <i>Acacia confusa</i>	KT/T123_2 Included bark

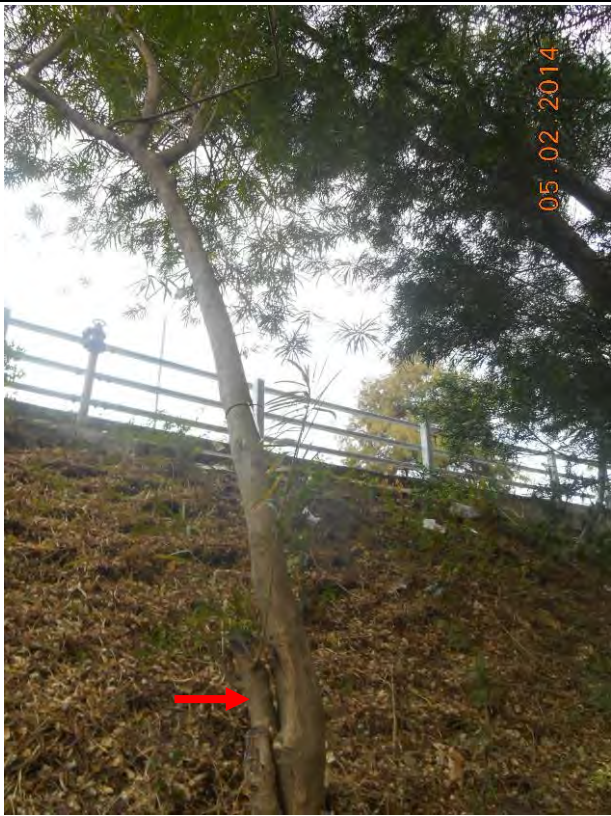
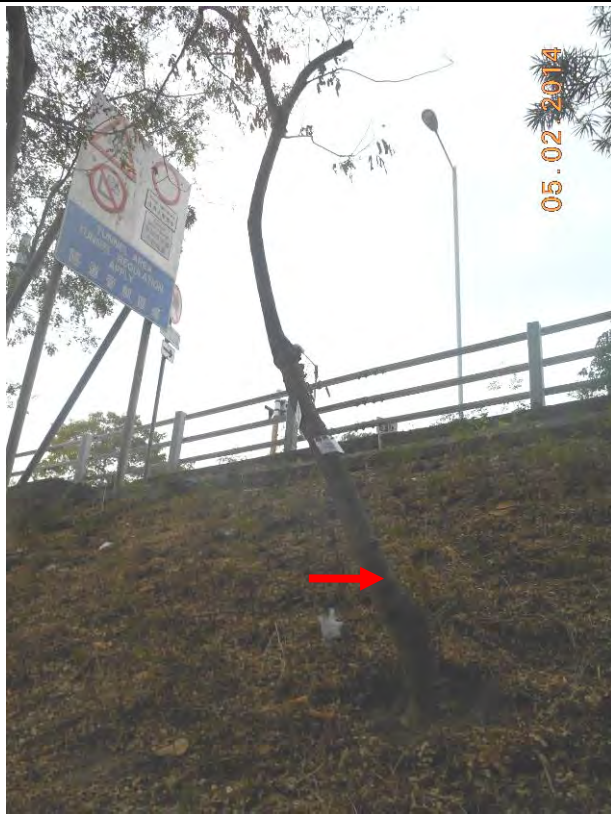
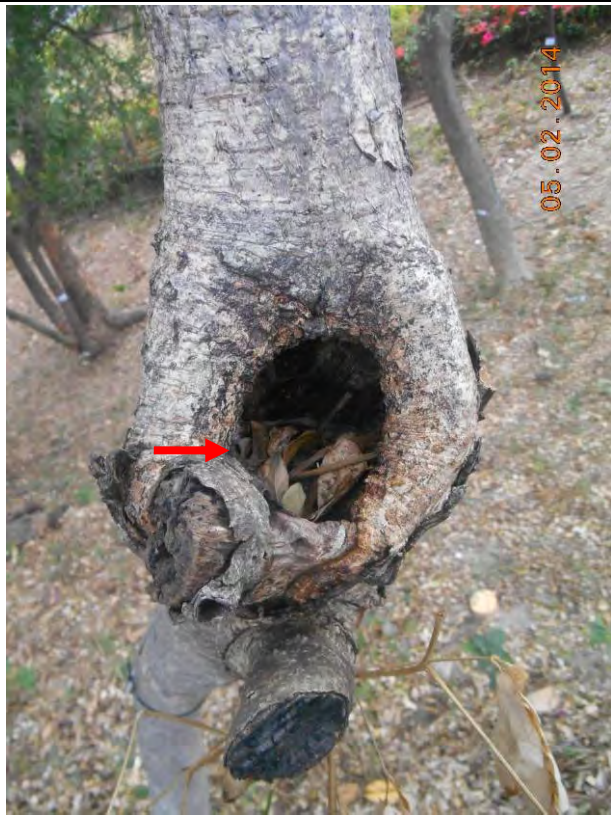
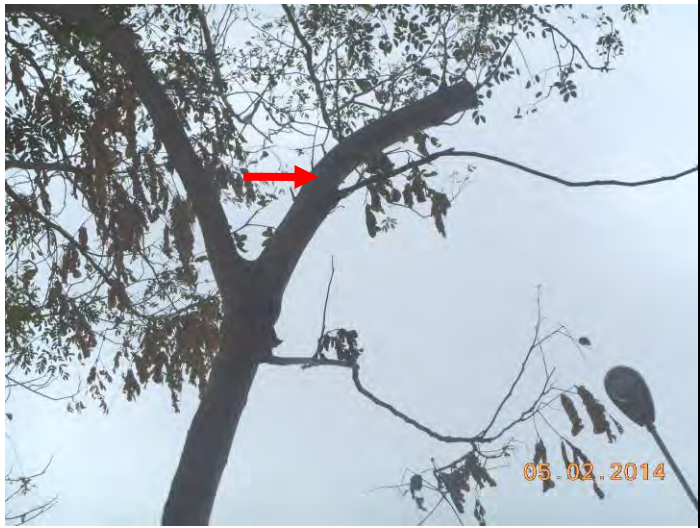
KT/T125_2 Leaning; Dead stump at trunk base	KT/T126_1 (Fell) Scientific Name: <i>Albizia lebbek</i>	KT/T126_2 Cavity on trunk	KT/T126_3 Very few leaves

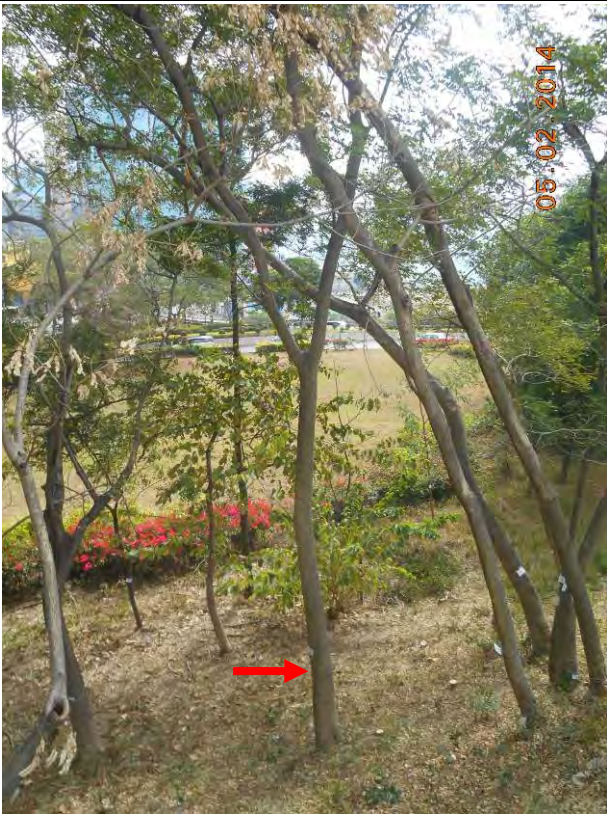
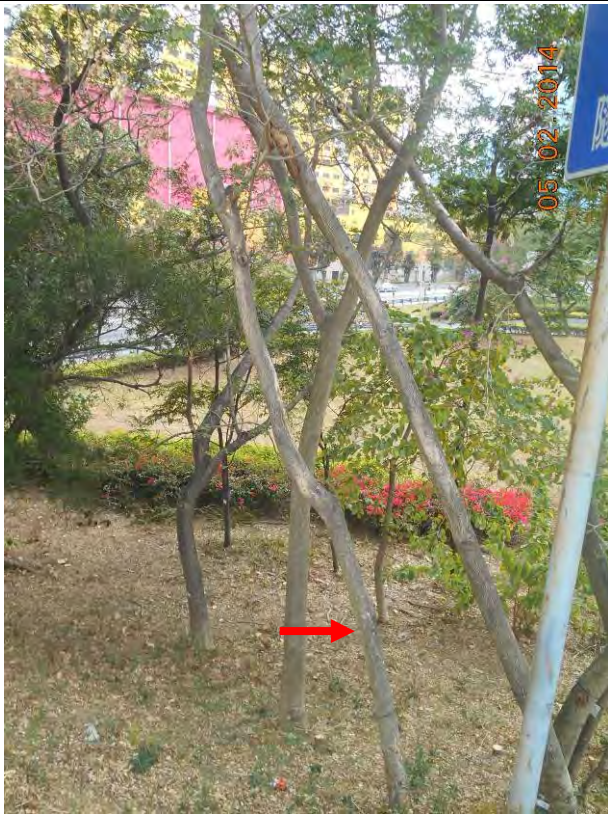
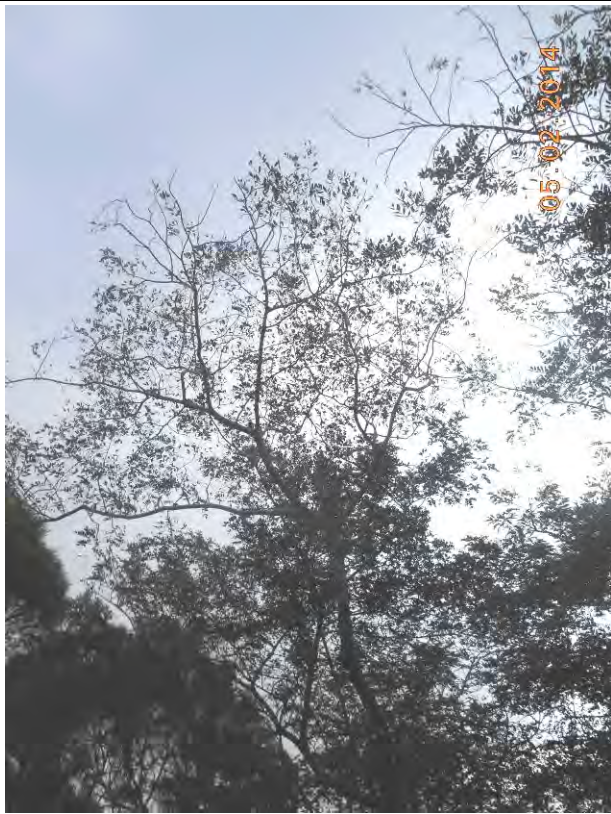
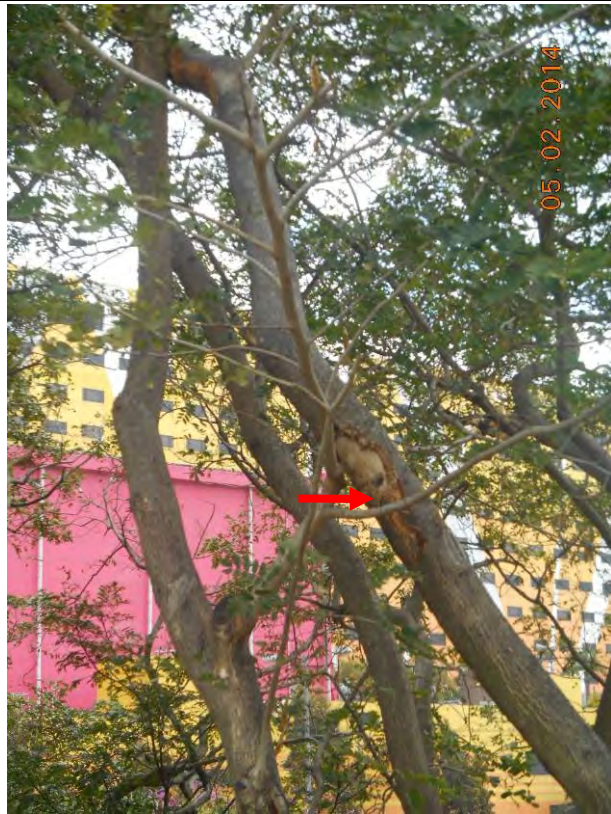
KT/T127_1 (Fell) Scientific Name: <i>Albizia lebbeck</i>	KT/T128_1 (Fell) Scientific Name: <i>Albizia lebbeck</i>	KT/T128_2	KT/T128_3 Cross branches; Wounds on trunk

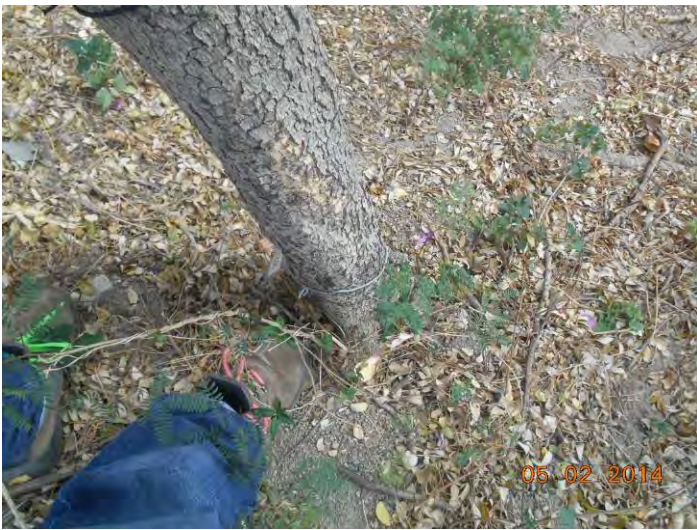
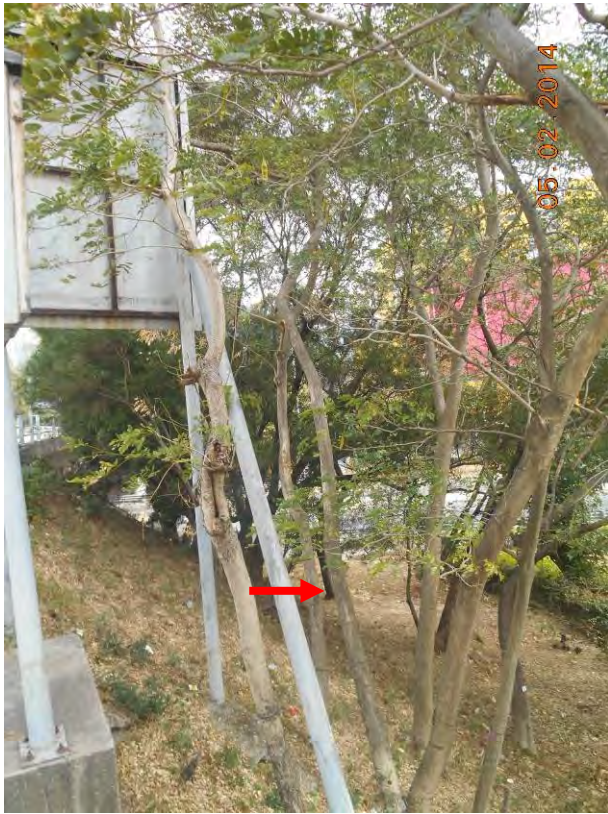
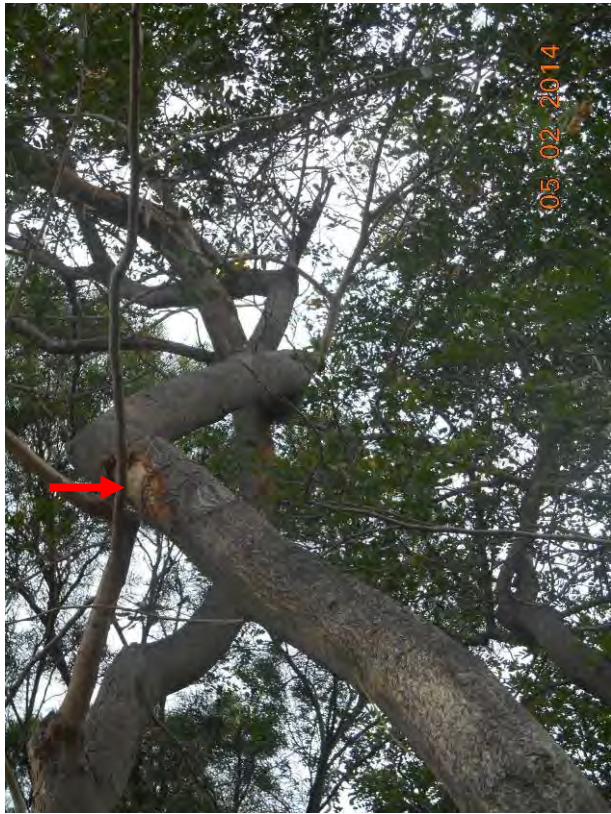
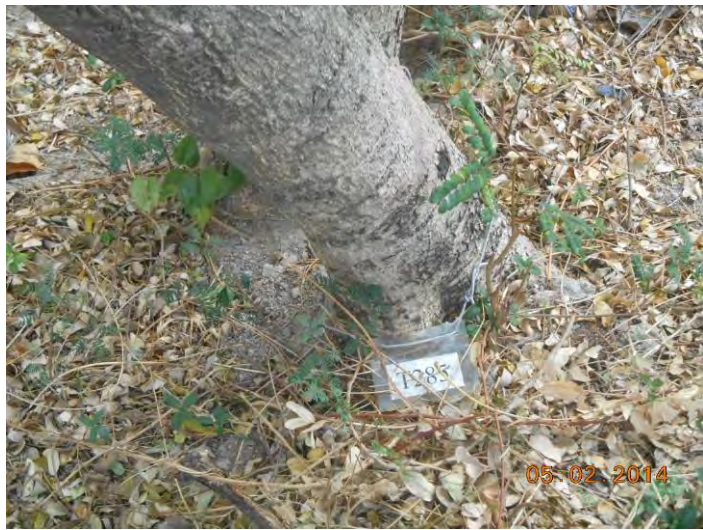
KT/T128_4	KT/T129_1 (Fell) Scientific Name: <i>Albizia lebbeck</i>	KT/T129_3 Crooked trunk; Wound on trunk	KT/T129_4

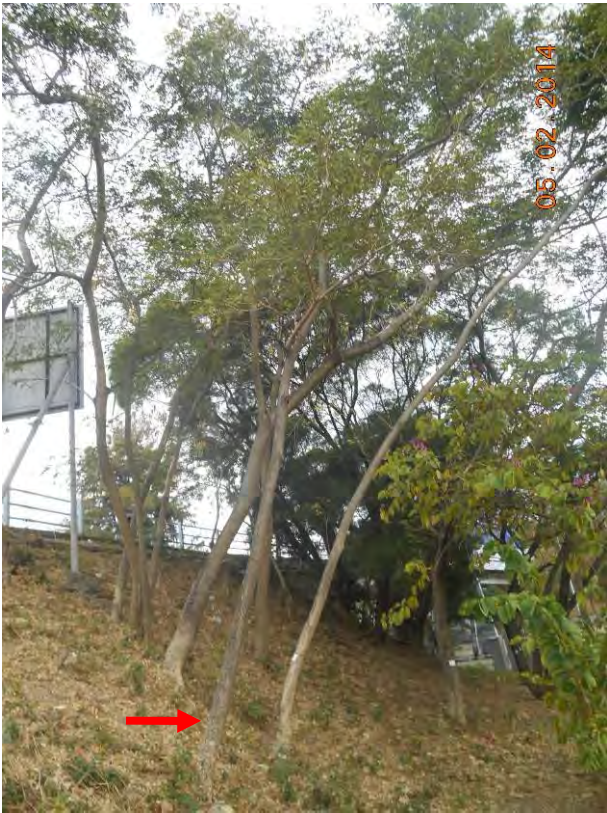
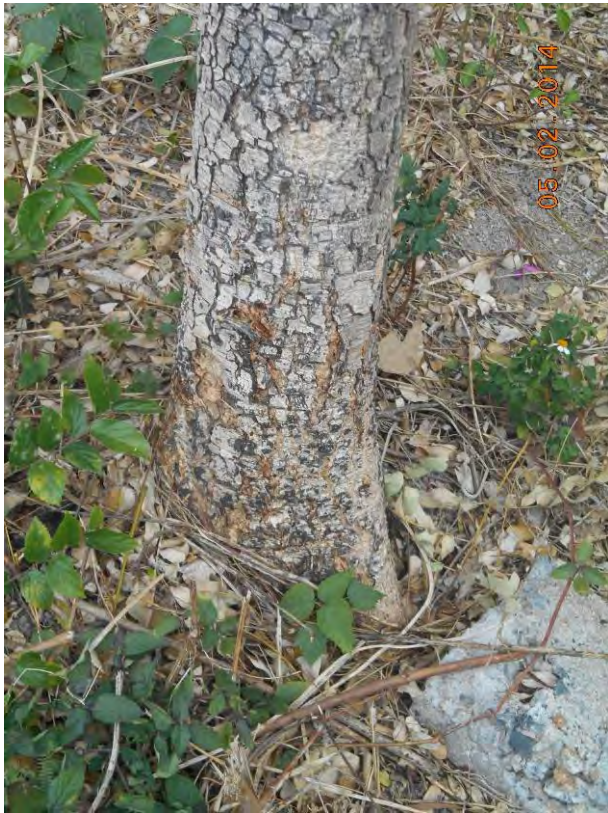
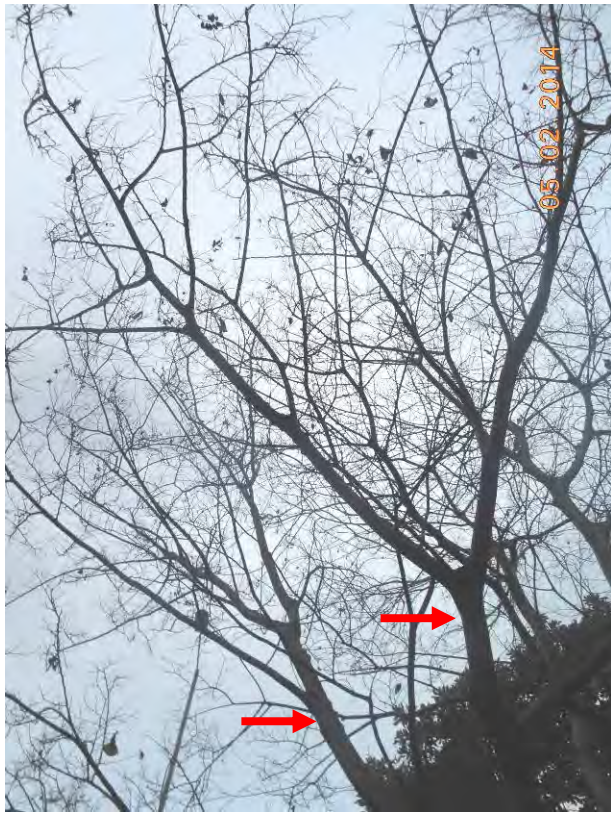
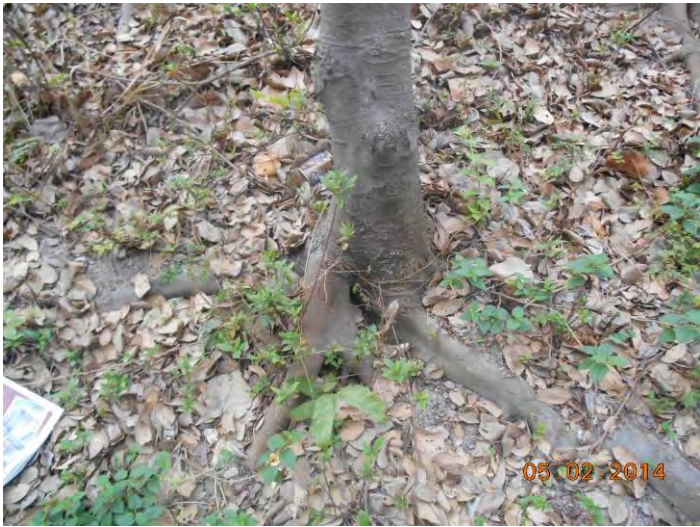
KT/T136_1 (Fell) Scientific Name: <i>Albizia lebbeck</i>	KT/T136_2	KT/T137_1 (Fell) Scientific Name: <i>Celtis sinensis</i>	KT/T137_2
