## **CKR – Kai Tak**

Central Kowloon Route -  
Design and Construction

Tree Assessment Schedule - Kai Tak Area (Trees under AFCD to Provide Expert Advice)

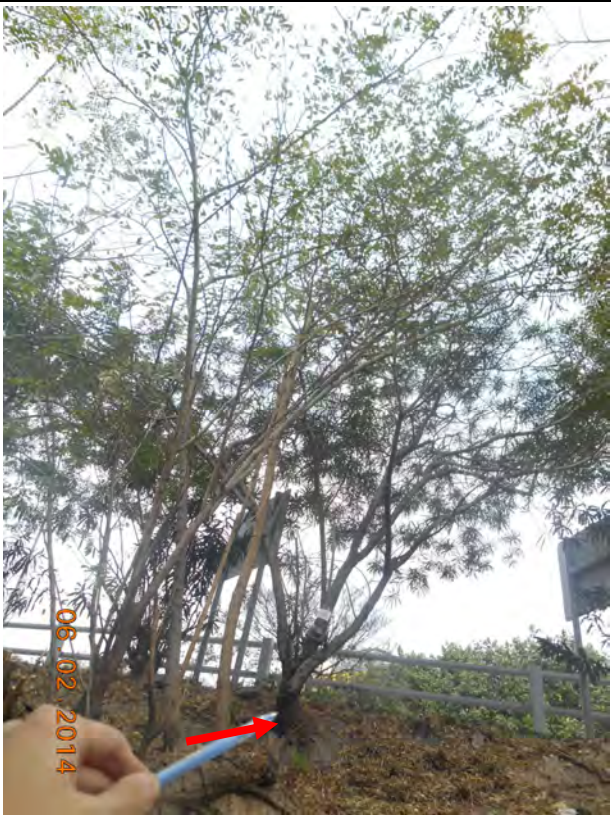
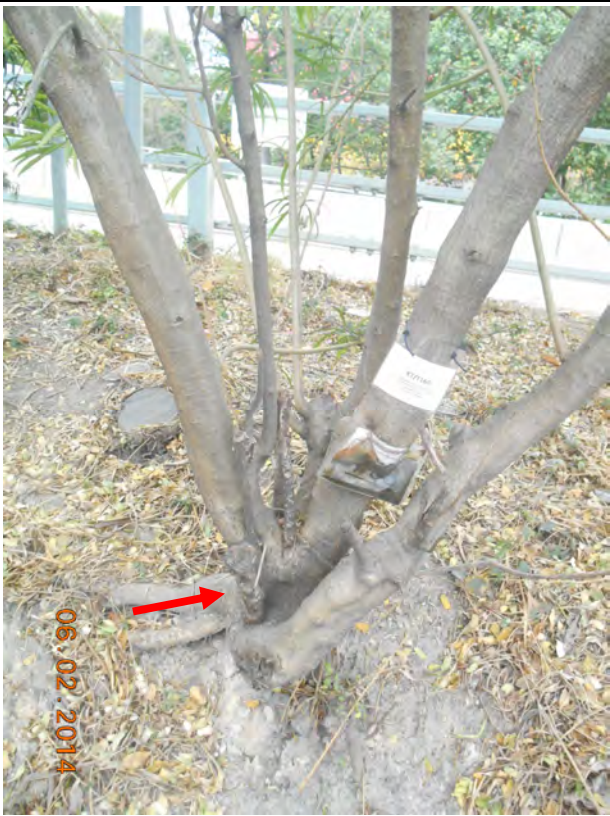
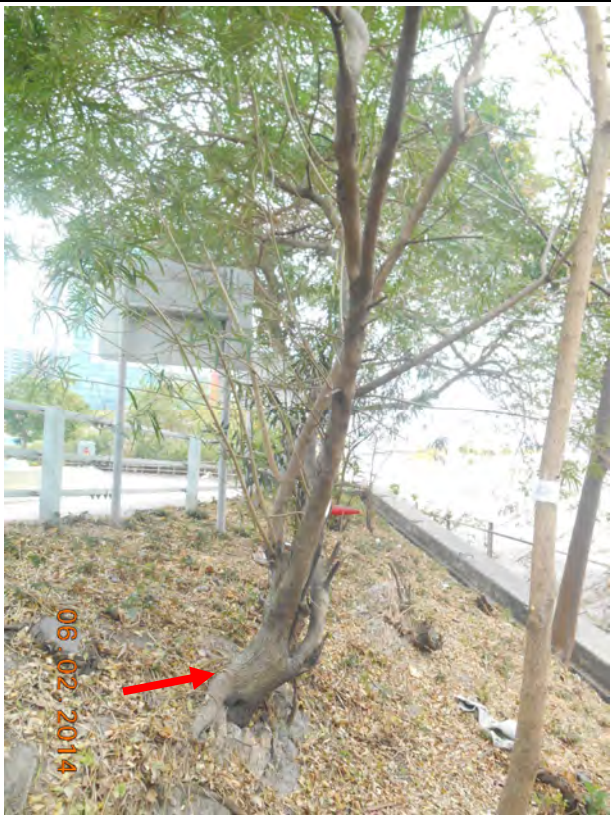
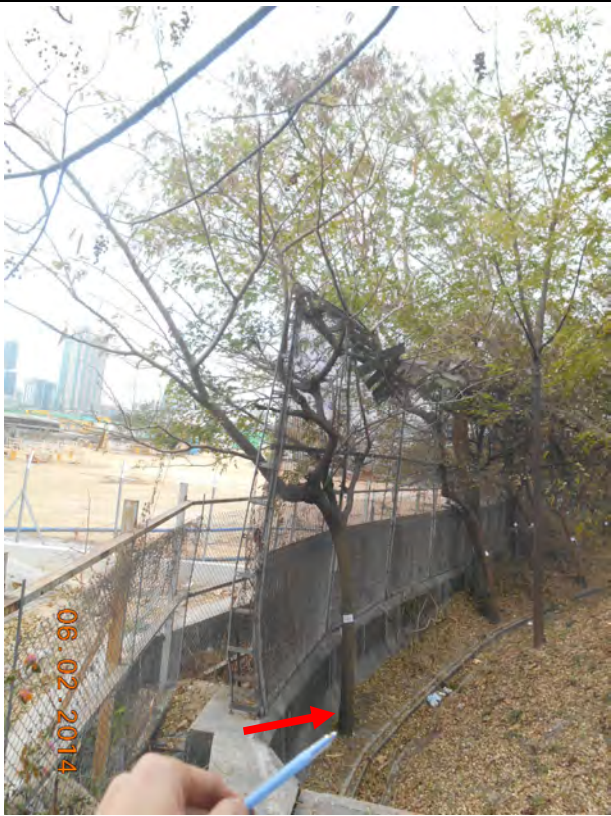
KT/T160_1 (Fell) Scientific Name: <i>Thevetia peruviana</i>	KT/T160_2 Multi-trunk	KT/T160_3	KT/T161_1 (Fell) Scientific Name: <i>Albizia lebbbeck</i>

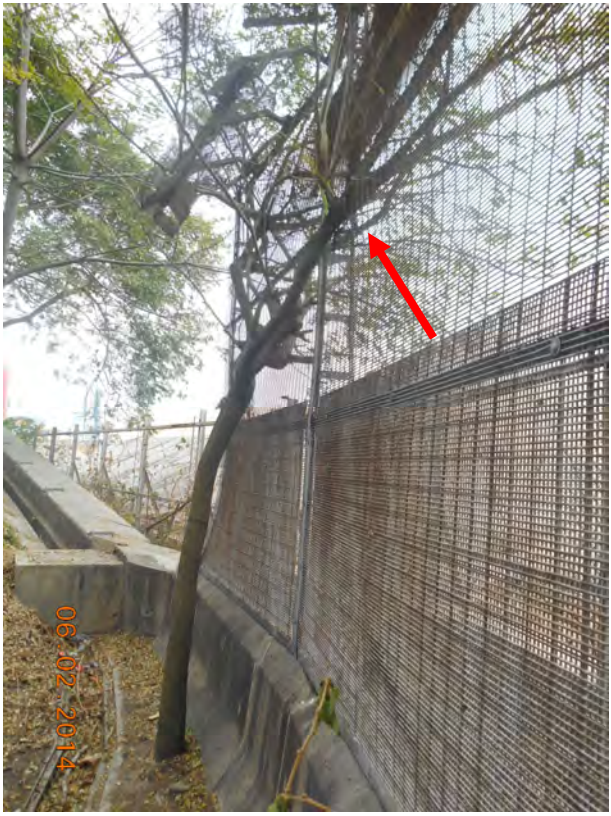
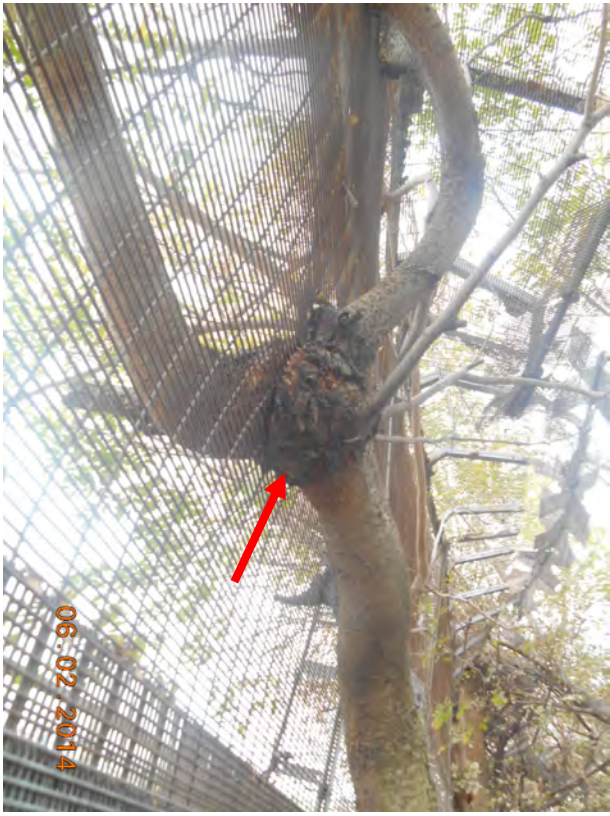
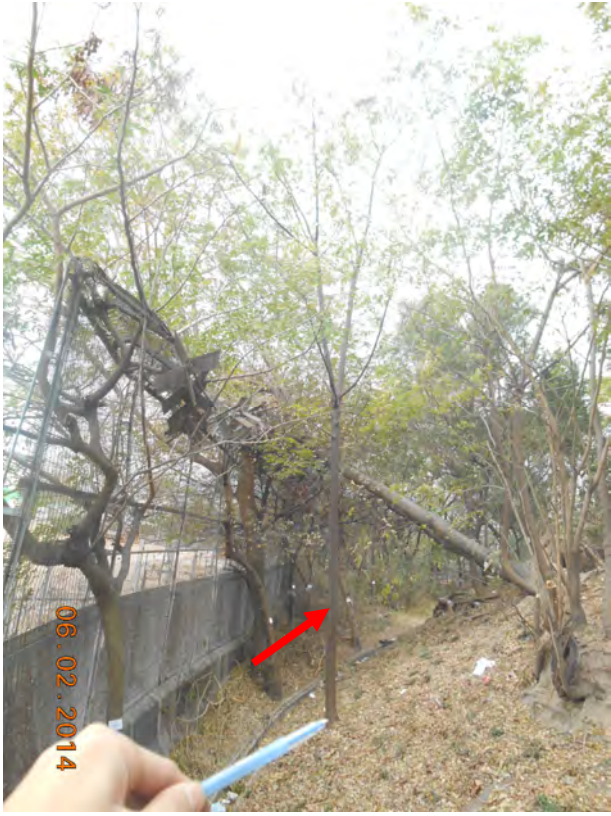
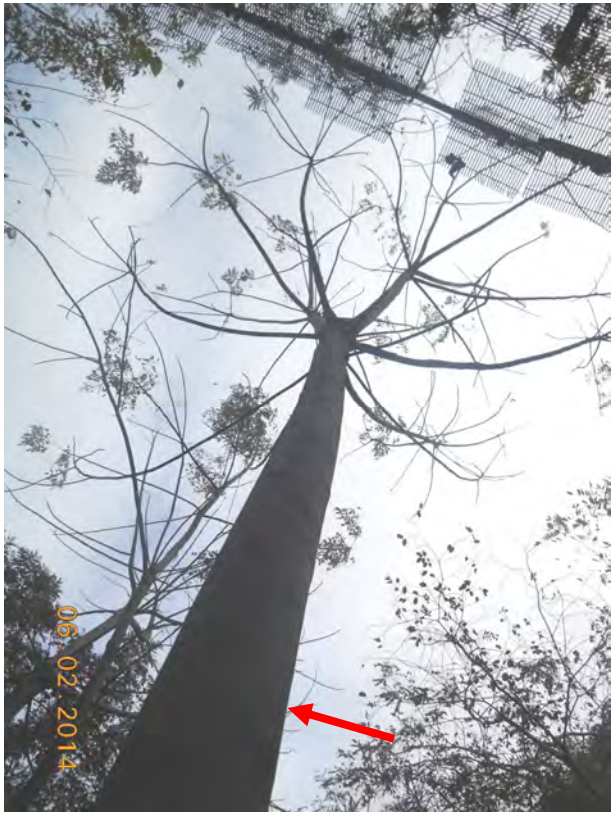
KT/T161_2 Bent trunk	KT/T161_2 Mingled with fence	KT/T162_1 (Fell) Scientific Name: <i>Melia azedarach</i>	KT/T162_2

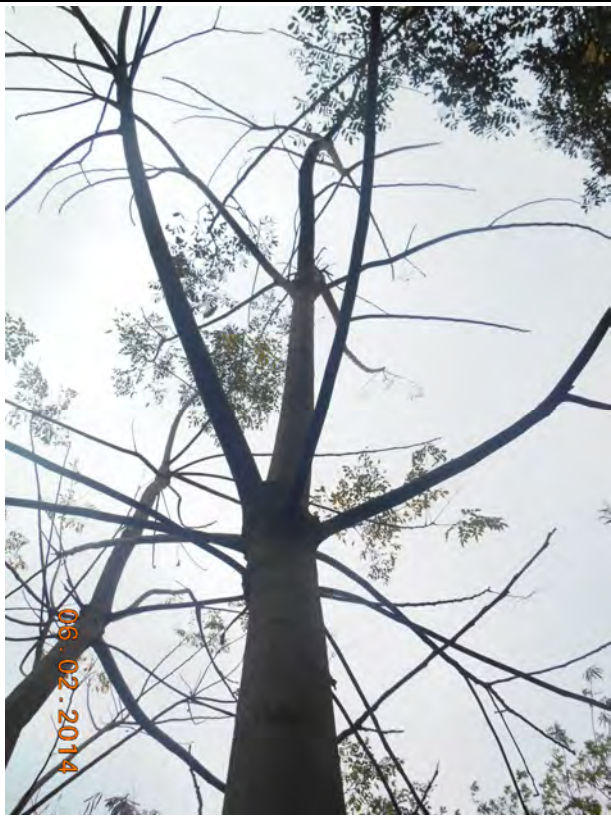
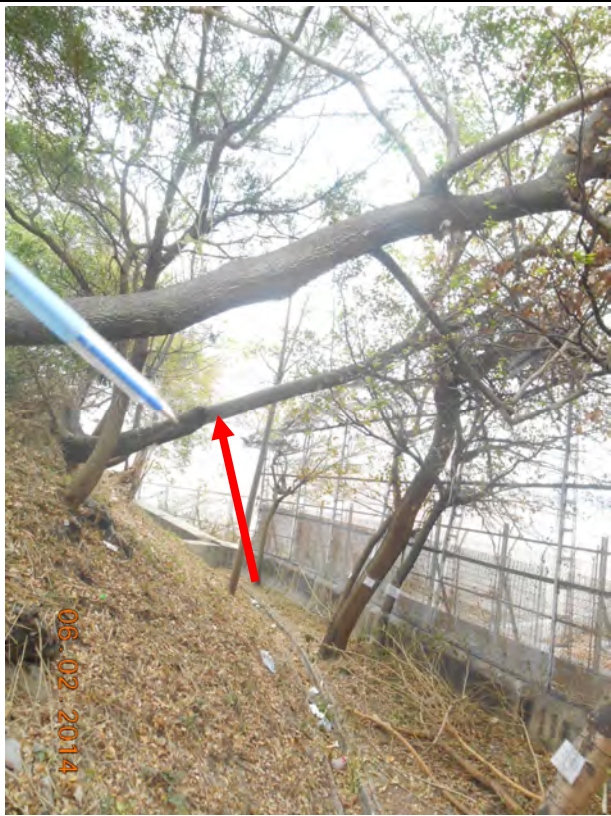
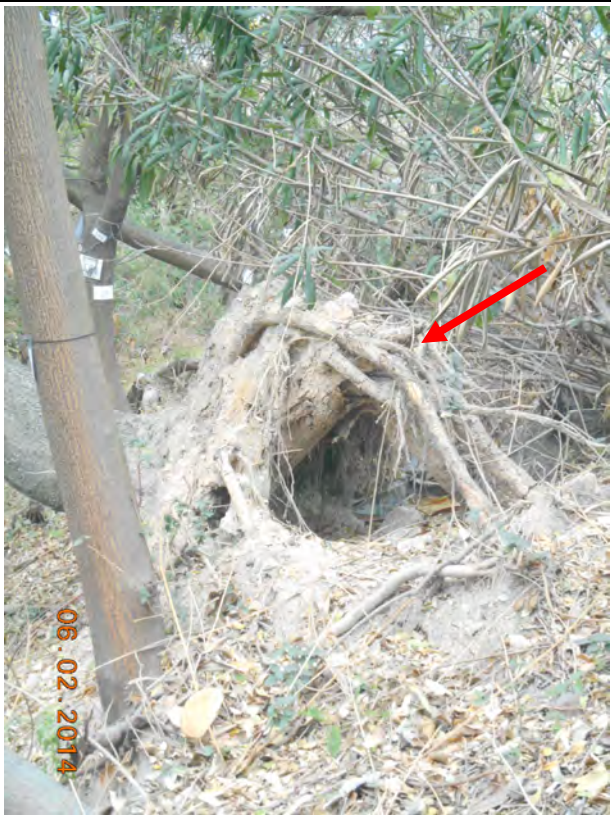
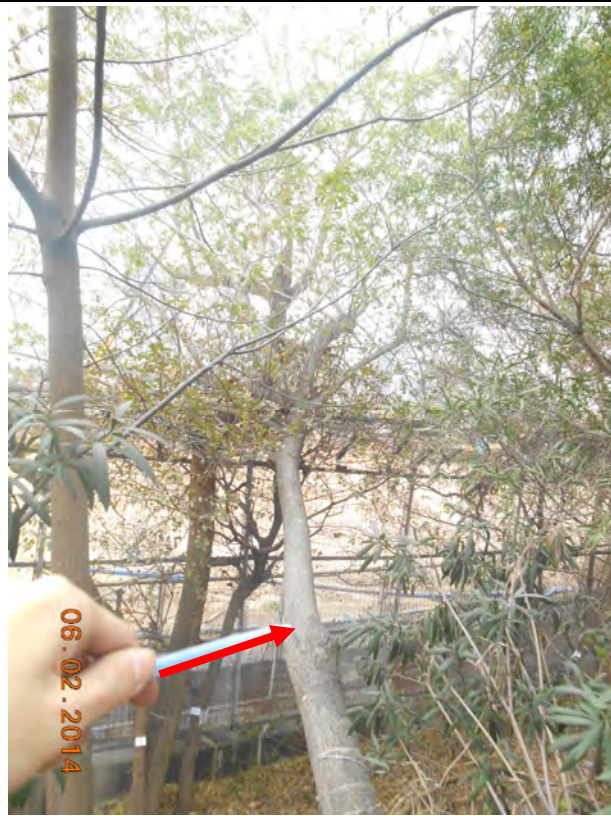
KT/T166_2	KT/T167_1 (Fell) Scientific Name: <i>Albizia lebbbeck</i>	KT/T167_2 Uprooted	KT/T167_3 Leaning on fence

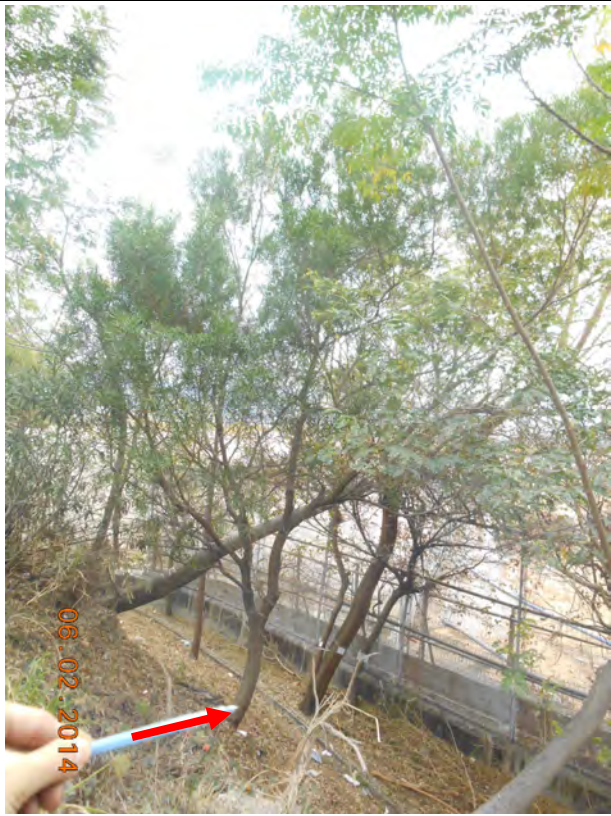
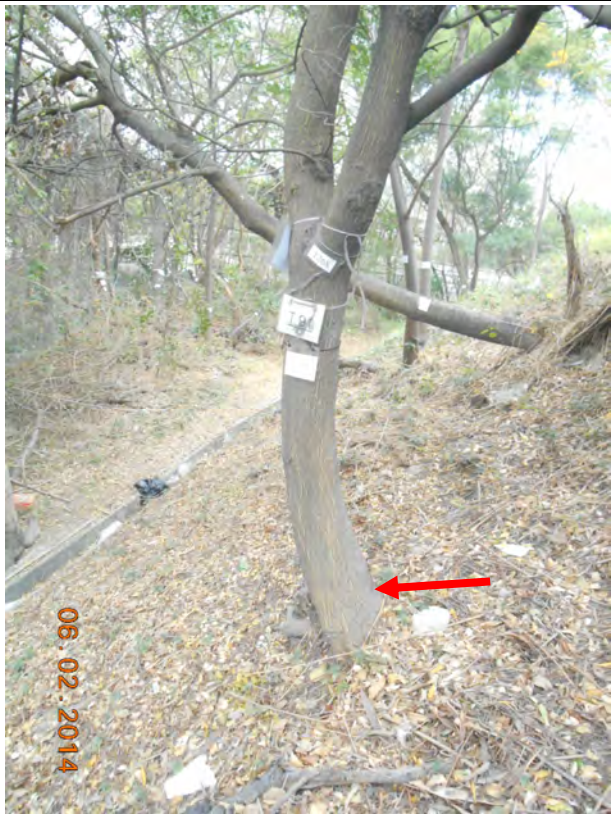
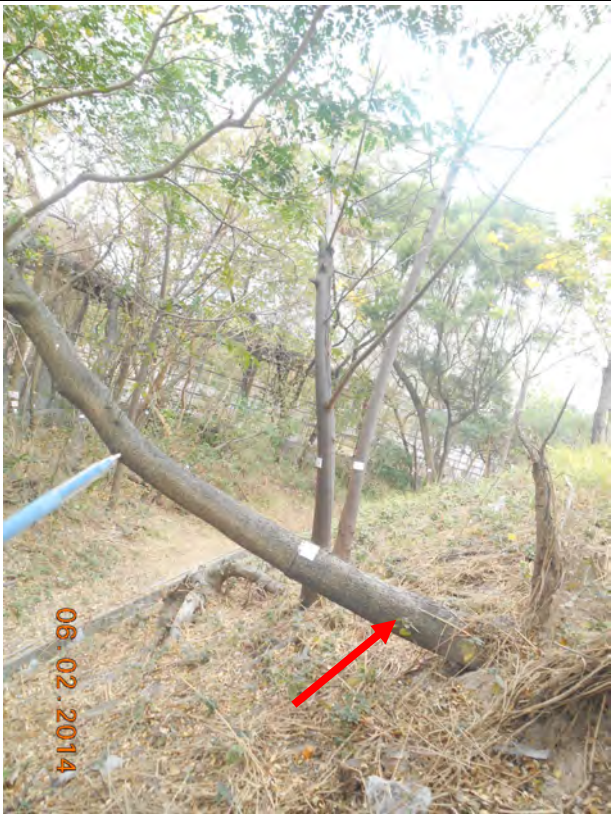
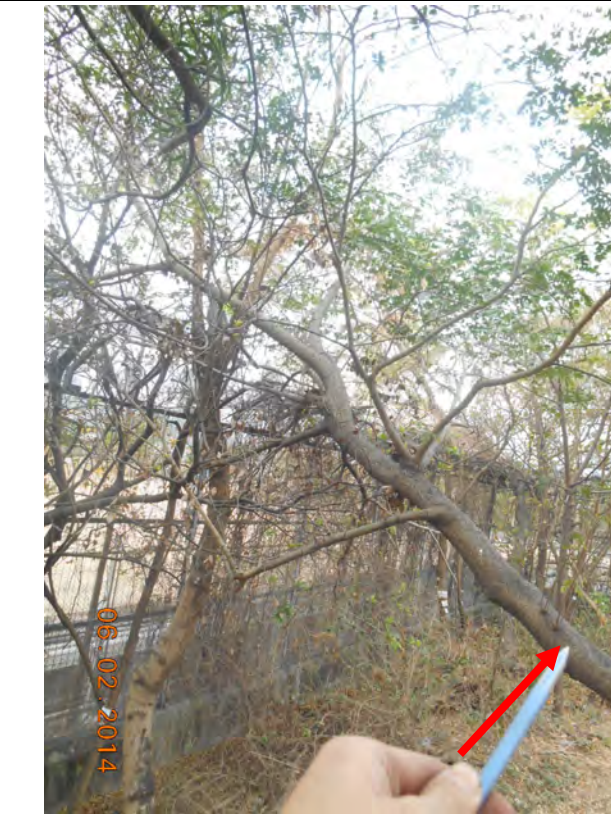
KT/T168_1 (Fell) Scientific Name: <i>Acacia confusa</i>	KT/T168_2	KT/T169_1 (Fell) Scientific Name: <i>Albizia lebbbeck</i>	KT/T169_2 Heavily leaning

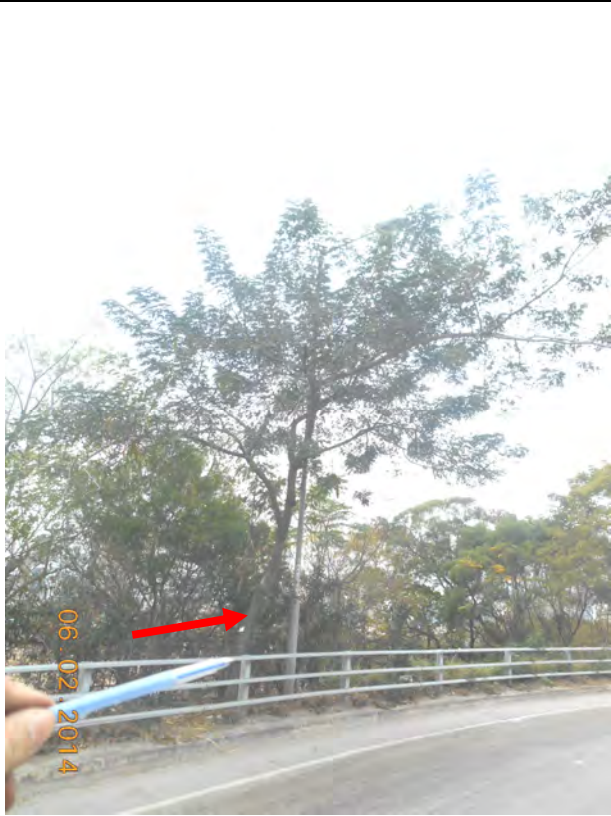
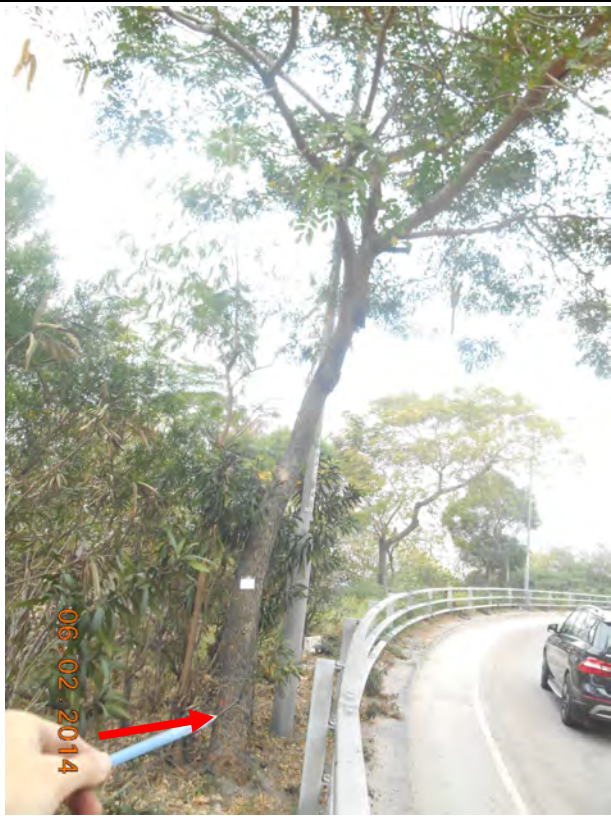
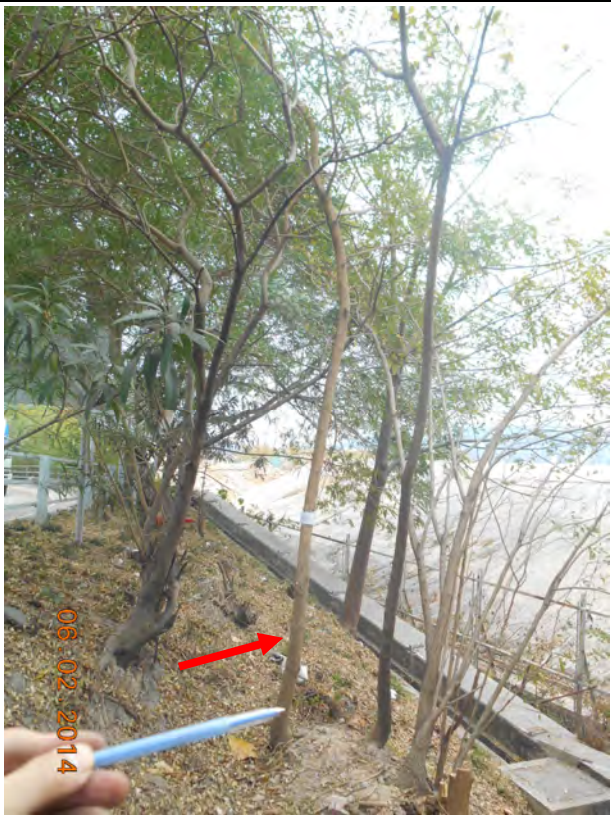
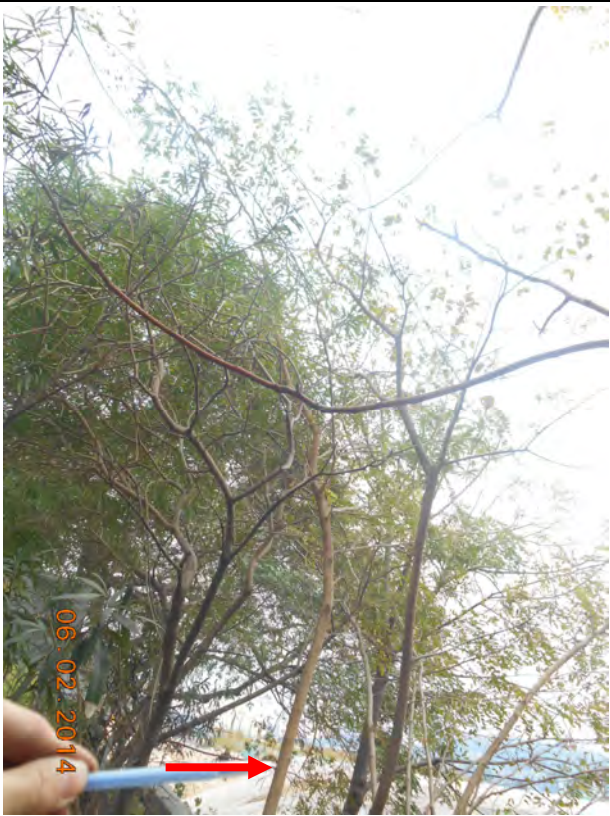
KT/T170_1_(Fell) Scientific Name: <i>Albizia lebbeck</i>	KT/T170_2 Next to carriageway	KT/T171_1 (Fell) Scientific Name: <i>Albizia lebbeck</i>	KT/T171_5 Poor taper

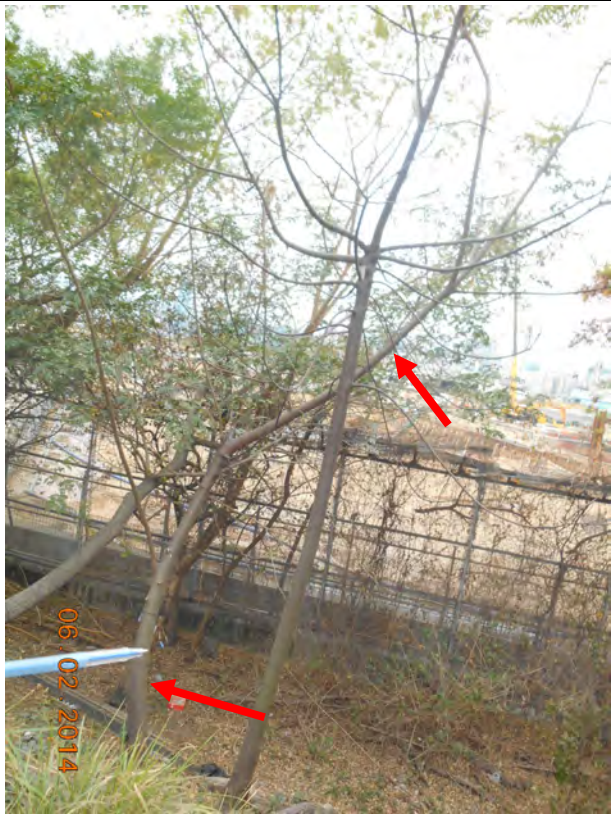
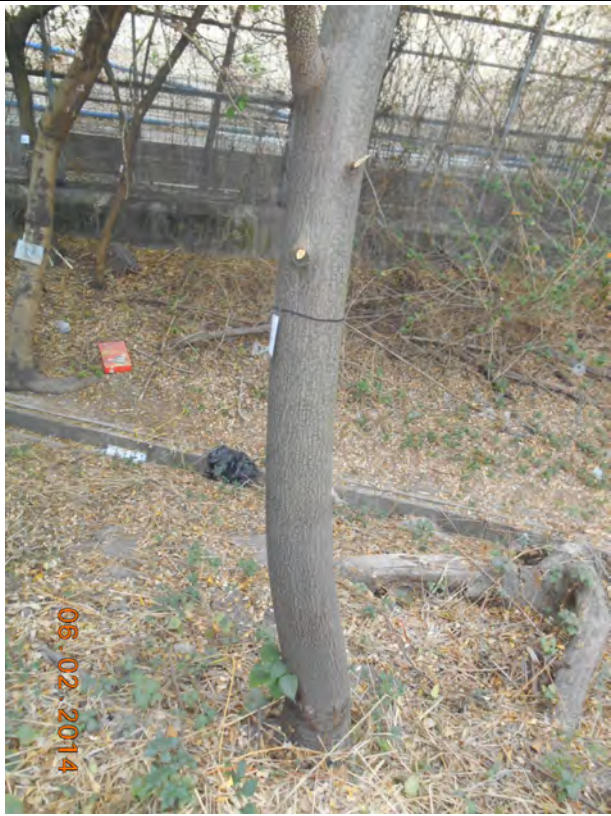
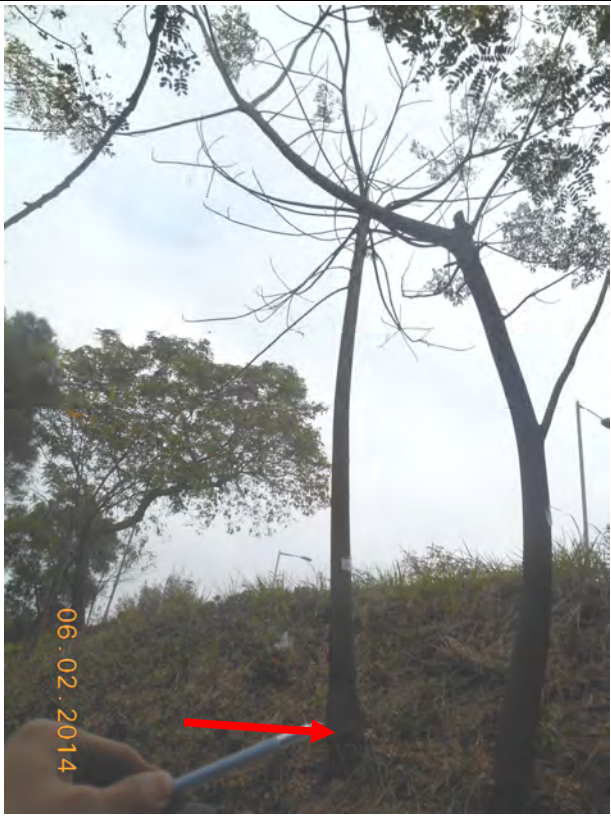
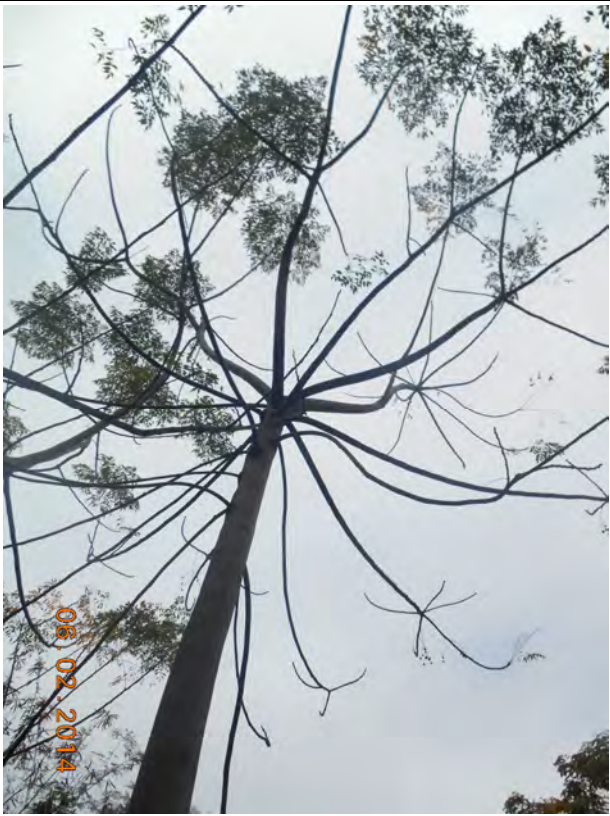
KT/T172_1 (Fell) Scientific Name: <i>Melia azedarach</i>	KT/T172_2	KT/T173_1 (Fell) Scientific Name: <i>Melia azedarach</i>	KT/T173_2

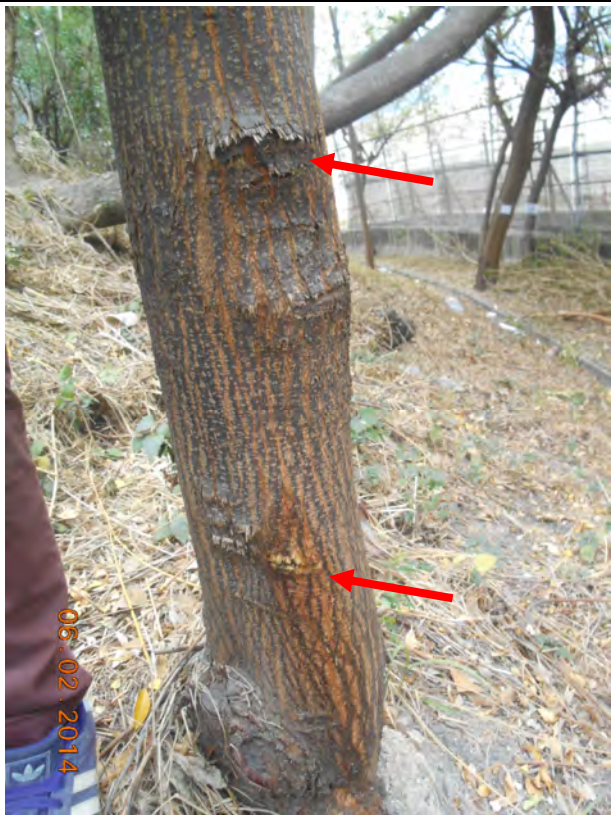
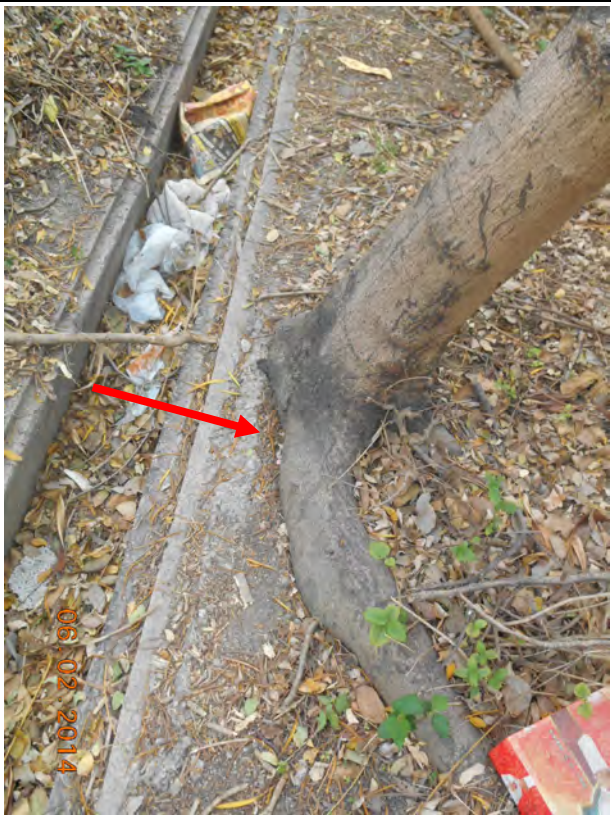
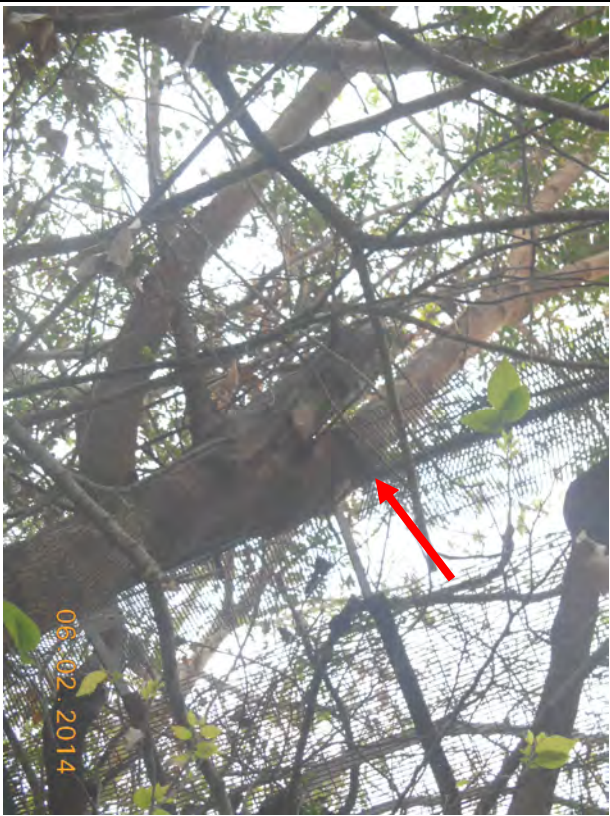
KT/T173_3 Multiple wounds on trunk	KT/T174_1 (Fell) Scientific Name: <i>Leucaena leucocephala</i>	KT/T174_3 Next to u-channel	KT/T174_4 Mingled with fence

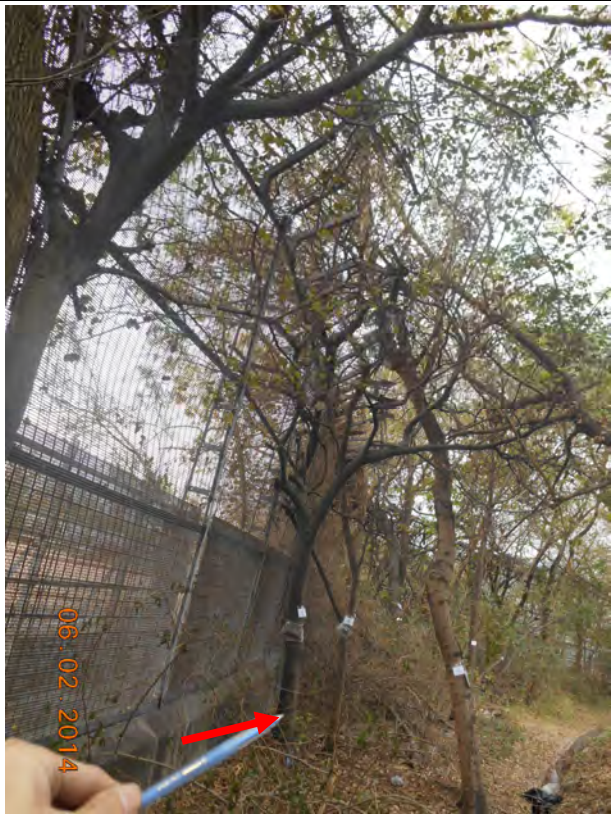
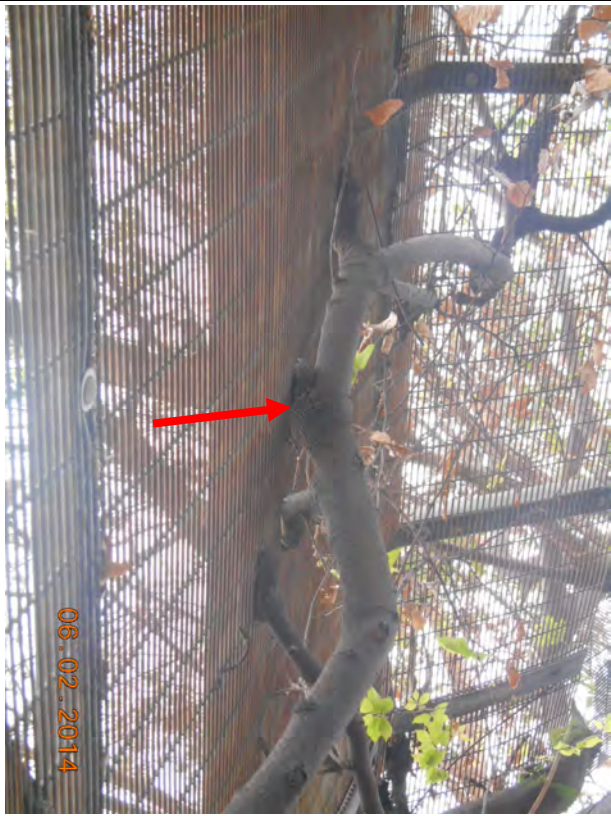
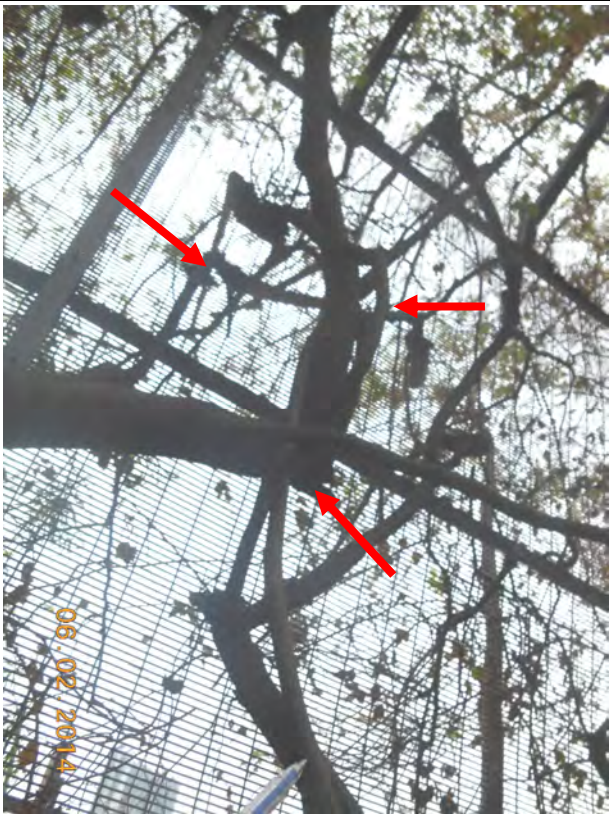
KT/T175_1 (Fell) Scientific Name: <i>Celtis sinensis</i>	KT/T175_2 Mingled with fence	KT/T176_1 (Fell) Scientific Name: <i>Leucaena leucocephala</i>	KT/T176_2 Mingled with fence

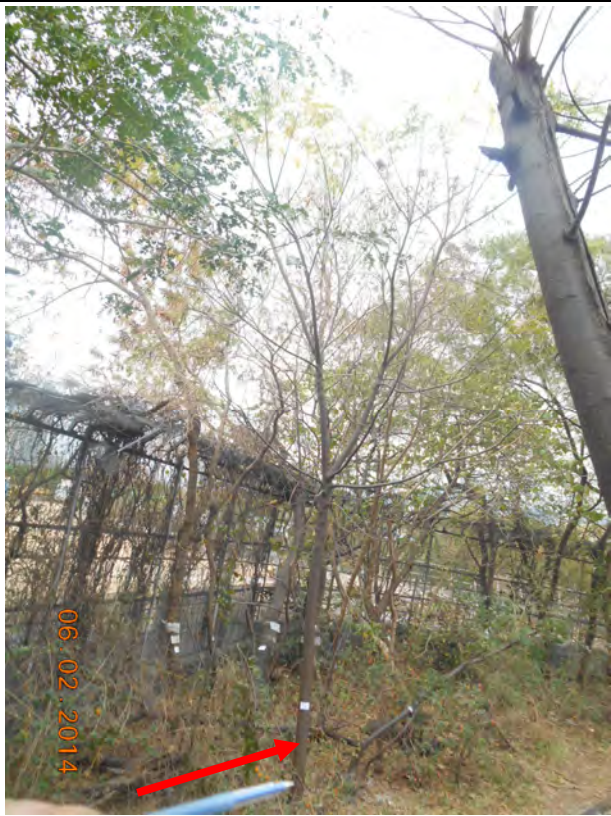
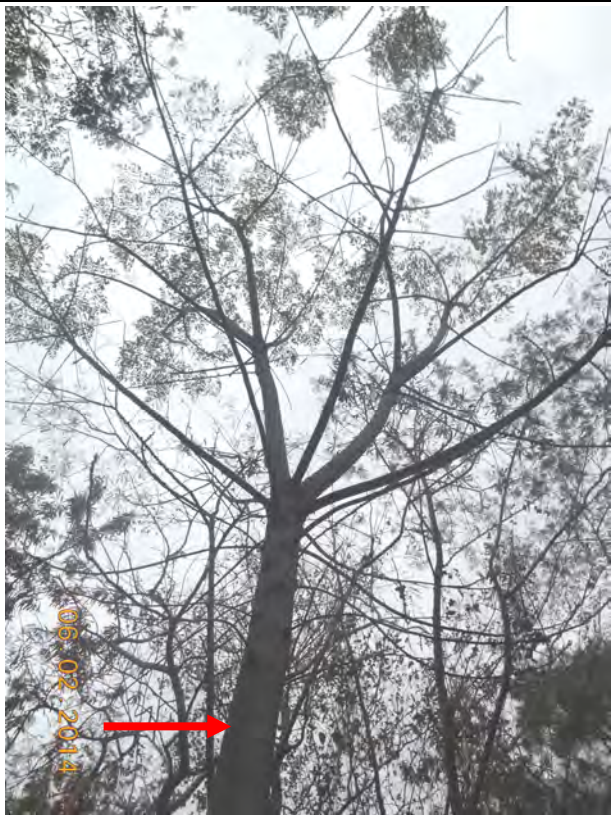
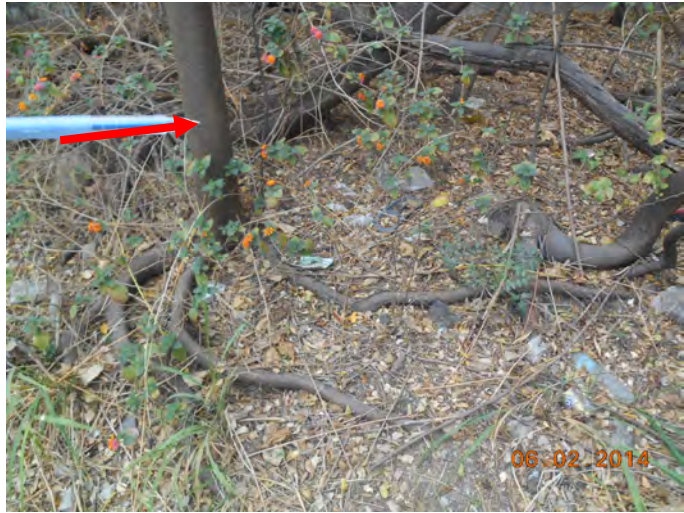
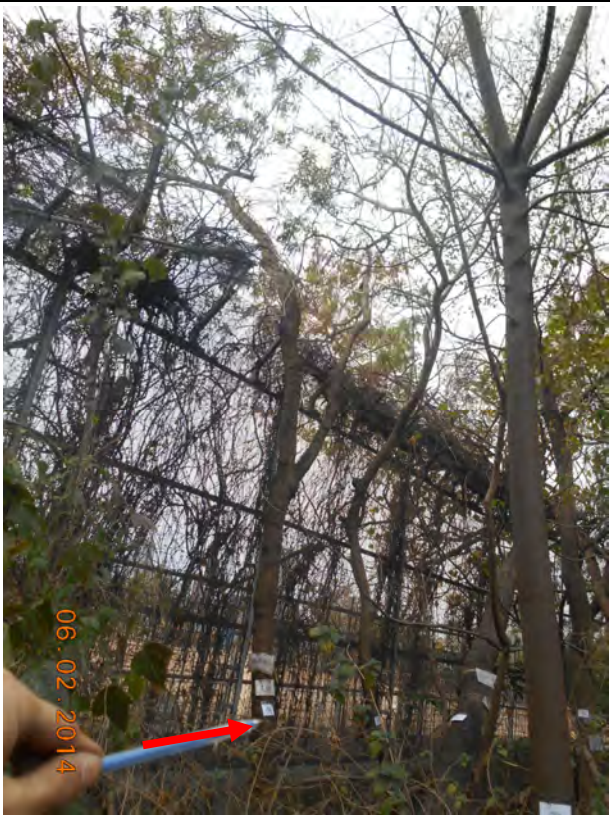
KT/T177_1 (Fell) Scientific Name: <i>Melia azedarach</i>	KT/T177_2	KT/T177_3 Exposed roots	KT/T178_1 (Fell) Scientific Name: <i>Leucaena leucocephala</i>

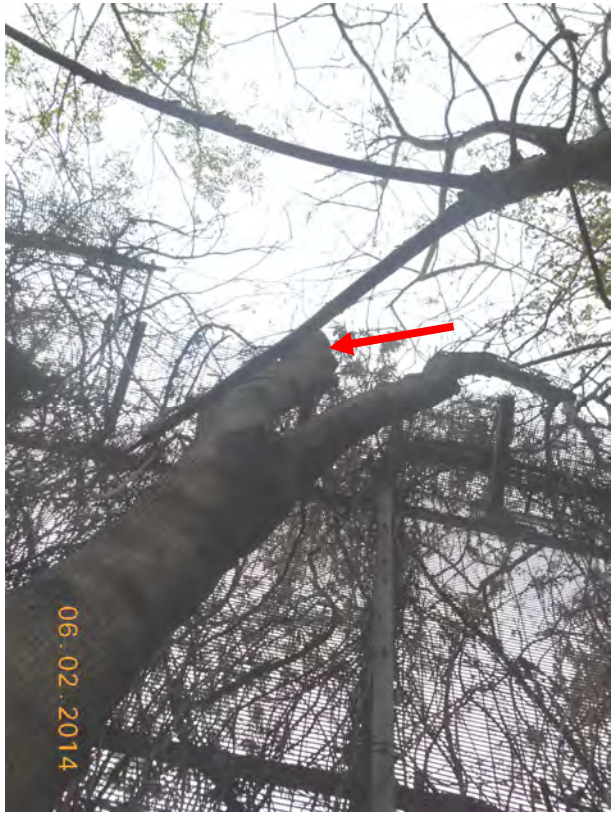
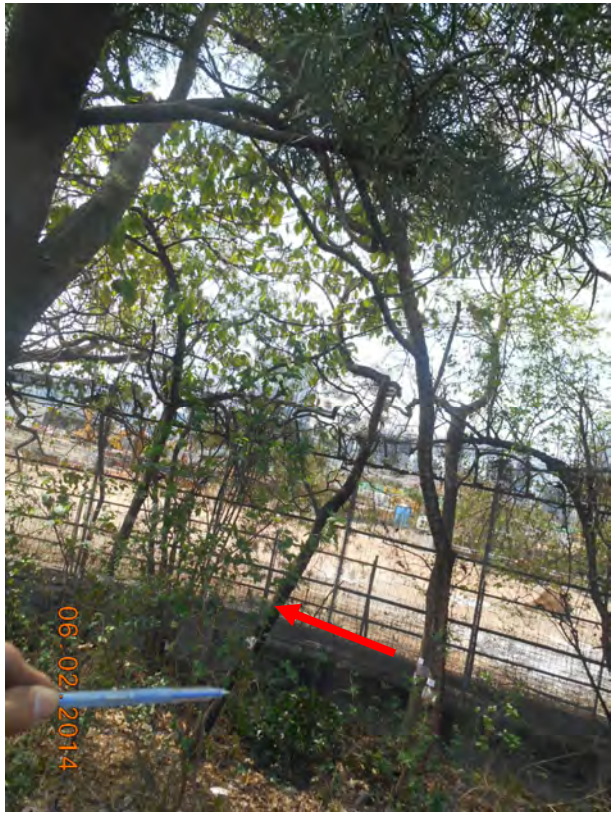
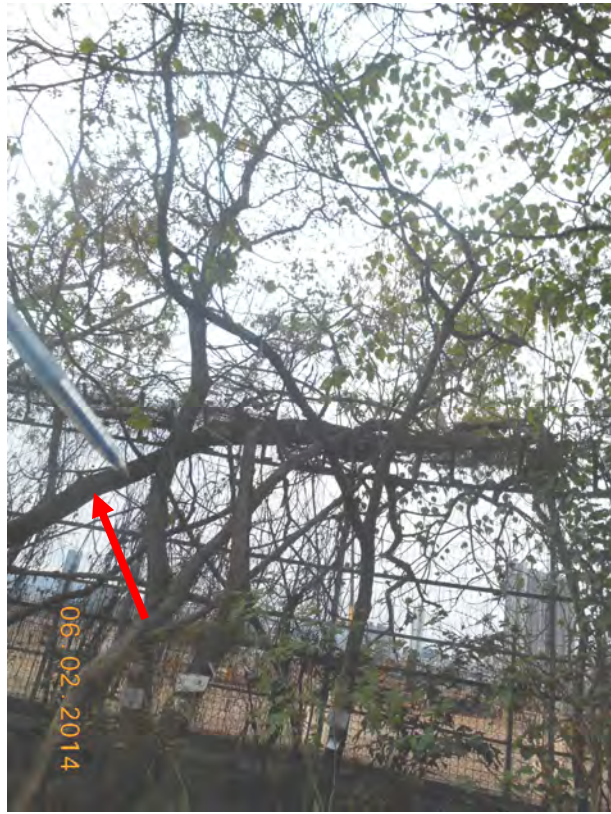
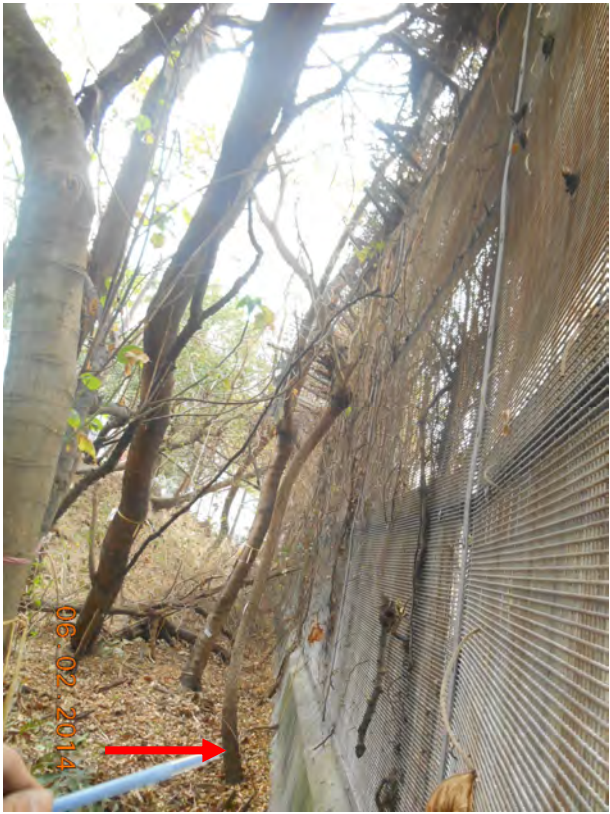
KT/T178_2 Leaning on fence	KT/T179_1 (Fell) Scientific Name: <i>Leucaena leucocephala</i>	KT/T179_2 Leaning on fence	KT/T180_1 (Fell) Scientific Name: <i>Albizia lebbeck</i>

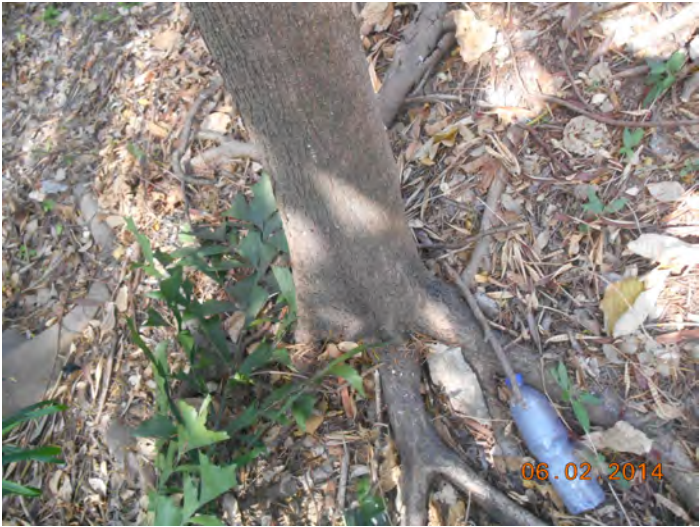
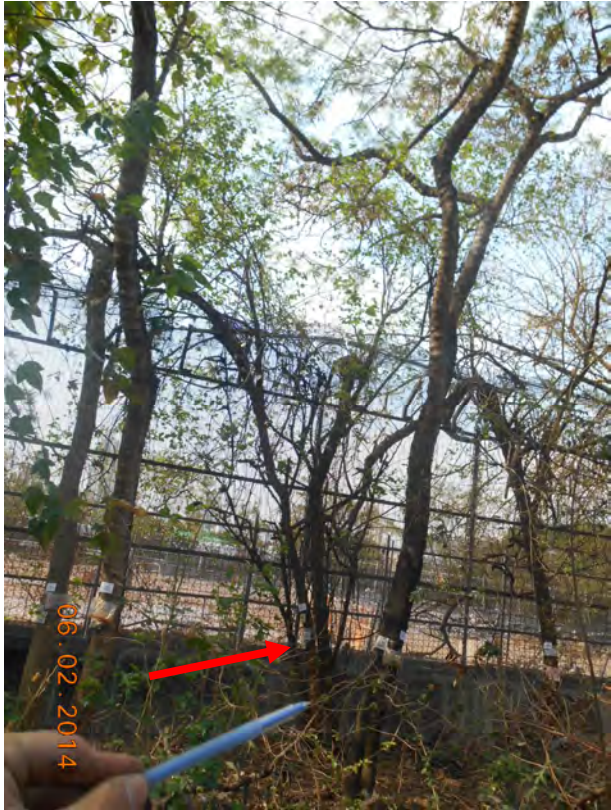
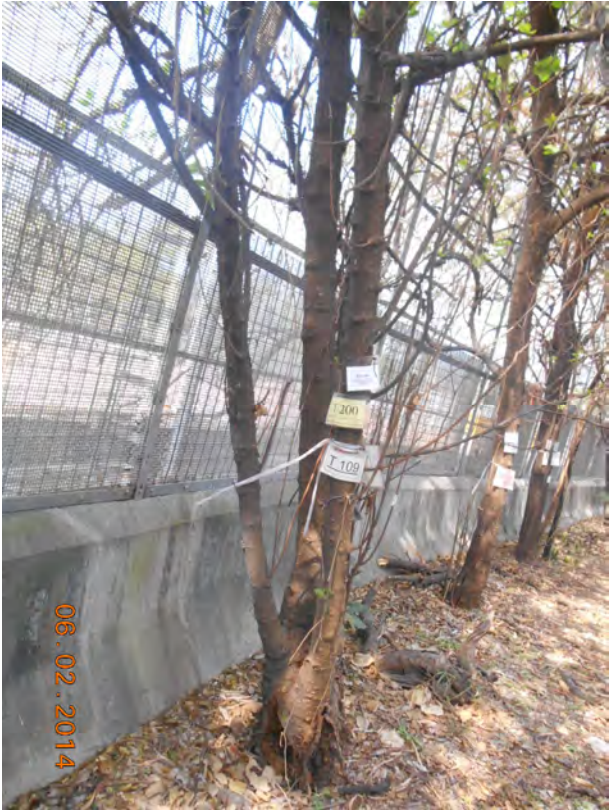
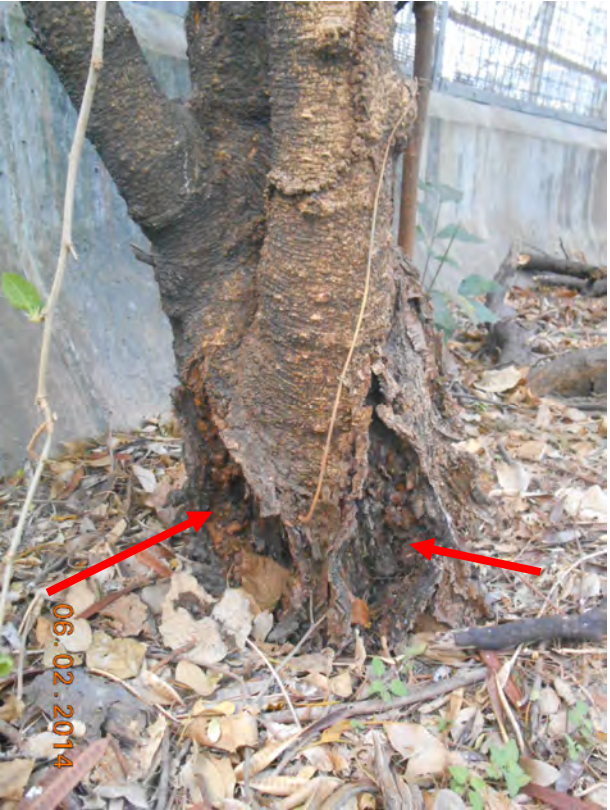
<p>06.02.2014</p>
KT/T193_2	KT/T194_1 (Fell) Scientific Name: <i>Morus alba</i>	KT/T194_2 Multi-trunk	KT/T194_3 Decay at trunk base

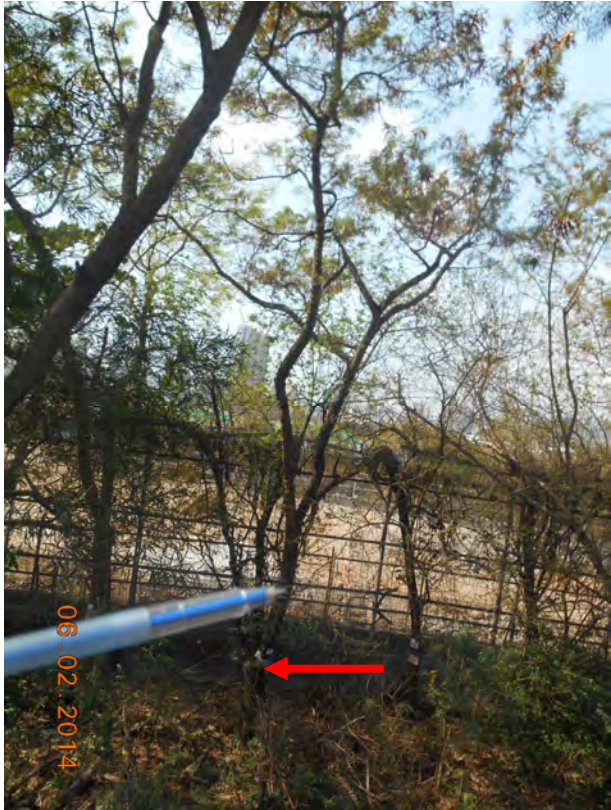
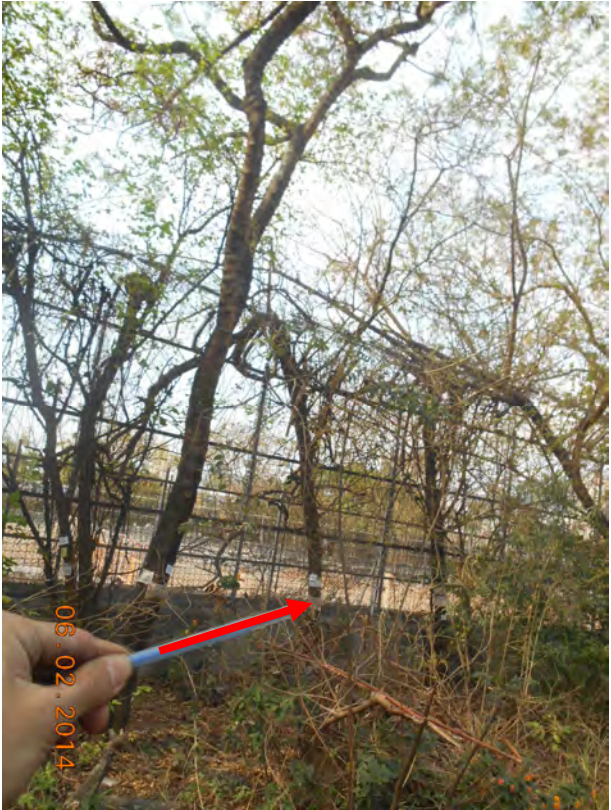
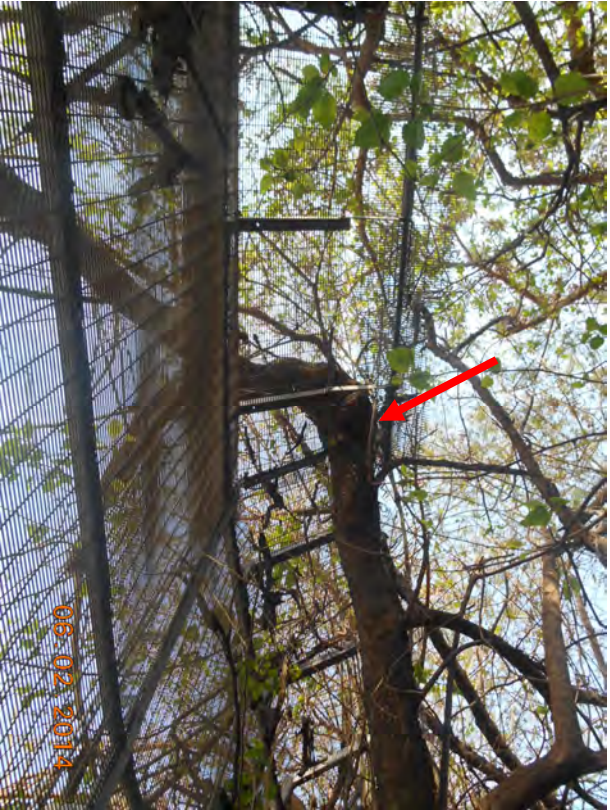
<p>06.02.2014</p>
KT/T194_4 Mingled with fence	KT/T195_1 (Fell) Scientific Name: <i>Leucaena leucocephala</i>	KT/T196_1 (Fell) Scientific Name: <i>Morus alba</i>	KT/T196_2 Mingled with fence

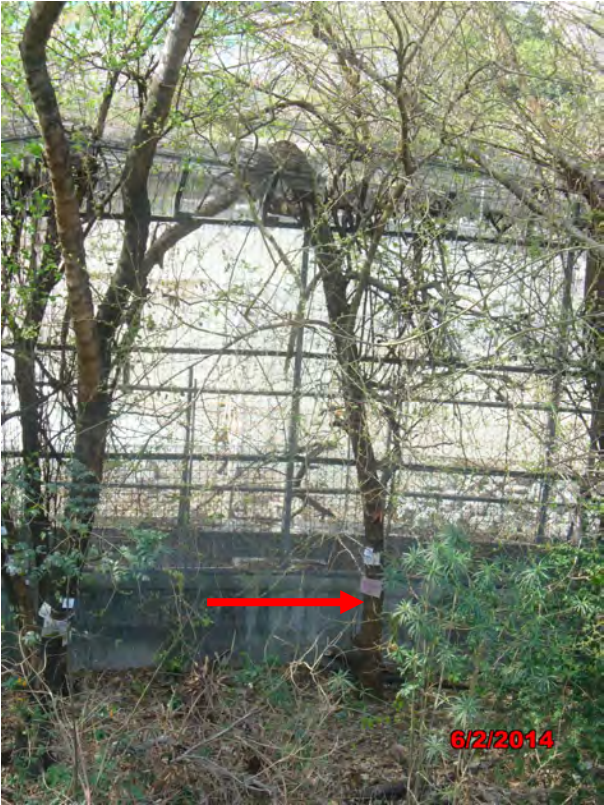
KT/T197_1 (Fell) Scientific Name: <i>Morus alba</i>	KT/T197_2 Cavity on trunk	KT/T198_1 (Fell) Scientific Name: <i>Leucaena leucocephala</i>	KT/T198_2 Twin stems
