## **CKR – Kai Tak**

Central Kowloon Route -  
Design and Construction

Tree Assessment Schedule - Kai Tak Area (Trees under AFCD to Provide Expert Advice)

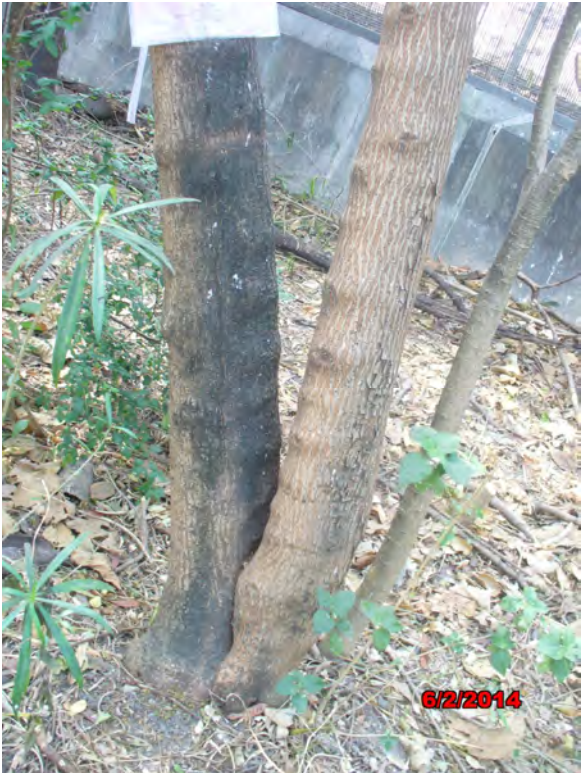
KT/T199_1 (Fell) Scientific Name: <i>Leucaena leucocephala</i>	KT/T199_2 Twin stems	KT/T200_1 (Fell) Scientific Name: <i>Leucaena leucocephala</i>	KT/T200_2 Mingled with fence

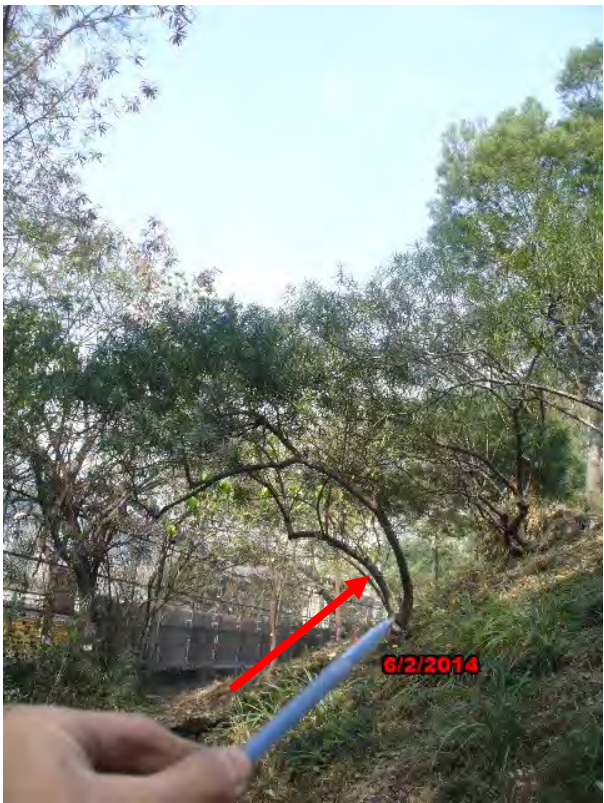
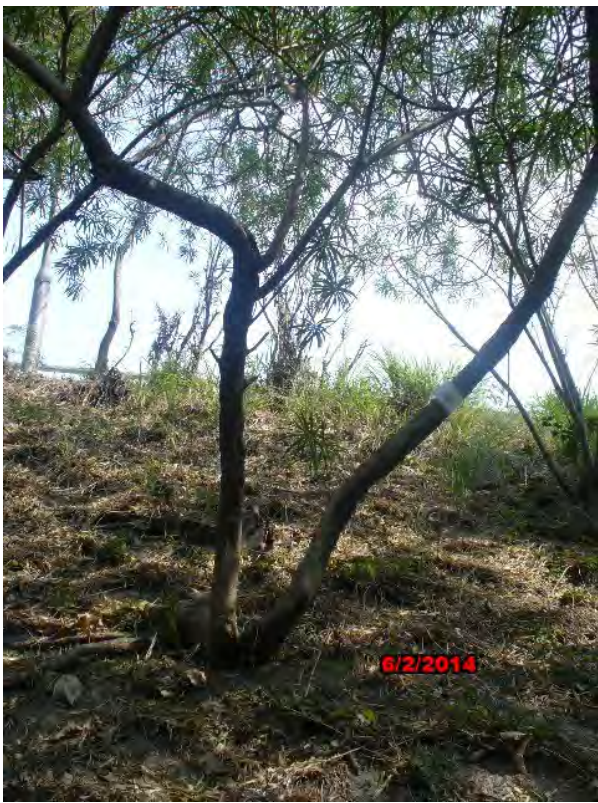
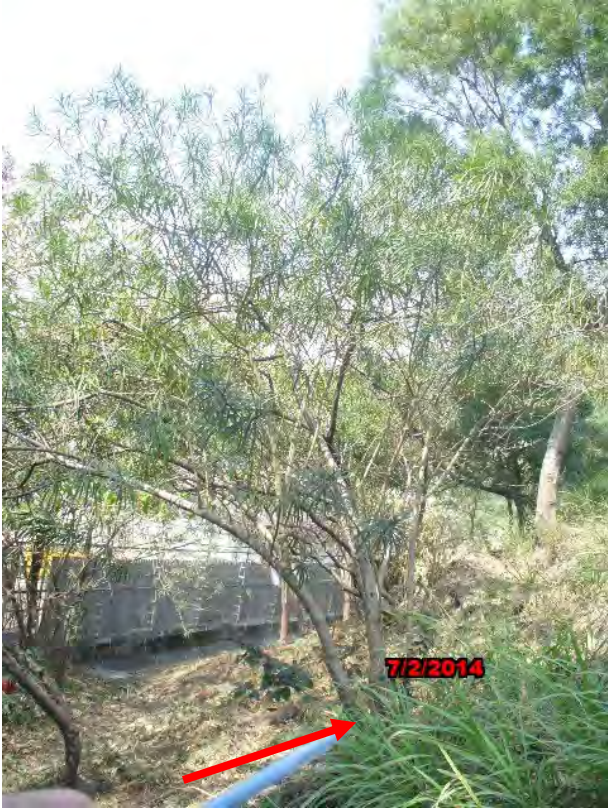
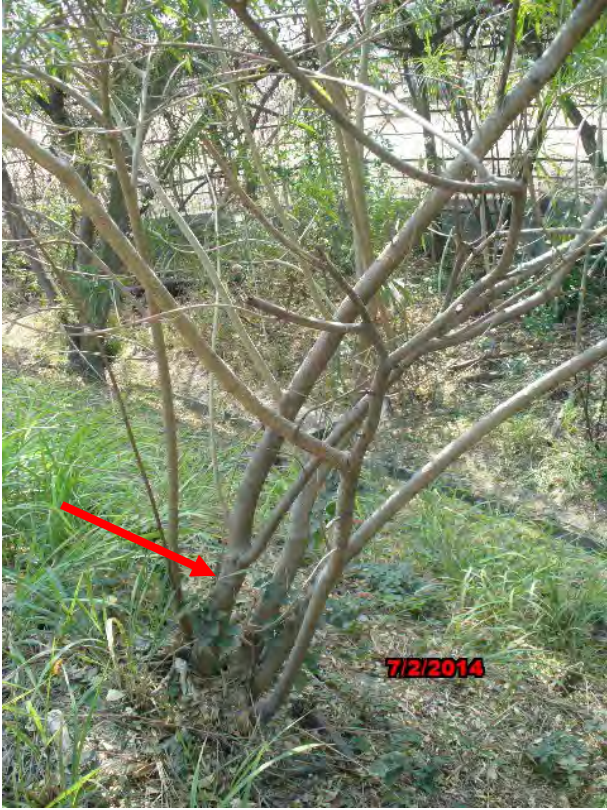
KT/T201_1 (Fell) Scientific Name: <i>Thevetia peruviana</i>	KT/T201_2 Twin stems; Heavily leaning	KT/T202_1(Fell) Scientific Name: <i>Thevetia peruviana</i>	KT/T202_2 Multi-trunk

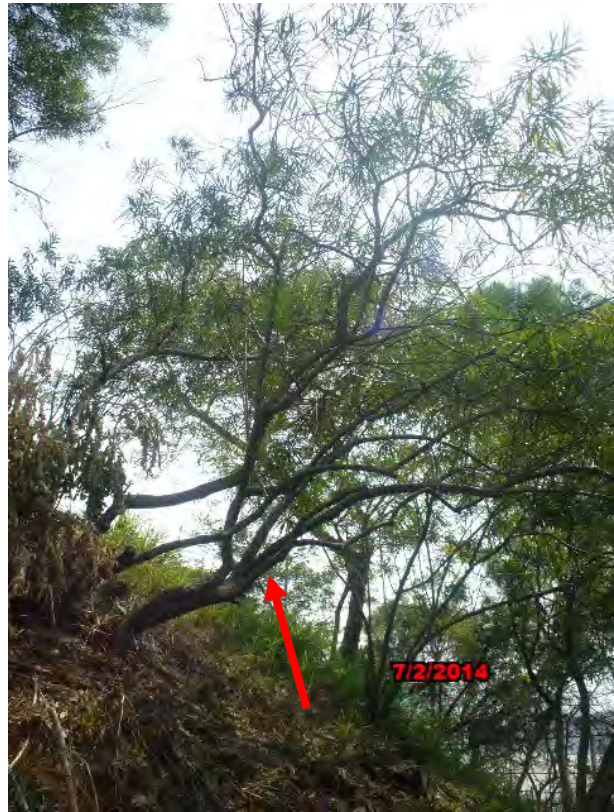
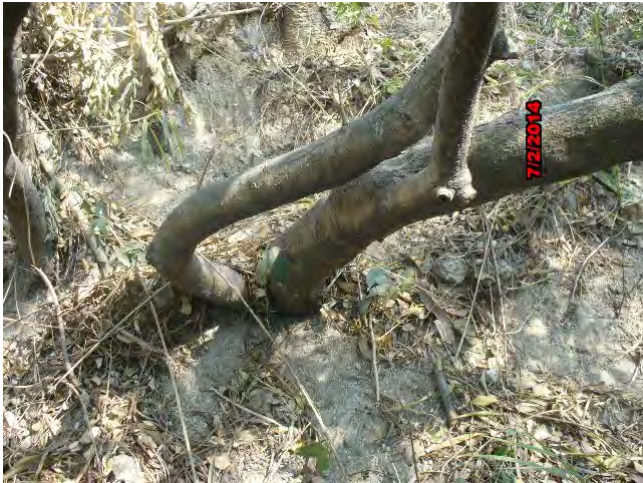
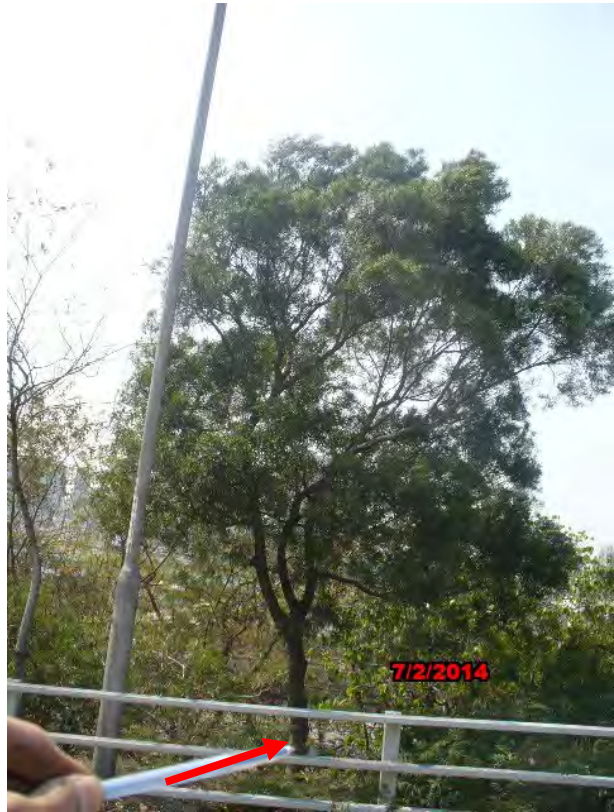
KT/T203_1(Fell) Scientific Name: <i>Thevetia peruviana</i>	KT/T203_3 Twin stems; Heavily leaning	KT/T204_1 (Fell) Scientific Name: <i>Acacia confusa</i>

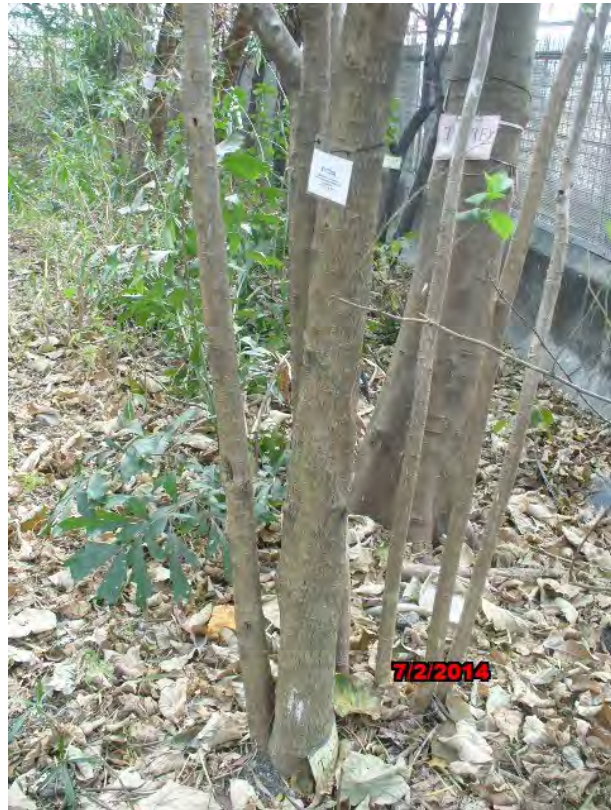
KT/T207_1 (Fell) <i>Macaranga tanarius</i> var. <i>tomentosa</i>	KT/T207_2 Mingled with fence	KT/T208_1 (Fell) Scientific Name: <i>Thevetia peruviana</i>	KT/T208_2 Multi-trunk

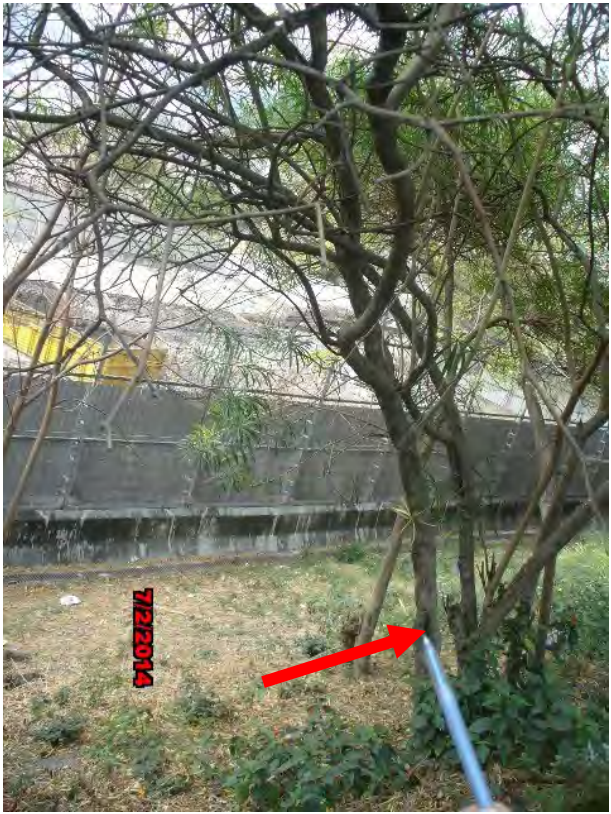
KT/T213_1 (Fell) Scientific Name: <i>Thevetia peruviana</i>	KT/T213_2 Large wound on trunk	KT/T214_1 (Fell) Scientific Name: <i>Thevetia peruviana</i>	KT/T214_2 Wound on trunk

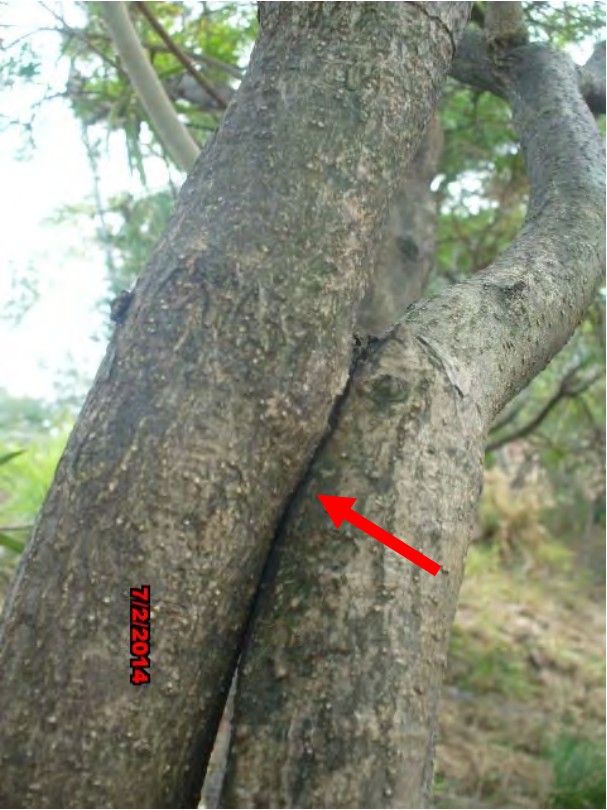
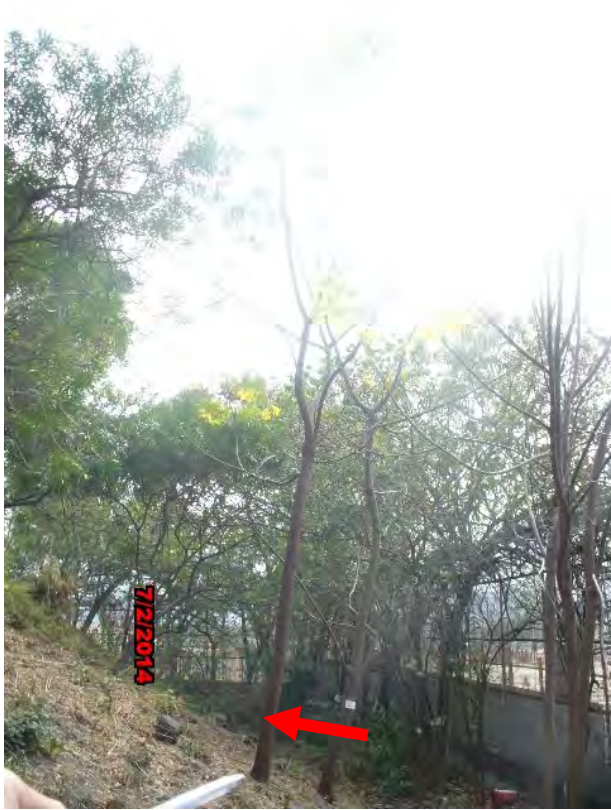
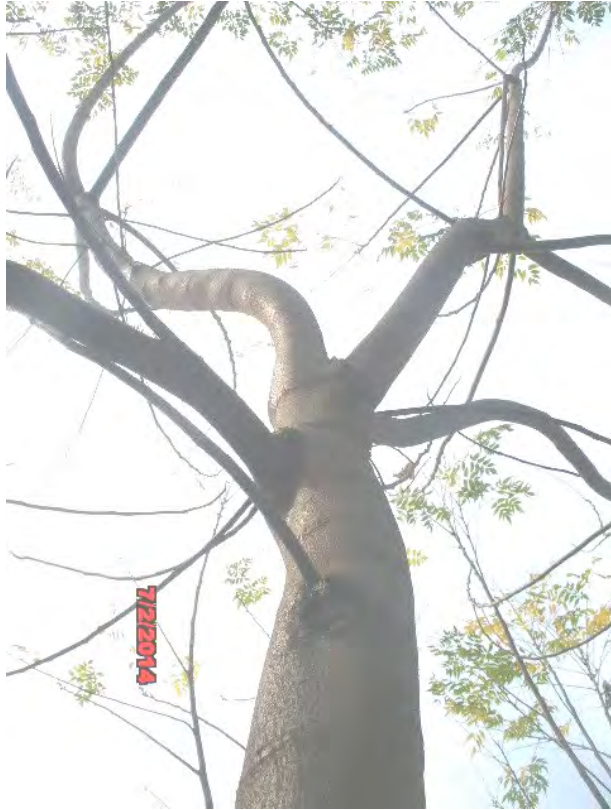
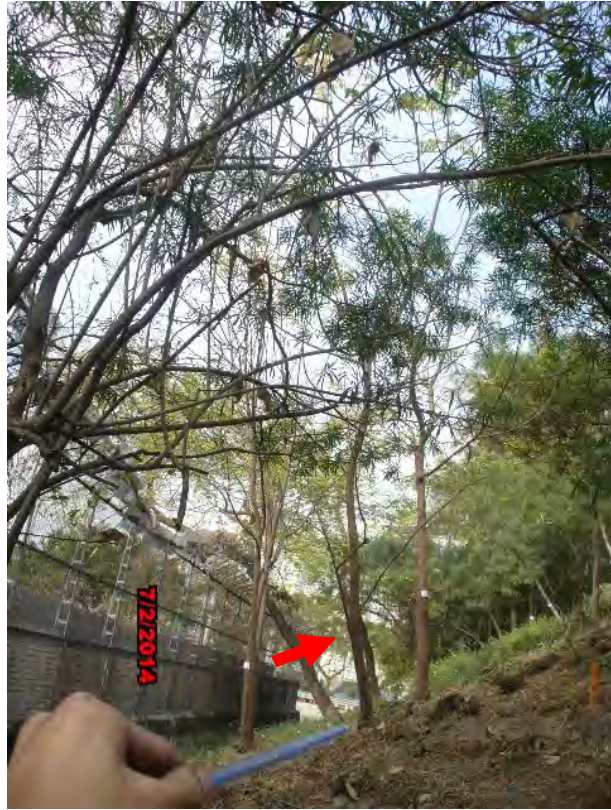
KT/T214_3 Cross branches	KT/T215_1 (Fell) Scientific Name: <i>Melia azedarach</i>	KT/T215_2	KT/T216_1 (Fell) Scientific Name: <i>Melia azedarach</i>

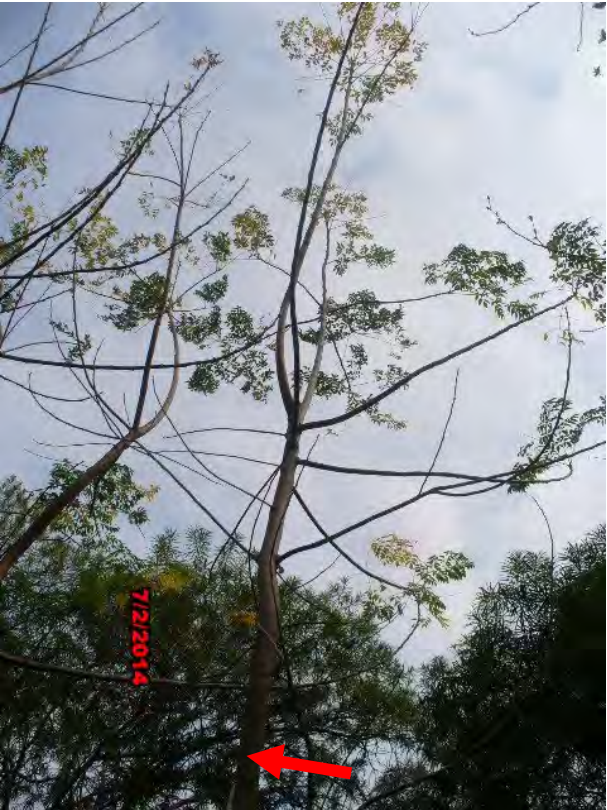
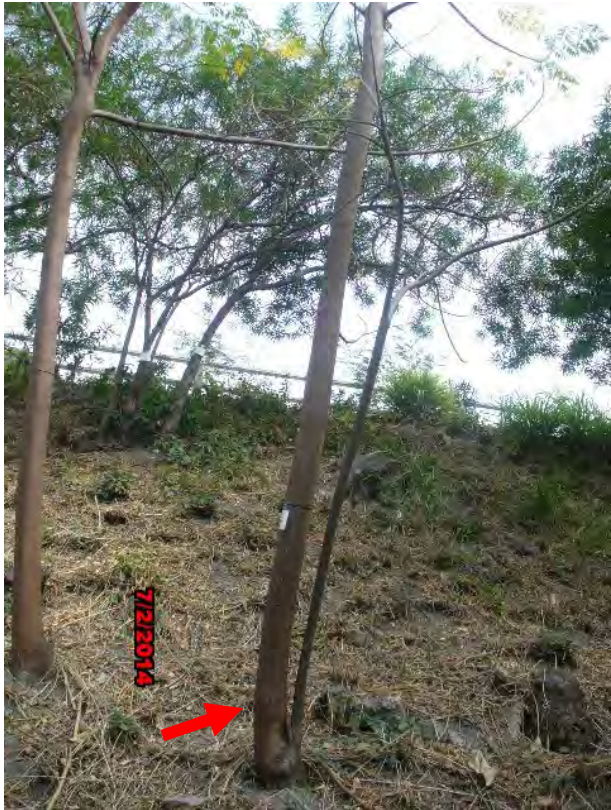
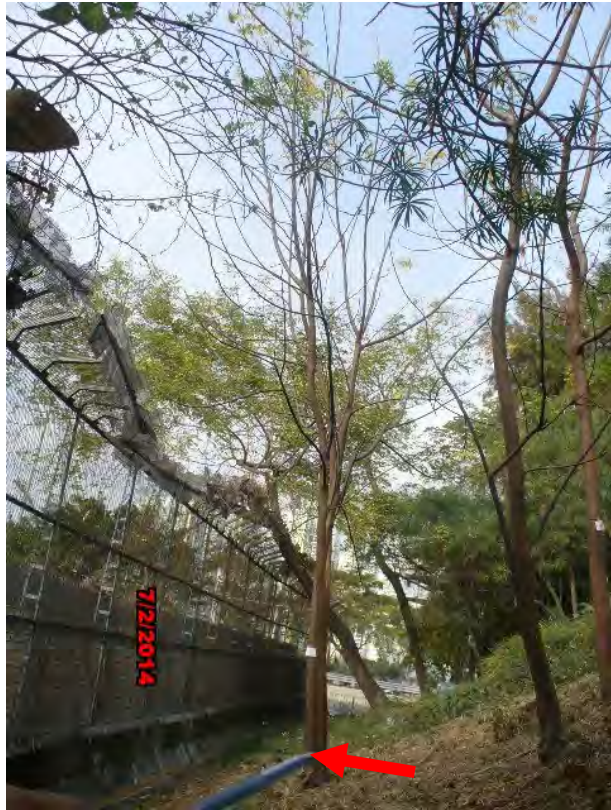
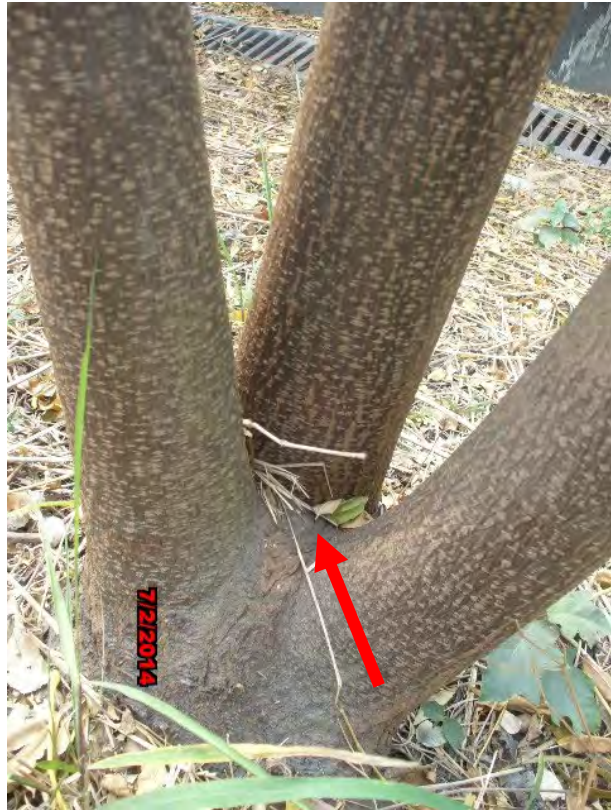
KT/T216_2	KT/T216_3 Twin stems; Leaning	KT/T217_1 (Fell) Scientific Name: <i>Melia azedarach</i>	KT/T217_4 Multi-trunk

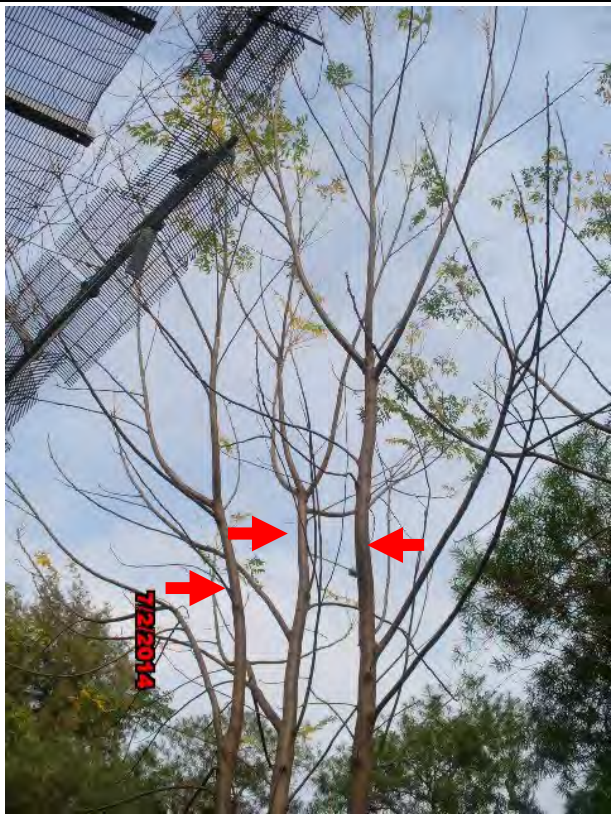
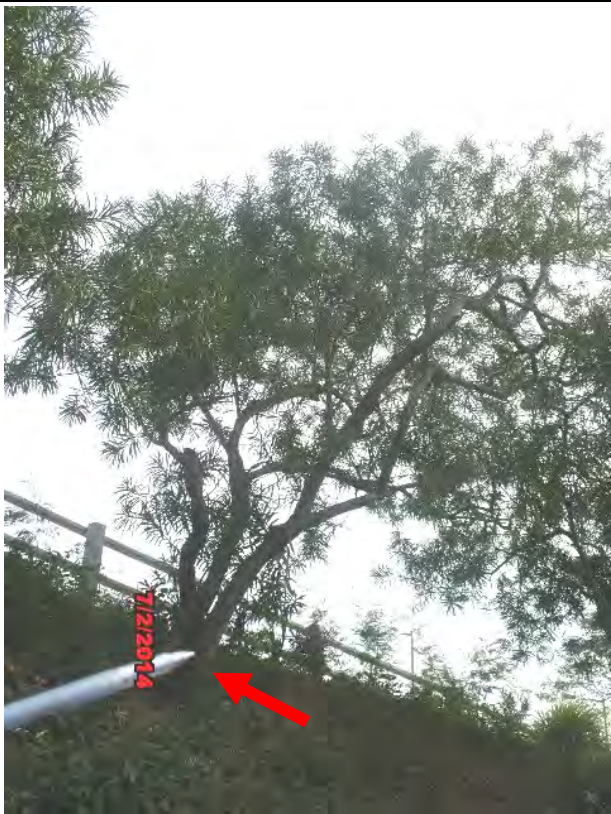
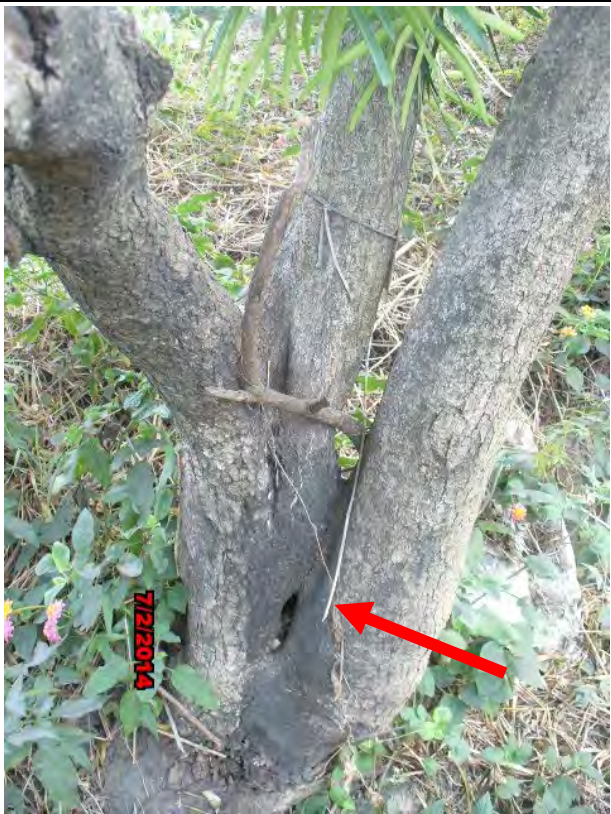
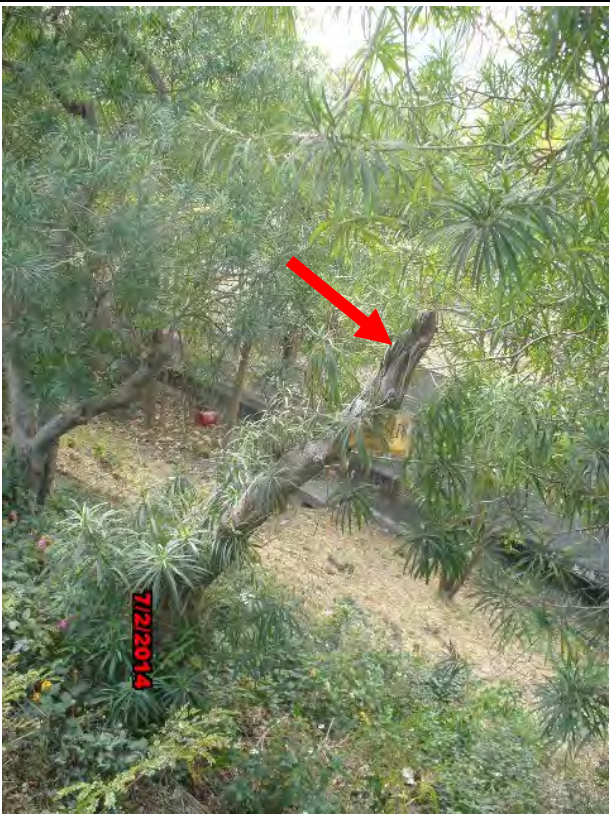
KT/T217_3 Multi-trunk	KT/T218_1 (Fell) Scientific Name: <i>Thevetia peruviana</i>	KT/T218_2 Multi-trunk	KT/T219_1 (Fell) Scientific Name: <i>Thevetia peruviana</i>

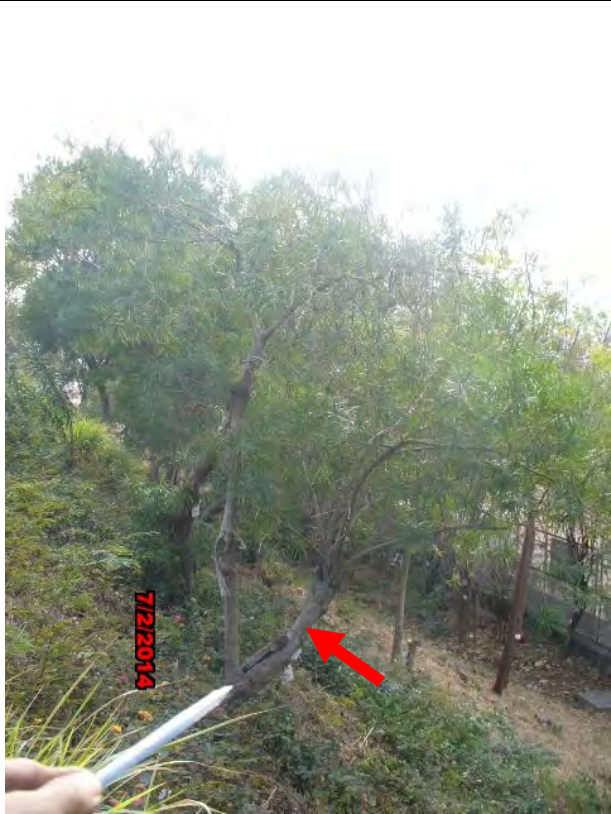
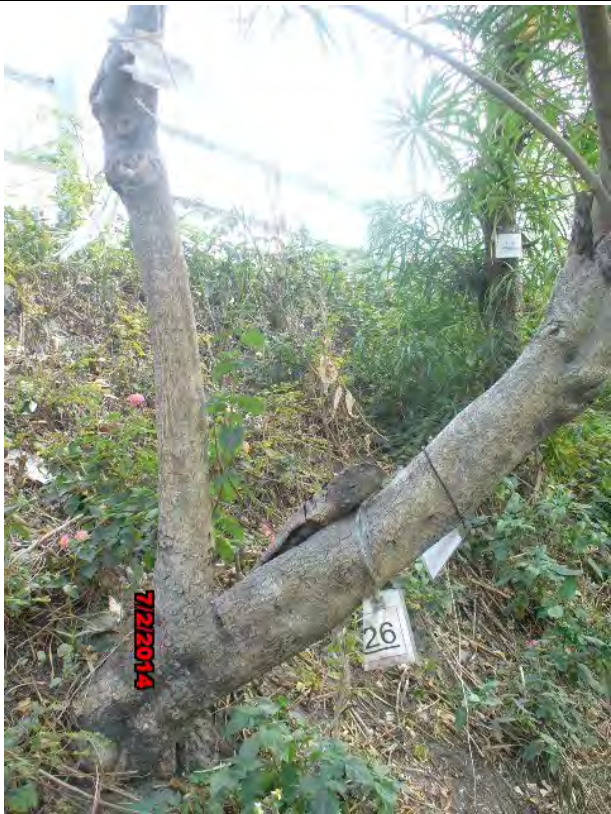
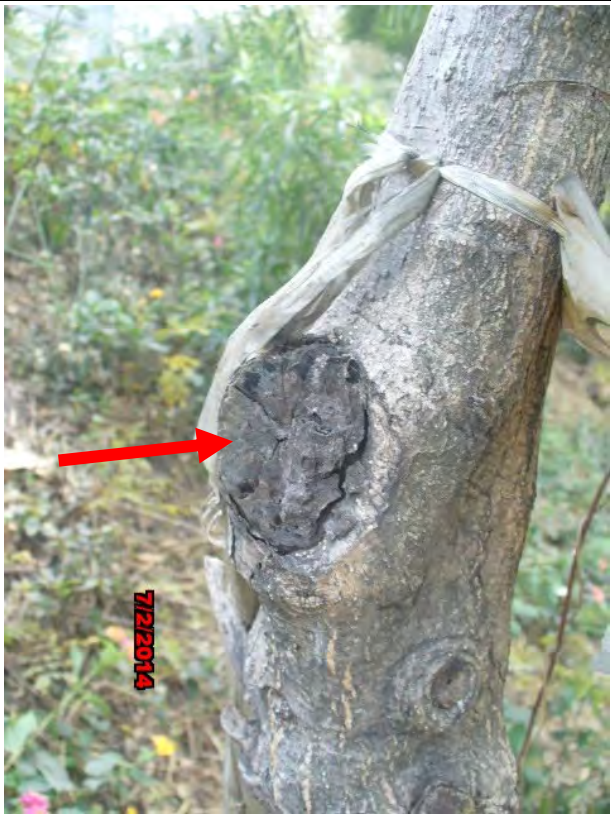
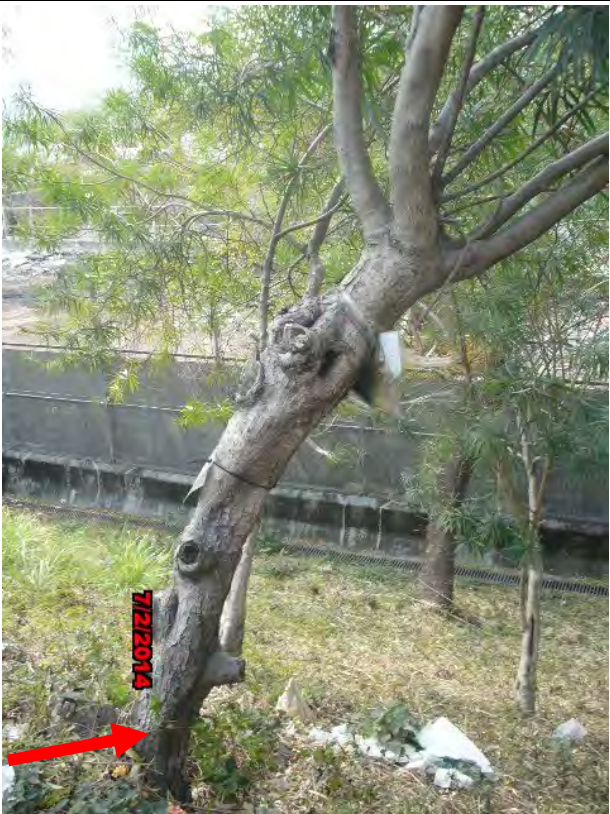
KT/T220_1 (Fell) Scientific Name: <i>Thevetia peruviana</i>	KT/T220_2 Twin stems; Heavily leaning	KT/T220_3 Wound on trunk	KT/T221_1 (Fell) Scientific Name: <i>Thevetia peruviana</i>

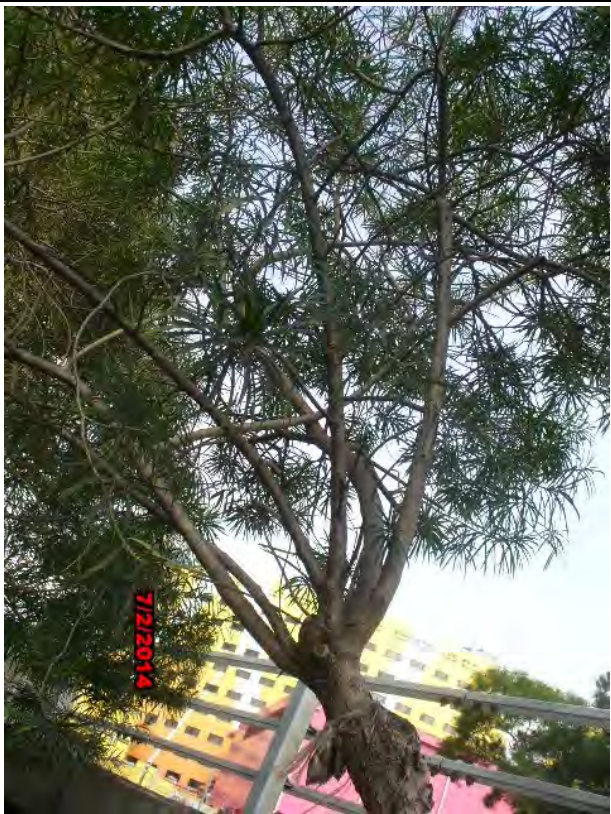
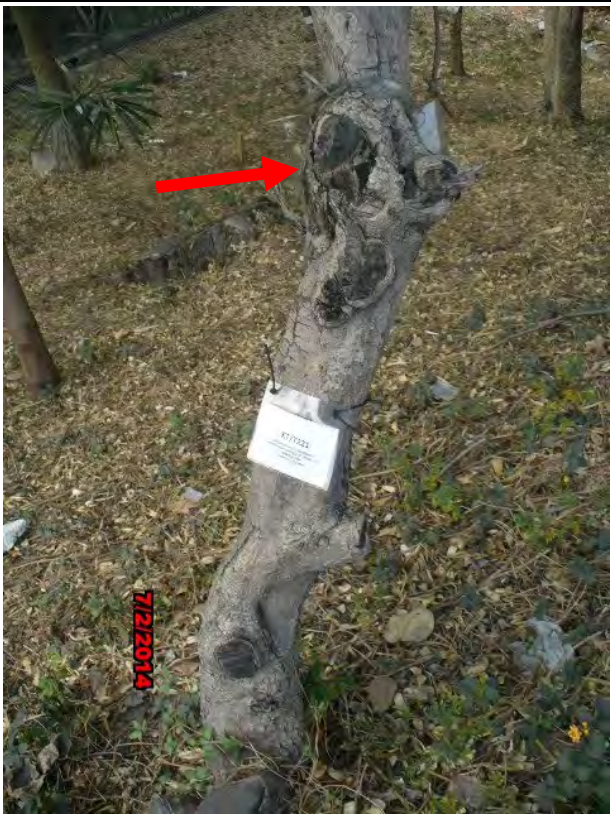
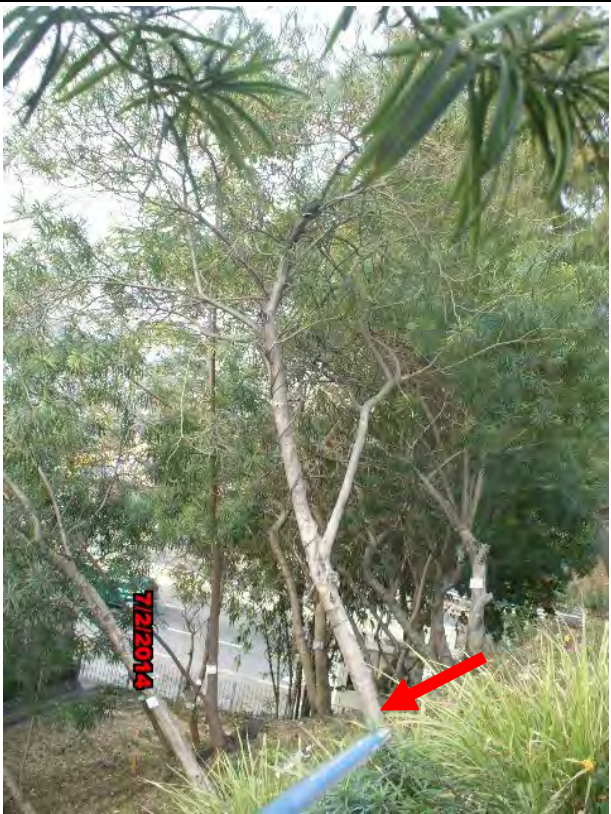
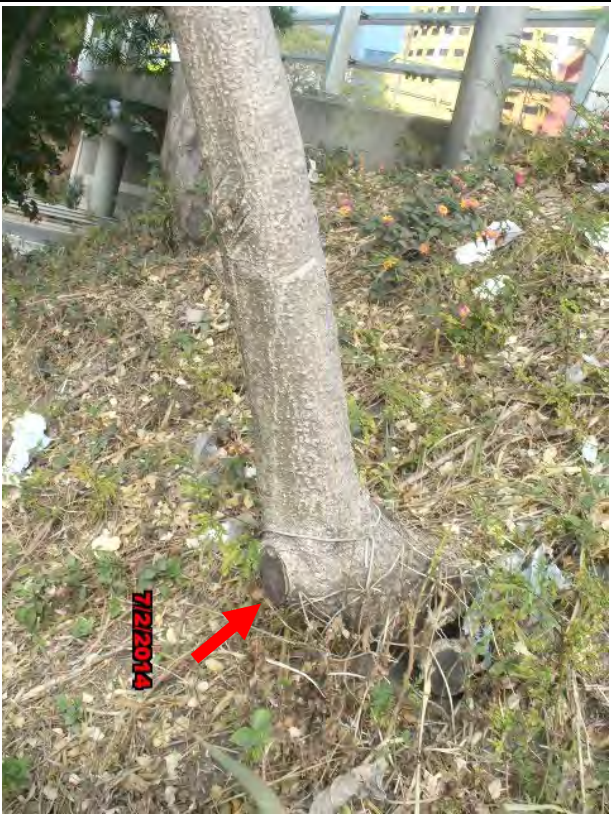
KT/T221_2	KT/T221_3 Multiple wounds on trunk	KT/T222_1 (Fell) Scientific Name: <i>Thevetia peruviana</i>	KT/T222_2 Wound at base

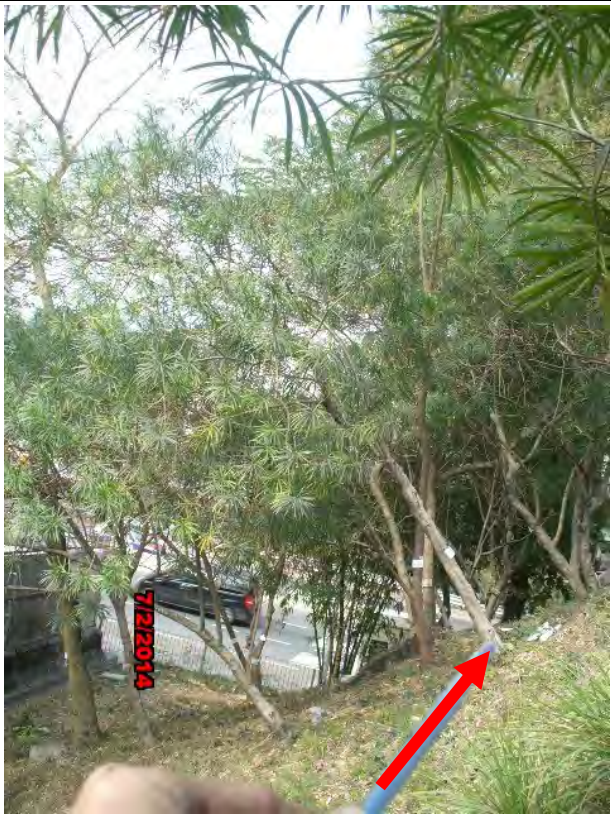
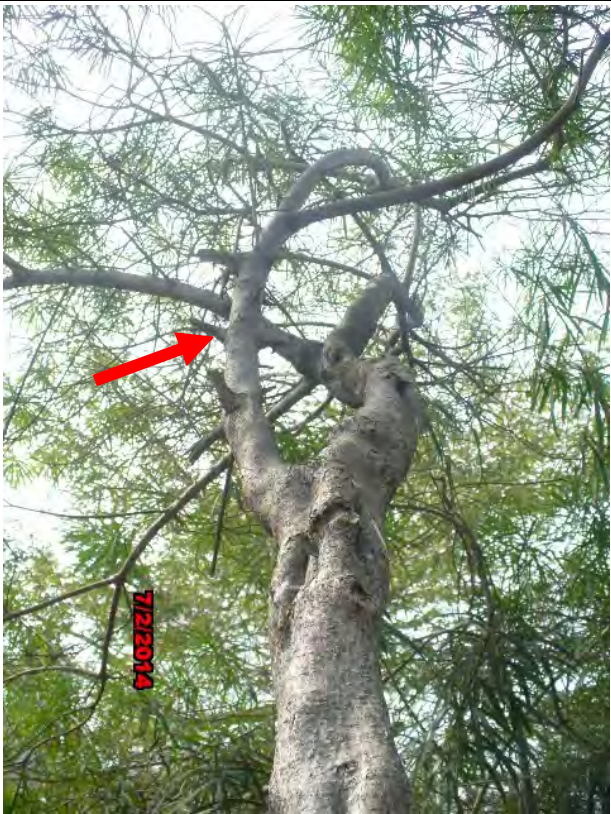
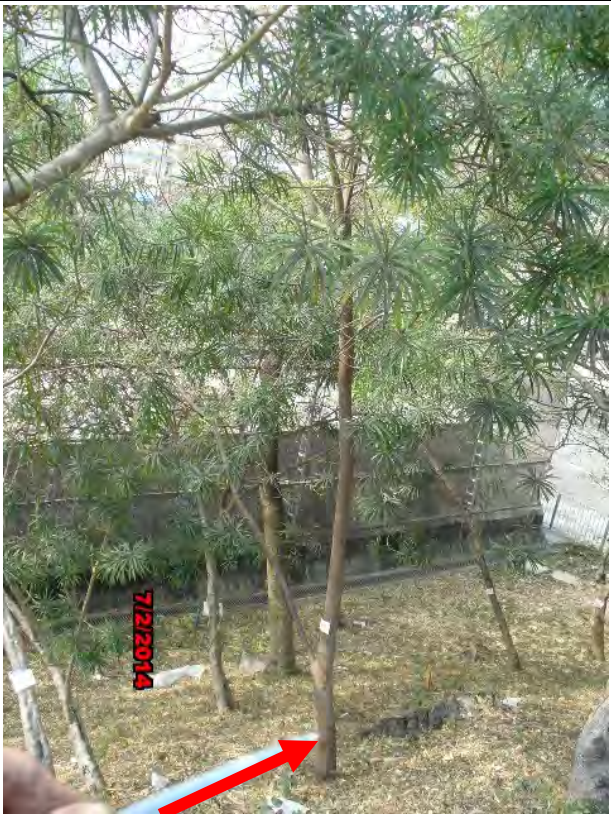
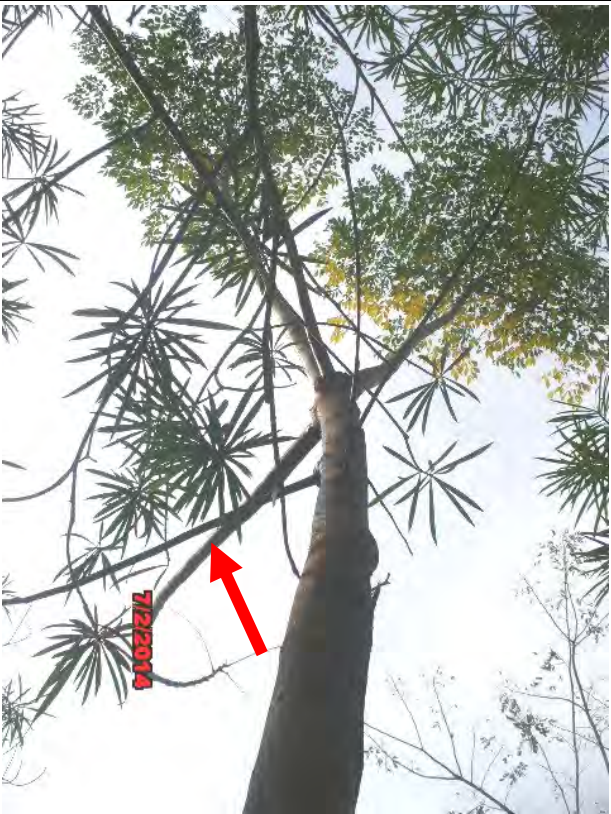
KT/T223_1 (Fell) Scientific Name: <i>Thevetia peruviana</i>	KT/T223_2 Crossed branches	KT/T224_1 (Fell) Scientific Name: <i>Melia azedarach</i>	KT/T224_2

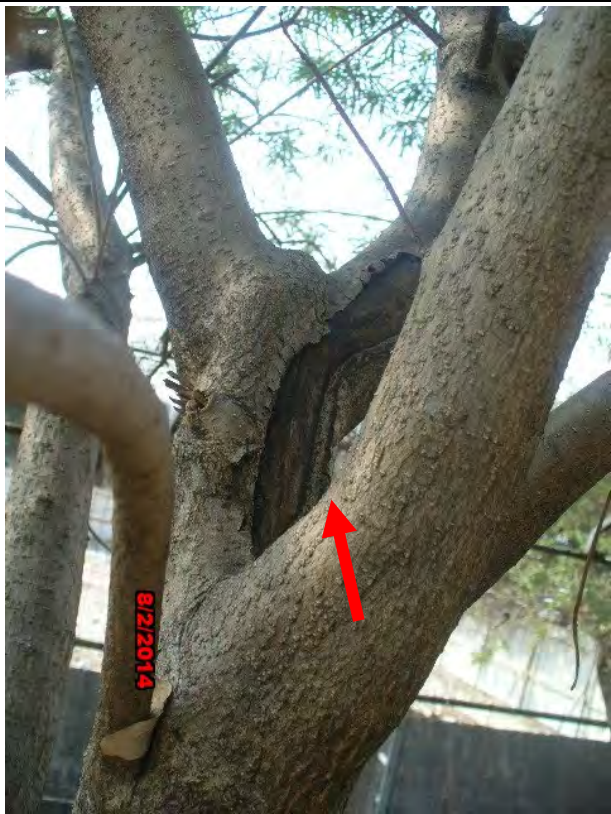
KT/T228_3 Large wound at branch union	KT/T229_1 (Fell) Scientific Name: <i>Albizia lebbbeck</i>	KT/T229_2 Heavily leaning	KT/T230_1 (Fell) Scientific Name: <i>Albizia lebbbeck</i>

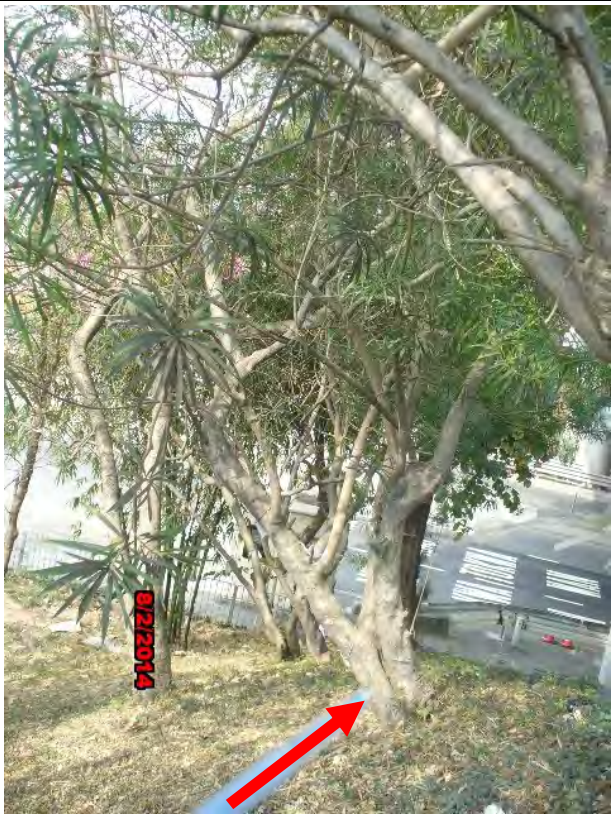
KT/T230_2 Twin stems	KT/T231_1 (Fell) Scientific Name: <i>Thevetia peruviana</i>	KT/T231_2 Multi-trunk	KT/T232_1 (Fell) Scientific Name: <i>Thevetia peruviana</i>

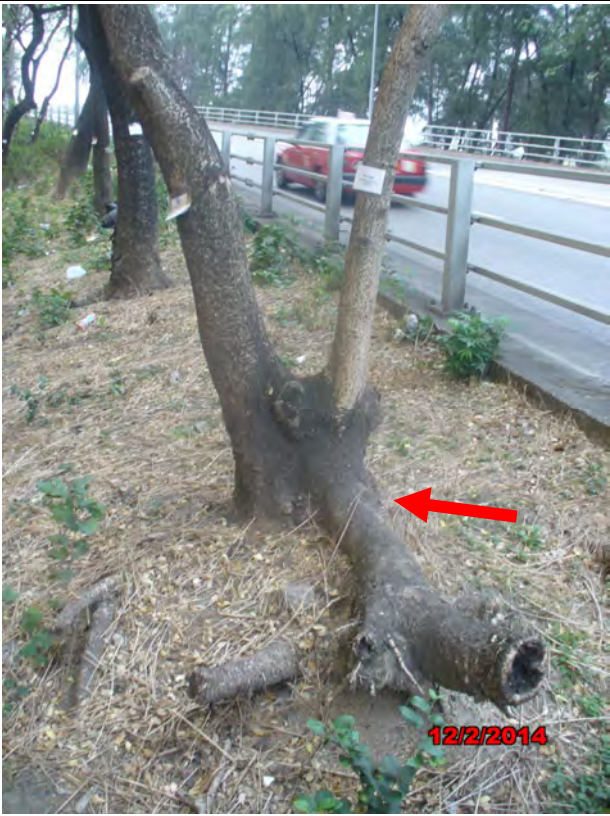
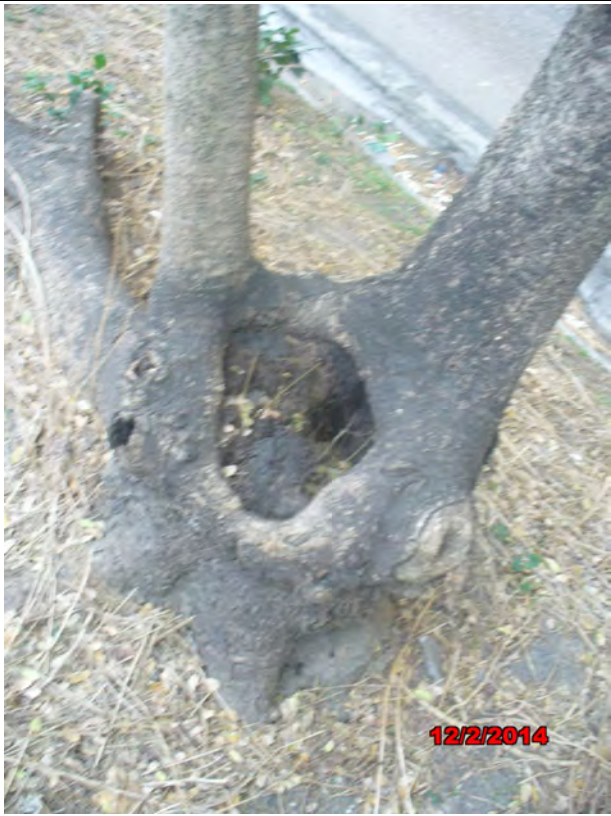
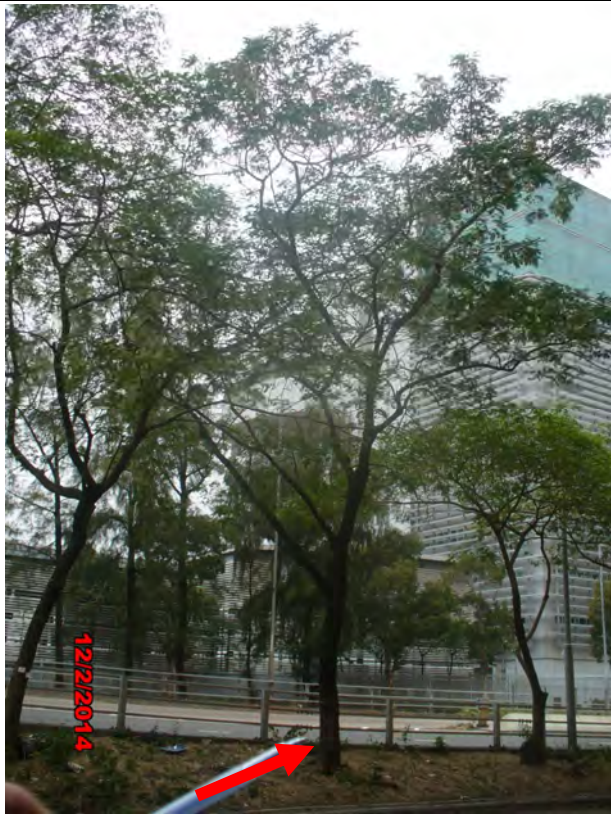
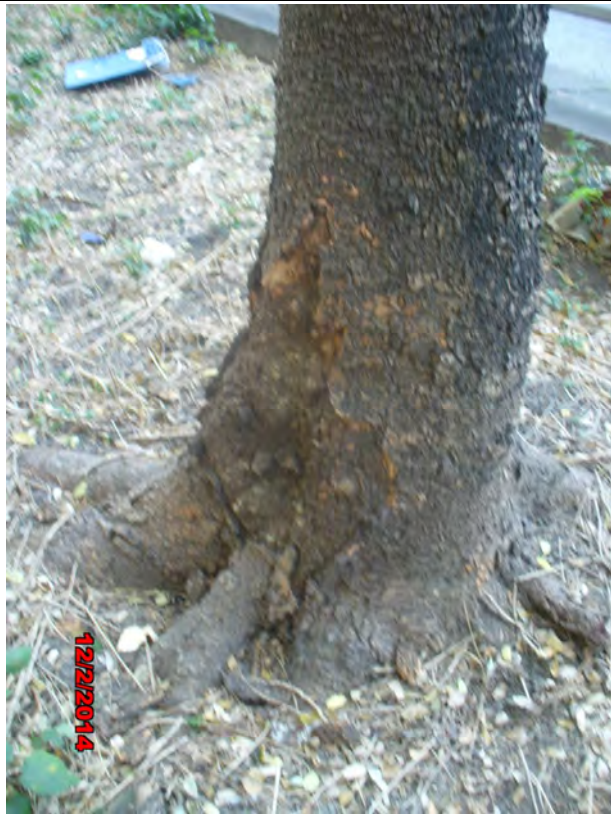
KT/T282_2 Multi-trunk	KT/T282_3 Large cavity at trunk base	KT/T283_1 (Fell) Scientific Name: <i>Albizia lebbbeck</i>	KT/T283_2

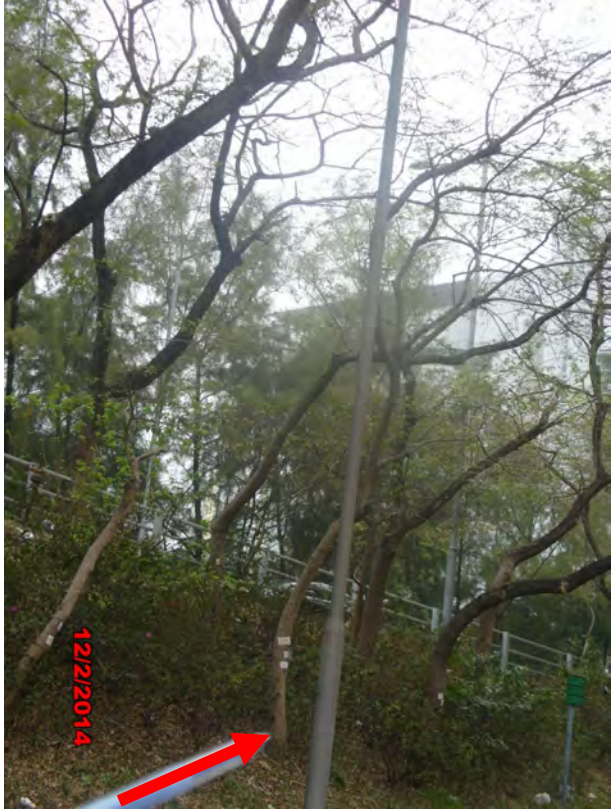
KT/T297_1 (Fell) Scientific Name: <i>Albizia lebbeck</i>	KT/T298_1 (Fell) Scientific Name: <i>Albizia lebbeck</i>	KT/T298_2 Heavily leaning	KT/T299_1 (Fell) Scientific Name: <i>Albizia lebbeck</i>

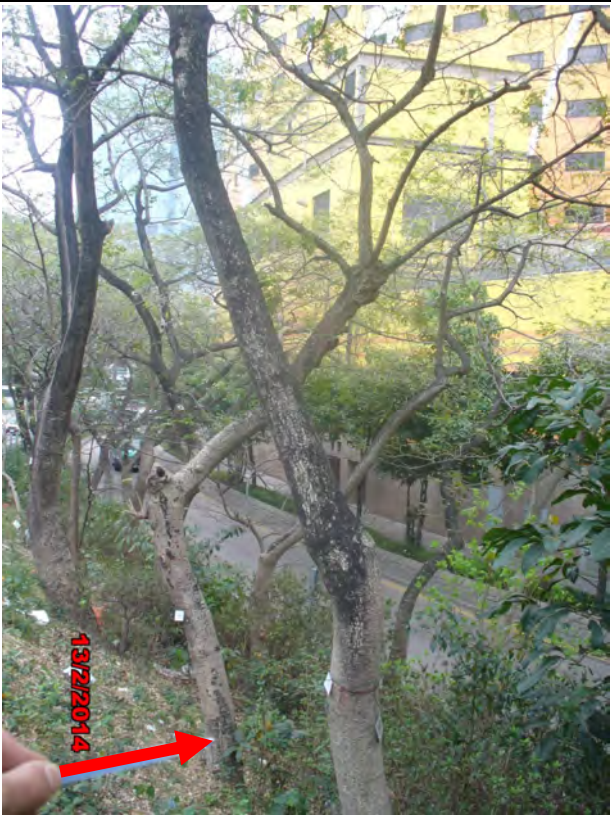
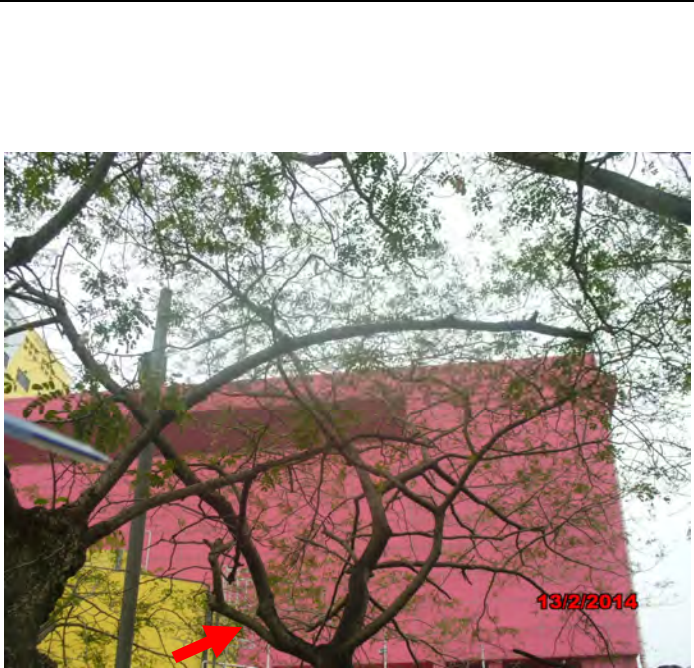
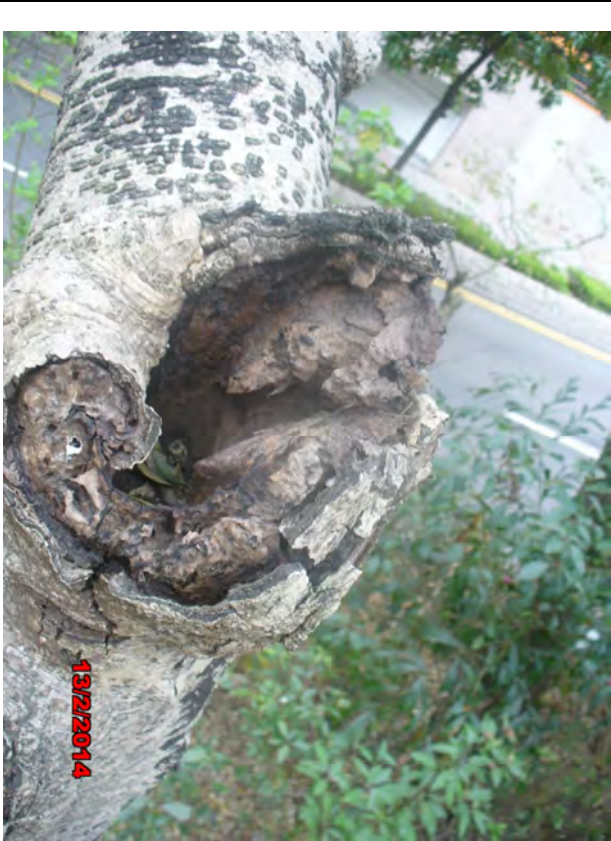
KT/T301_1 (Fell) Scientific Name: <i>Albizia lebbbeck</i>	KT/T301_2	KT/T301_3 Cavity on trunk	KT/T302_1 (Fell) Scientific Name: <i>Albizia lebbbeck</i>
