## **CKR – Kai Tak**

Central Kowloon Route -  
Design and Construction

Tree Assessment Schedule - Kai Tak Area (Trees under AFCD to Provide Expert Advice)

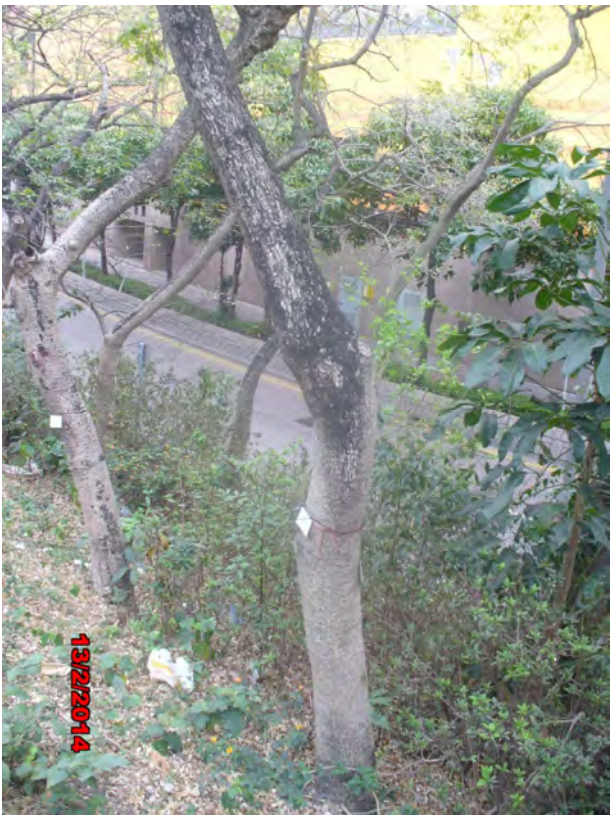
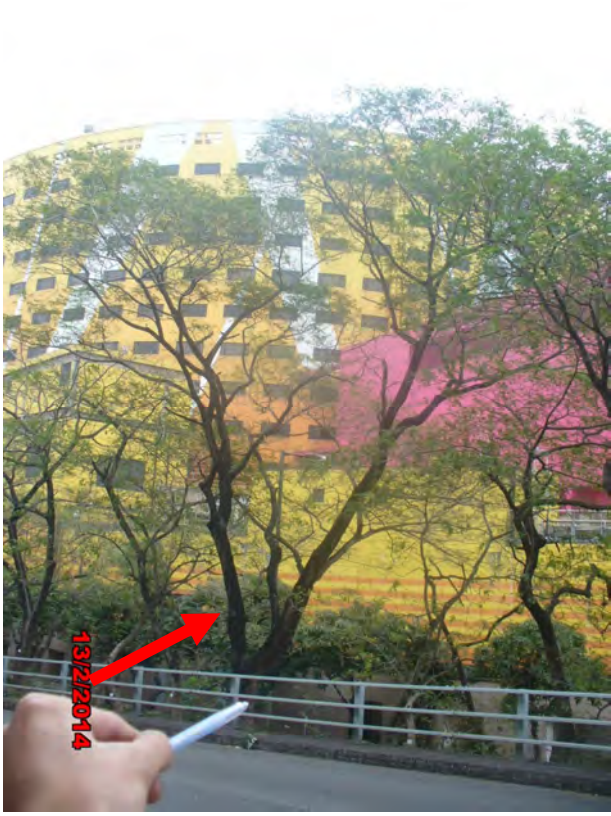
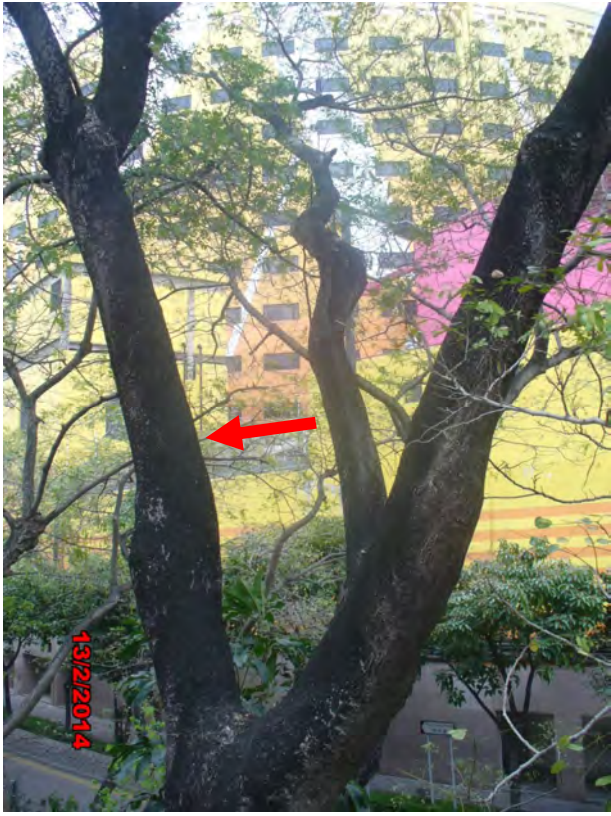
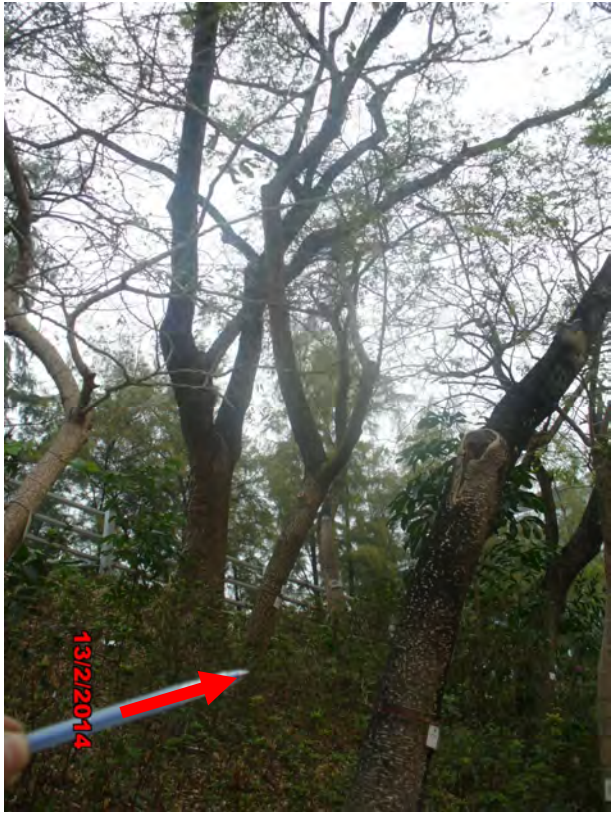
KT/T302_2 Leaning	KT/T303_1 (Fell) Scientific Name: <i>Albizia lebbbeck</i>	KT/T303_2	KT/T304_1 (Fell) Scientific Name: <i>Albizia lebbbeck</i>

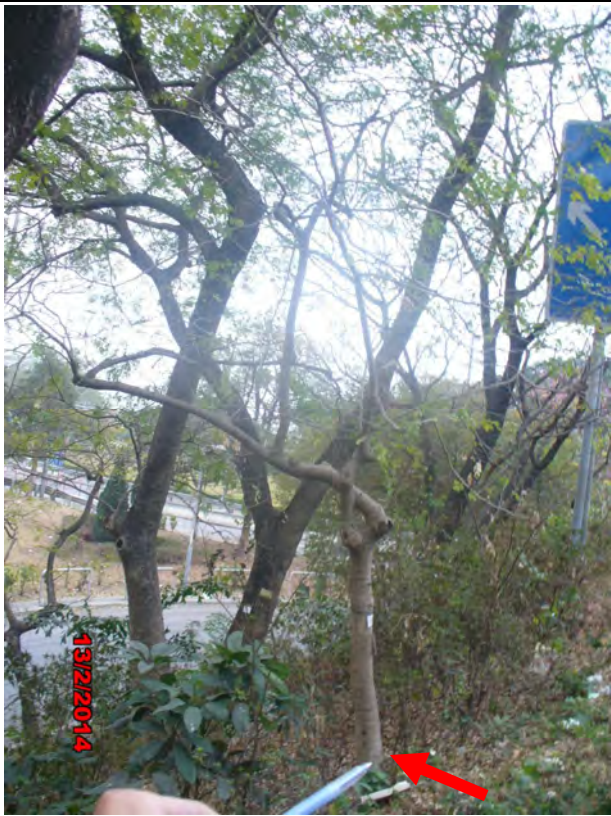
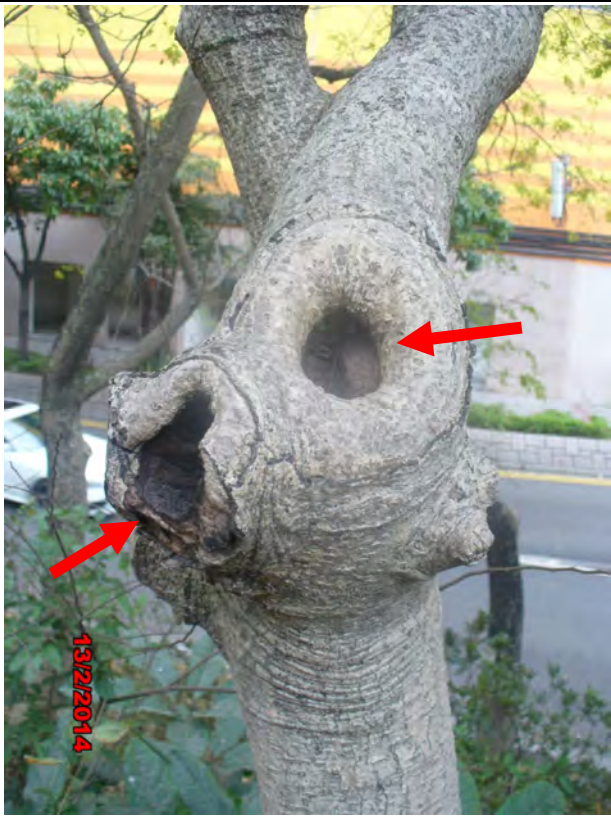
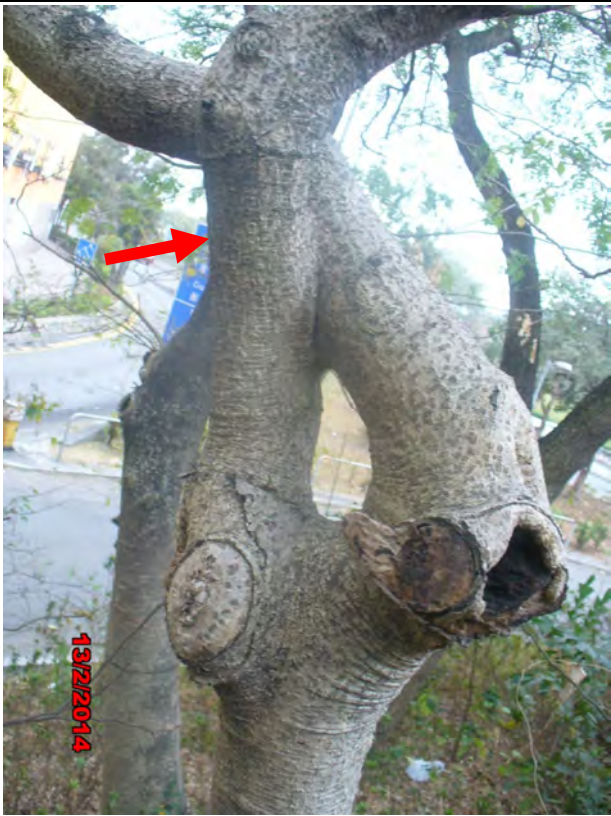
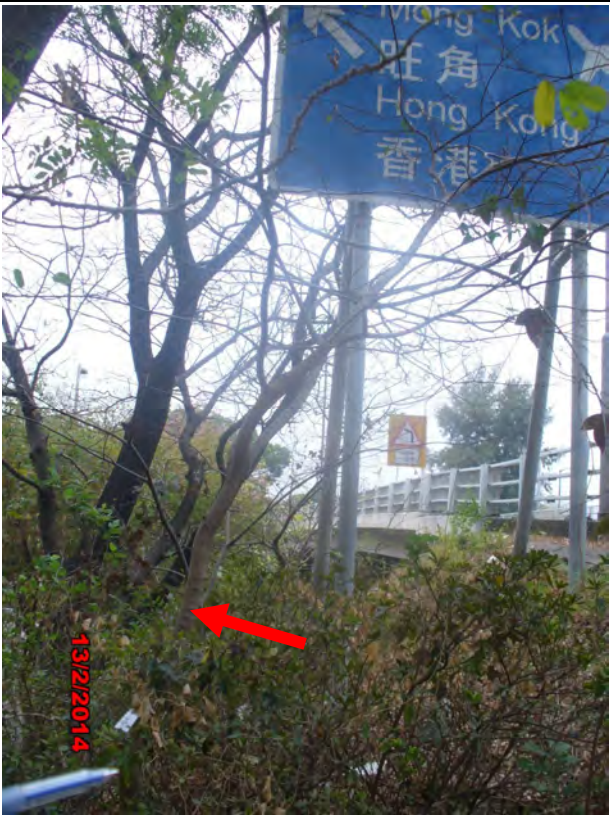
KT/T308_1 (Fell) Scientific Name: <i>Albizia lebbbeck</i>	KT/T308_2 Multiple wounds on trunk	KT/T308_3 Cross branches	KT/T309_1 (Fell) Scientific Name: <i>Celtis sinensis</i>

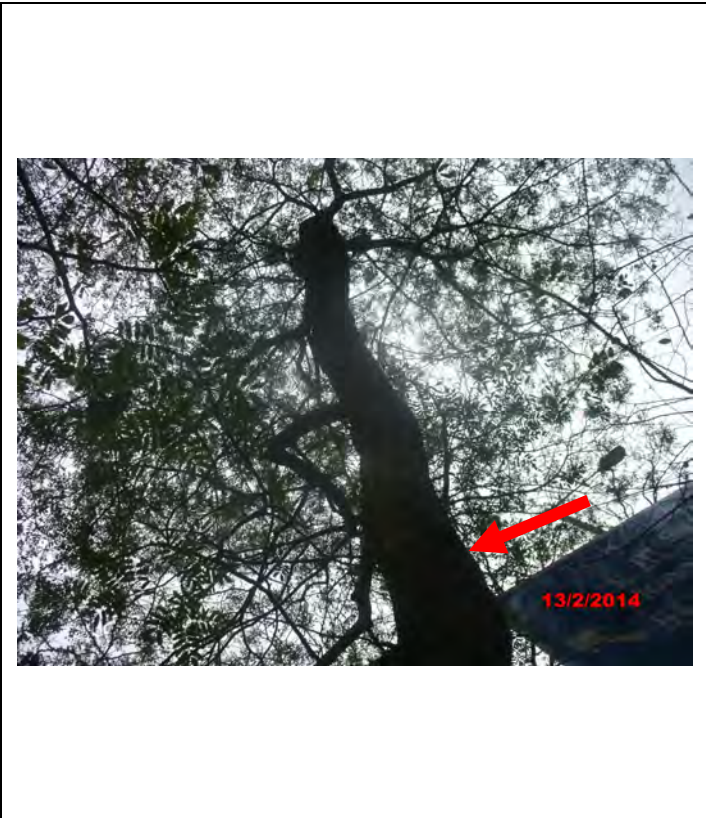
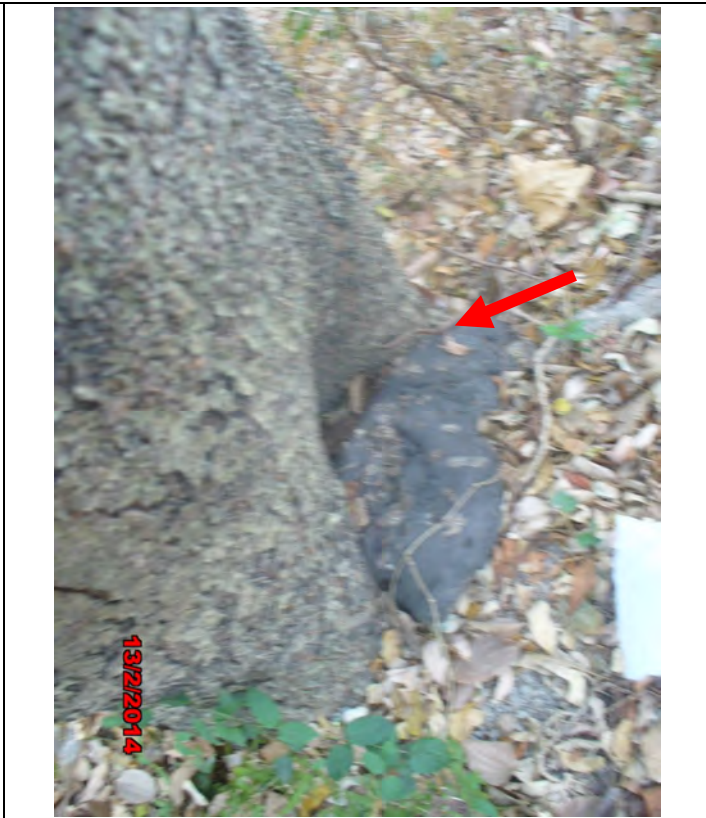
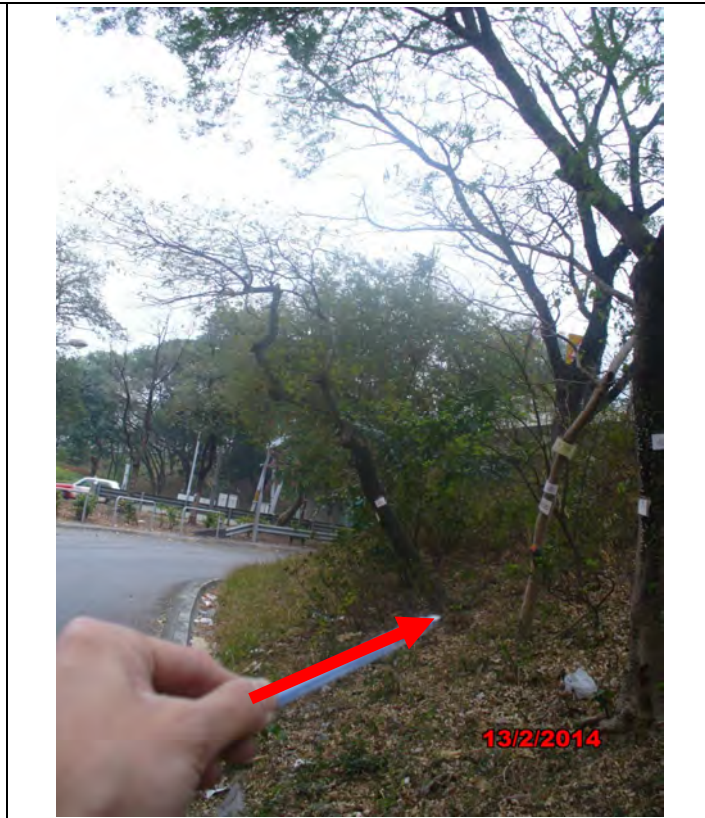
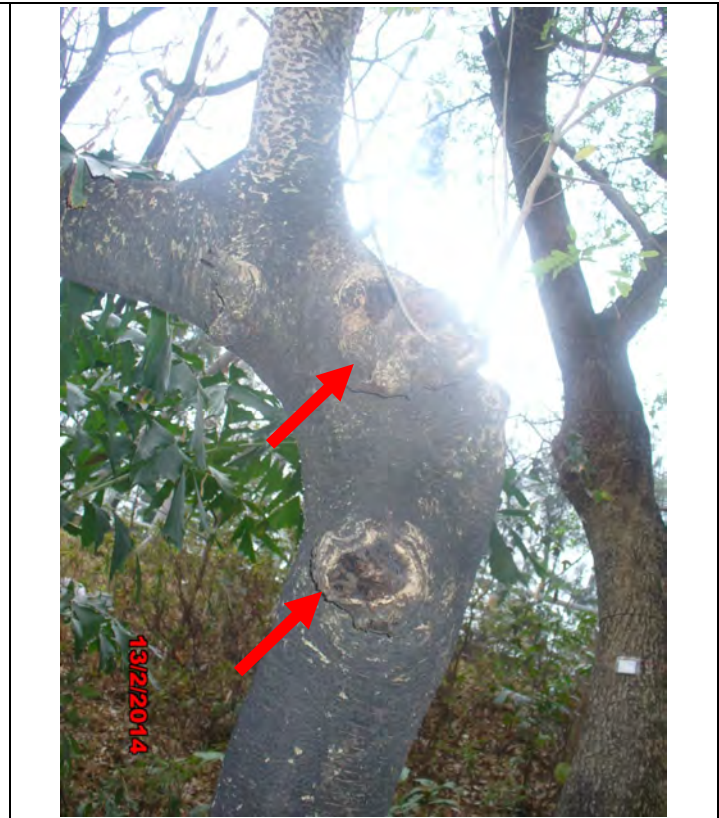
KT/T309_2	KT/T309_3	KT/T310_1 (Fell) Scientific Name: <i>Albizia lebbbeck</i>	KT/T310_2

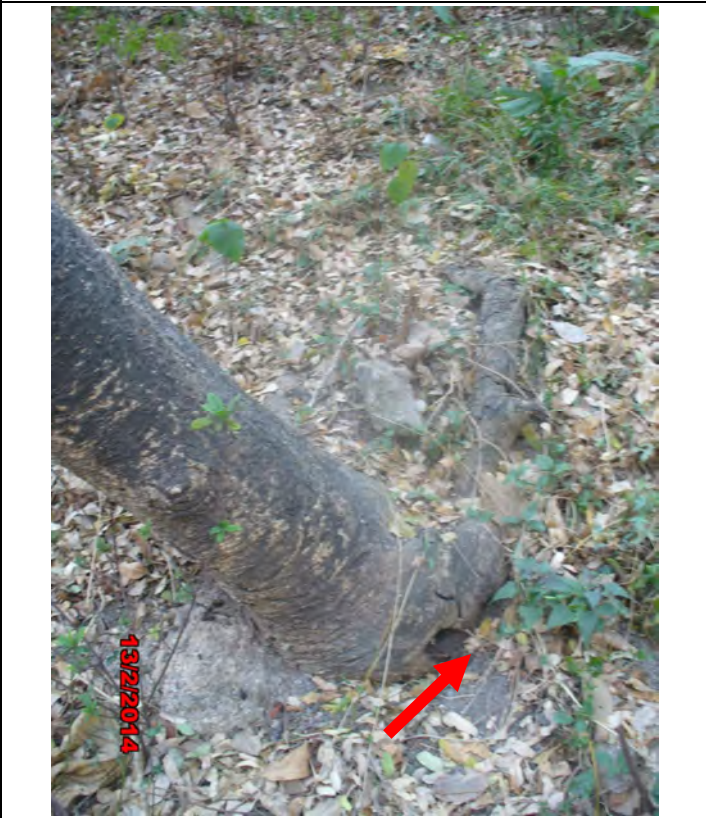
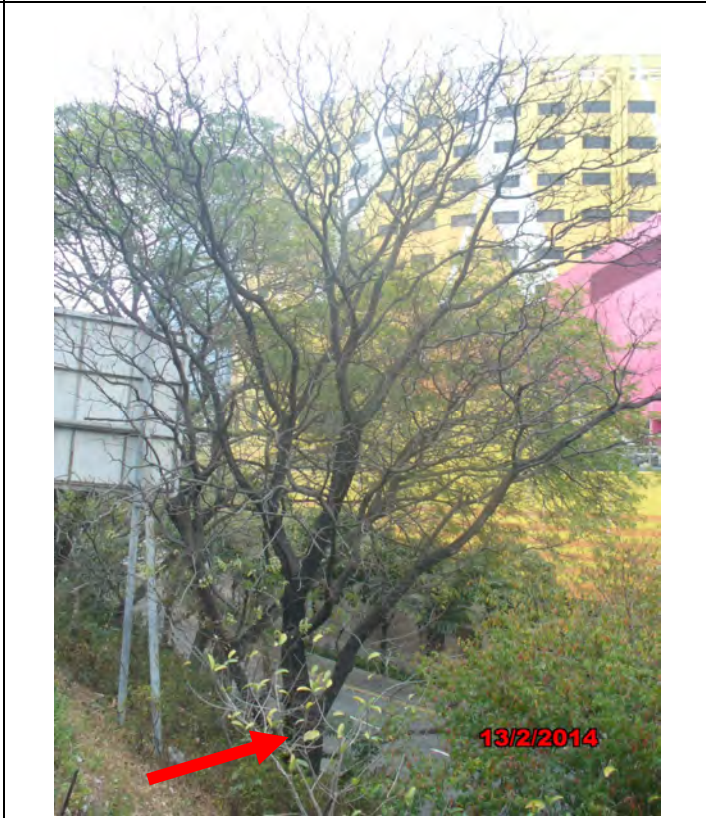
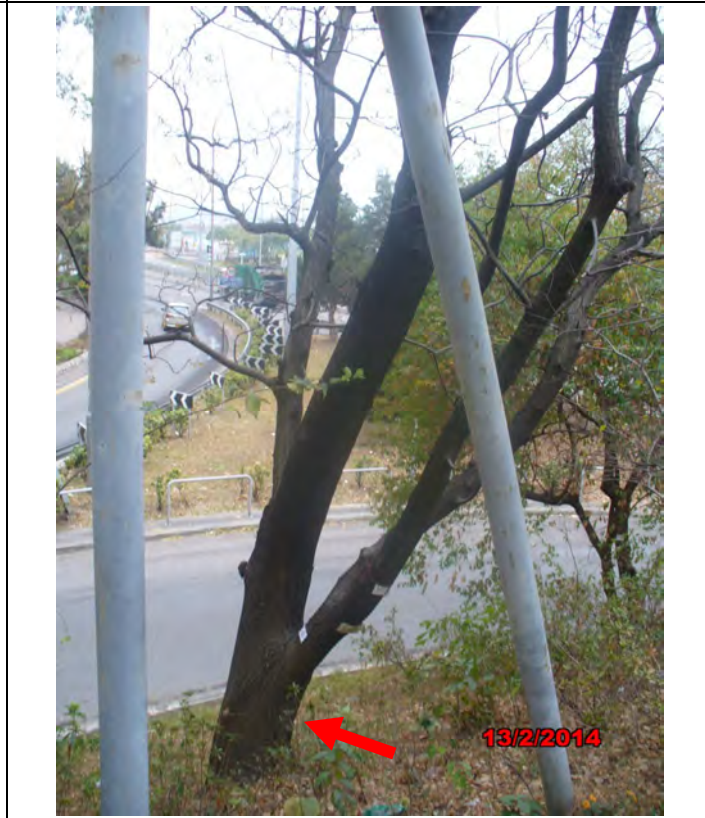
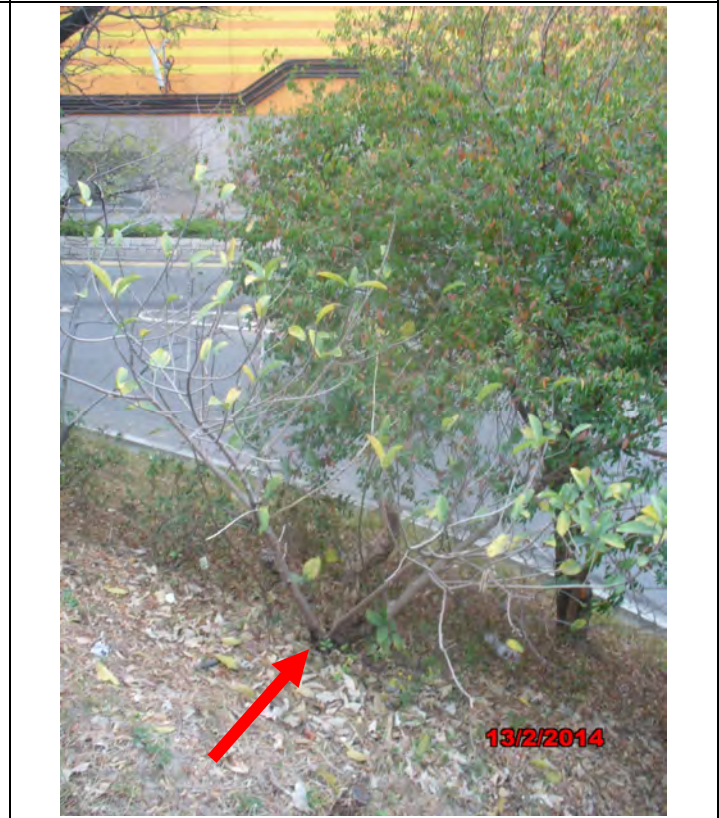
KT/T310_3	KT/T310_4	KT/T311_1 (Fell) Scientific Name: <i>Albizia lebbbeck</i>	KT/T311_2 Wounds along trunk

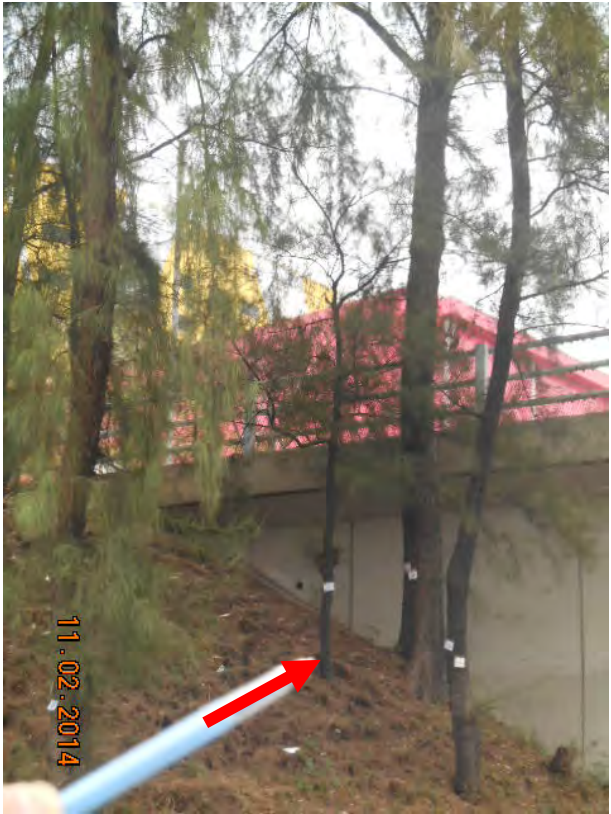
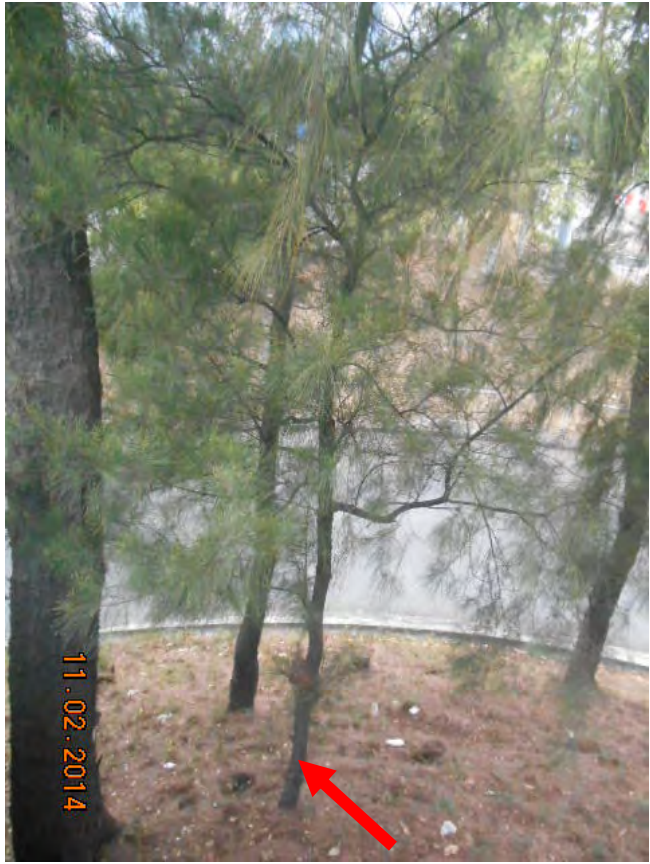
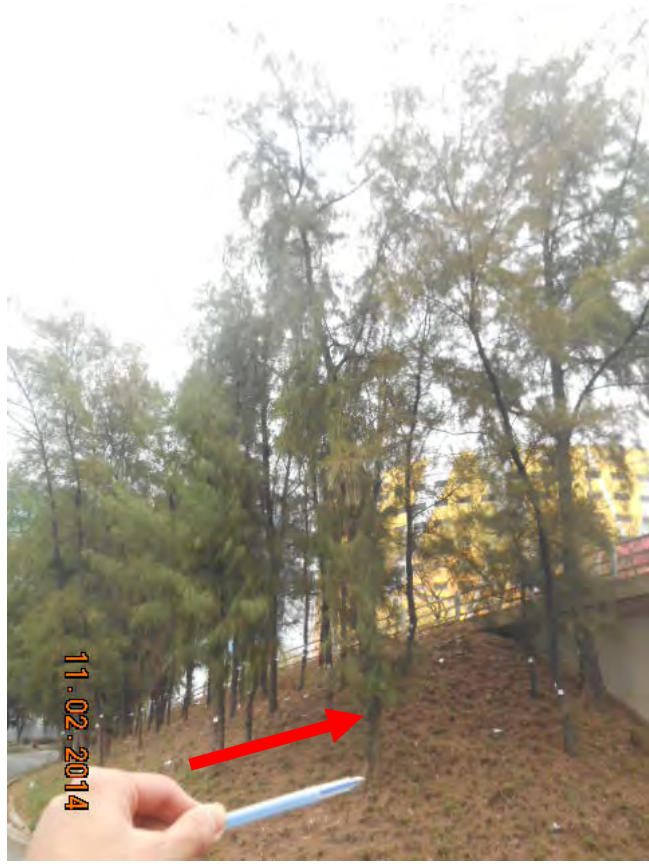
KT/T330_1 (Fell) Scientific Name: <i>Casuarina equisetifolia</i>	KT/T330_2 Heavily leaning	KT/T331_1 (Fell) Scientific Name: <i>Casuarina equisetifolia</i>	KT/T331_2

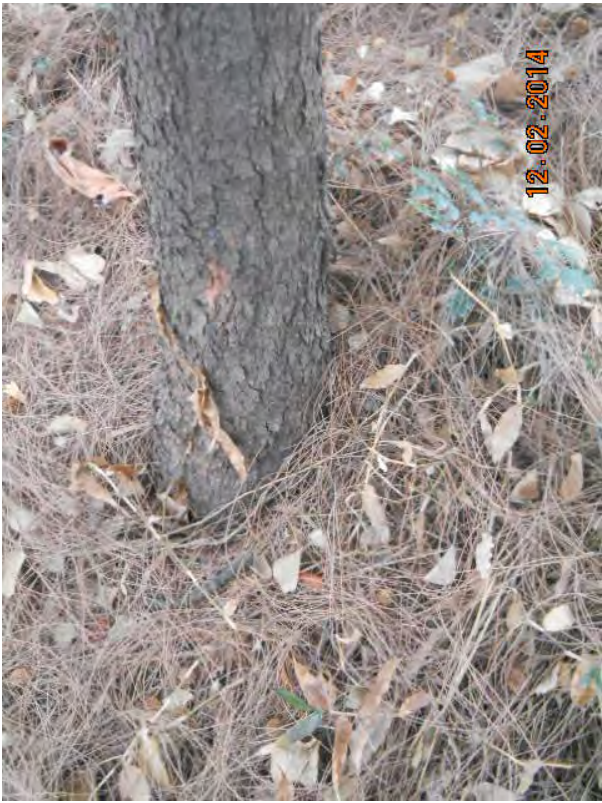
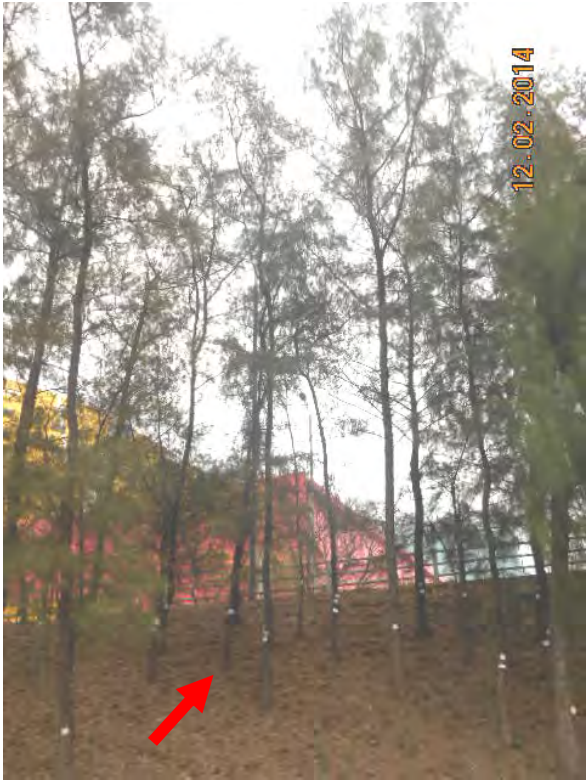
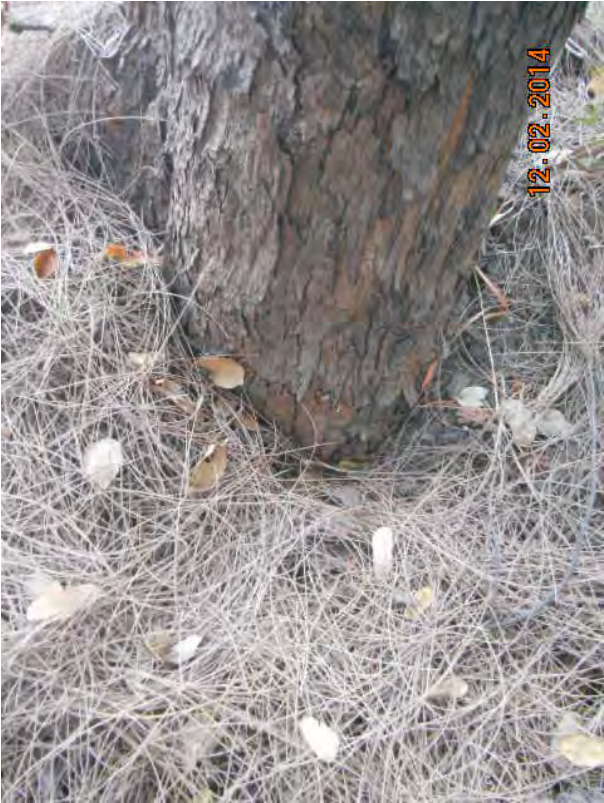
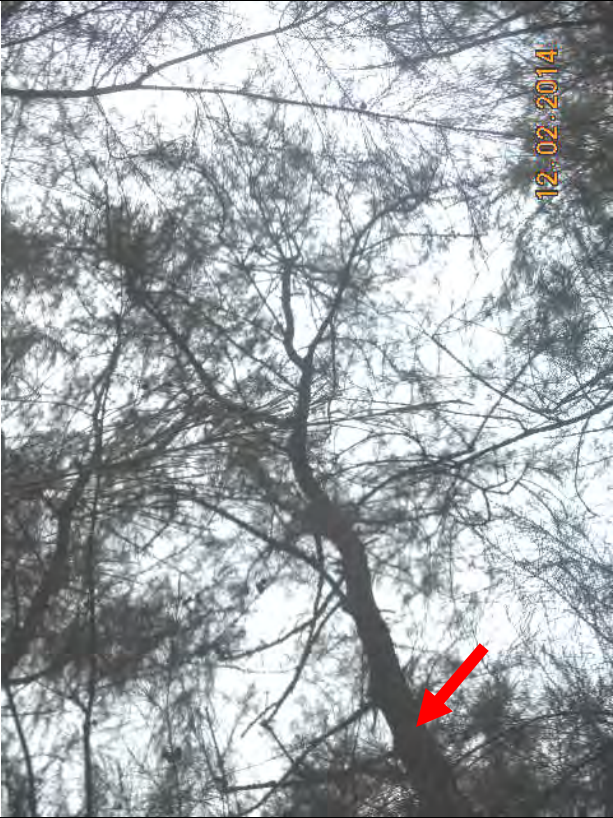
KT/T341_1 (Fell) Scientific Name: <i>Casuarina equisetifolia</i>	KT/T342_1 (Fell) Scientific Name: <i>Casuarina equisetifolia</i>	KT/T342_2	KT/T343_1 (Fell) Scientific Name: <i>Casuarina equisetifolia</i>

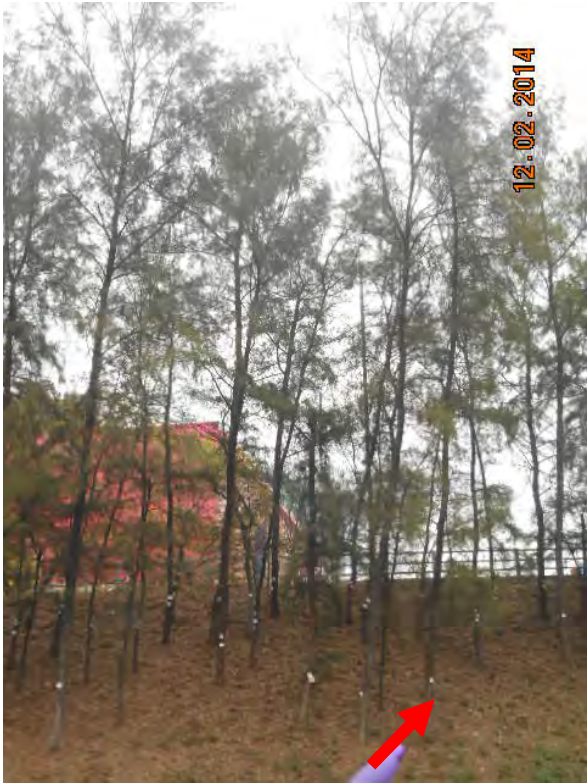
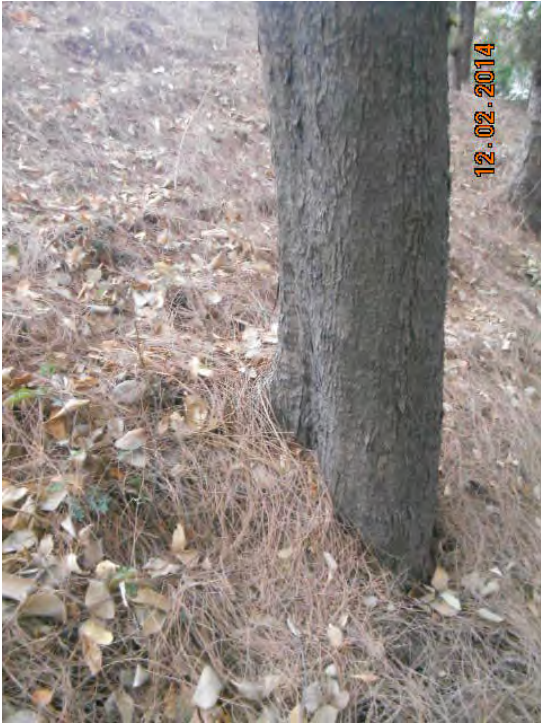
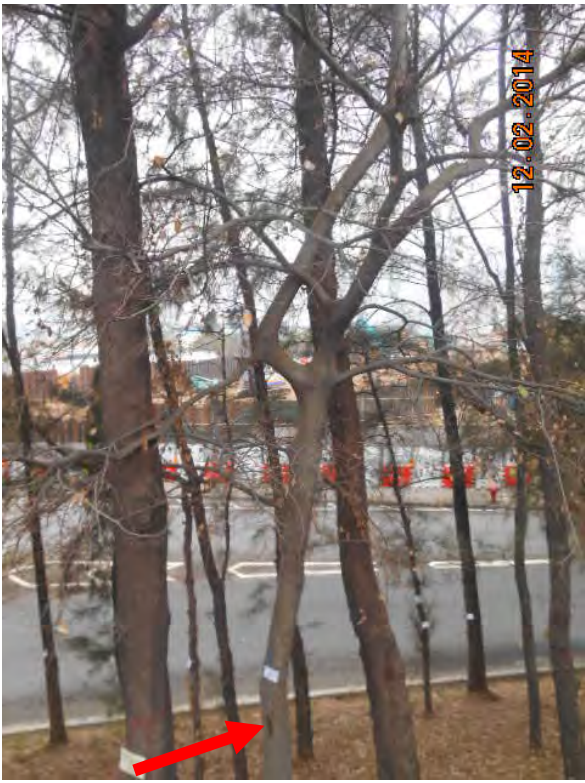
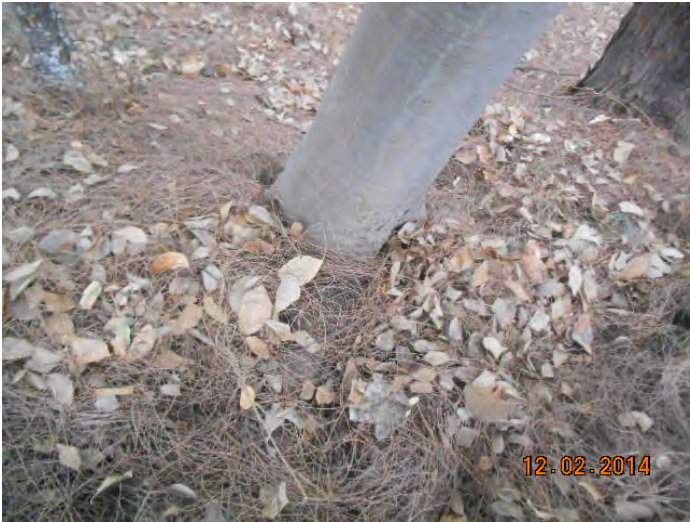
KT/T351_1 (Fell) Scientific Name: <i>Casuarina equisetifolia</i>	KT/T351_2	KT/T352_1 (Fell) Scientific Name: <i>Casuarina equisetifolia</i>	KT/T352_2

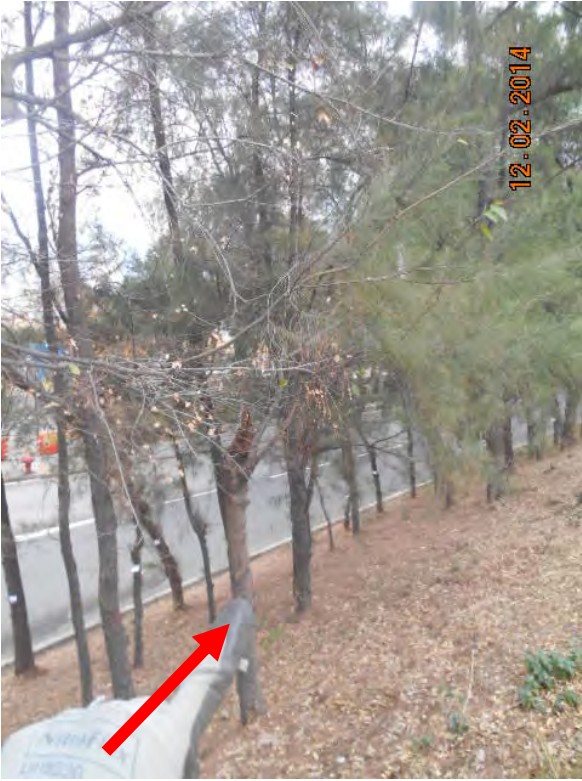
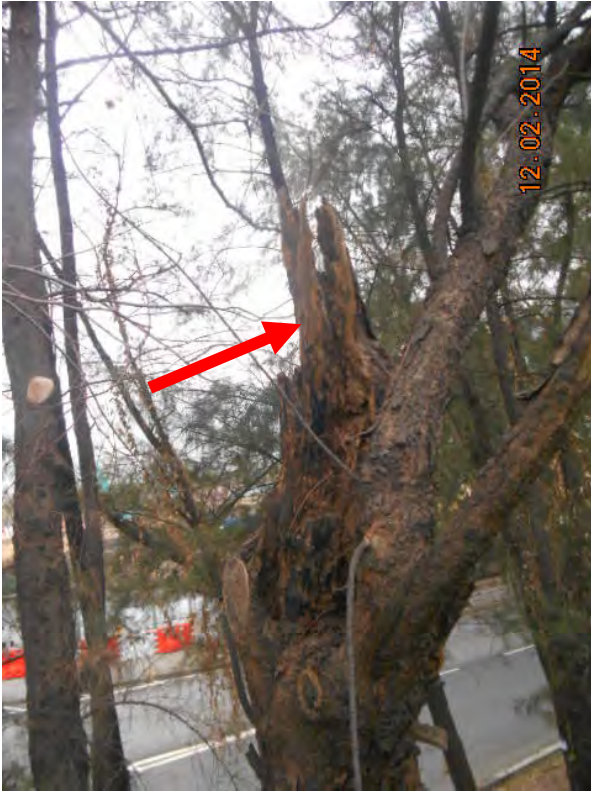
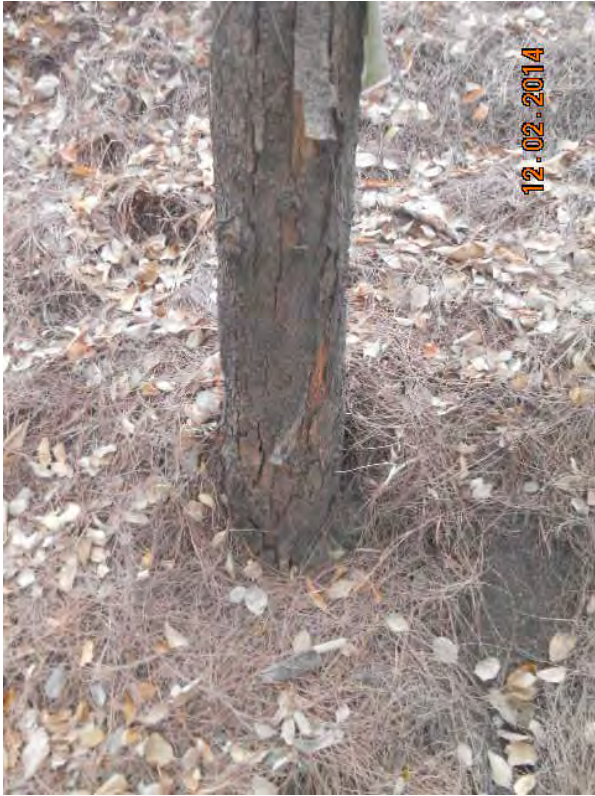
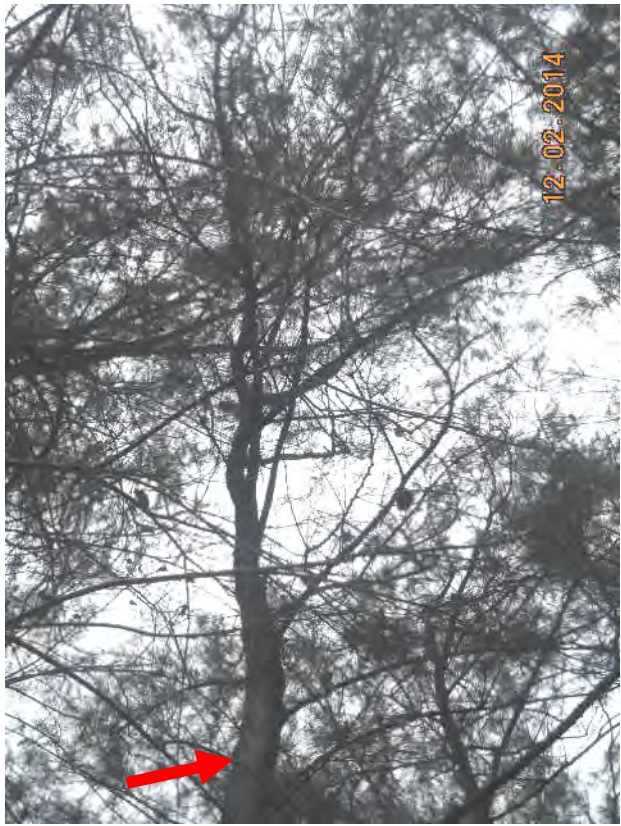
KT/T355_1 (Fell) Scientific Name: <i>Casuarina equisetifolia</i>	KT/T355_2

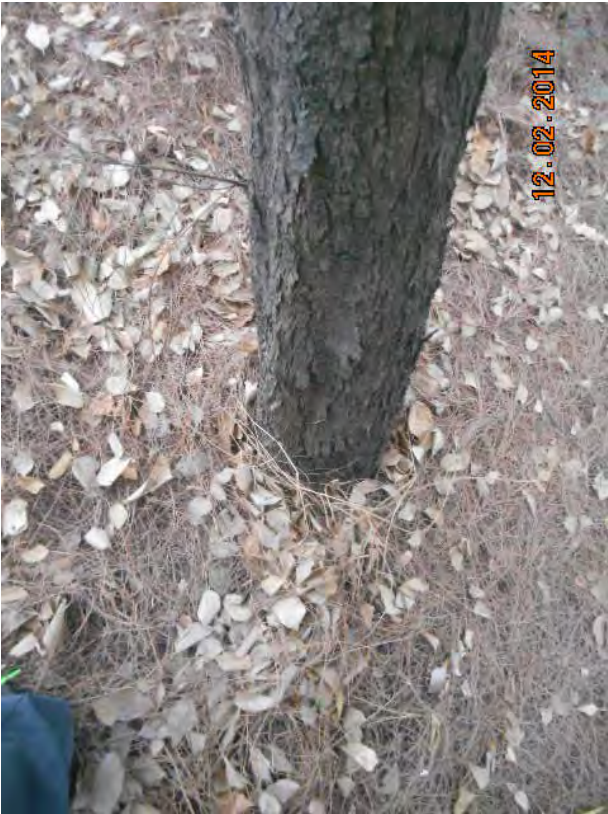
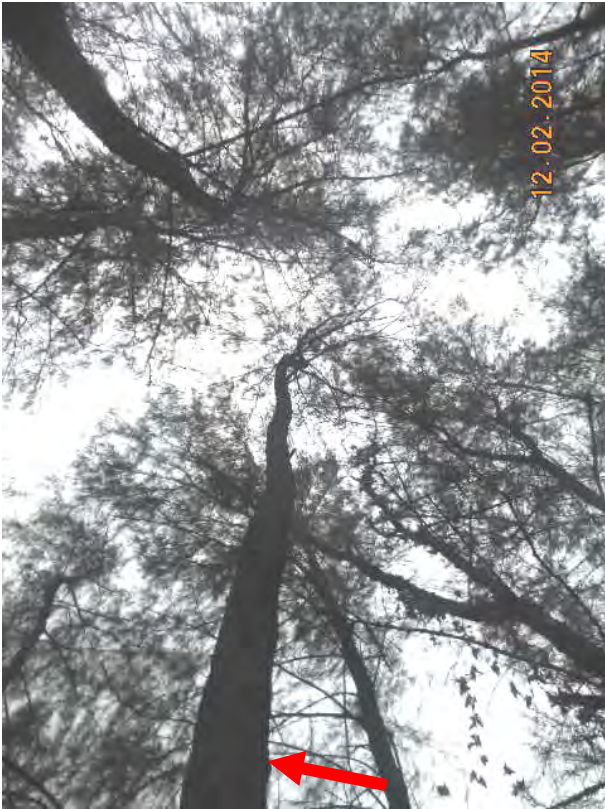
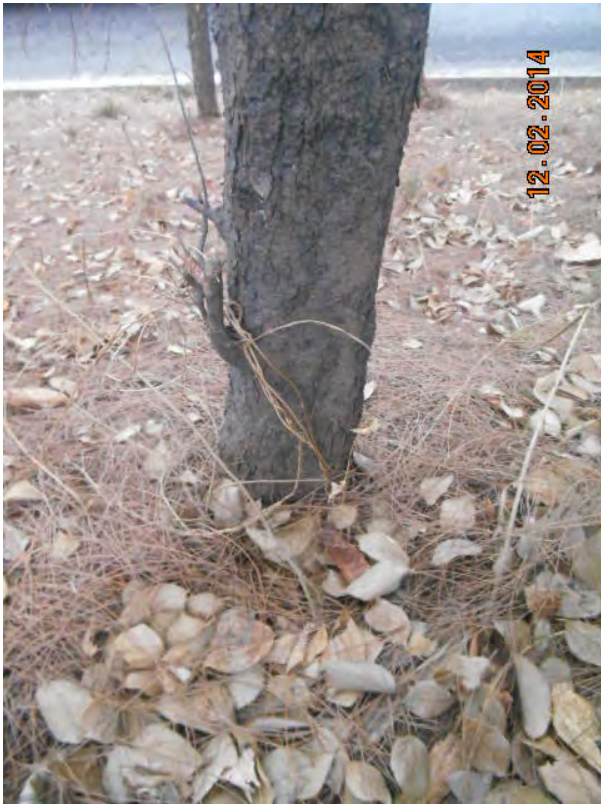
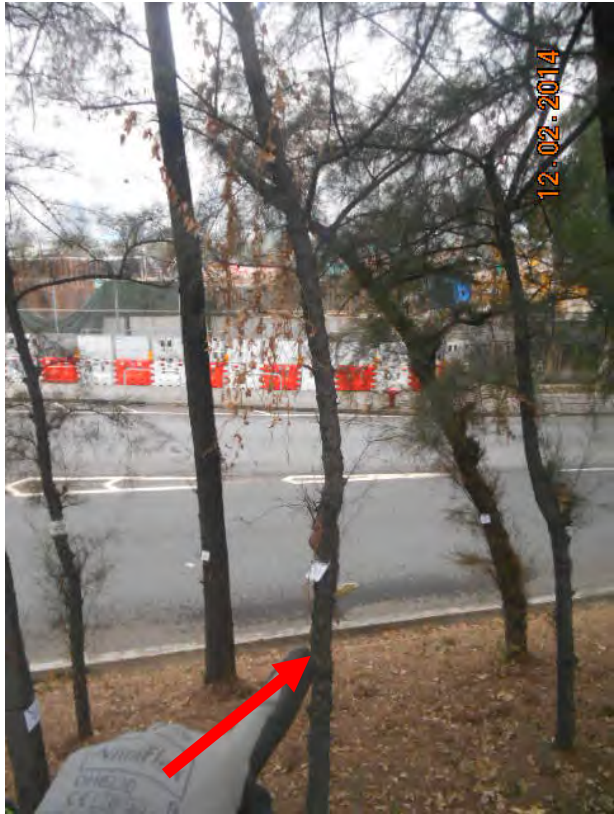
KT/T356_1 (Fell) Scientific Name: <i>Casuarina equisetifolia</i>	KT/T356_2 Broken leader	KT/T356_3	KT/T357_1 (Fell) Scientific Name: <i>Casuarina equisetifolia</i>

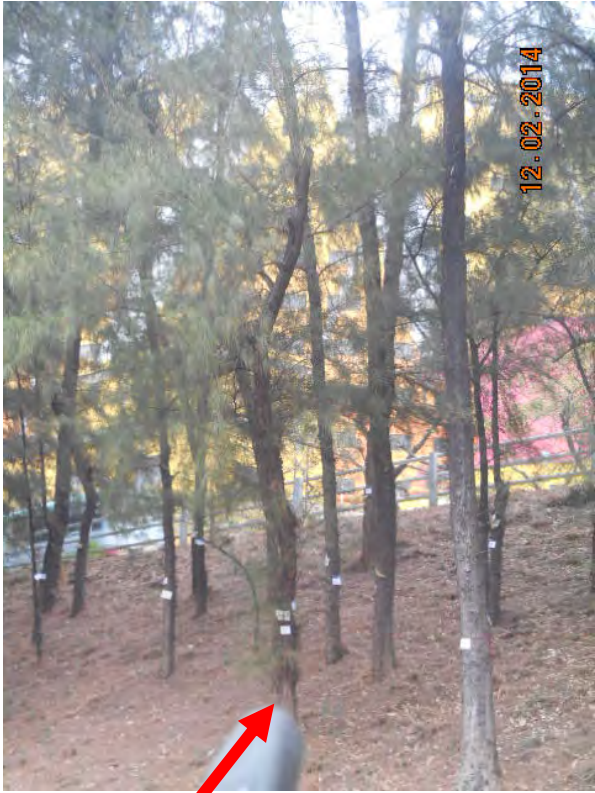
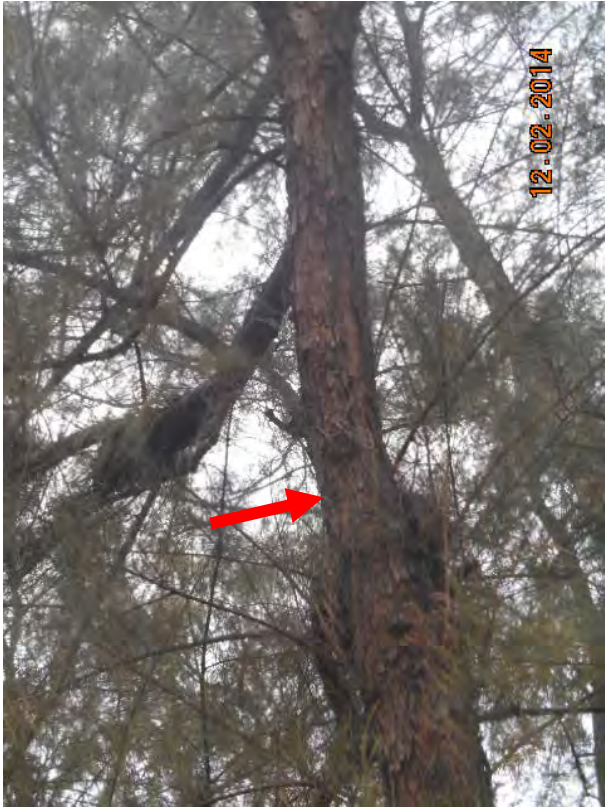
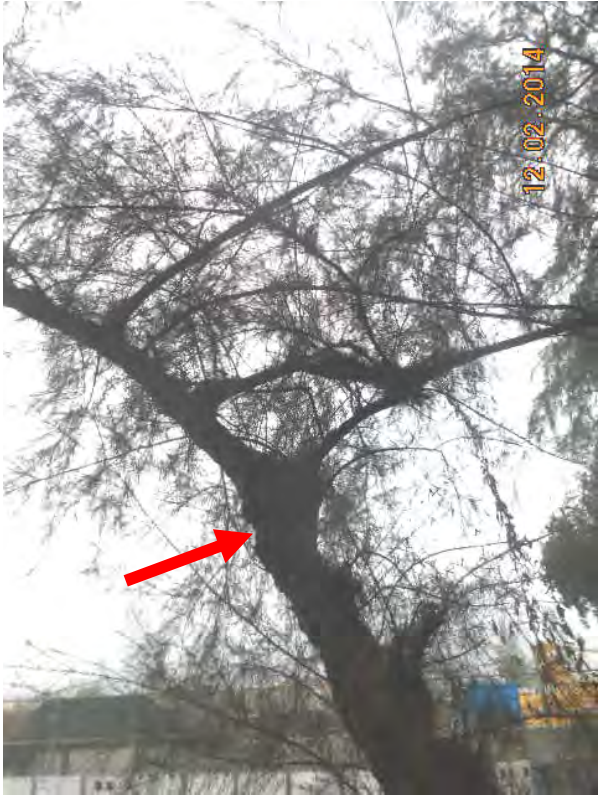
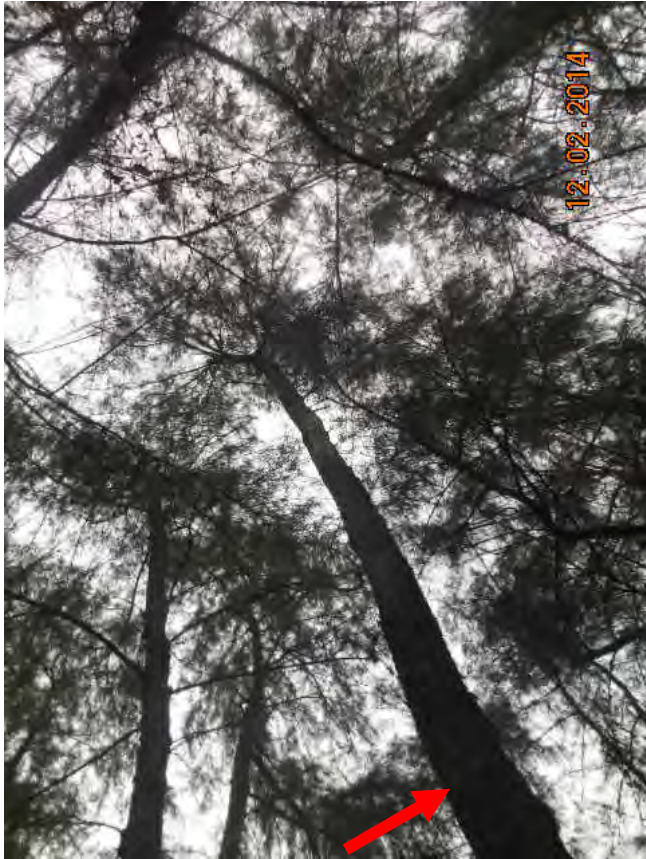
KT/T360_3	KT/T361_1 (Fell) Scientific Name: <i>Casuarina equisetifolia</i>	KT/T361_2	KT/T361_3

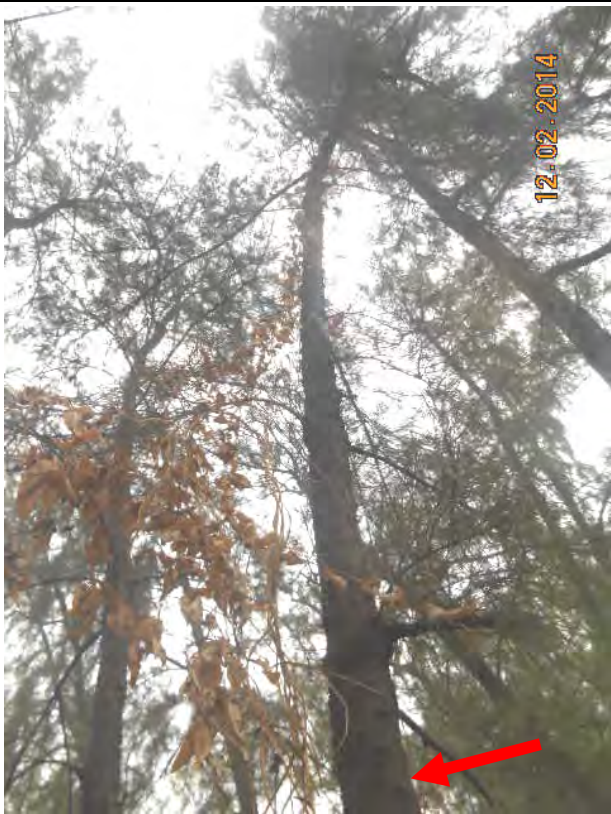
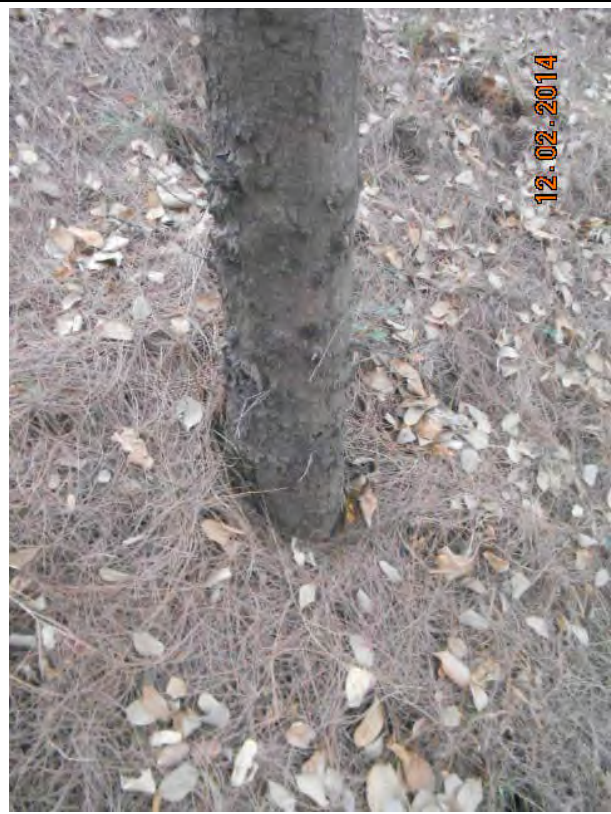
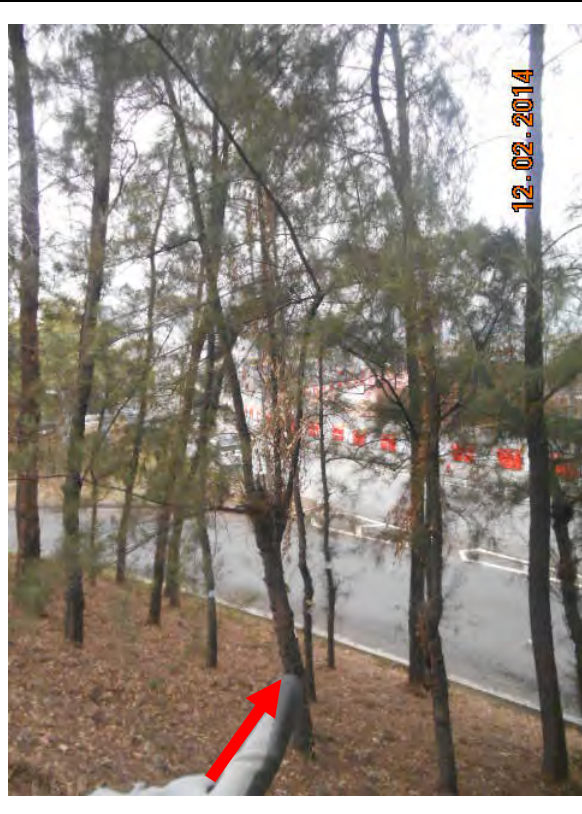
KT/T366_1 (Fell) Scientific Name: <i>Casuarina equisetifolia</i>	KT/T366_2 Broken main trunk	KT/T366_3	KT/T367_1 (Fell) Scientific Name: <i>Casuarina equisetifolia</i>
