## **CKR – Kai Tak**

Central Kowloon Route -  
Design and Construction

Tree Assessment Schedule - Kai Tak Area (Trees under AFCD to Provide Expert Advice)

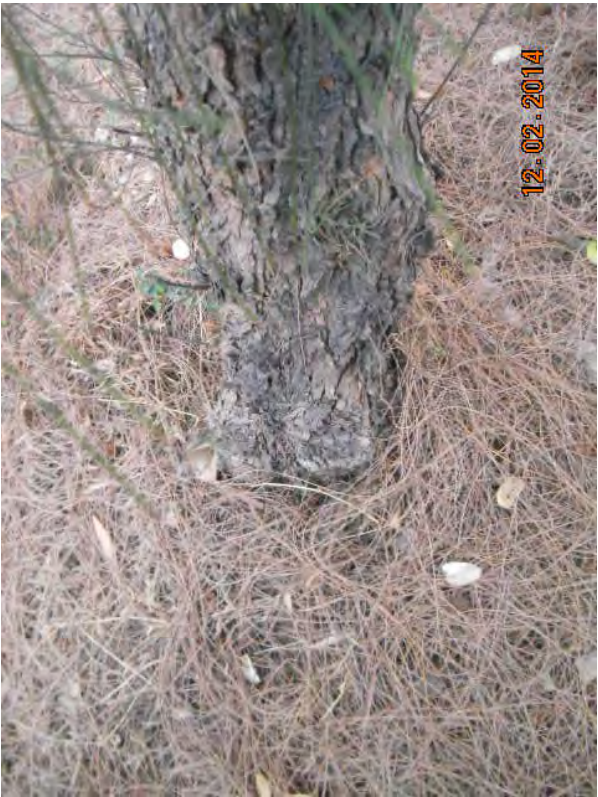
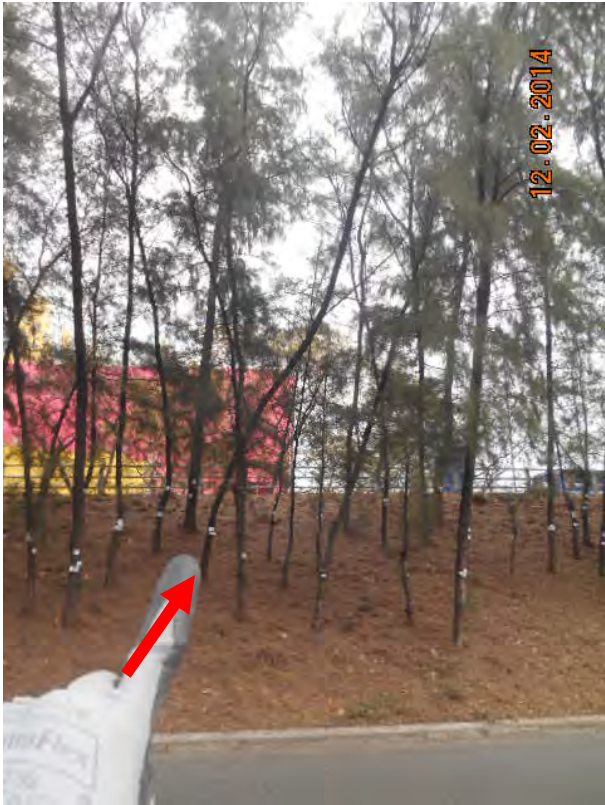
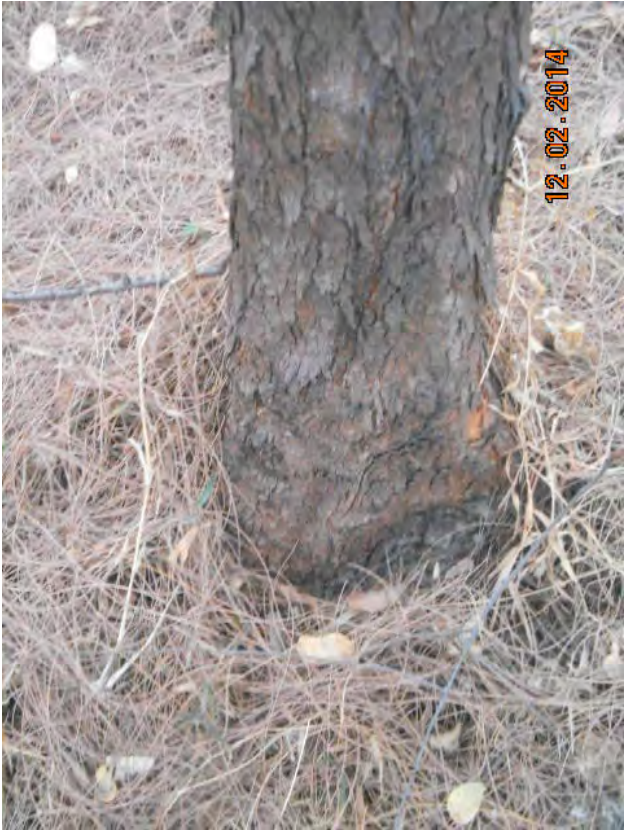
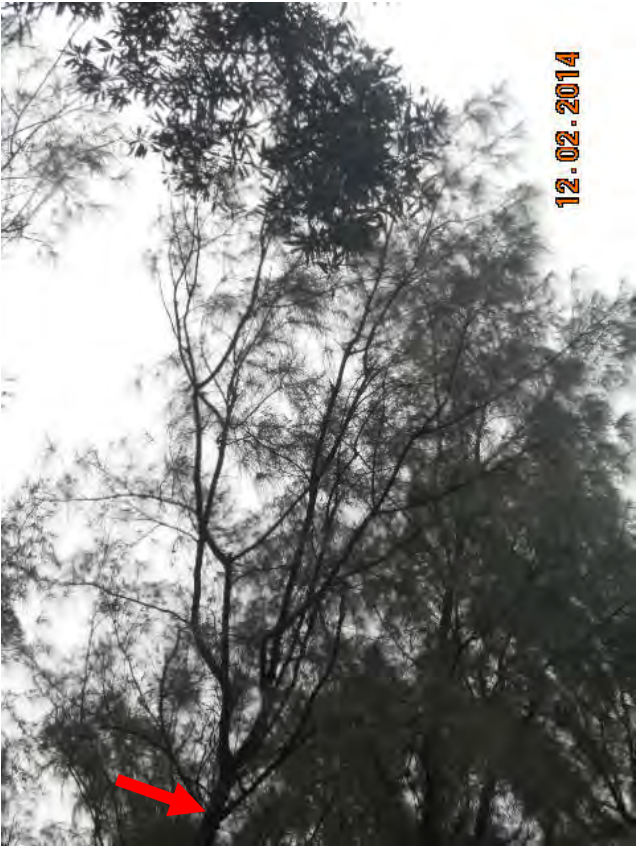
KT/T376_2	KT/T377_1 (Fell) Scientific Name: <i>Casuarina equisetifolia</i>	KT/T377_2	KT/T377_3 Dead branches

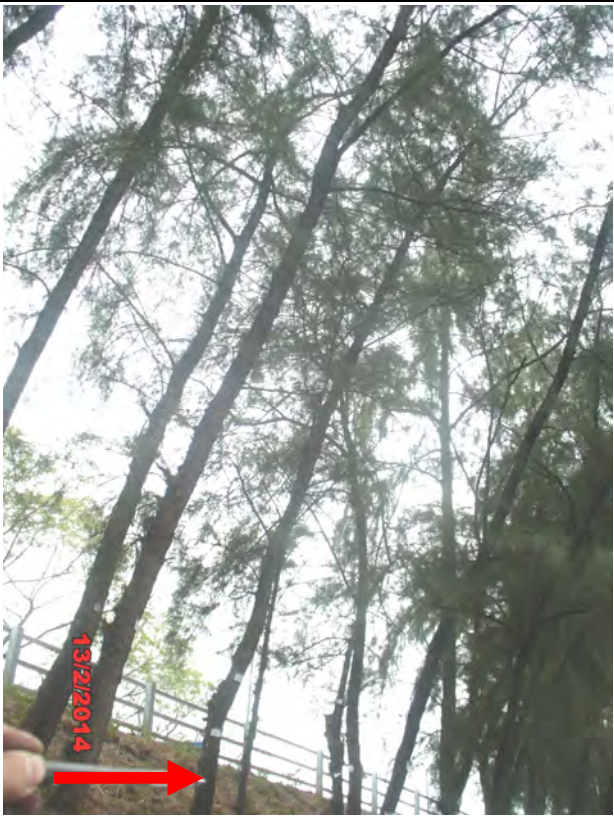
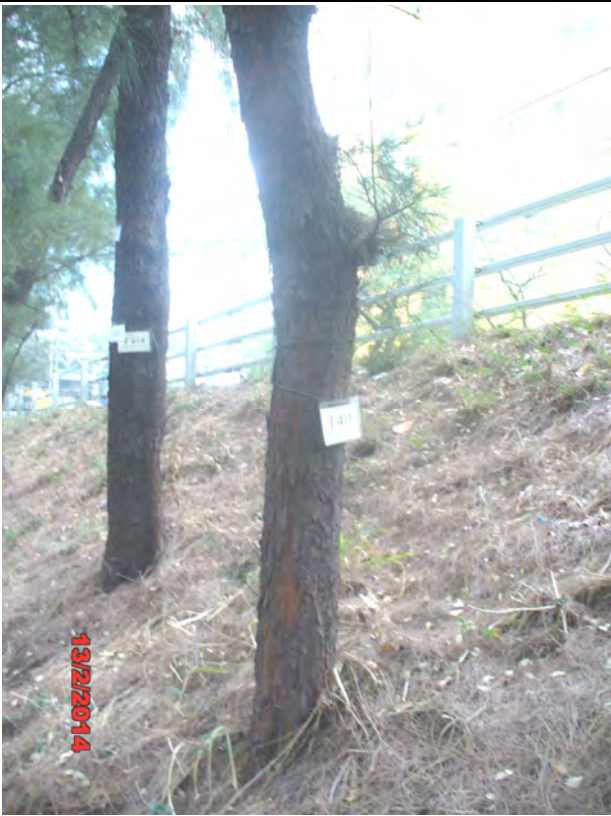
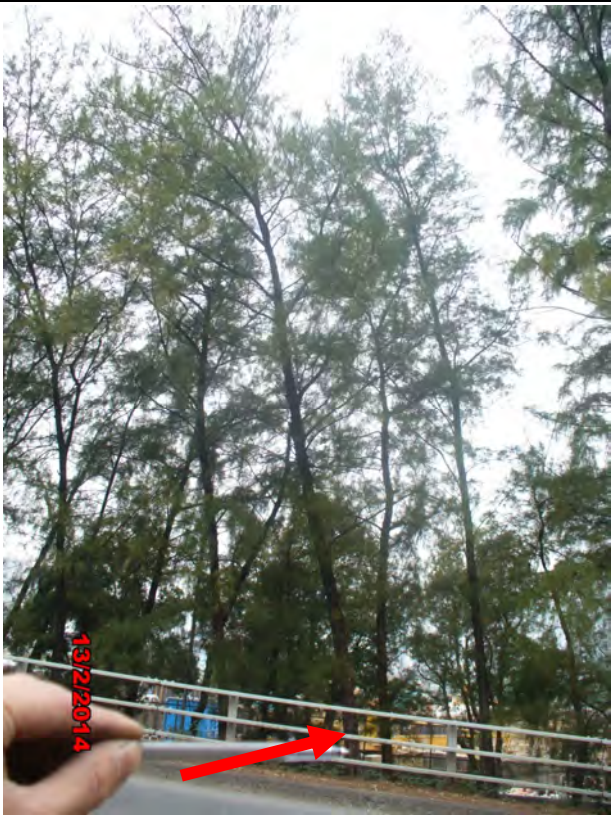
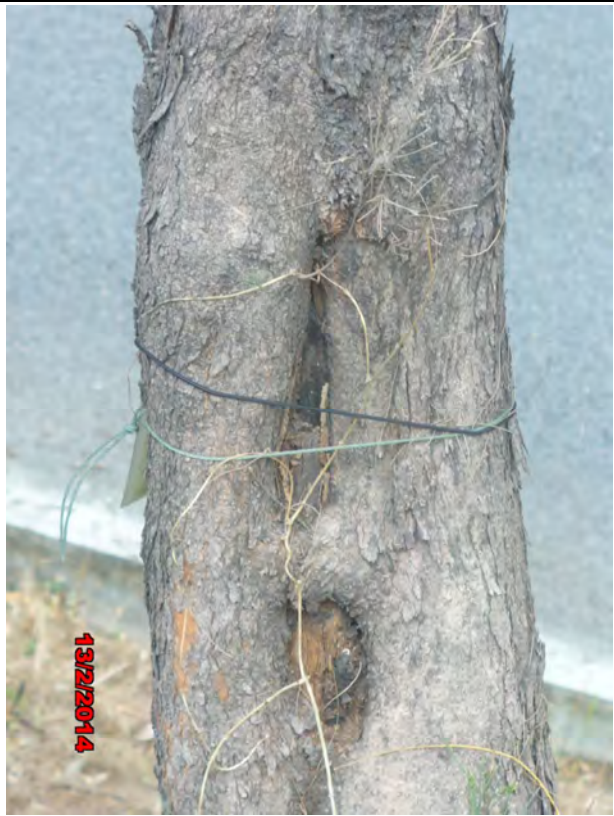
KT/T391_1 (Fell) Scientific Name: <i>Casuarina equisetifolia</i>	KT/T391_2	KT/T392_1 (Fell) Scientific Name: <i>Casuarina equisetifolia</i>	KT/T392_2 Wound on trunk

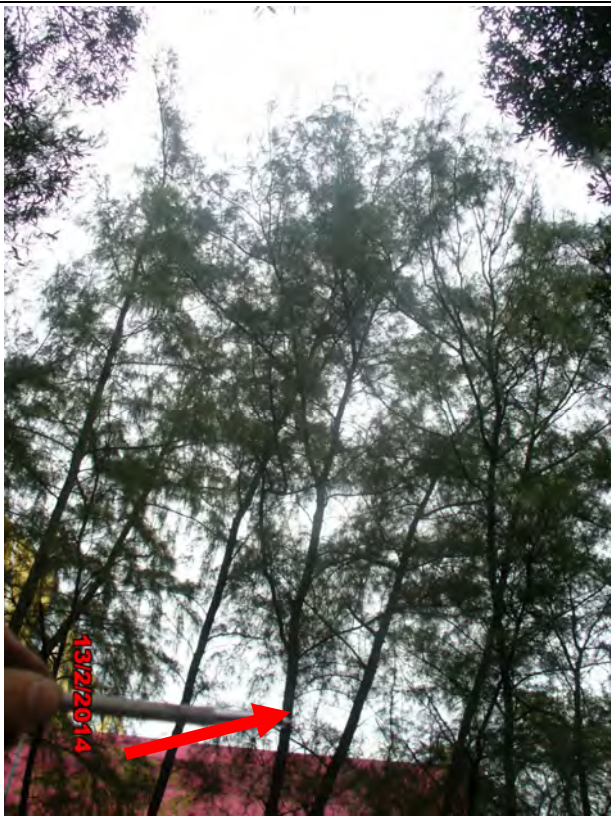
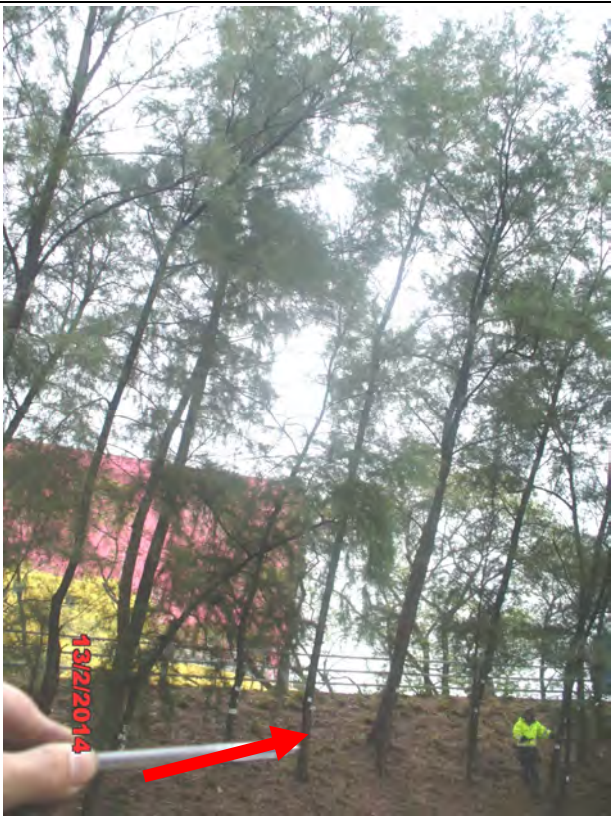
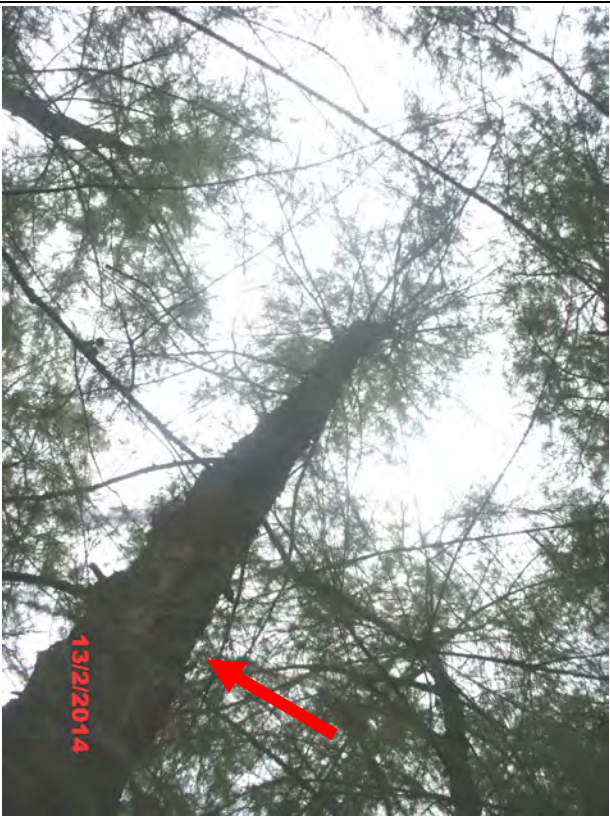
KT/T393_1 (Fell) Scientific Name: <i>Casuarina equisetifolia</i>	KT/T393_2	KT/T394_1 (Fell) Scientific Name: <i>Casuarina equisetifolia</i>	KT/T394_2

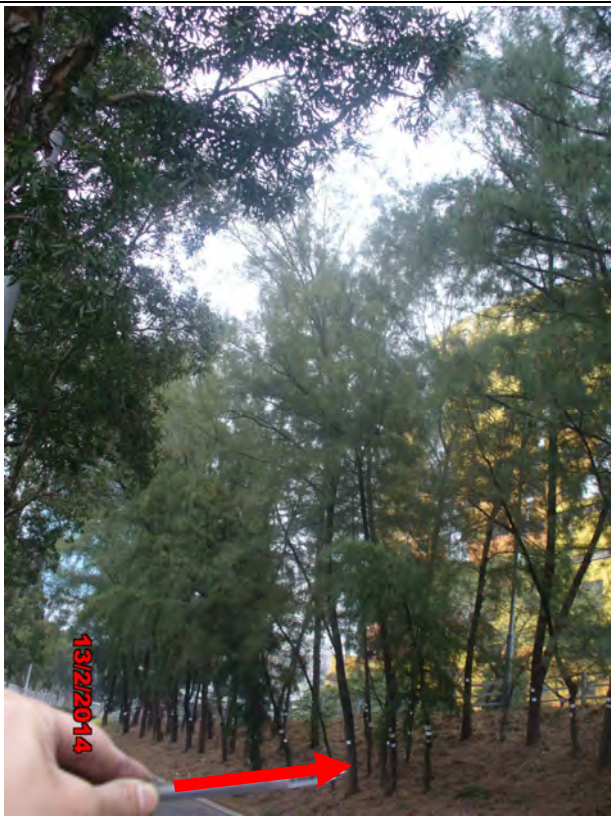
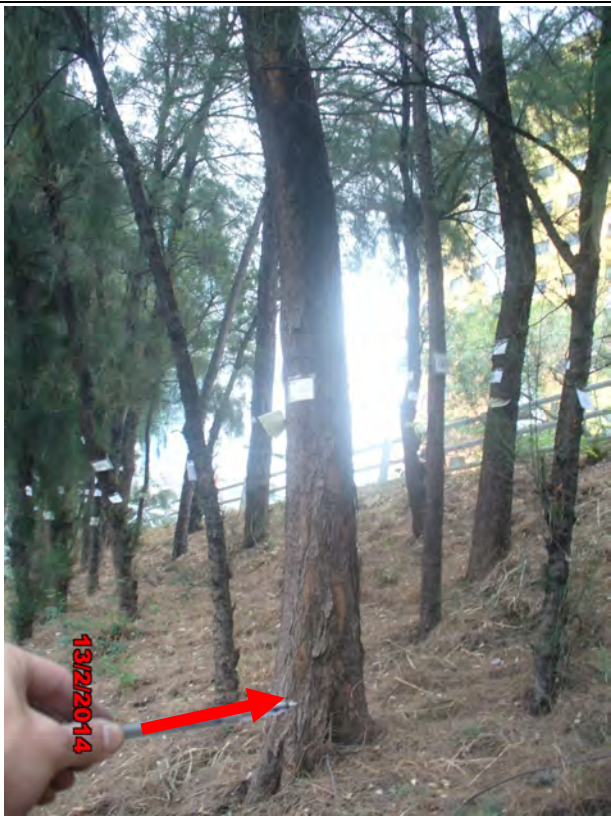
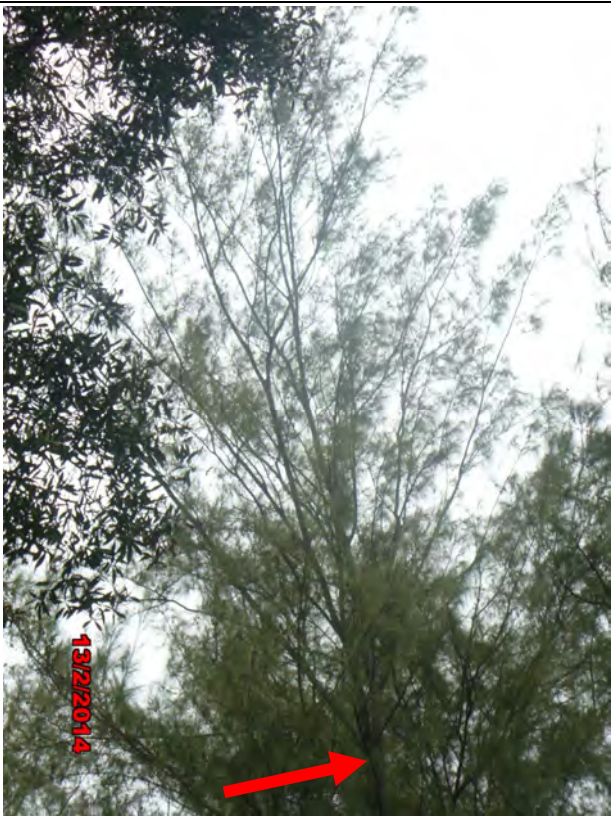
KT/T397_2	KT/T397_3 Heavily leaning	KT/T398_1 (Fell) Scientific Name: <i>Casuarina equisetifolia</i>	KT/T398_2 Large wound at trunk base

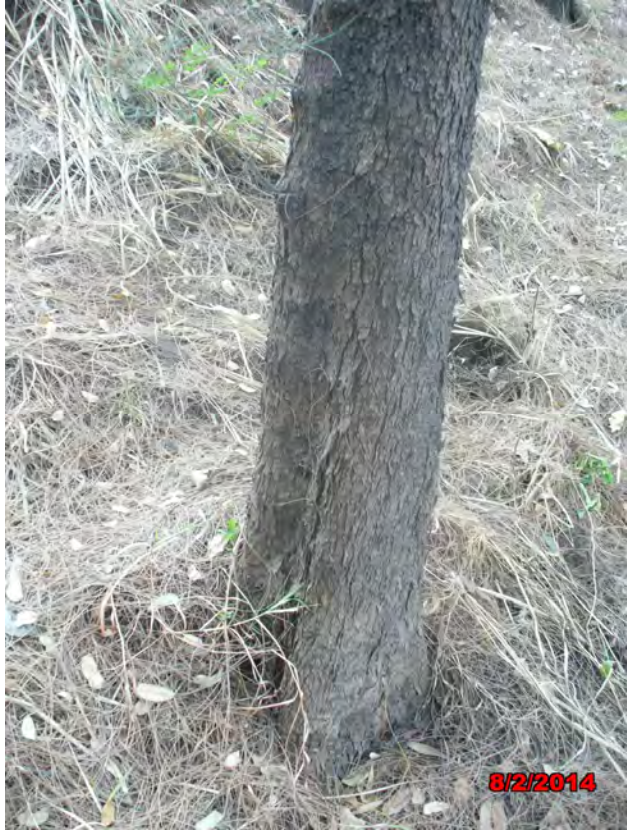
KT/T401_3	KT/T402_1 (Fell) Scientific Name: <i>Casuarina equisetifolia</i>	KT/T402_2	KT/T402_3

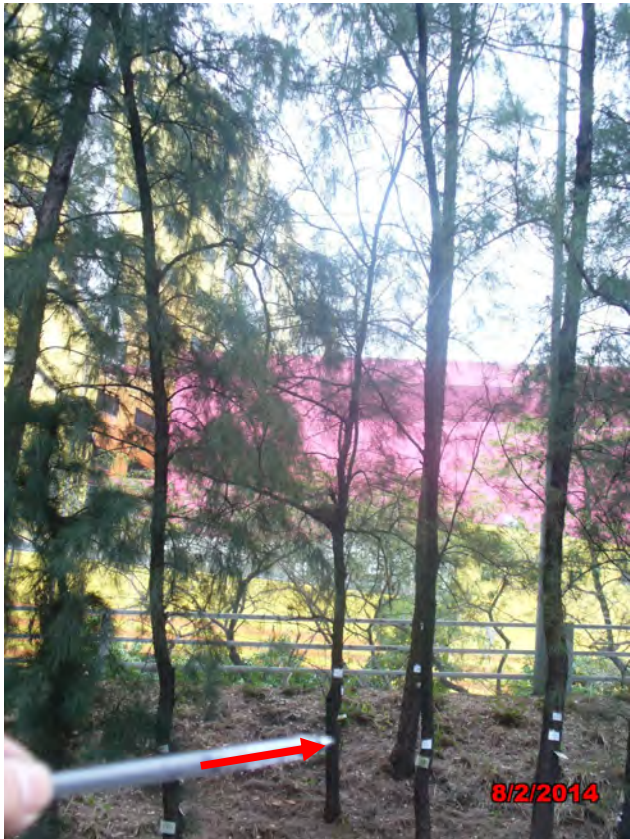
KT/T403_1 (Fell) Scientific Name: <i>Casuarina equisetifolia</i>	KT/T403_2	KT/T403_3	KT/T404_1 (Fell) Scientific Name: <i>Casuarina equisetifolia</i>

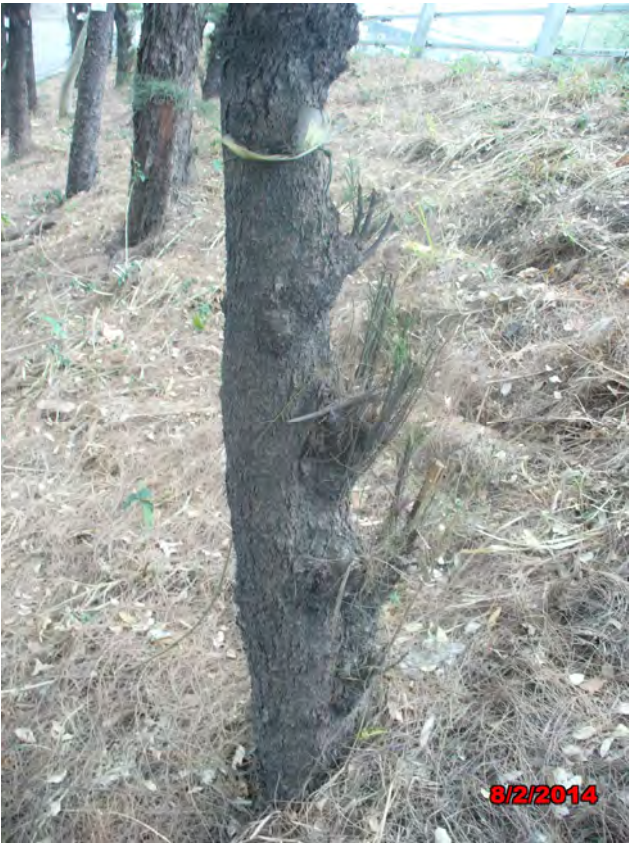
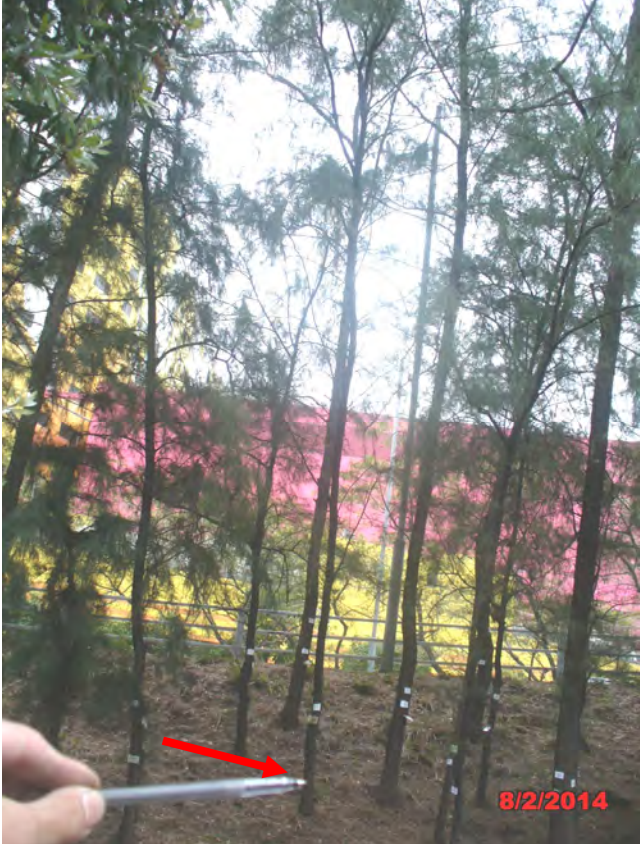
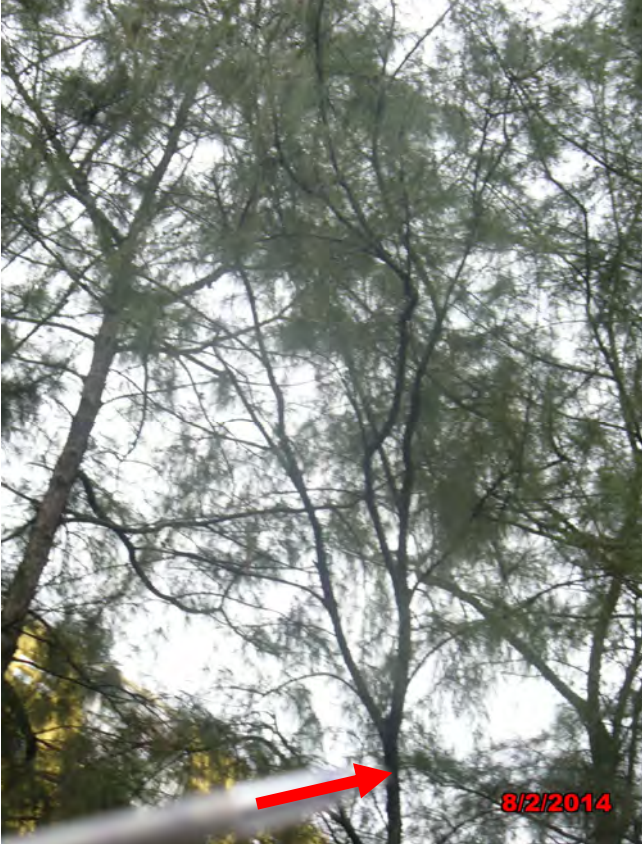
KT/T404_2	KT/T405_1 (Fell) Scientific Name: <i>Casuarina equisetifolia</i>	KT/T405_2	KT/T406_1 (Fell) Scientific Name: <i>Casuarina equisetifolia</i>

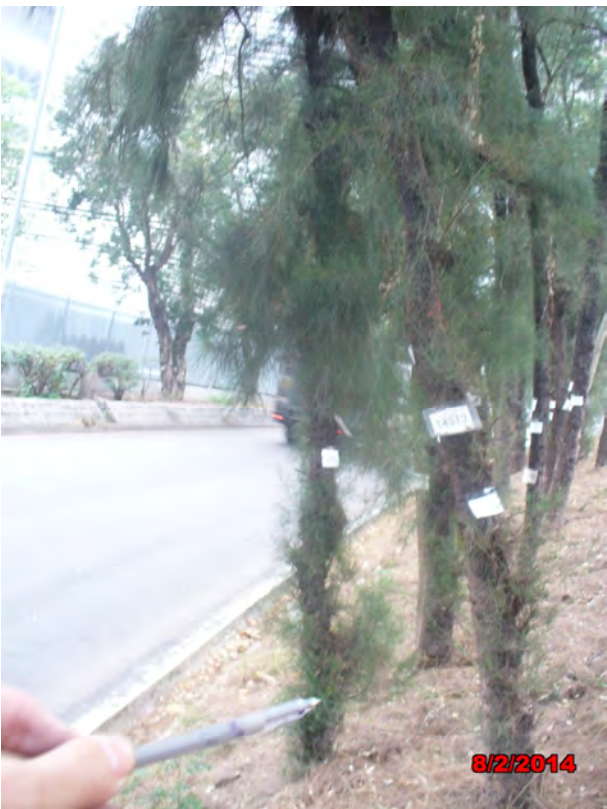
KT/T406_2	KT/T407_1 (Fell) Scientific Name: <i>Casuarina equisetifolia</i>	KT/T407_2	KT/T407_3

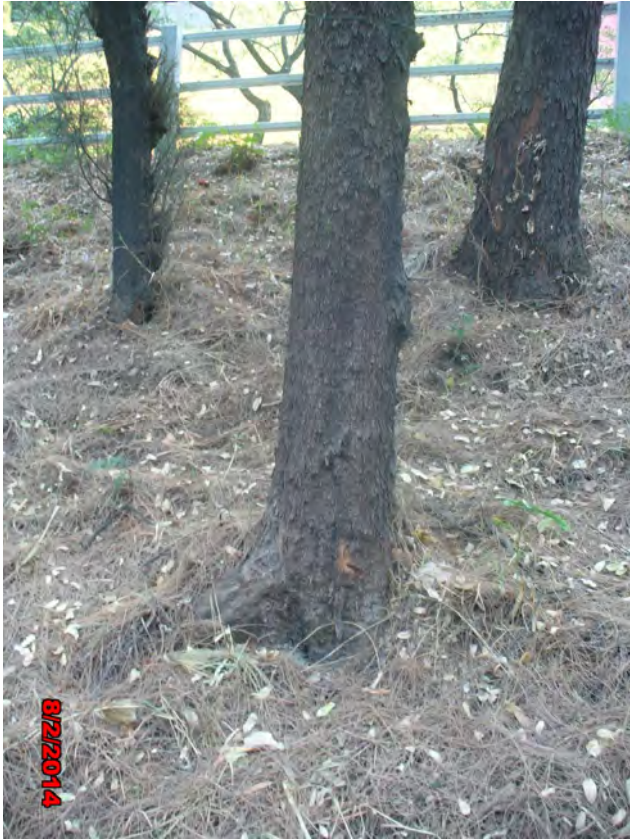
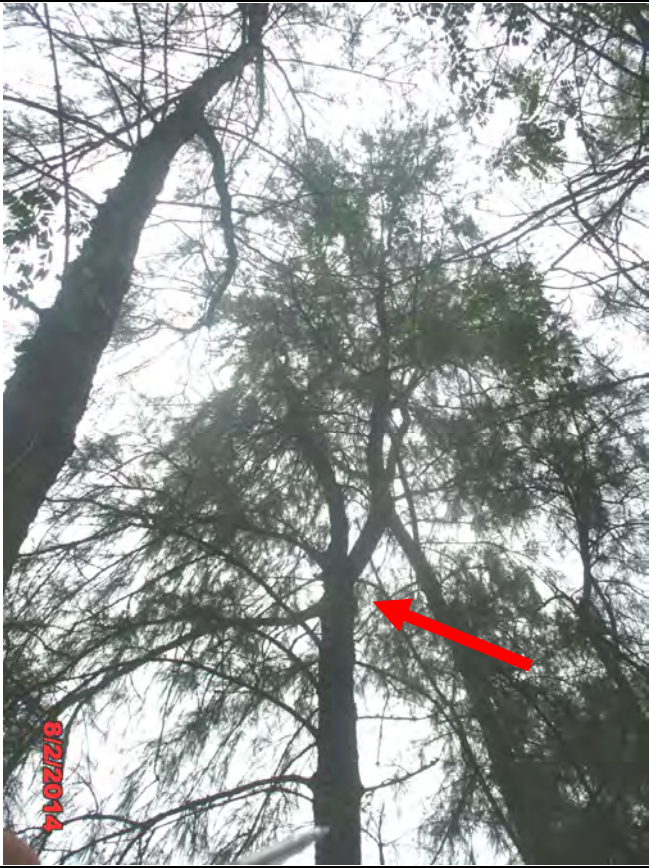
KT/T419_3	KT/T420_1 (Fell) Scientific Name: <i>Casuarina equisetifolia</i>	KT/T420_2	KT/T420_3

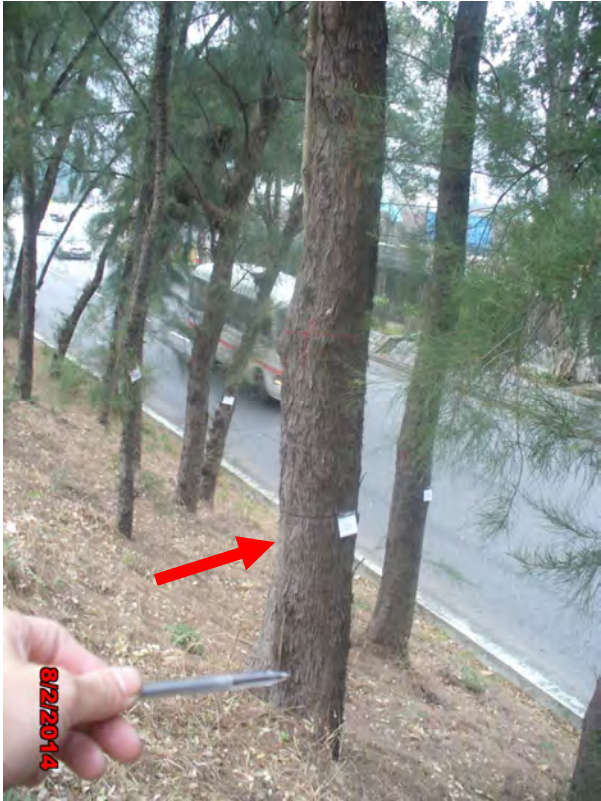
KT/T421_1 (Fell) Scientific Name: <i>Casuarina equisetifolia</i>	KT/T421_2	KT/T421_3	KT/T422_1 (Fell) Scientific Name: <i>Casuarina equisetifolia</i>

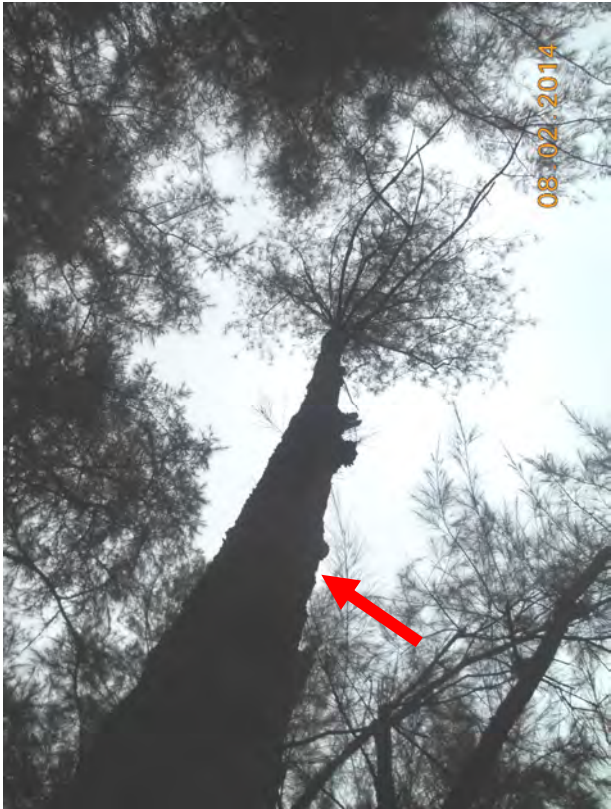
KT/T424_4 Dead branches	KT/T424_1_(Fell) Scientific Name: <i>Casuarina equisetifolia</i>	KT/T424_2	KT/T424_3 Wound

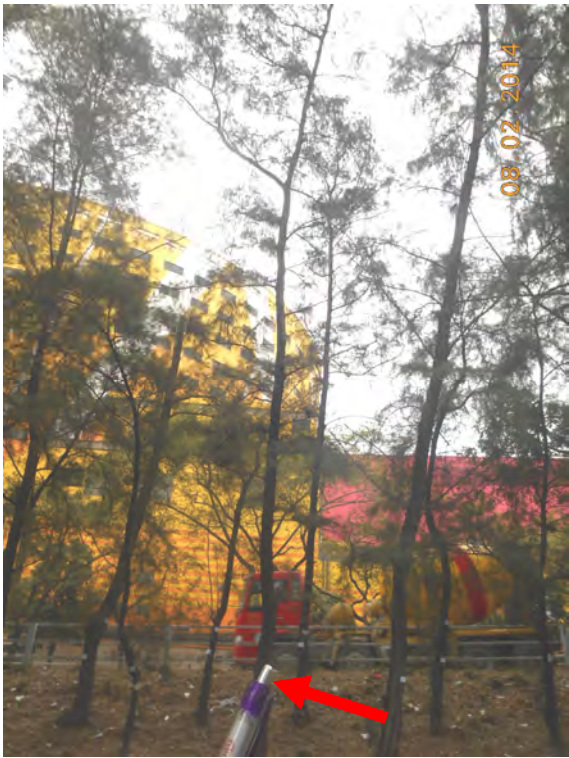
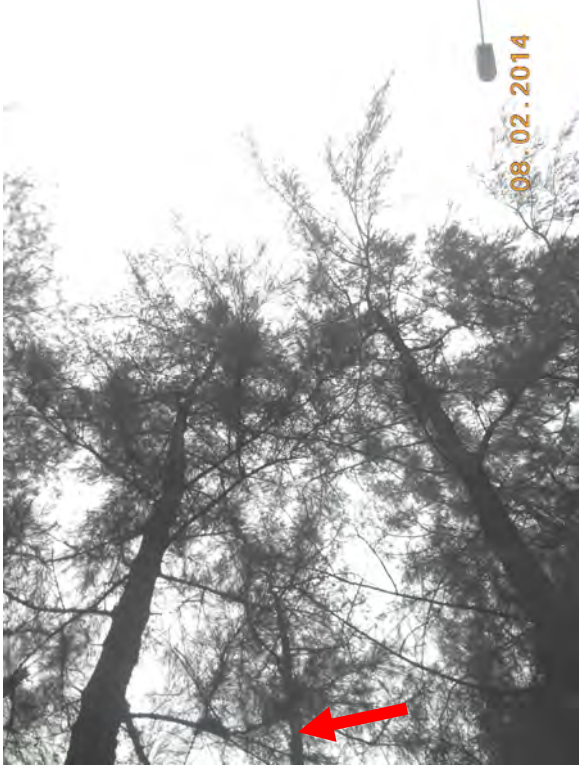
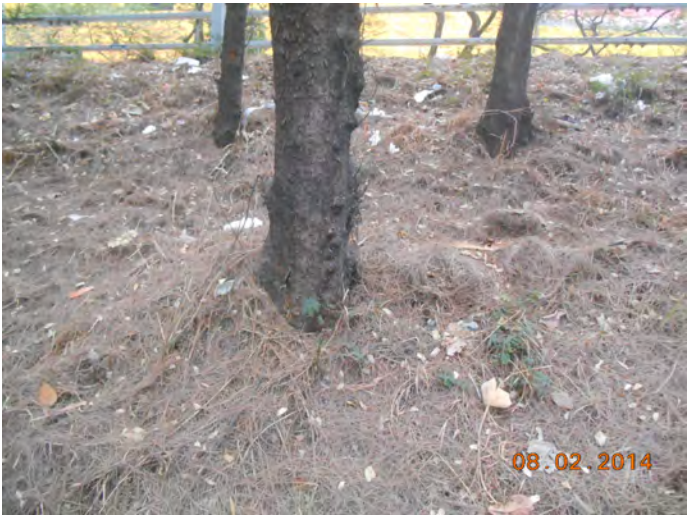
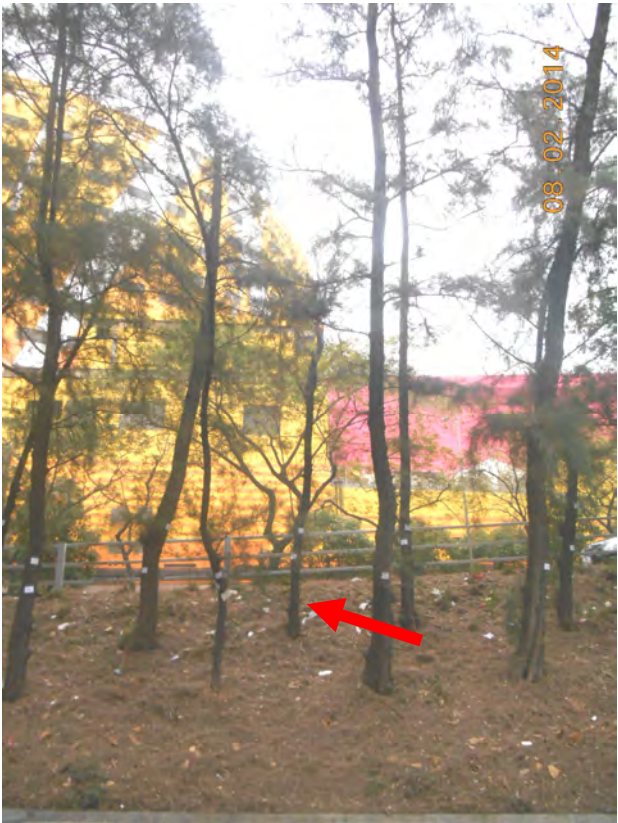
KT/T425_1 (Fell) Scientific Name: <i>Casuarina equisetifolia</i>	KT/T425_2	KT/T426_1 (Fell) Scientific Name: <i>Casuarina equisetifolia</i>	KT/T426_2

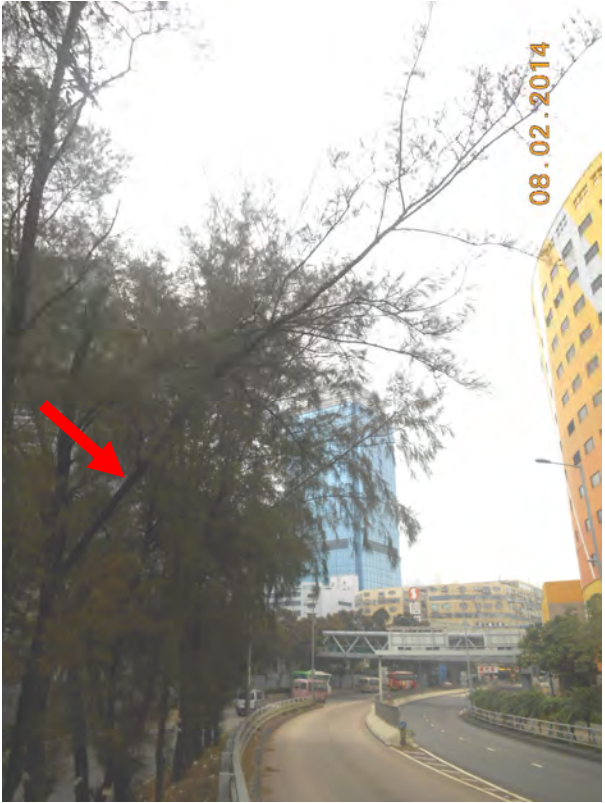
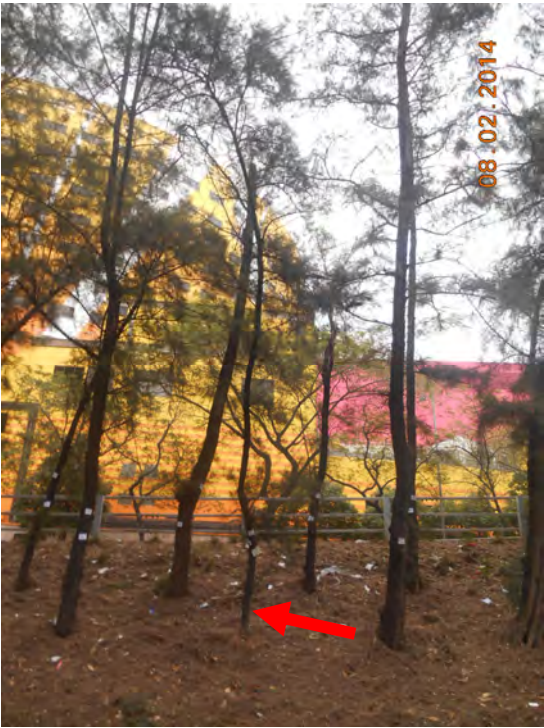
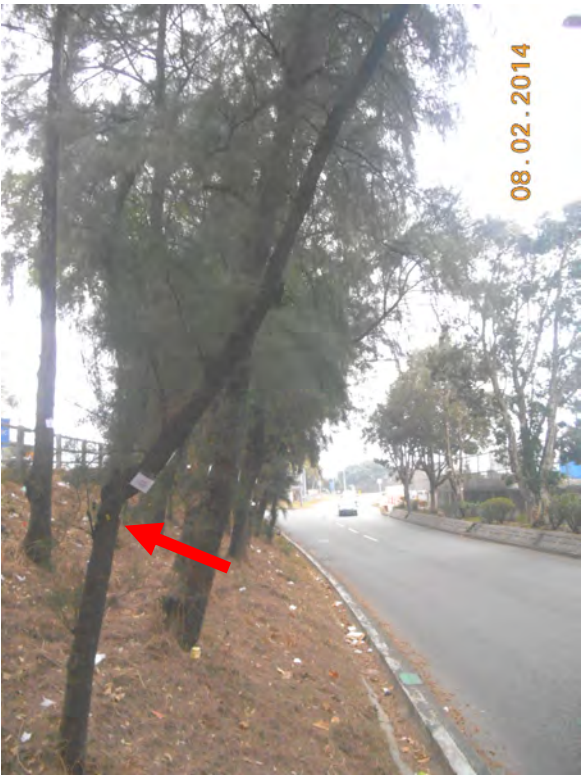
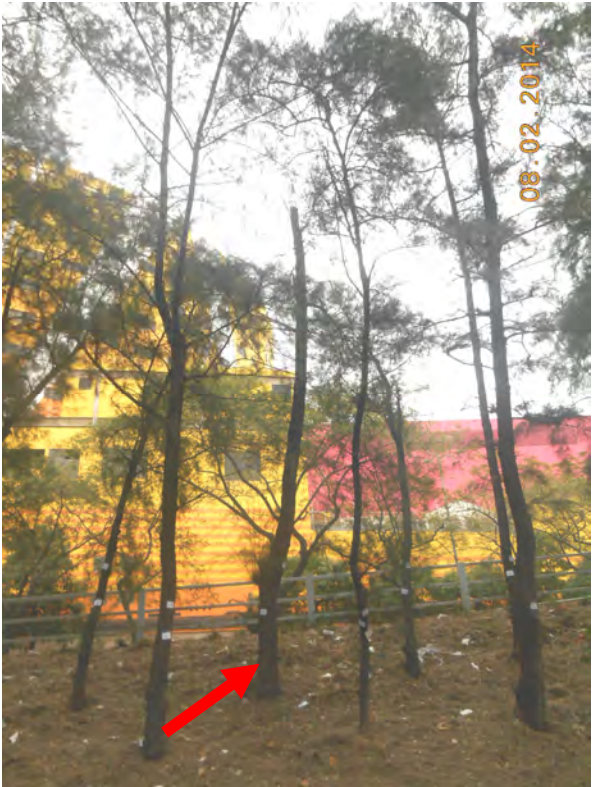
KT/T427_1_(Fell) Scientific Name: <i>Casuarina equisetifolia</i>	KT/T427_2	KT/T427_3	KT/T428_1 (Fell) Scientific Name: <i>Casuarina equisetifolia</i>

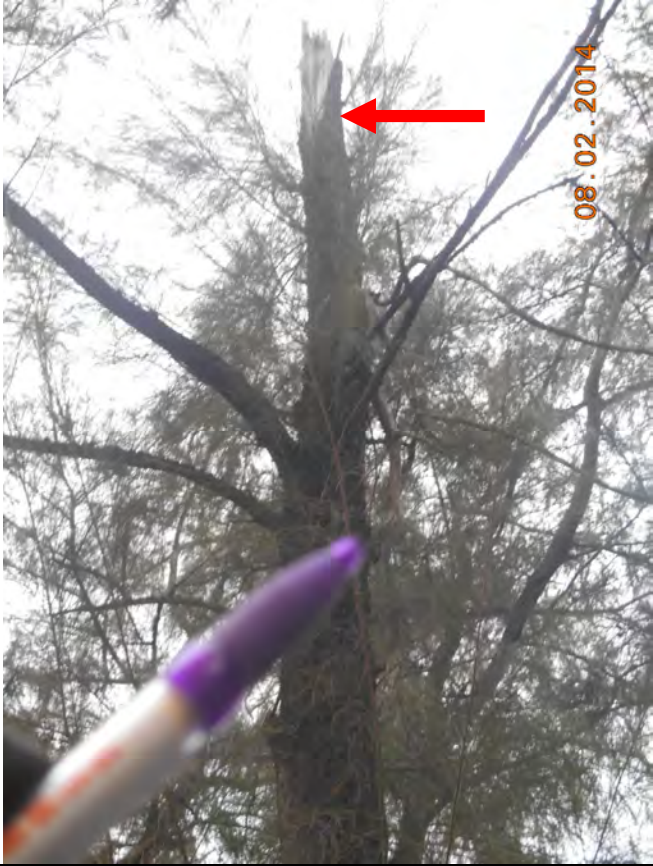
KT/T428_2 Heavily leaning	KT/T429_1 (Fell) Scientific Name: <i>Casuarina equisetifolia</i>	KT/T429_2 Crooked trunk	KT/T430_1 (Fell) Scientific Name: <i>Casuarina equisetifolia</i>

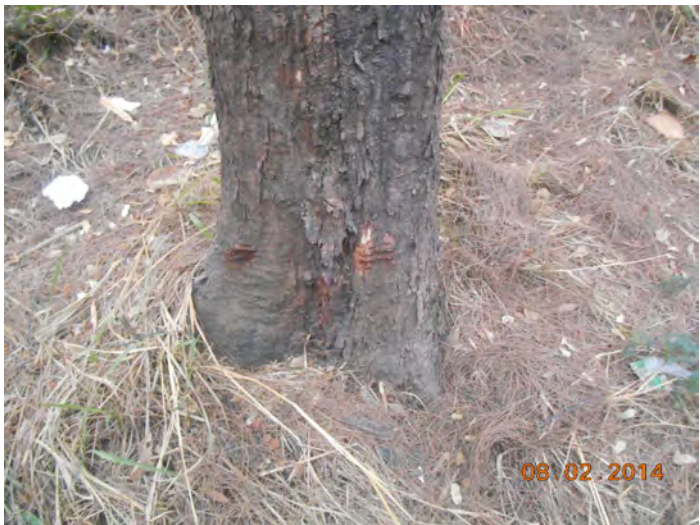
KT/T433_1 (Fell) Scientific Name: <i>Casuarina equisetifolia</i>	KT/T433_2 Co-dominant leaders	KT/T433_3 Broken leader	KT/T433_4

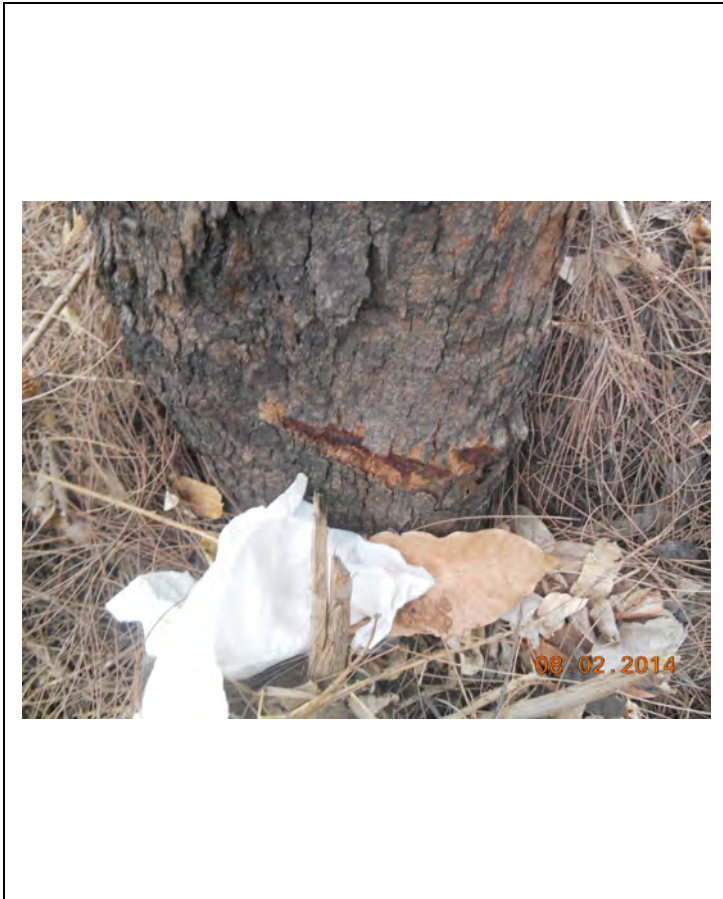
KT/T434_1 (Fell) Scientific Name: <i>Casuarina equisetifolia</i>	KT/T434_2	KT/T435_1 (Fell) Scientific Name: <i>Casuarina equisetifolia</i>	KT/T435_2

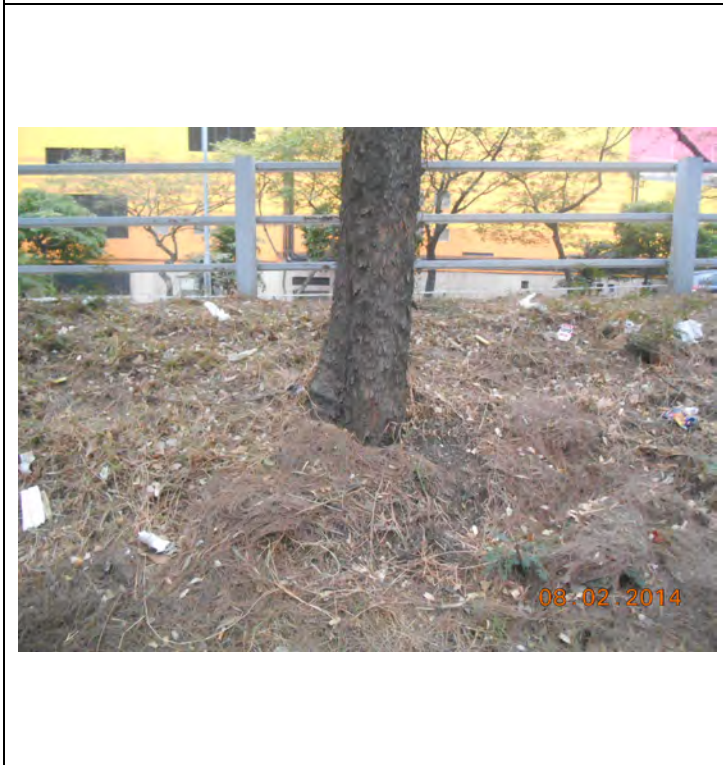
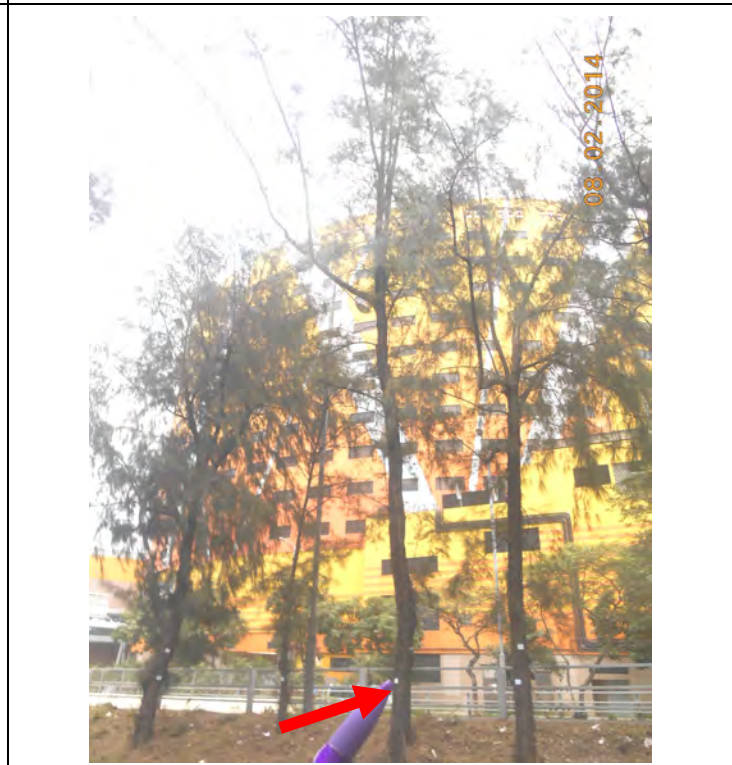
KT/T435_3 Wound on trunk base	KT/T436_1 (Fell) Scientific Name: <i>Casuarina equisetifolia</i>	KT/T436_2	KT/T437_1 (Fell) Scientific Name: <i>Casuarina equisetifolia</i>

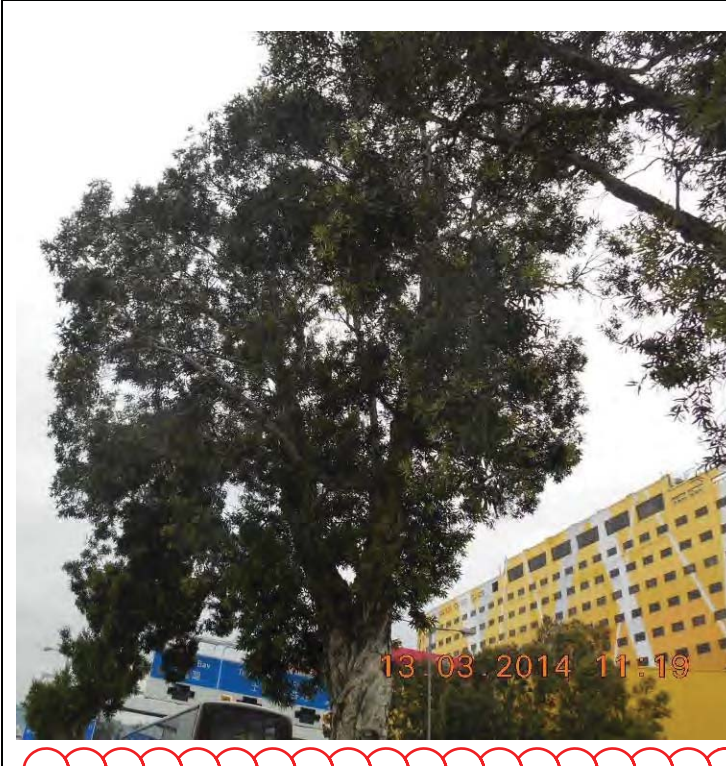
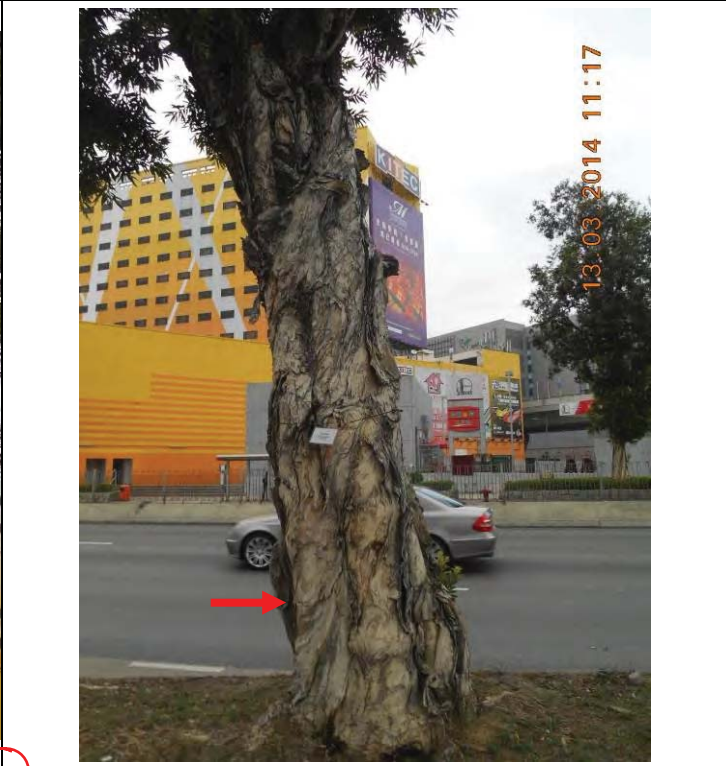
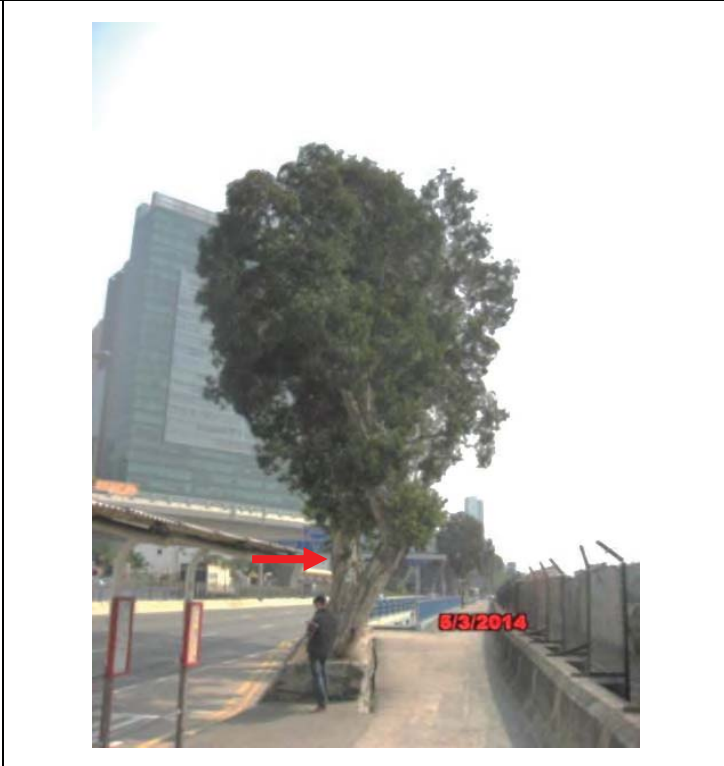
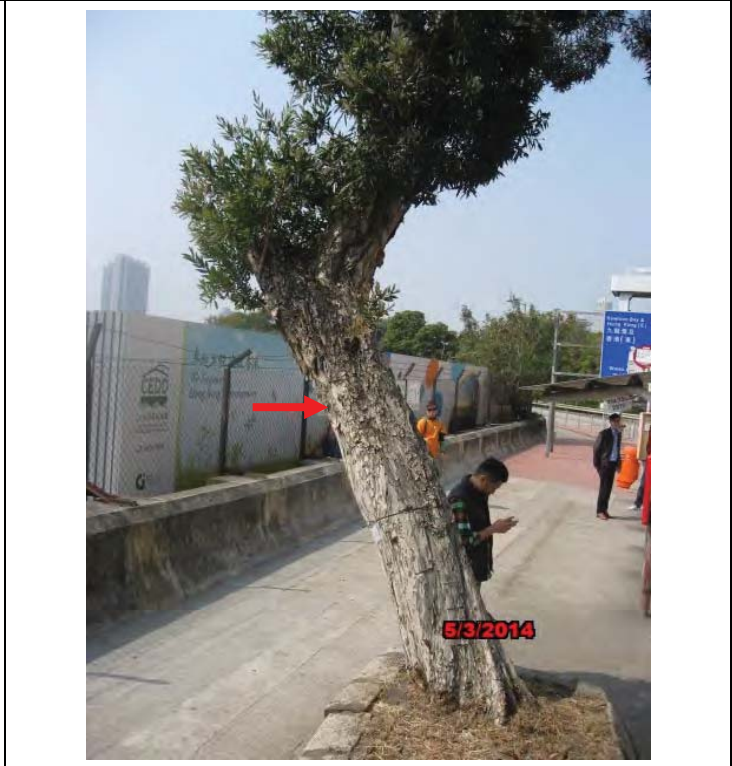
KT/T79_1 Transplant <i>Melaleuca cajuputi</i> subsp. <i>cumingiana</i>		KT/T79_2 In narrow raised planter
