## **CKR – Kai Tak**

Central Kowloon Route -  
Design and Construction

Tree Assessment Schedule - Kai Tak Area (Trees under AFCD to Provide Expert Advice)

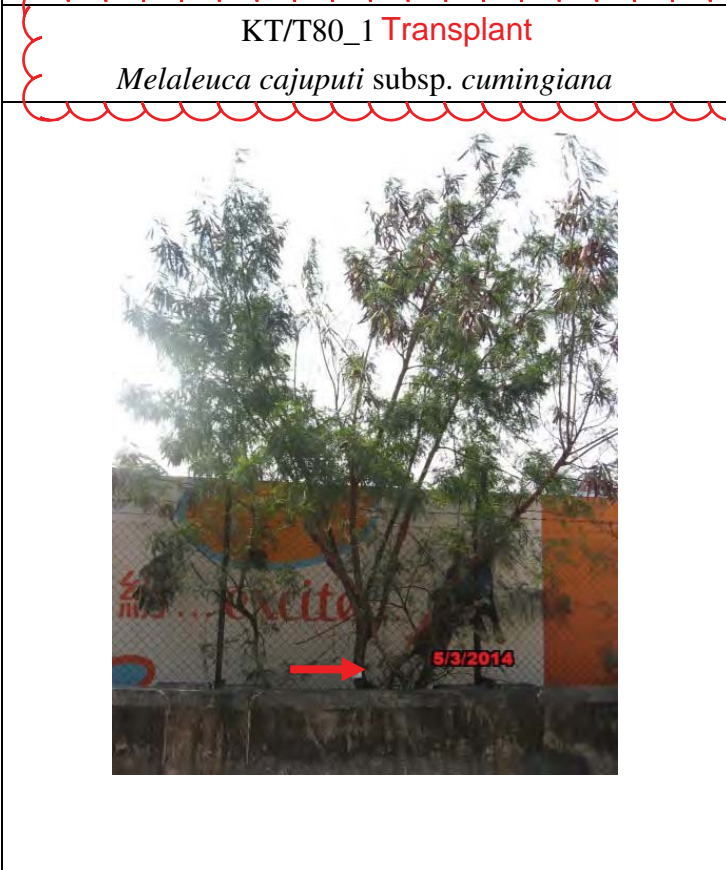
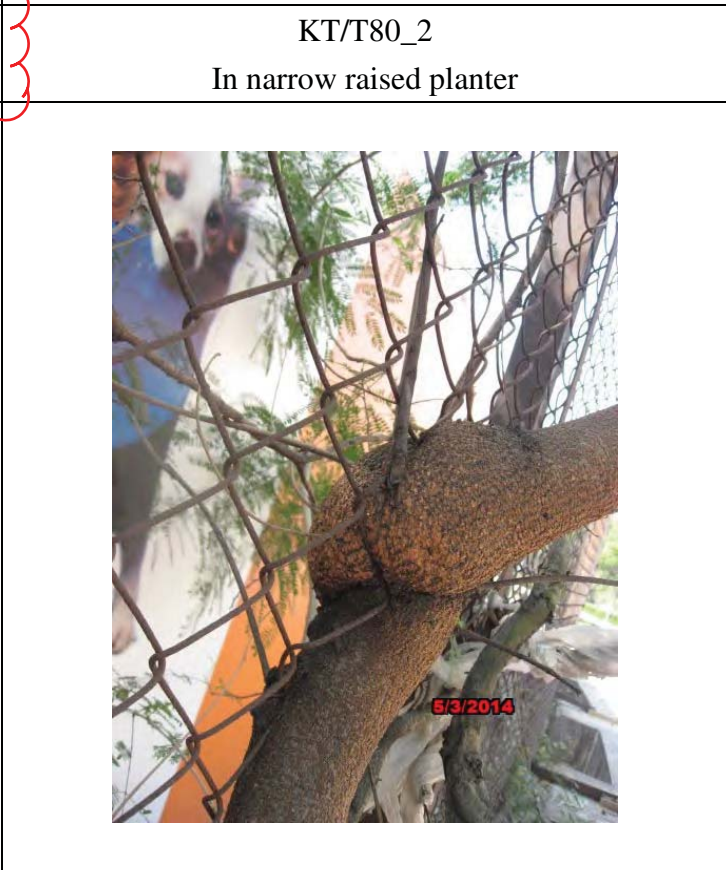
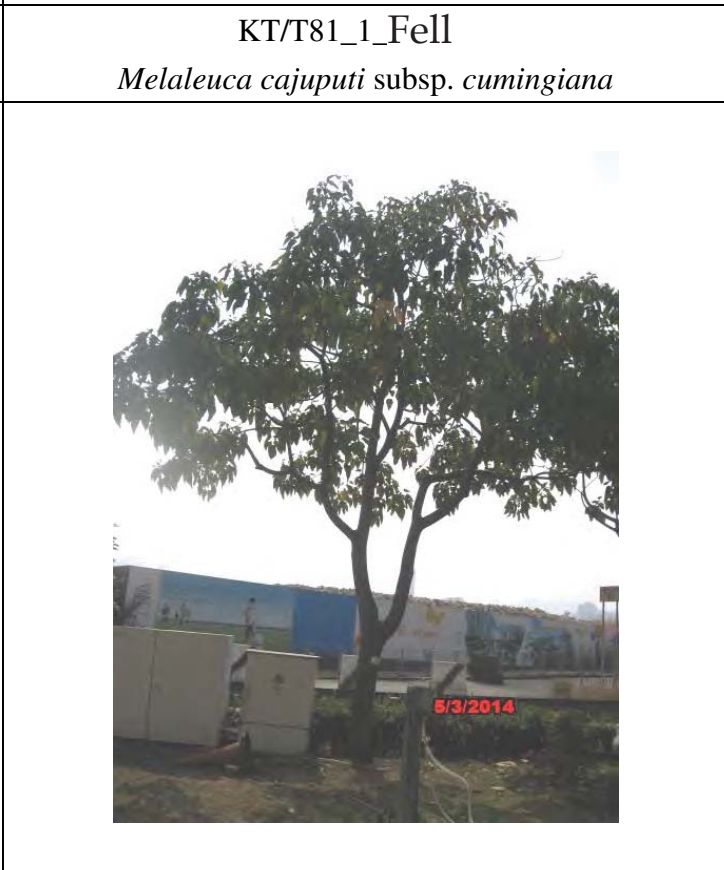
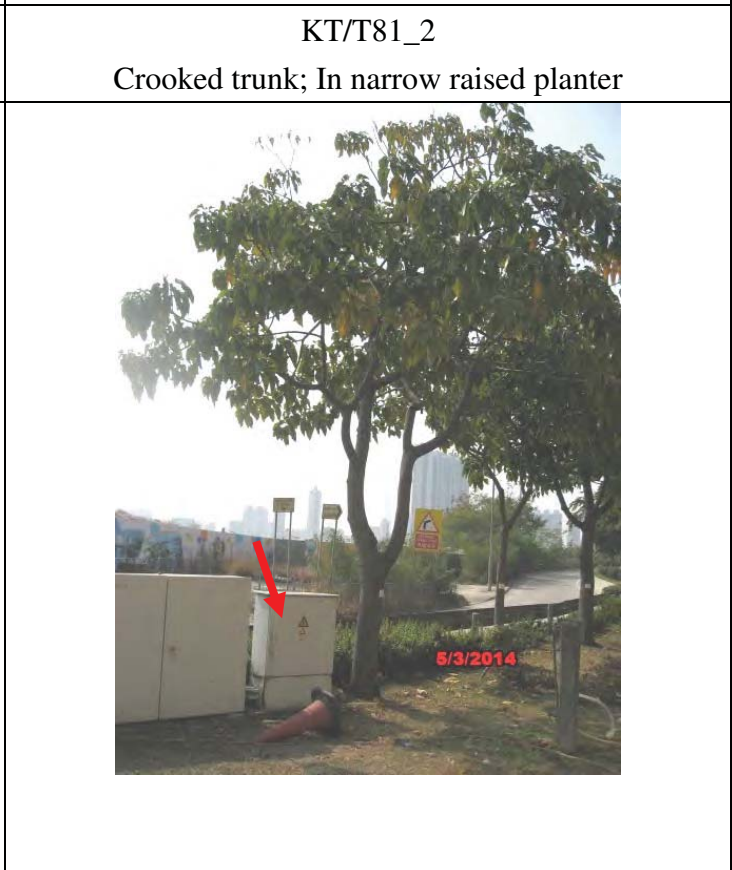
KT/T80_1 Transplant <i>Melaleuca cajuputi</i> subsp. <i>cumingiana</i>	KT/T80_2 In narrow raised planter	KT/T81_1_Fell <i>Melaleuca cajuputi</i> subsp. <i>cumingiana</i>	KT/T81_2 Crooked trunk; In narrow raised planter

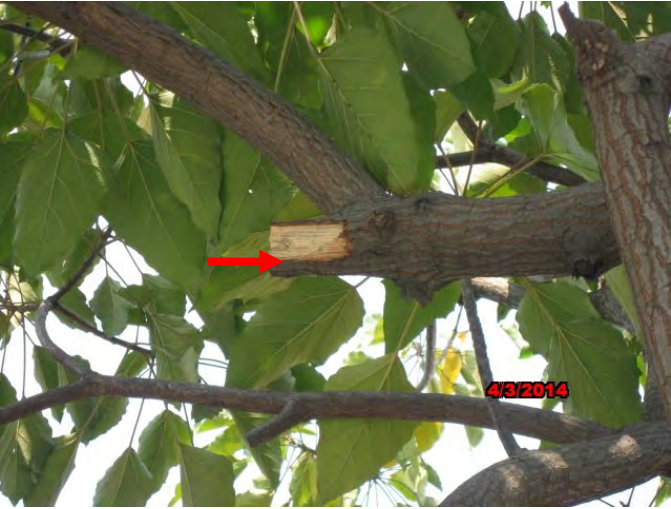
KT/T82_1 (Fell) Scientific Name: <i>Leucaena leucocephala</i>	KT/T82_5 Mingled with chain link fence	KT/T83_1 (Fell) Scientific Name: <i>Aleurites moluccana</i>	KT/T83_2 Close to utilities box

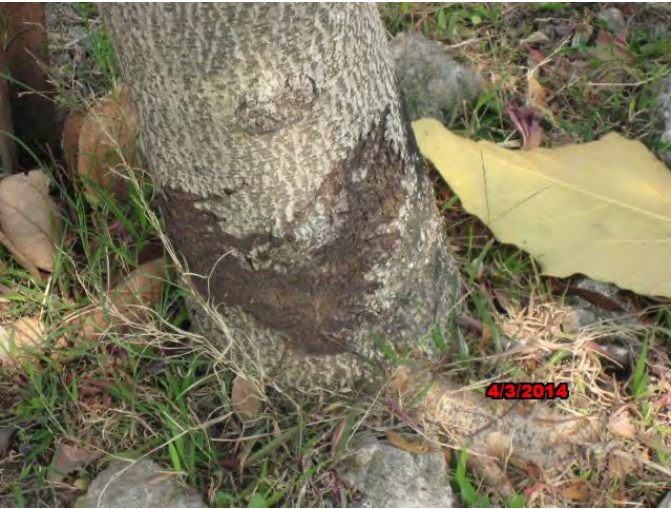
KT/T84_1 Transplant Scientific Name: <i>Aleurites moluccana</i>	KT/T84_2	KT/T85_1 Transplant Scientific Name: <i>Aleurites moluccana</i>	KT/T85_2 Broken branches

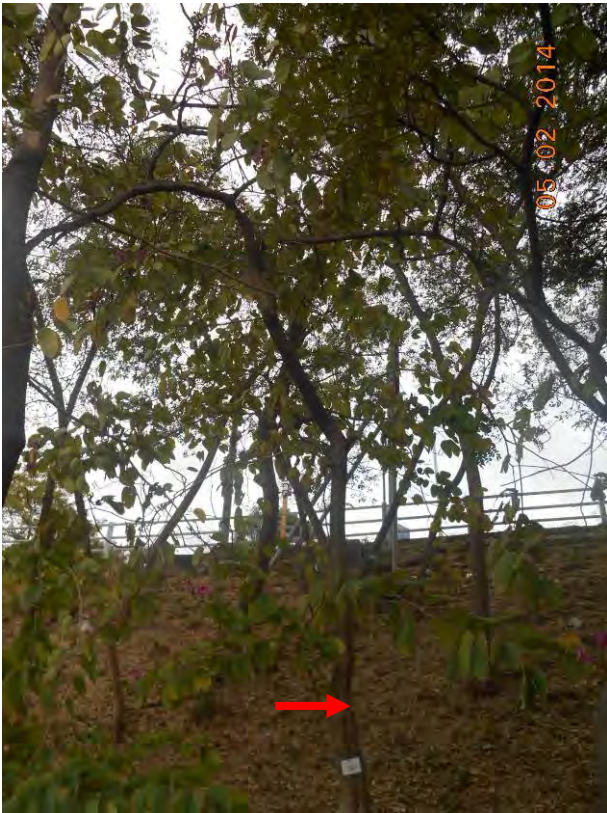
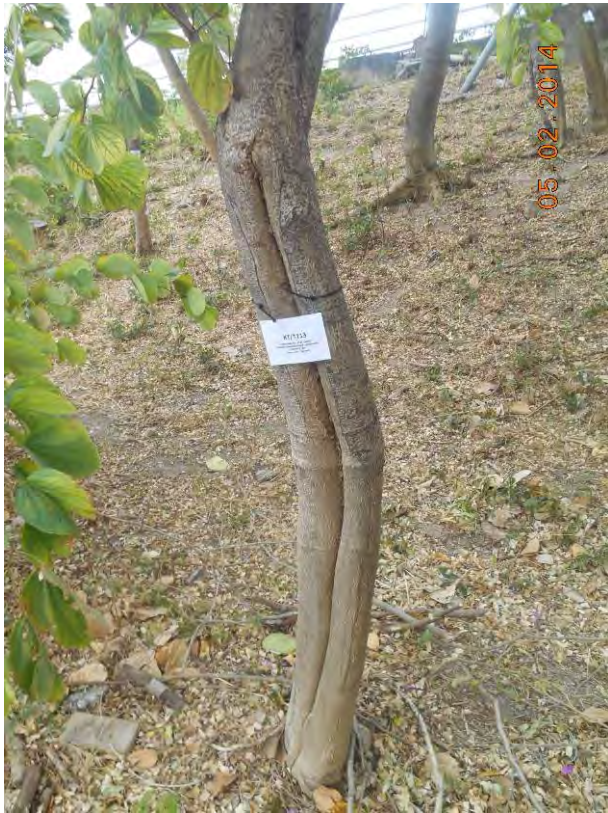
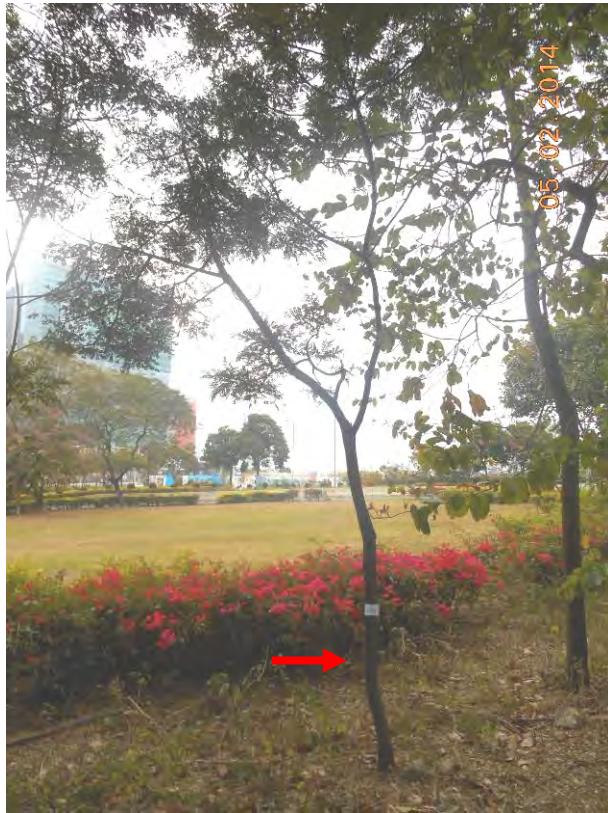
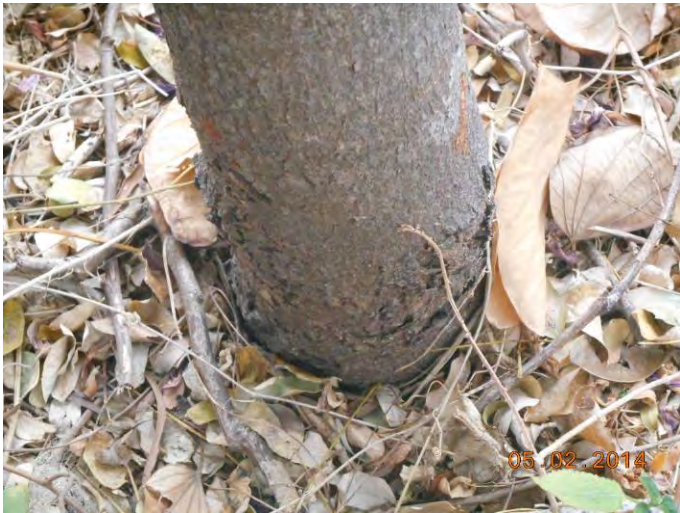
KT/T112_1 (Fell) Scientific Name: <i>Albizia lebbbeck</i>	KT/T112_2 Wound on trunk; Crossed branches	KT/T112_3

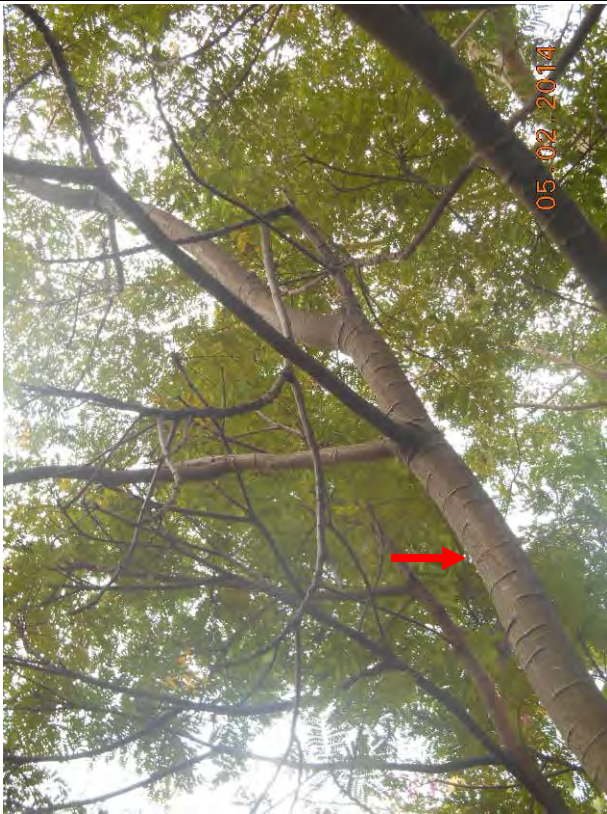
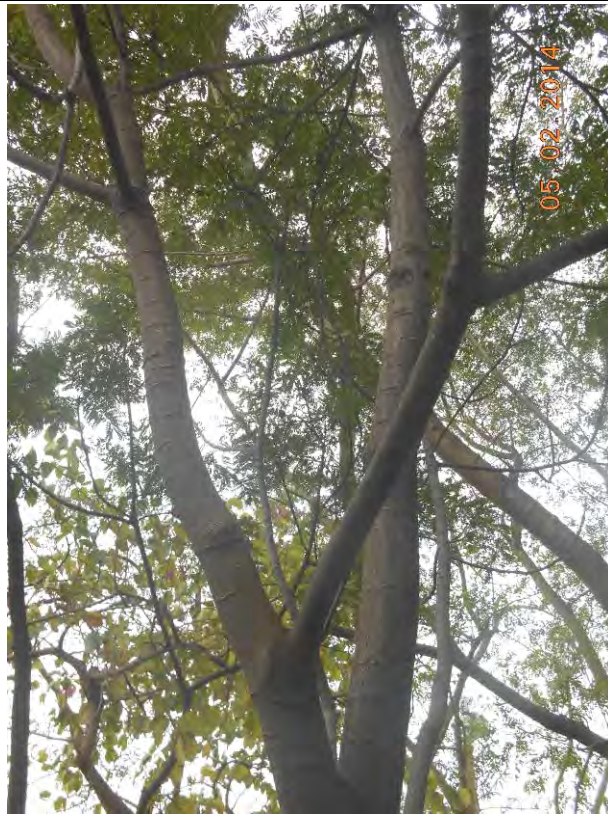
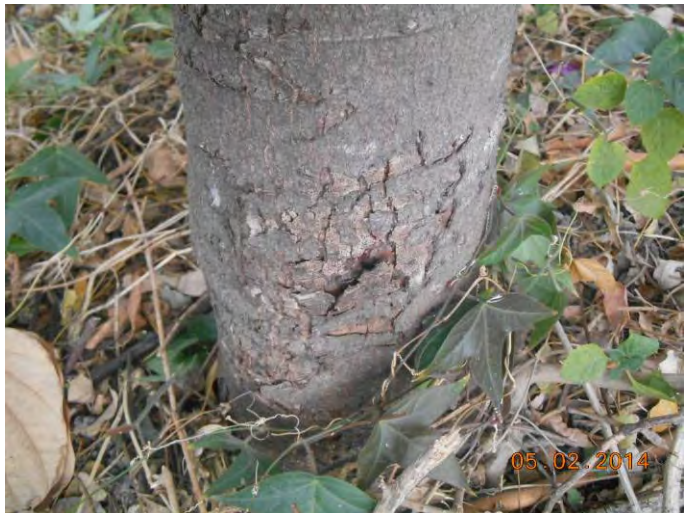
KT/T113_1 (Fell) Scientific Name: <i>Bauhinia x blakeana</i>	KT/T113_2 Large wound on lower trunk	KT/T114_1 (Fell) Scientific Name: <i>Albizia lebbeck</i>	KT/T114_3

KT/T115_1 (Fell) Scientific Name: <i>Albizia lebbeck</i>	KT/T115_2	KT/T115_3

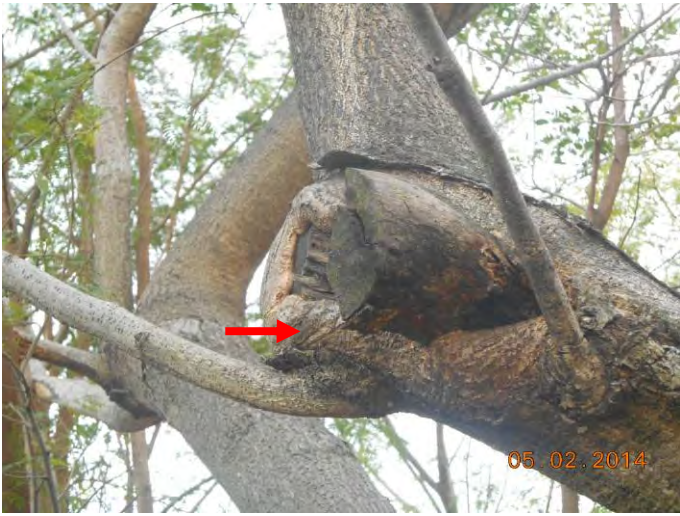
KT/T155_2 Twin stems	KT/T155_3 Wound on branch

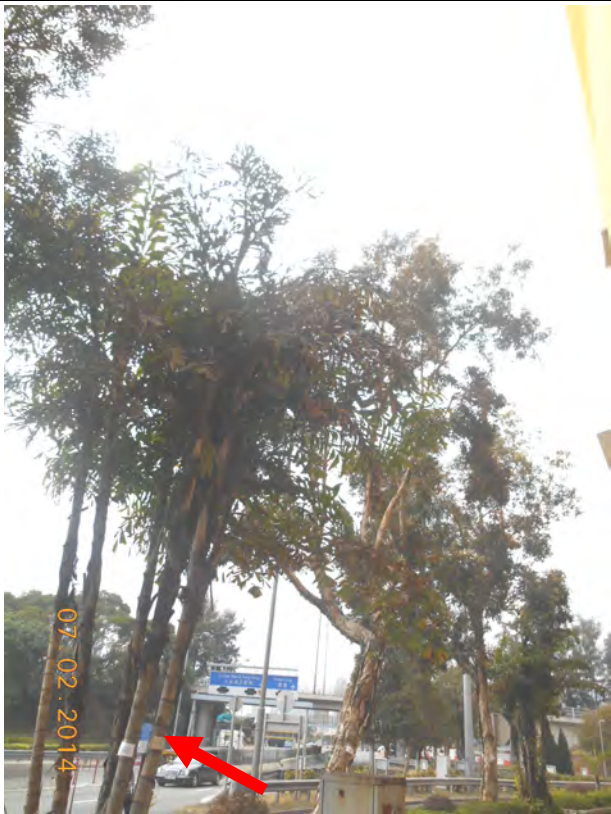
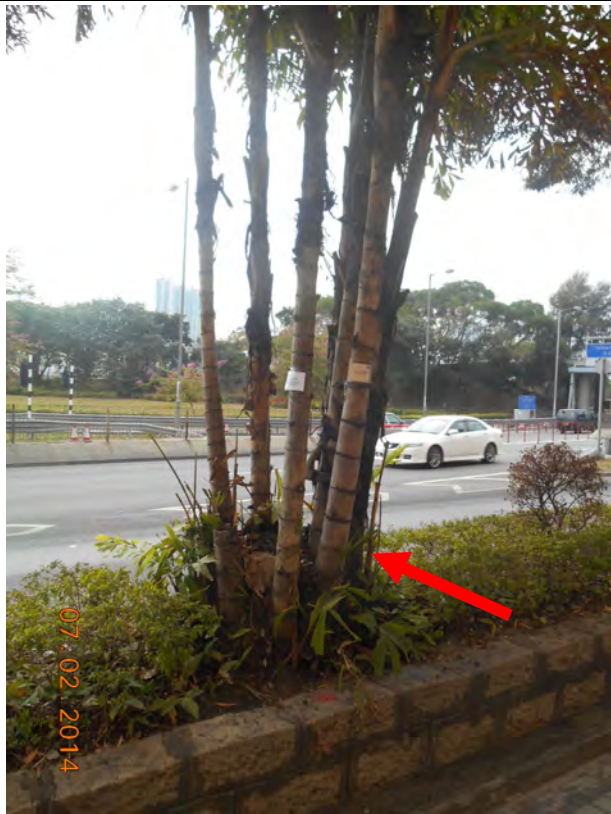
KT/T254_2 In narrow raised planter	KT/T255_1 (Retain) Scientific Name: <i>Caryota mitis</i>	KT/T255_2 In narrow raised planter	KT/T256_1 (Retain) <i>Melaleuca cajuputi</i> subsp. <i>cumingiana</i>

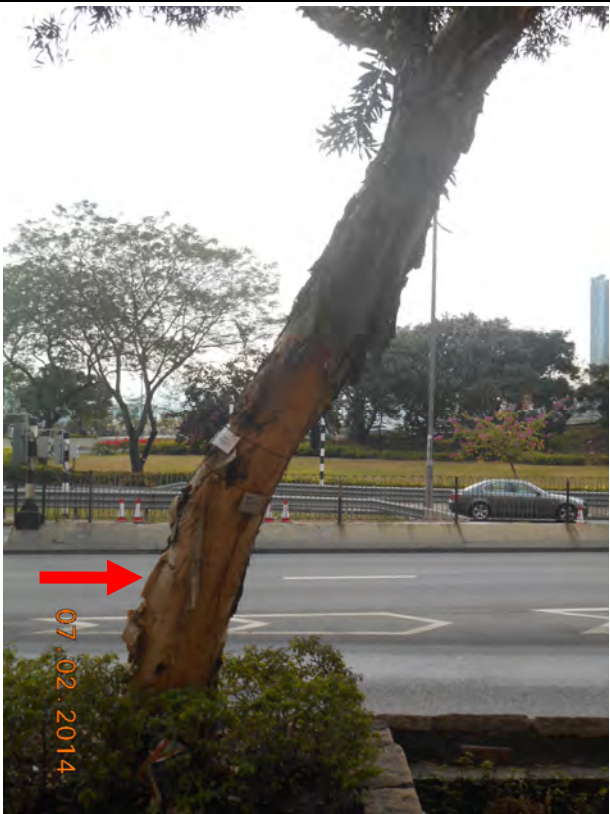
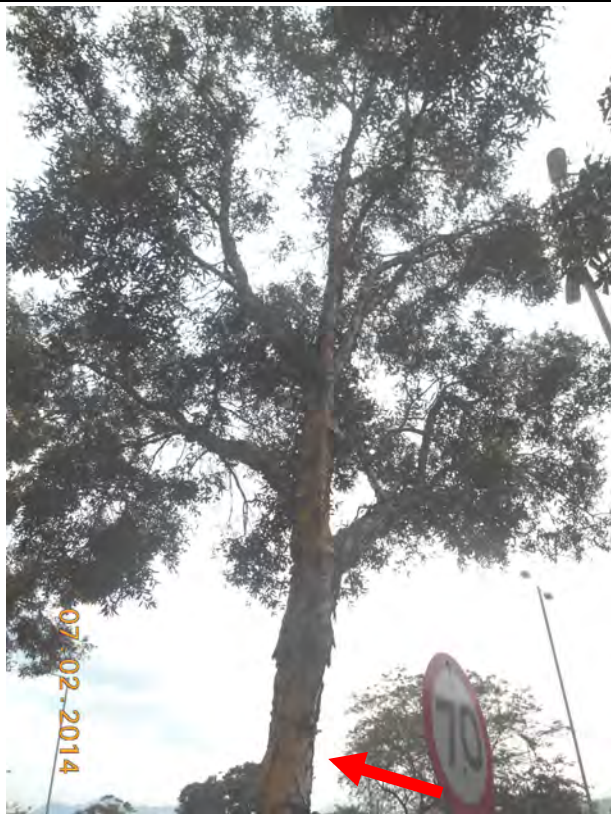
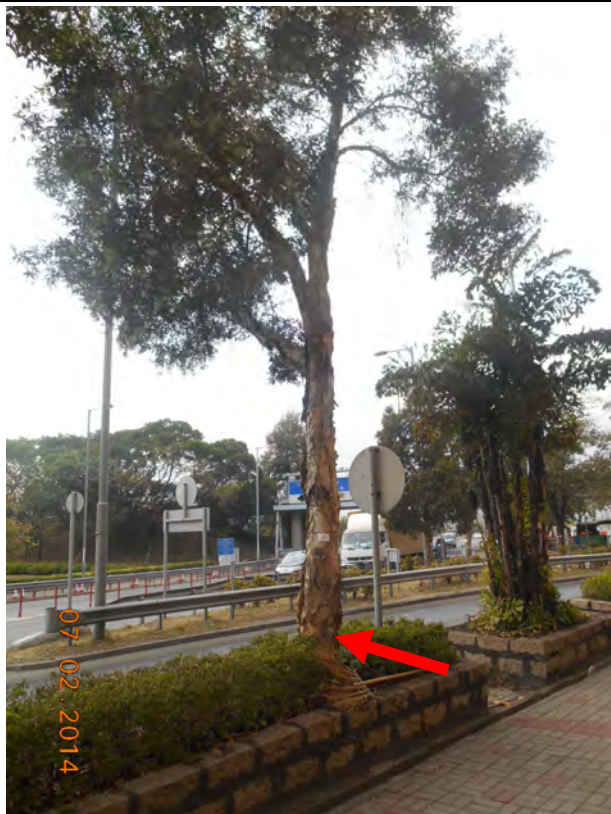
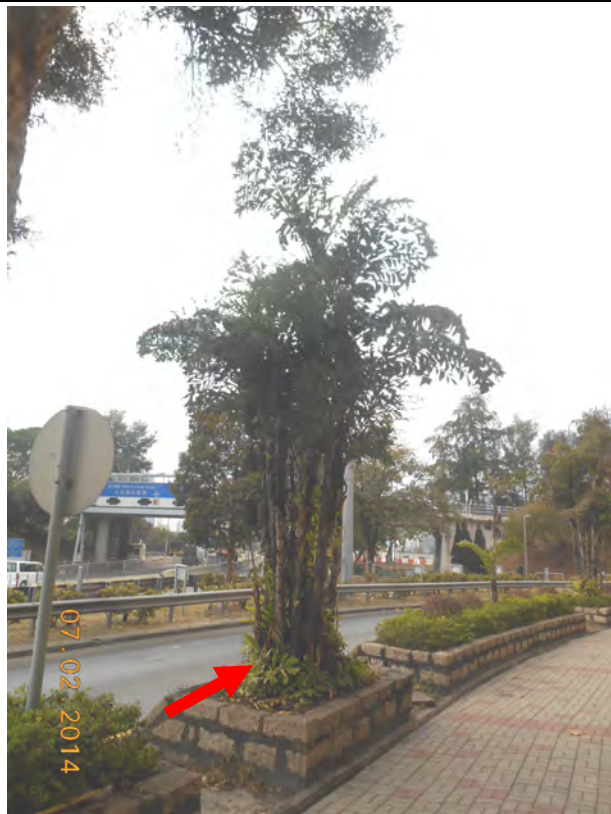
KT/T256_2 Crooked trunk; In narrow raised planter	KT/T257_1 (Retain) Scientific Name: <i>Caryota mitis</i>	KT/T257_2 In narrow raised planter	KT/T258_1 (Retain) <i>Melaleuca cajuputi</i> subsp. <i>cumingiana</i>

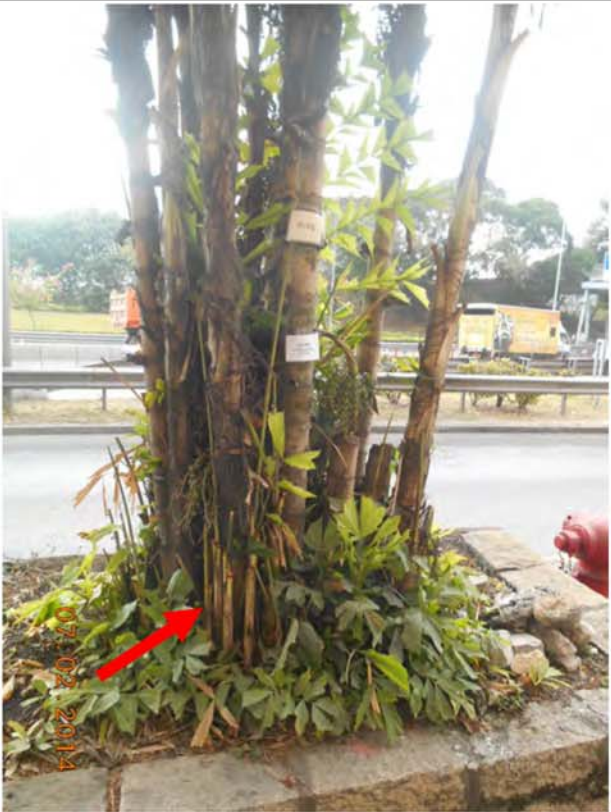
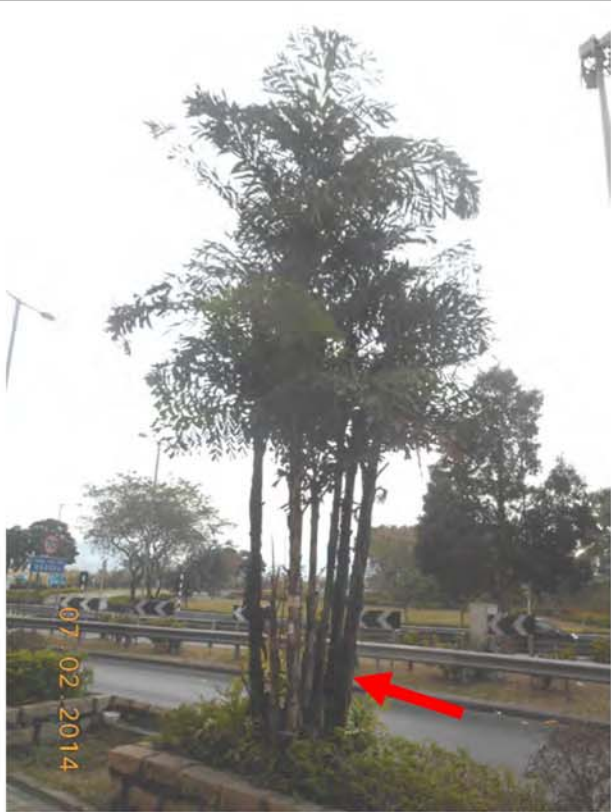
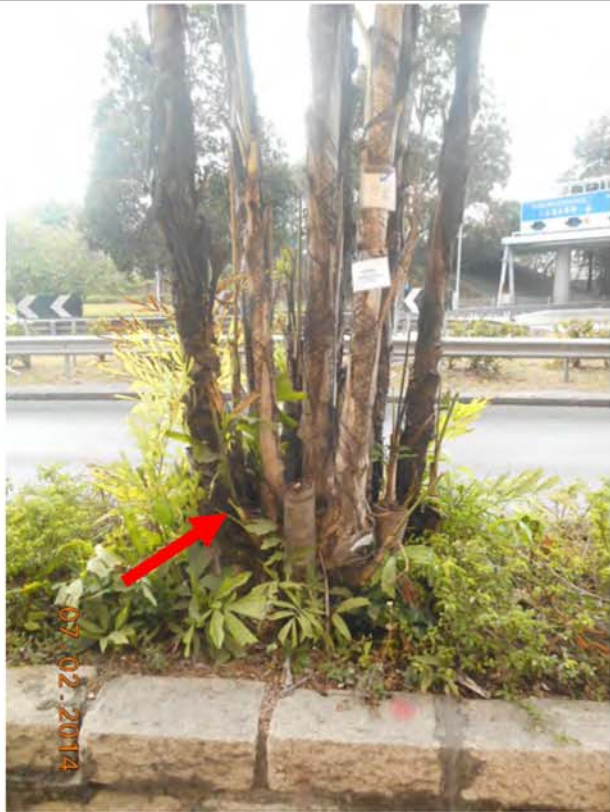
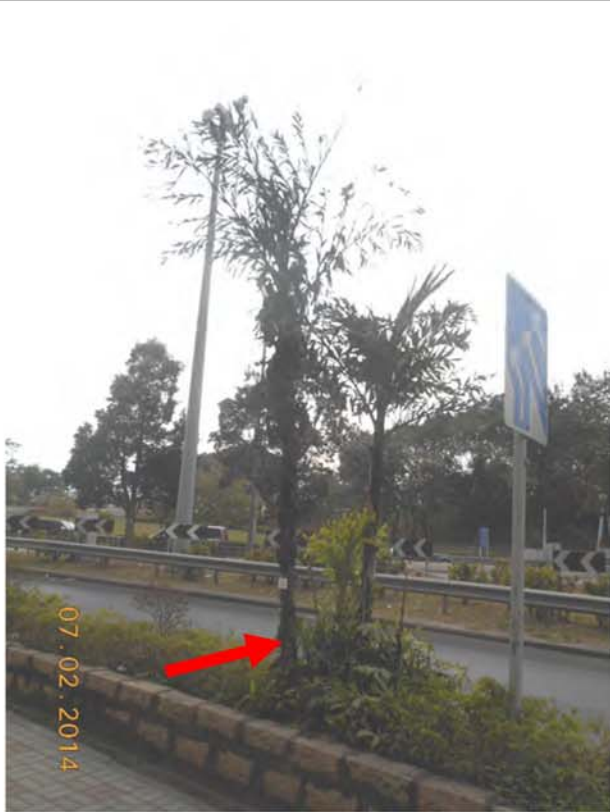
KT/T258_2 Heavily leaning; In narrow raised planter	KT/T259_1 (Retain) <i>Melaleuca cajuputi</i> subsp. <i>cumingiana</i>	KT/T259_2 In narrow raised planter	KT/T260_1 (Retain) Scientific Name: <i>Caryota mitis</i>

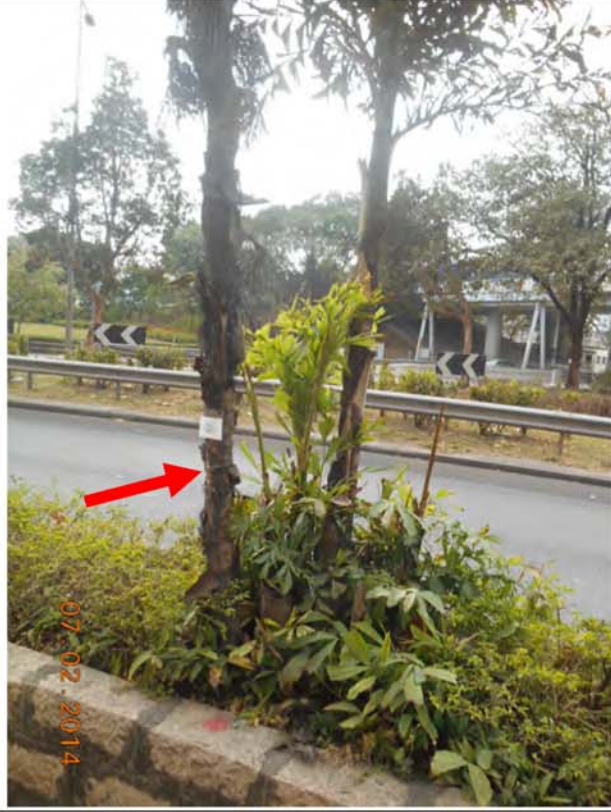
<p>KT/T260_2 In narrow raised planter</p>	<p>KT/T261_1 (Retain) Scientific Name: <i>Caryota mitis</i></p>	<p>KT/T261_2 In narrow raised planter</p>	<p>KT/T262_1 (Retain) Scientific Name: <i>Caryota mitis</i></p>

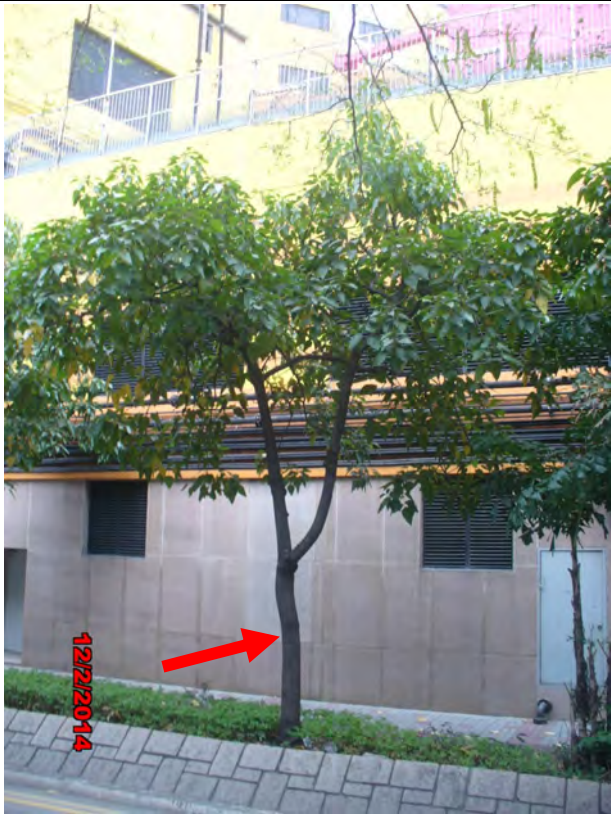
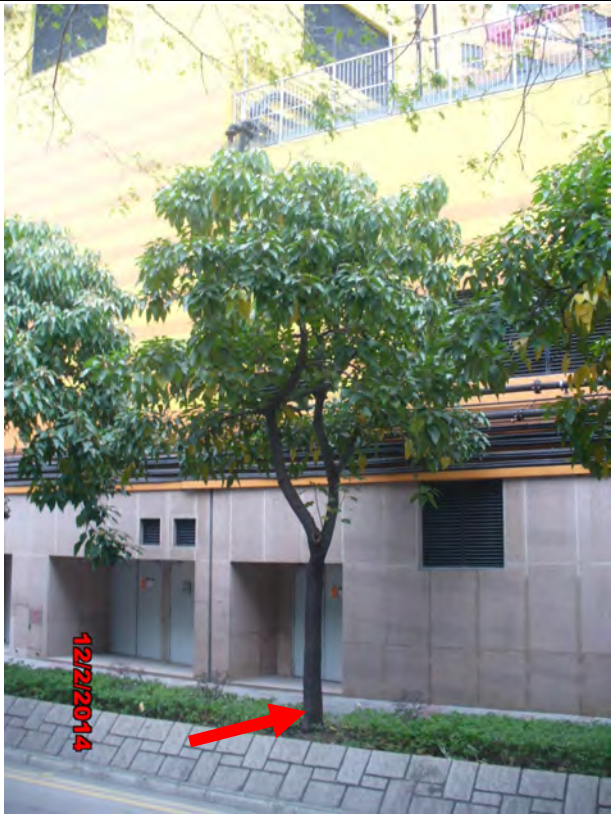
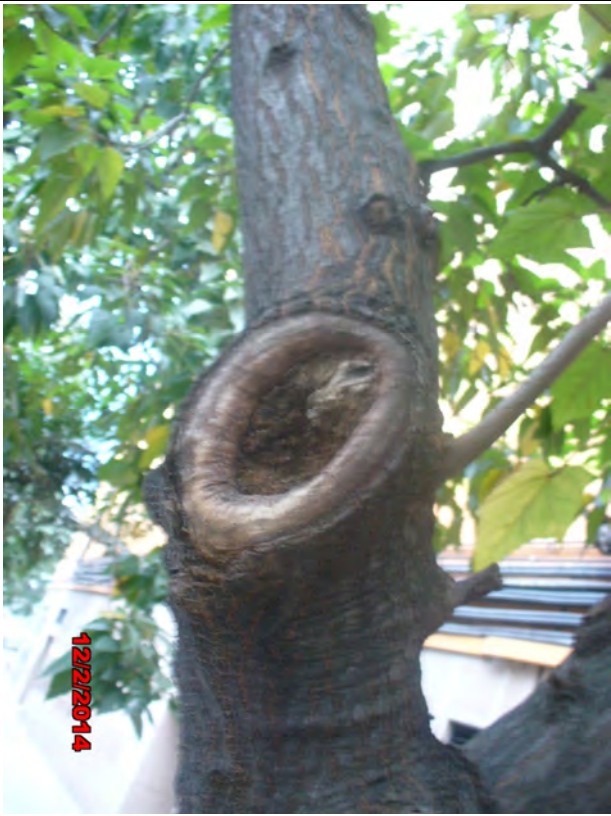
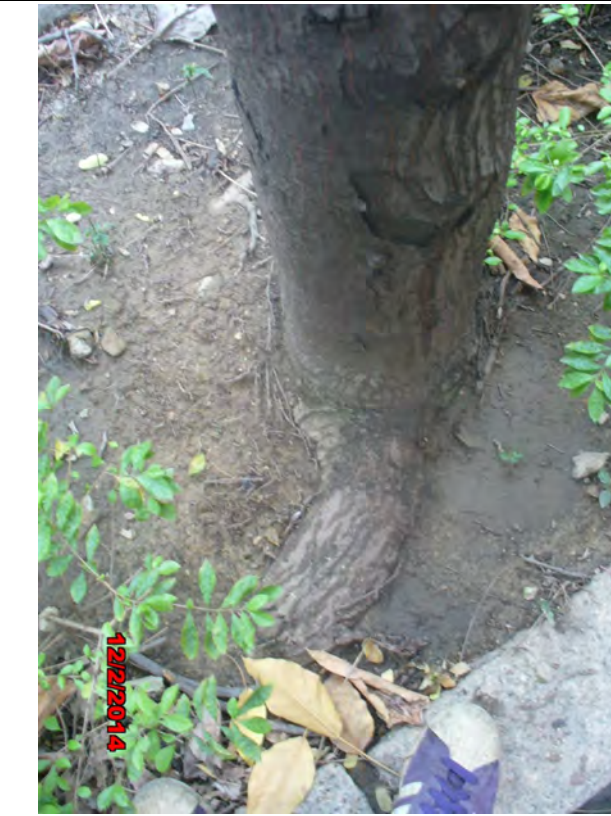
KT/T268_1_(Retain) Scientific Name: <i>Aleurites moluccana</i>	KT/T268_2 Large wound on trunk	KT/T269_1 (Retain) Scientific Name: <i>Caryota mitis</i>	KT/T269_2 In narrow raised planter

KT/T270_1 (Retain) Scientific Name: <i>Aleurites moluccana</i>	KT/T271_1_(Retain) Scientific Name: <i>Aleurites moluccana</i>	KT/T271_2 Large wound on branch	KT/T271_3 In narrow raised planter

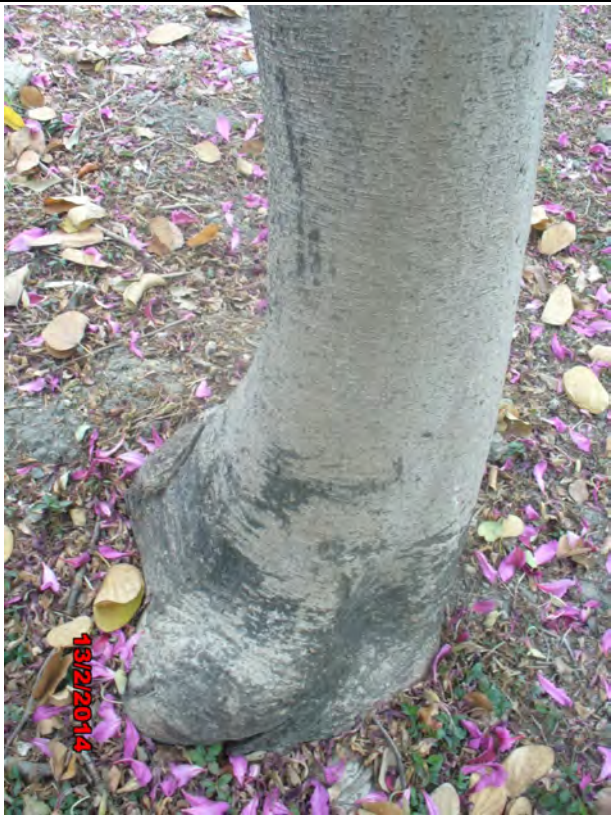
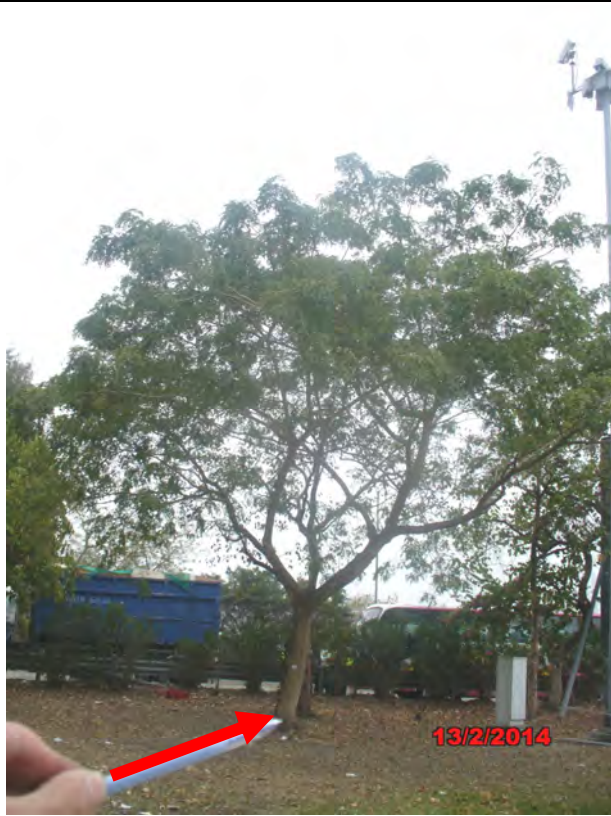
KT/T326_1 (Fell) Scientific Name: <i>Bischofia javanica</i>	KT/T326_2	KT/T327_1 (Fell) Scientific Name: <i>Bischofia javanica</i>	KT/T327_2

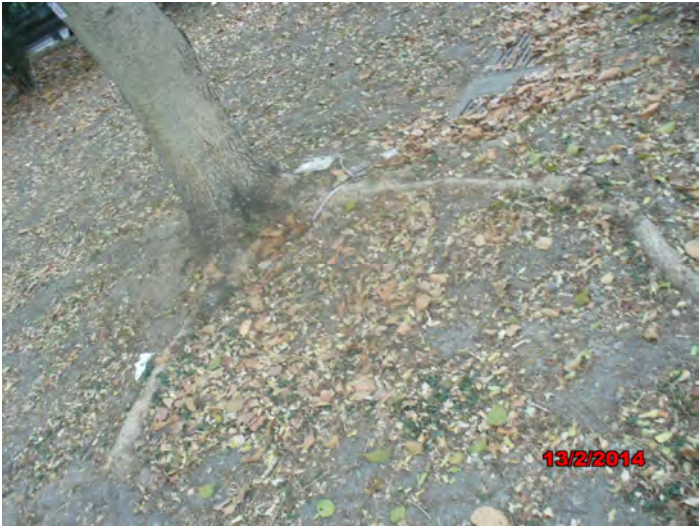
KT/T328_1 (Fell) Scientific Name: <i>Bauhinia x blakeana</i>	KT/T328_2	KT/T328_3 Large wound on branch	KT/T329_1 (Fell) Scientific Name: <i>Albizia lebbeck</i>

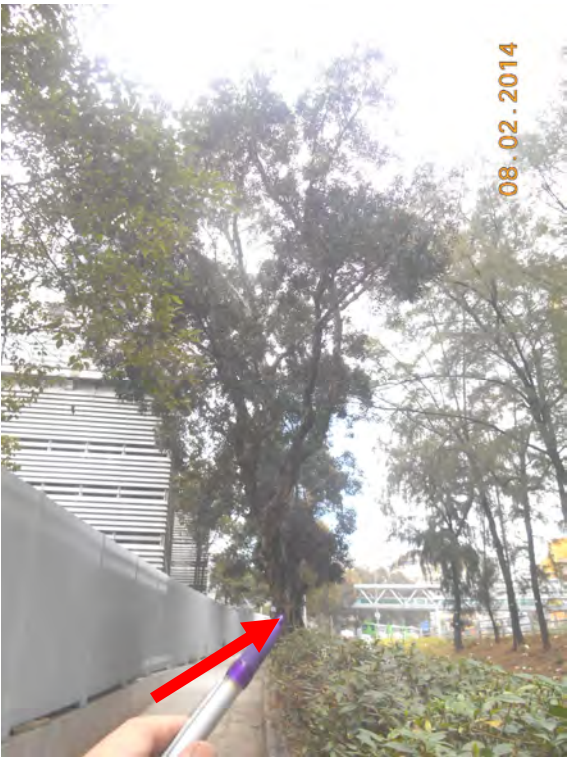
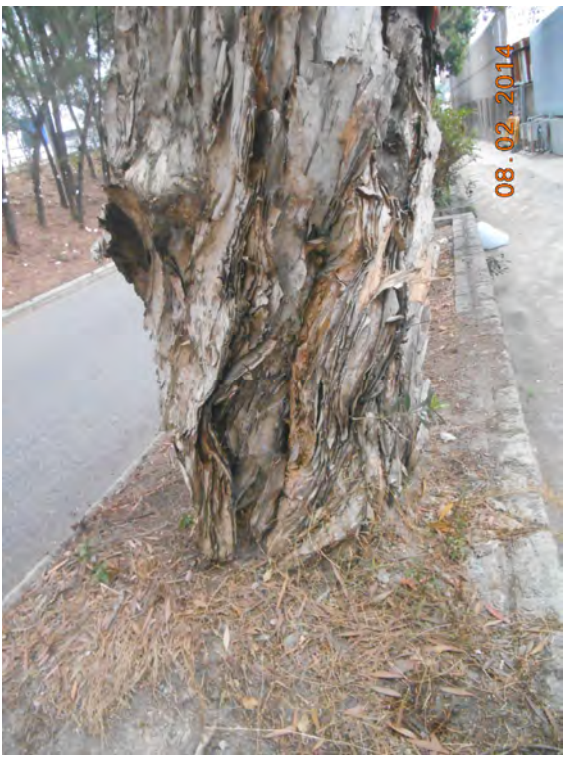
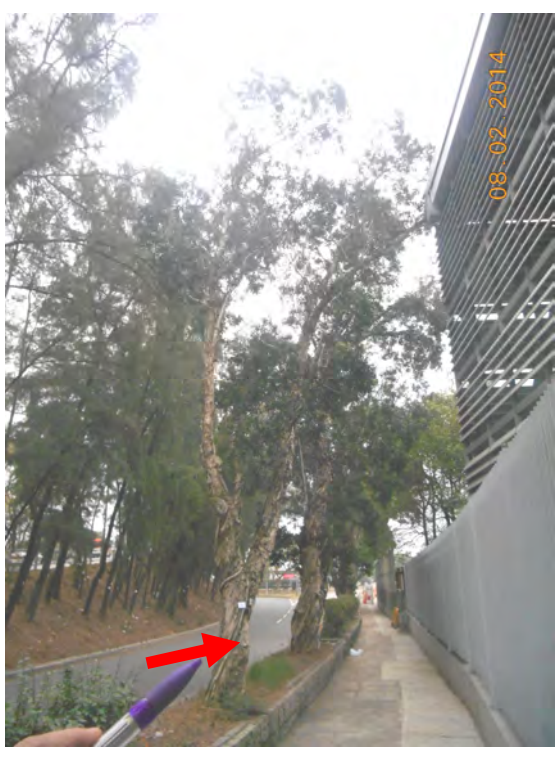
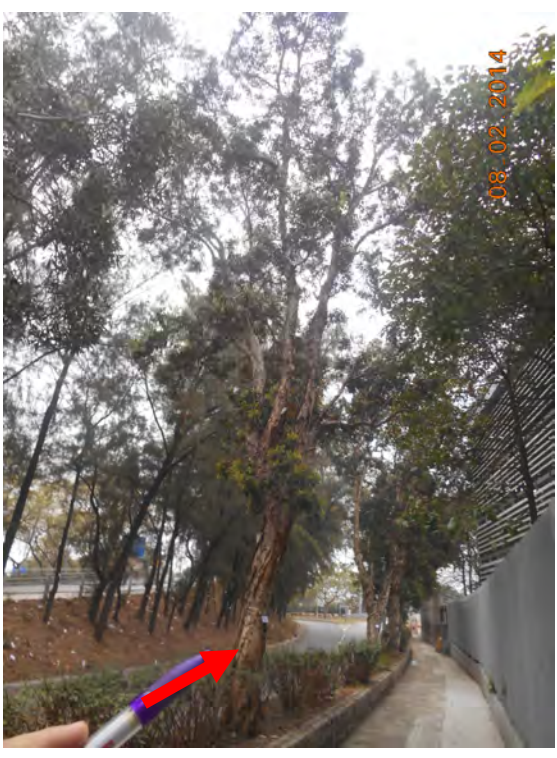
KT/T443_1 (Fell) <i>Melaleuca cajuputi</i> subsp. <i>cumingiana</i>	KT/T443_2 In narrow raised planter	KT/T444_1 (Fell) <i>Melaleuca cajuputi</i> subsp. <i>cumingiana</i>	KT/T444_2 Multi-trunk; In narrow raised planter

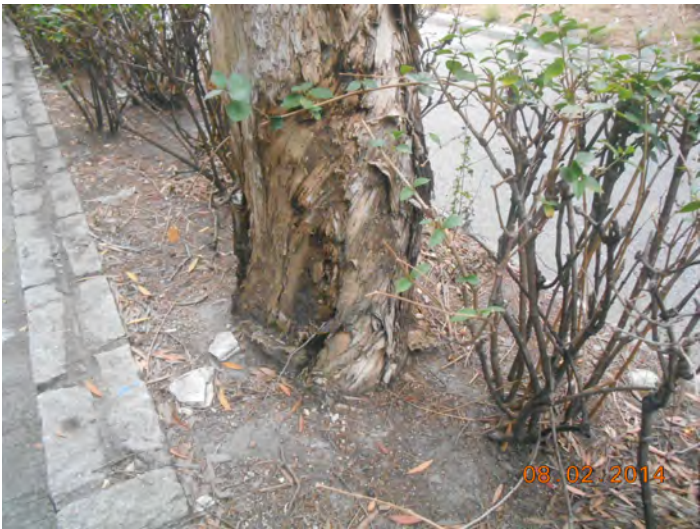
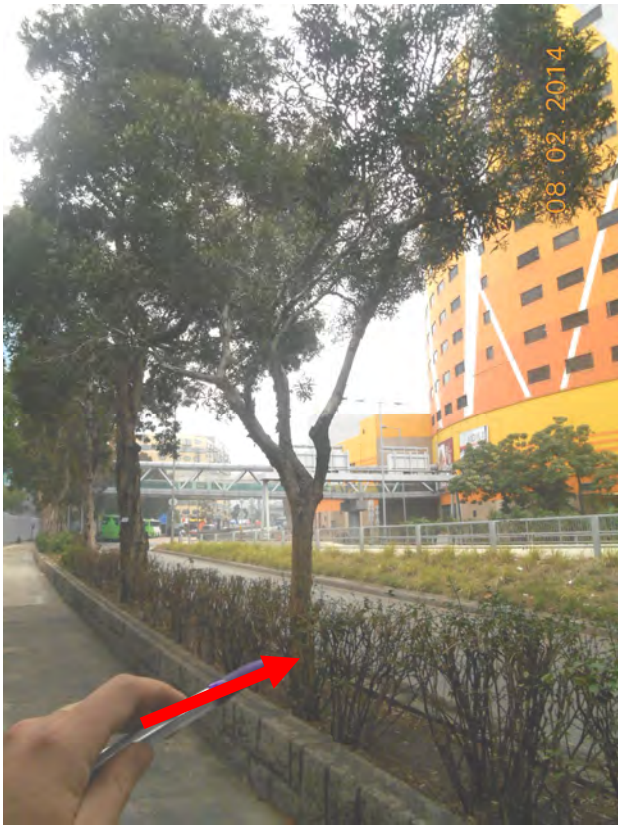
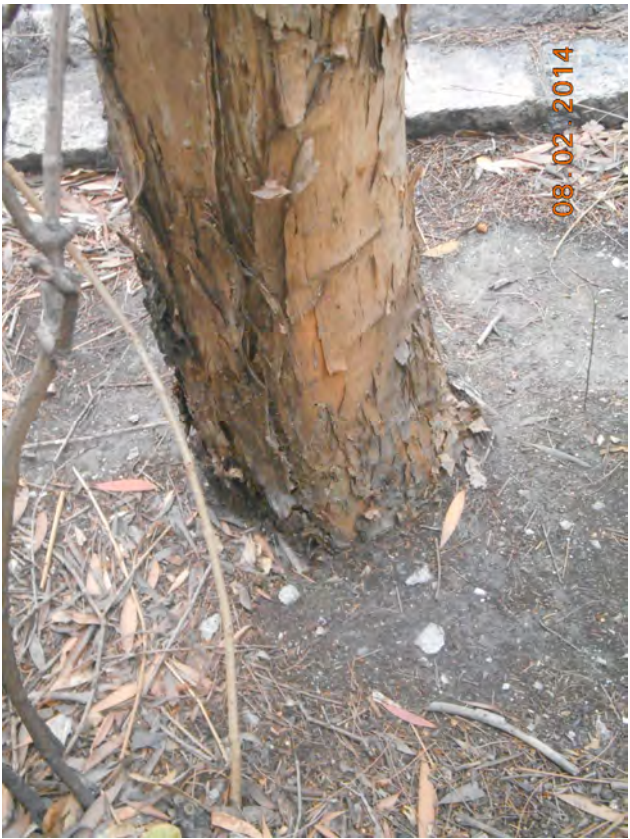
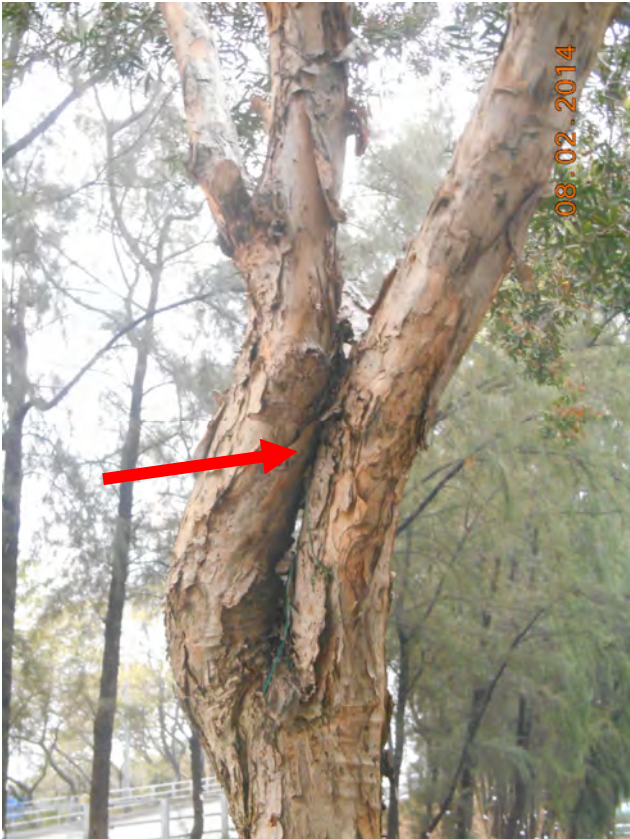
KT/T445_1 (Retain) <i>Melaleuca cajuputi</i> subsp. <i>cumingiana</i>	KT/T445_2 In narrow raised planter	KT/T446_1 (Retain) <i>Melaleuca cajuputi</i> subsp. <i>cumingiana</i>	KT/T447_1 (Retain) <i>Melaleuca cajuputi</i> subsp. <i>cumingiana</i>

KT/T447_2 In narrow raised planter	KT/T448_1 (Retain) <i>Melaleuca cajuputi</i> subsp. <i>cumingiana</i>	KT/T448_2 In narrow raised planter	KT/T448_3 Crossed main branches

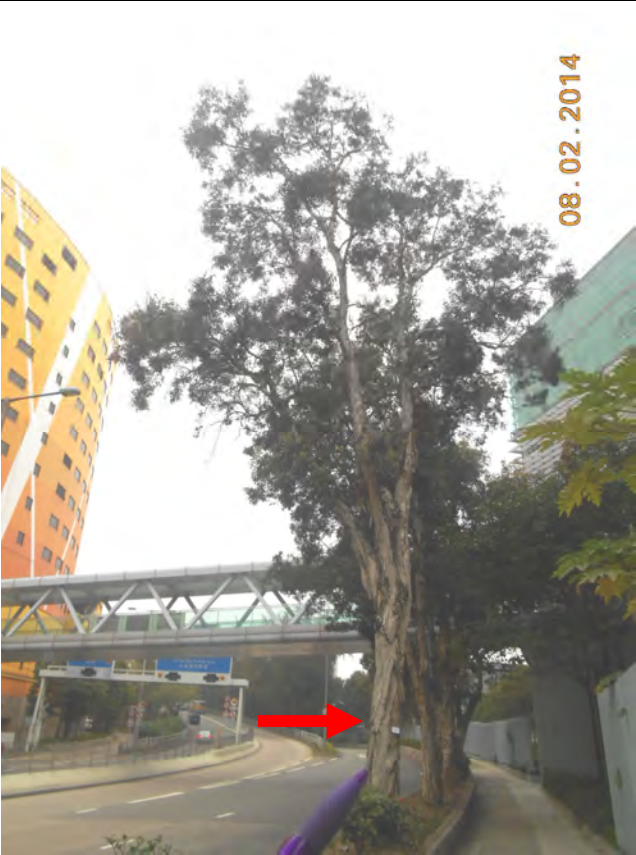
KT/T459_1 (Retain) <i>Melaleuca cajuputi</i> subsp. <i>cumingiana</i>	KT/T459_2 In narrow raised planter	KT/T460_1 (Retain) <i>Melaleuca cajuputi</i> subsp. <i>cumingiana</i>	KT/T460_2 In narrow raised planter

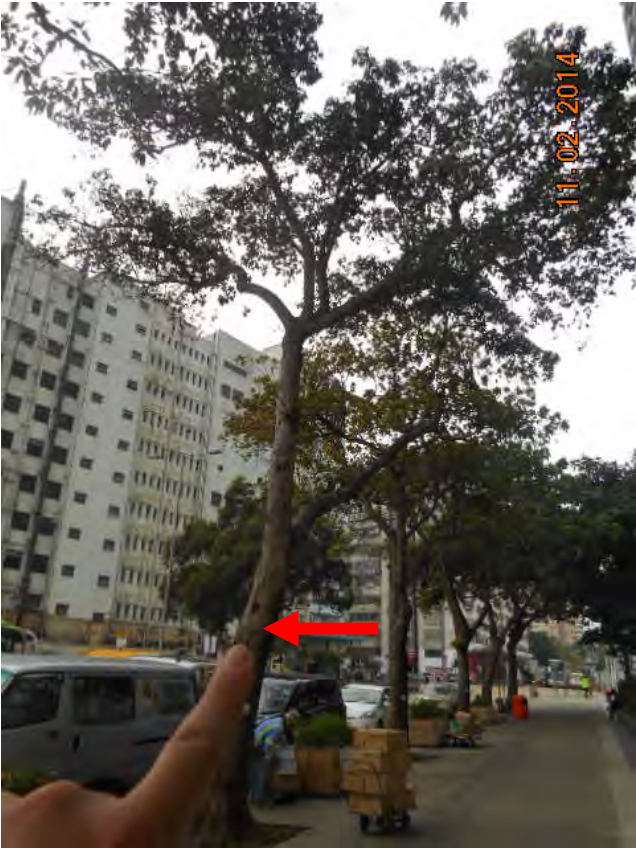
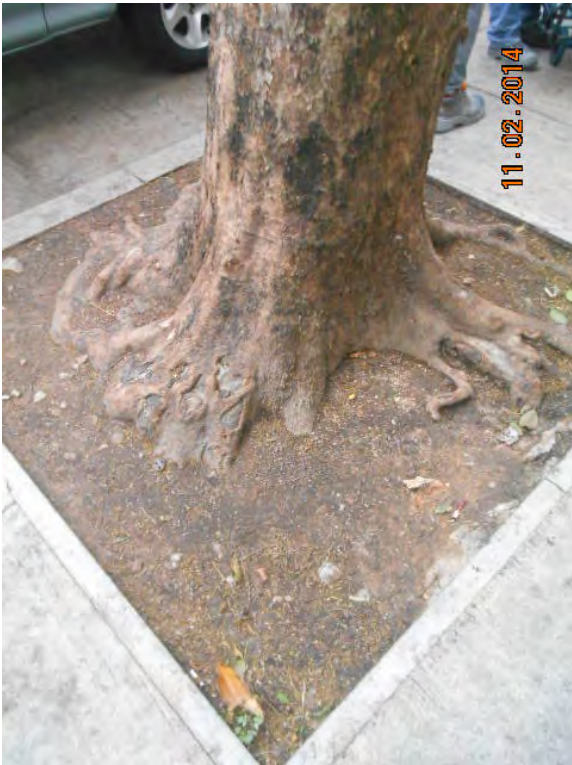
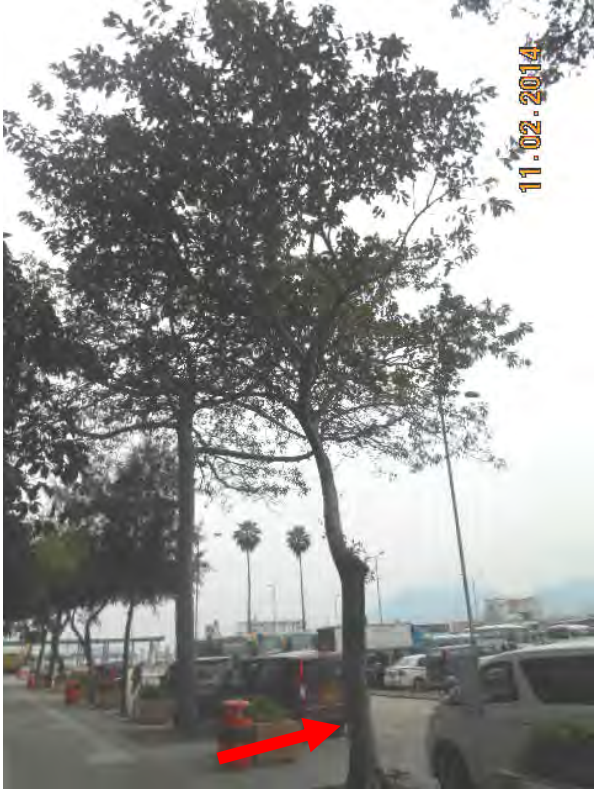
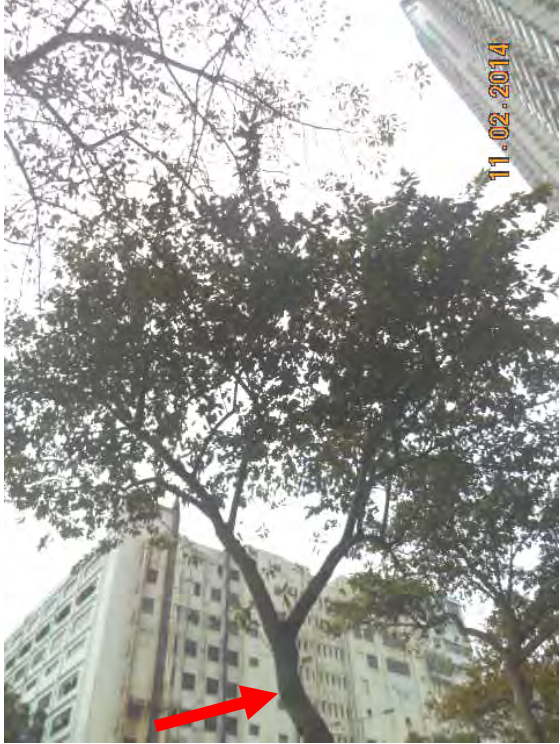
KT/T507_1 (Retain) Scientific Name: <i>Bischofia javanica</i>	KT/T507_2 Closely spaced co-dominant stems	KT/T507_3 In tree pit close to carriageway
