## **CKR – Kai Tak**

Central Kowloon Route -  
Design and Construction

Tree Assessment Schedule - Kai Tak Area (Trees under AFCD to Provide Expert Advice)

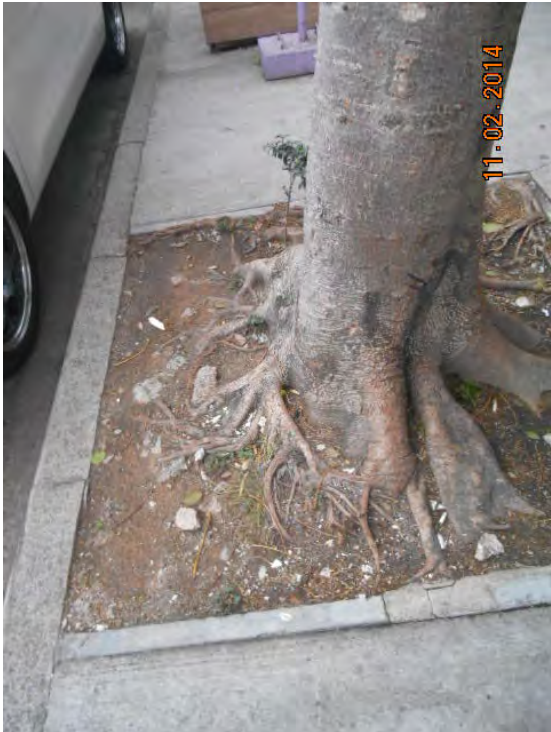
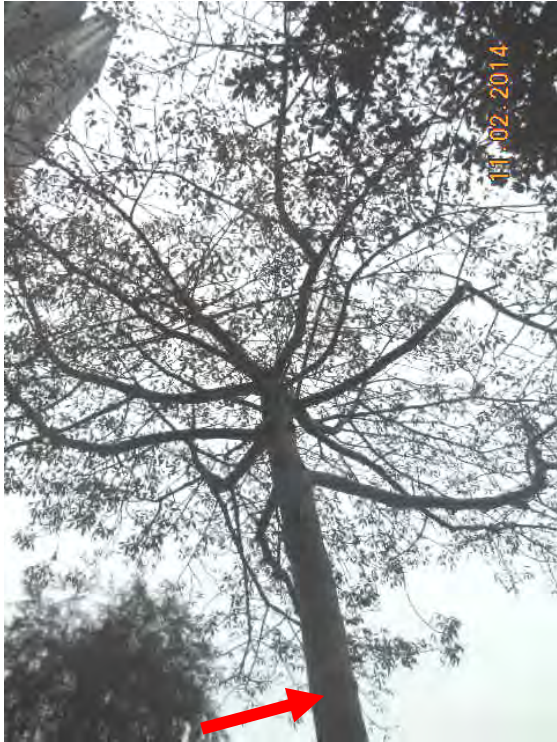
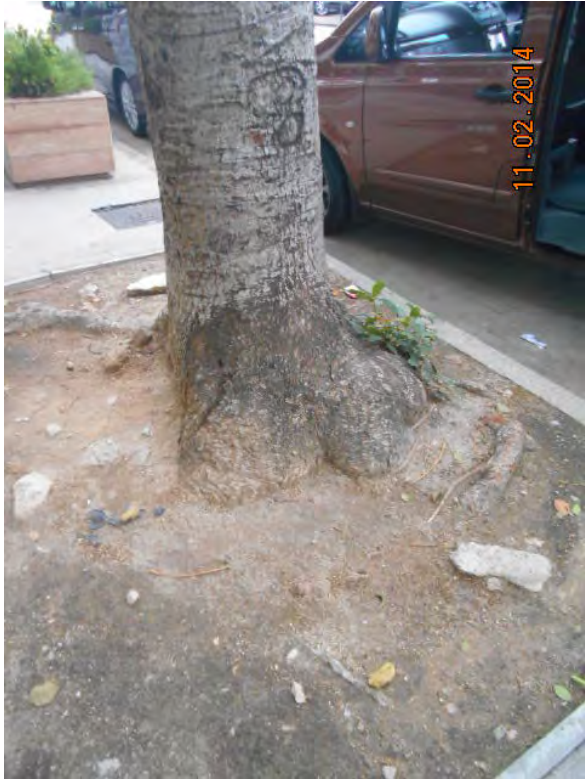
KT/T508_1 (Retain) Scientific Name: <i>Bischofia javanica</i>	KT/T508_2 In tree pit close to carriageway	KT/T509_1 (Retain) Scientific Name: <i>Ficus virens</i>	KT/T509_2 Leaning; Crooked trunk

KT/T509_4 In tree pit close to carriageway	KT/T510_1 (Retain) Scientific Name: <i>Bombax ceiba</i>	KT/T510_2 In tree pit close to carriageway

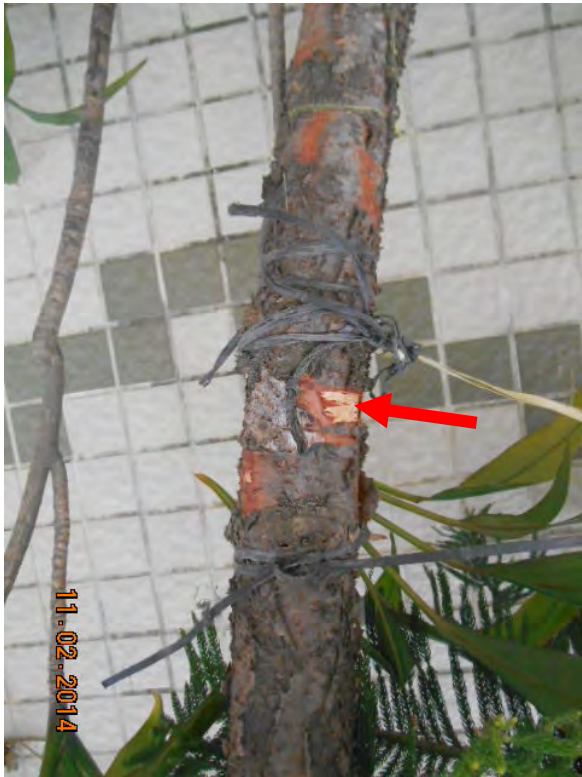
KT/T525_1 (Fell) Scientific Name: <i>Archontophoenix alexandrae</i>	KT/T525_2 In tree pit	KT/T526_1 (Fell) Scientific Name: <i>Archontophoenix alexandrae</i>	KT/T526_2 In tree pit

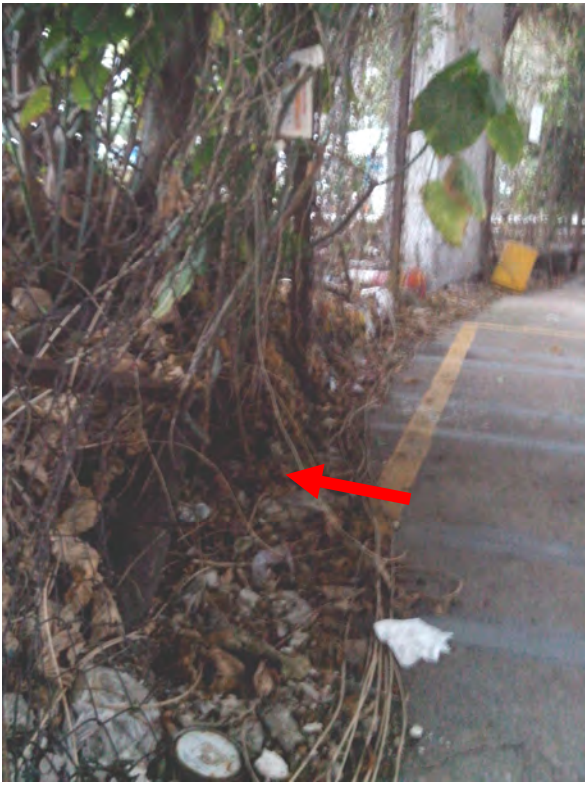
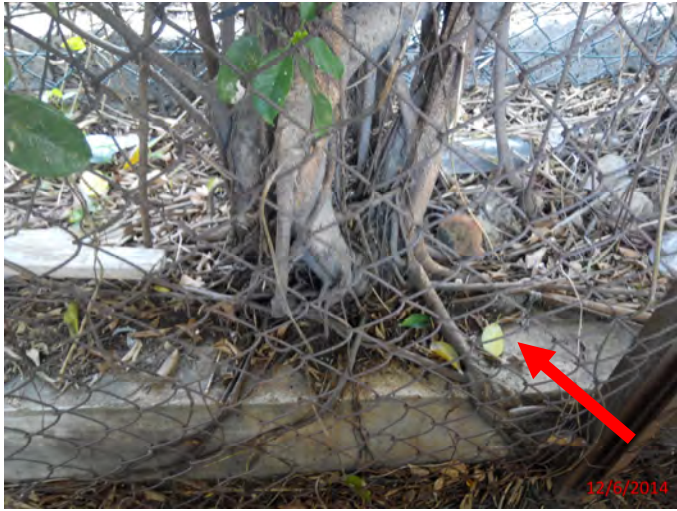
KT/T532_1 (Fell) <i>Macaranga tanarius</i> var. <i>tomentosa</i>	KT/T532_2 Surrounded by concrete pavement	KT/T533_1 (Fell) Scientific Name: <i>Ficus microcarpa</i>	KT/T533_2 Rooted on concrete

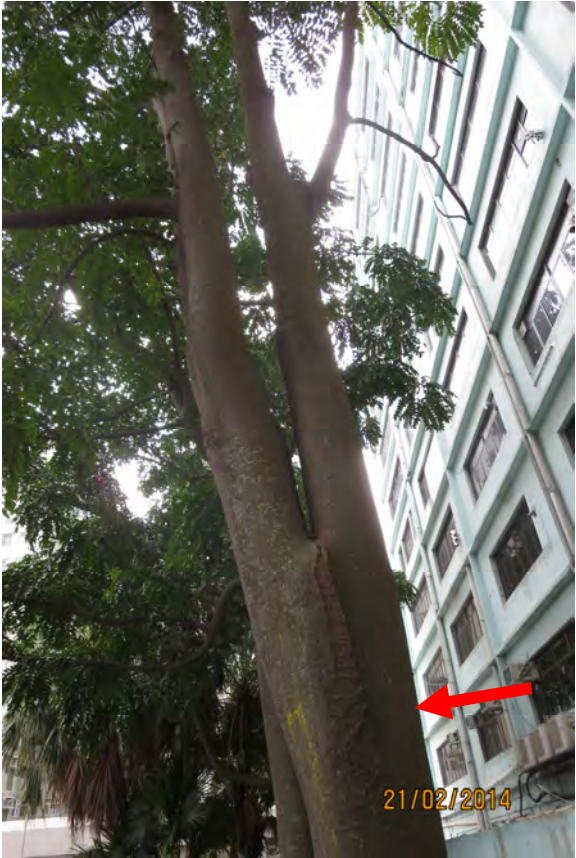
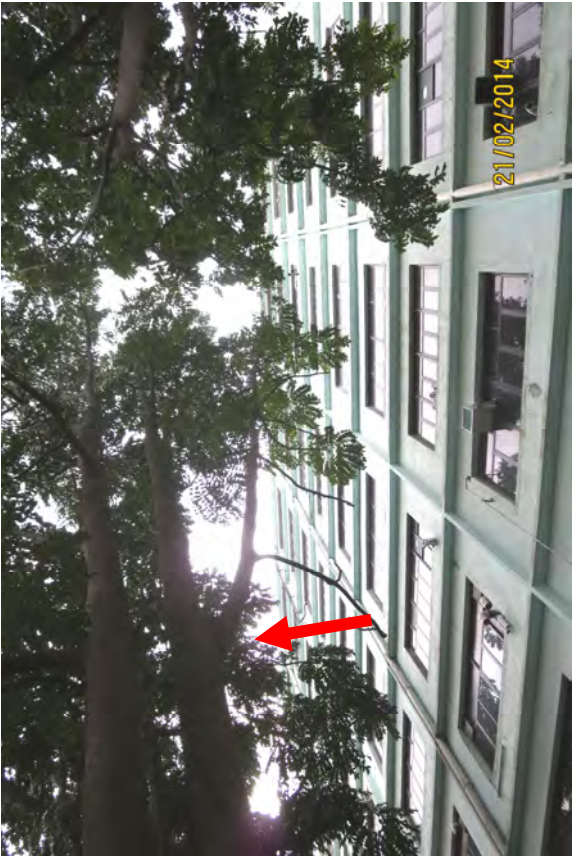
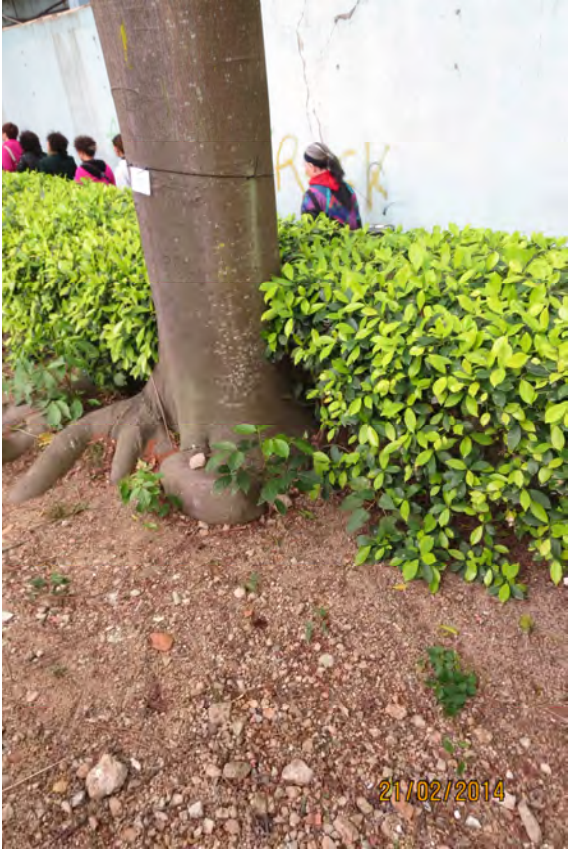
KT/T544_1 Retain Scientific Name: <i>Araucaria heterophylla</i>	KT/T544_2 Leaning	KT/T545_1 (Retain) Scientific Name: <i>Ailanthus fordii</i>	KT/T545_2 Close to edge of raised planter

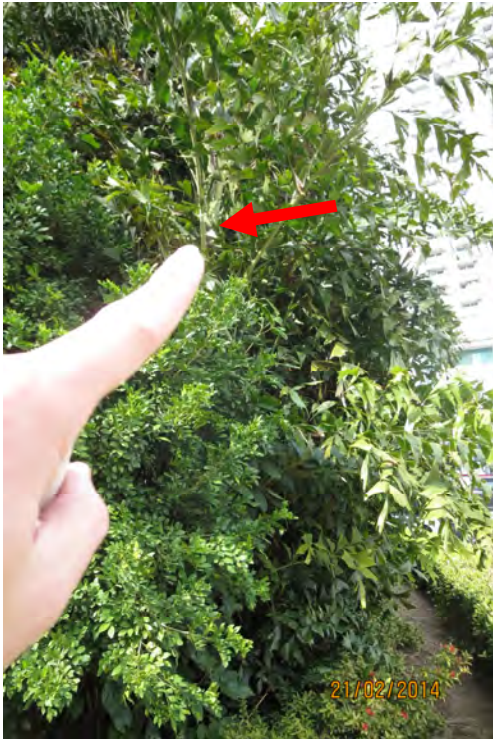
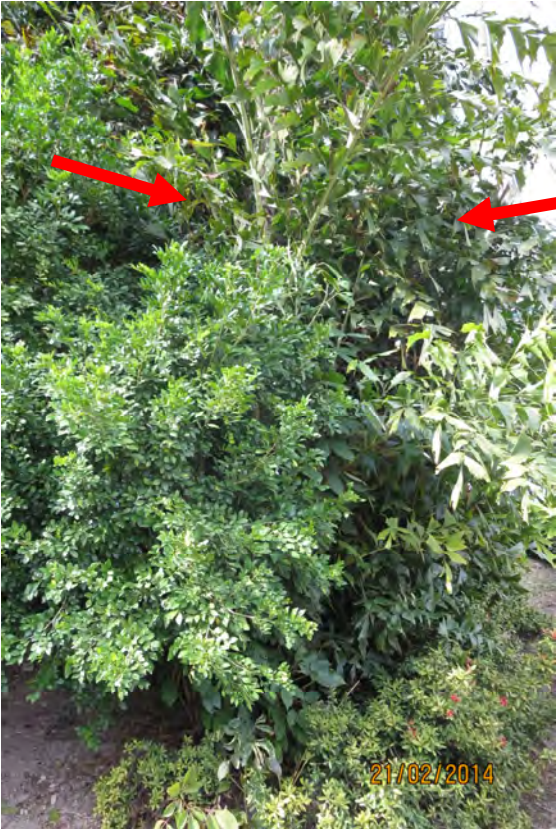
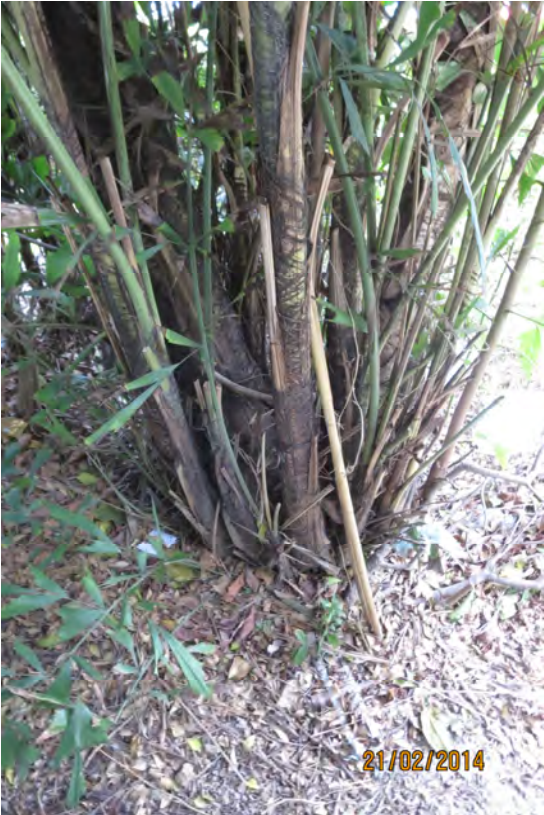
KT/T547_1 ( To Be Removed by Others ) Scientific Name: <i>Caryota mitis</i>	KT/T547_2	KT/T547_3

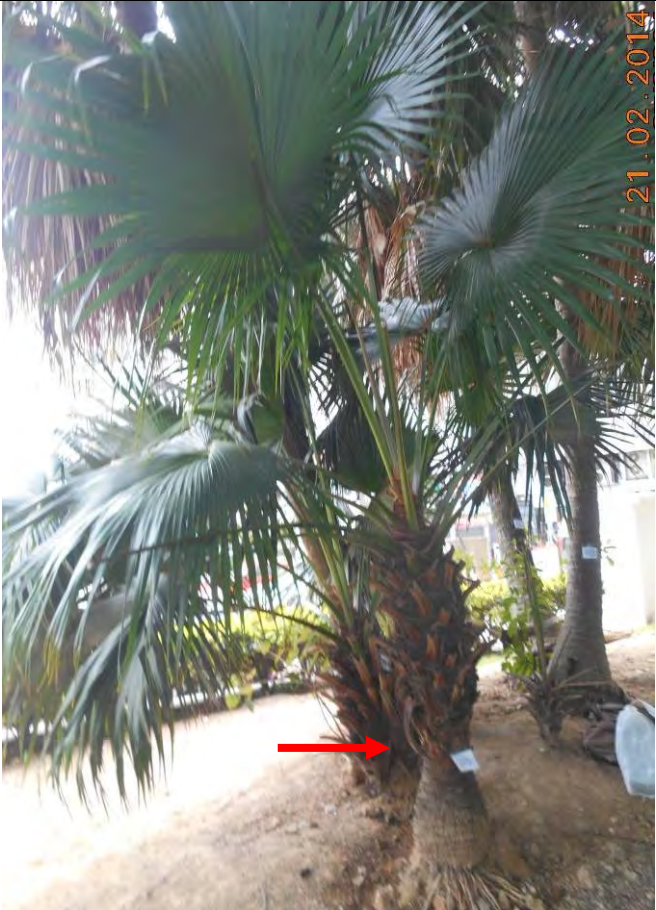
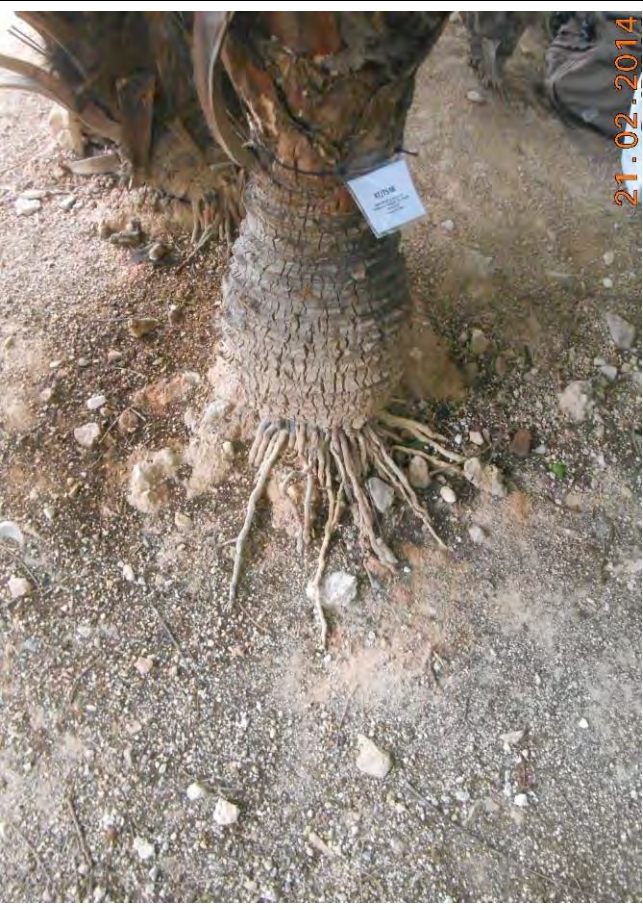
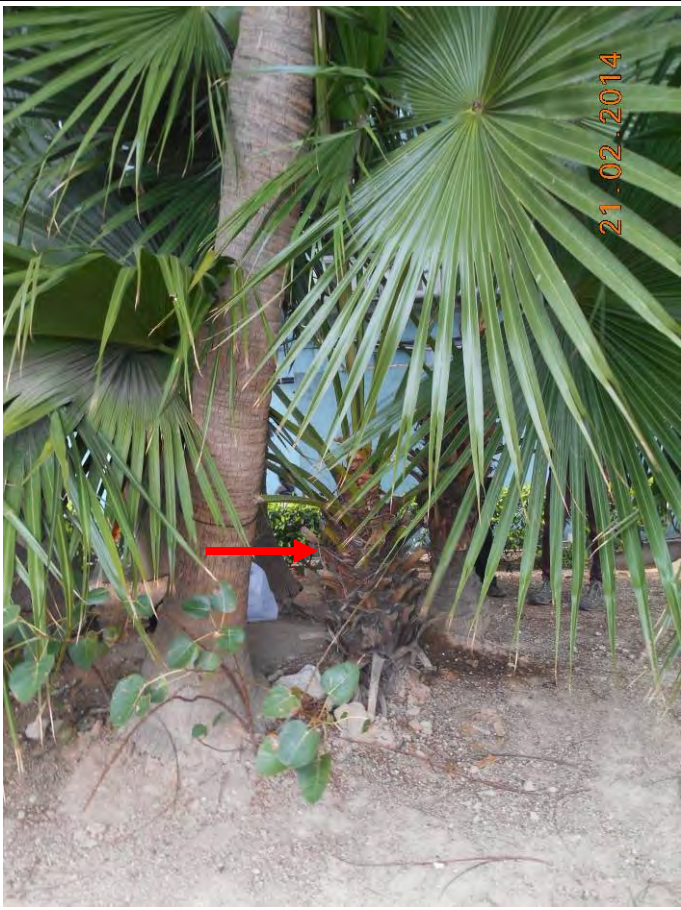
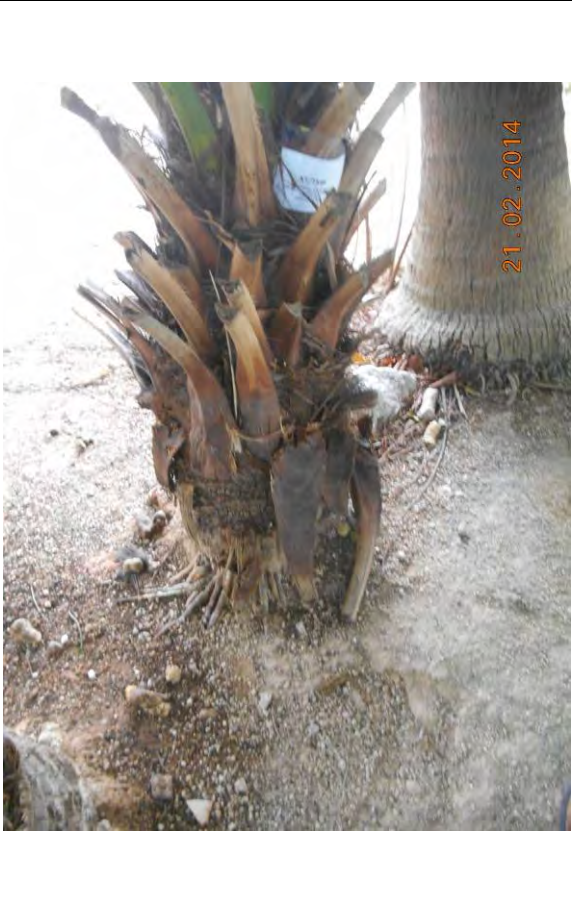
KT/T548_1 ( To Be Removed by Others ) Scientific Name: <i>Livistona chinensis</i>	KT/T548_2 Scientific Name: <i>Livistona chinensis</i>	KT/T549_1 ( To Be Removed by Others ) Scientific Name: <i>Livistona chinensis</i>	KT/T549_2 Scientific Name: <i>Livistona chinensis</i>

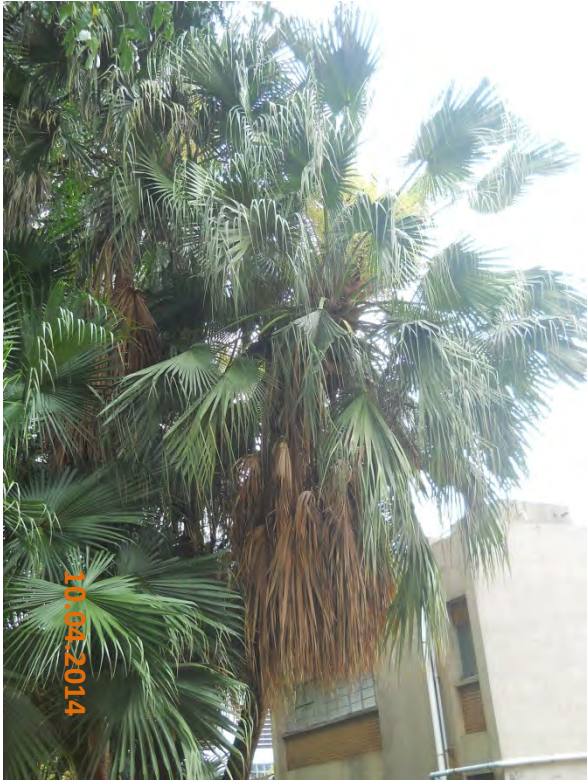
KT/T554_1 ( To Be Removed by Others ) Scientific Name: <i>Livistona chinensis</i>	KT/T554_2 Heavily leaning	KT/T554_3
