26 June 2023

# Incident of a 275-kV Fault in HK Electric's Power System on 19 April 2023

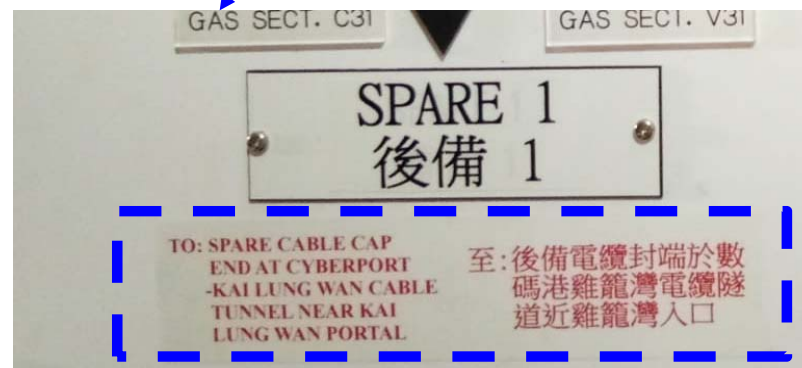
Details of the cap end cable have been added

1. Suspended all transmission GIS refurbishment works until the relevant guidelines are established
2. Checking and disconnection of all four identified spare transmission cable circuits from the associated GIS
3. Detailed labels have been added to the GIS. The relevant EMS diagrams have also been updated
4. Resources were re-allocated to check the integrity of critical equipment in transmission system
5. Counter-checking requirement has been adopted for recommissioning of all GIS after refurbishment.
