**Information Paper for LegCo**  
**Panel on Planning, Lands and Works**

**Causes of Flooding in the New Territories in June 2001**

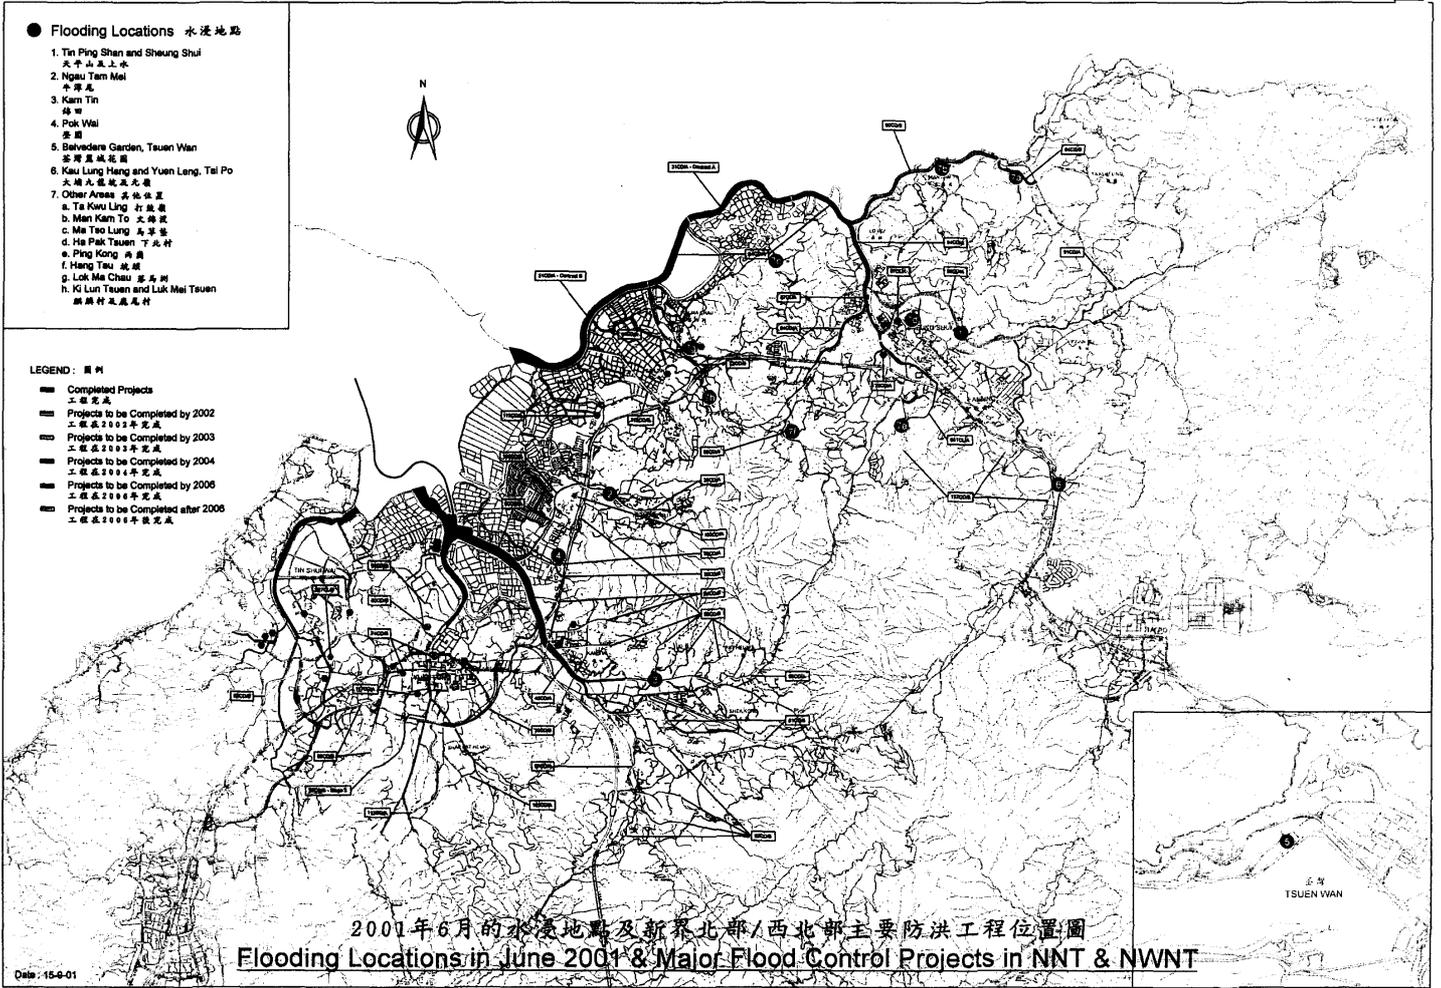
2001年6月的水浸地點及新界北部/西北部主要防洪工程位置圖

Flooding Locations in June 2001 & Major Flood Control Projects in NNT & NWNT
