**Legislative Council
Panel on Environmental Affairs**

**Supplementary Information on
Odour Problem and Polluted Seabed at Tsuen Wan Water-front**

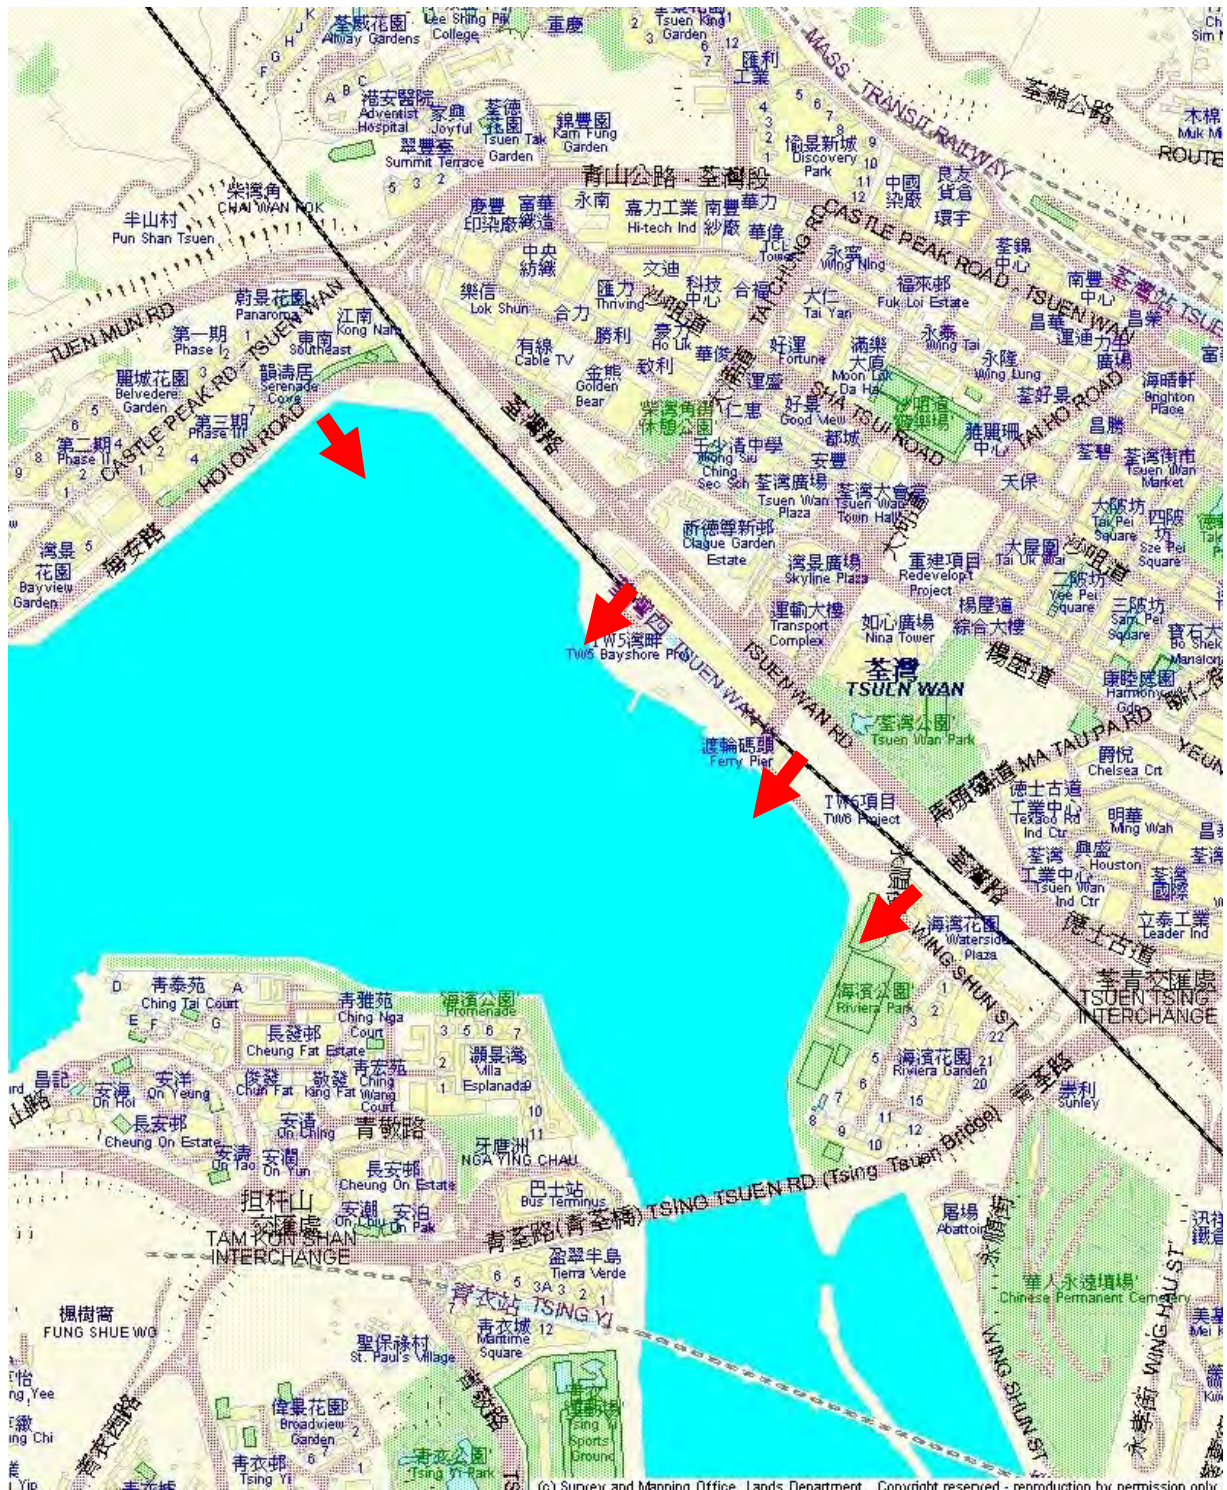
Outfall of major stormwater box culvert

Locations of the four major storm water box culvert outfalls at Tsuen Wan water-front

2. The odour problem at Tsuen Wan Bay water-front area has been the subject of concern of the members of the Tsuen Wan District Council (TWDC) for a number of years and was thought to be related to the poor quality of water and sediment along Rambler Channel. The subject has been discussed on several occasions by the Environmental and Health Affairs Committee of the TWDC since mid-2000s. In 2005, the Administration has organized an inter-departmental working group under the TWDC, involving the Environmental Protection Department (EPD), Drainage Services Department (DSD), Buildings Department (BD), Food and Environmental Hygiene Department (FEHD) and Highways Department (HyD) to investigate this issue. **Annex 1** shows the locations of the seafront and the four major stormwater box culverts.

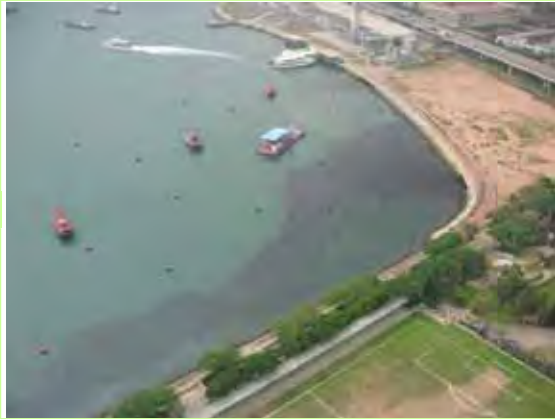
Before rectification in April 2005

Photos of Tsuen Wan Bay before (left) and after (right) the public sewer rectification

10. During the “Team Clean Campaign” from 2003 to 2005, the Administration further stepped up its efforts to identify and remove major building expedient connections in the Tsuen Wan area. An inter-departmental working group was organized to meet regularly to exchange information and to deal with the expedient connections and misconnections found in public and private sewers and the defects of public sewers and related problems. From 2006 to 2008, 21 building expedient connections in the area were found and rectified. As a result of joint departmental efforts, the number of related odour complaints was reduced from 71 in 2005 to 2 in 2008. A set of photographs of Tsuen Wan Bay before and after the public sewer rectification in 2005 is attached at **Annex 2** for reference.

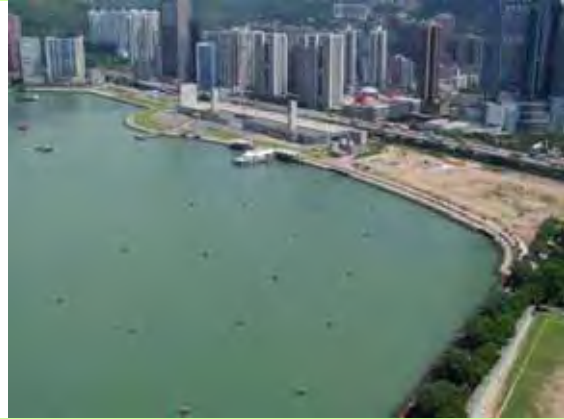
After rectification in July 2006
