**Legislative Council Panel on Transport  
Subcommittee on Matters Relating to Railways**

**MTR Kwun Tong Line Overhead Power System Failure on 8  
December 2008 and Recent Railway Incidents**

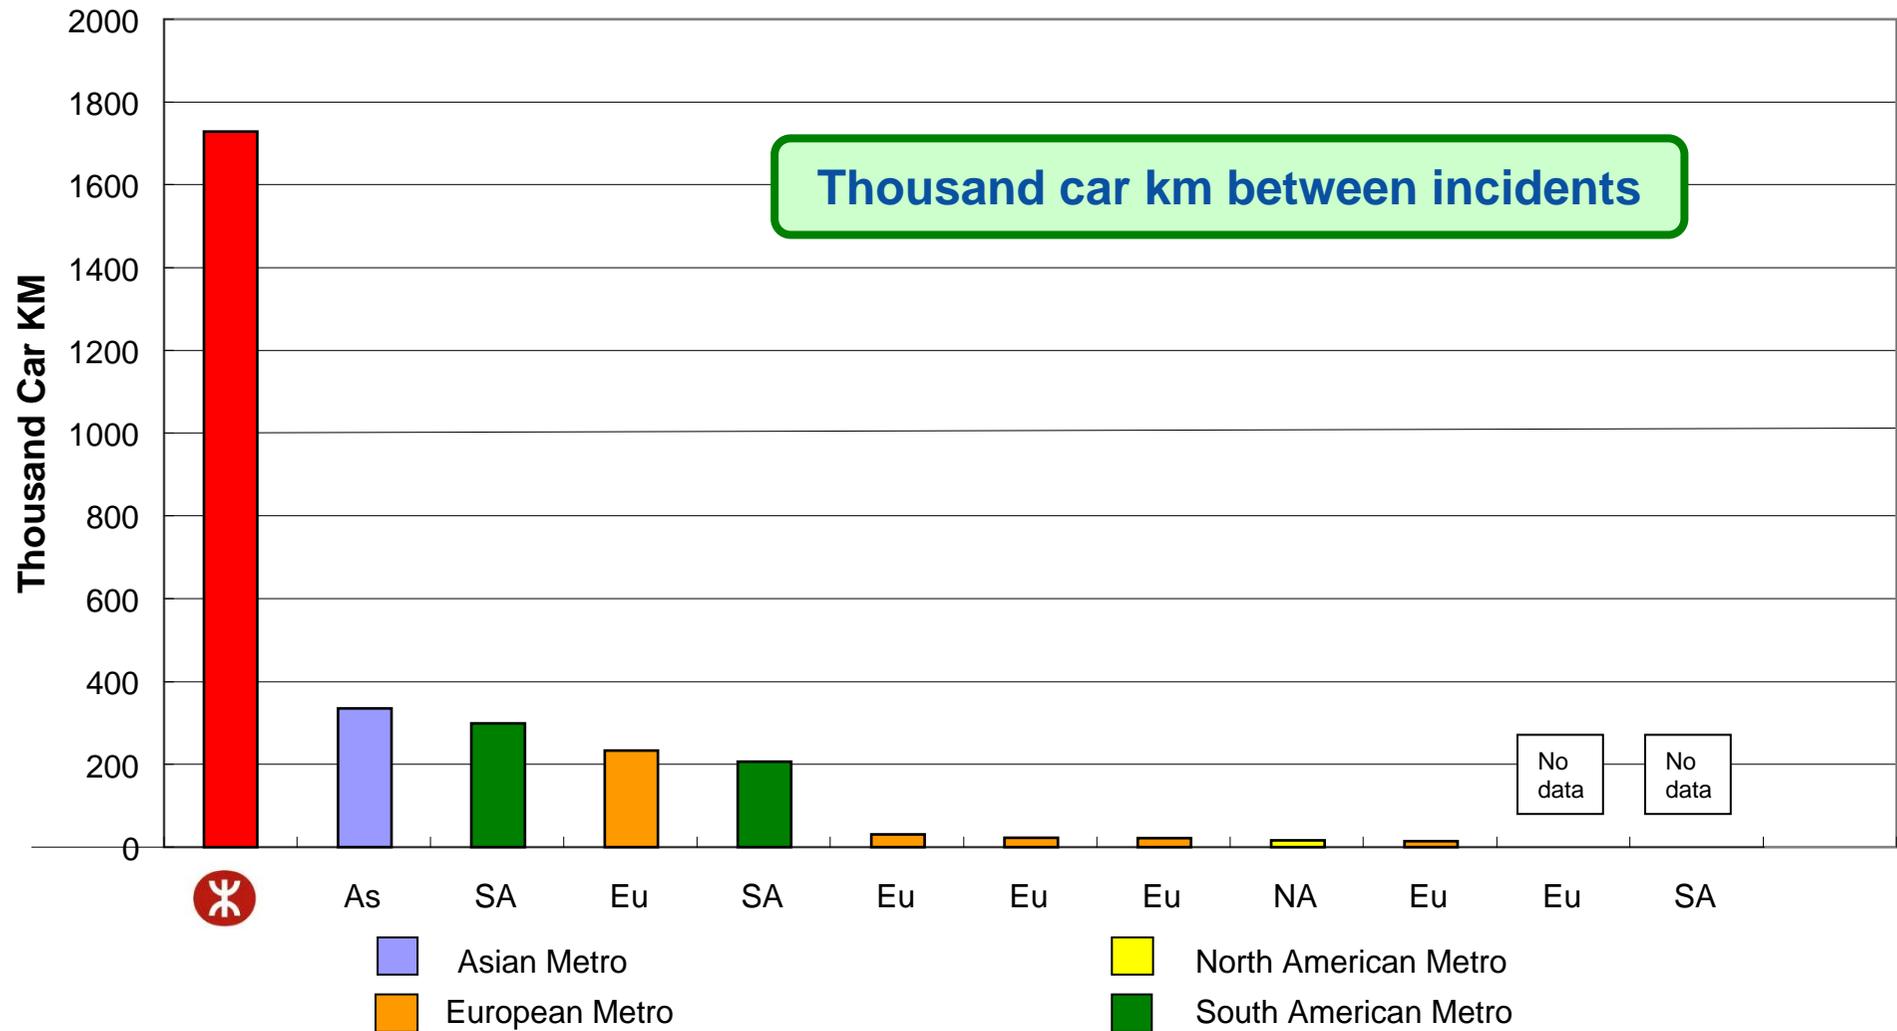
# Train Reliability Comparison – 2007

Source: CoMET Major Performance Index Report

24. The operation of a railway involves a large number of systems comprising millions of different components working together. Unfortunately, incidents that cause delays cannot be totally avoided. The Corporation aims to ensure that all passengers arrive safely at their destinations on time. Our current reliability rate is 99.9%. This means that for every 1000 trips a passenger takes, they will experience a delay of over five minutes once. While this reliability rate is among the highest in the world, the Corporation will continue to work towards minimizing delays as much as possible. A chart showing the performance of 10 railway metros is enclosed (Annex I).
