## **Legislative Council Panel on Transport**

### **Structural Safety of Hing Fat Street Slip Road to Island Eastern Corridor**

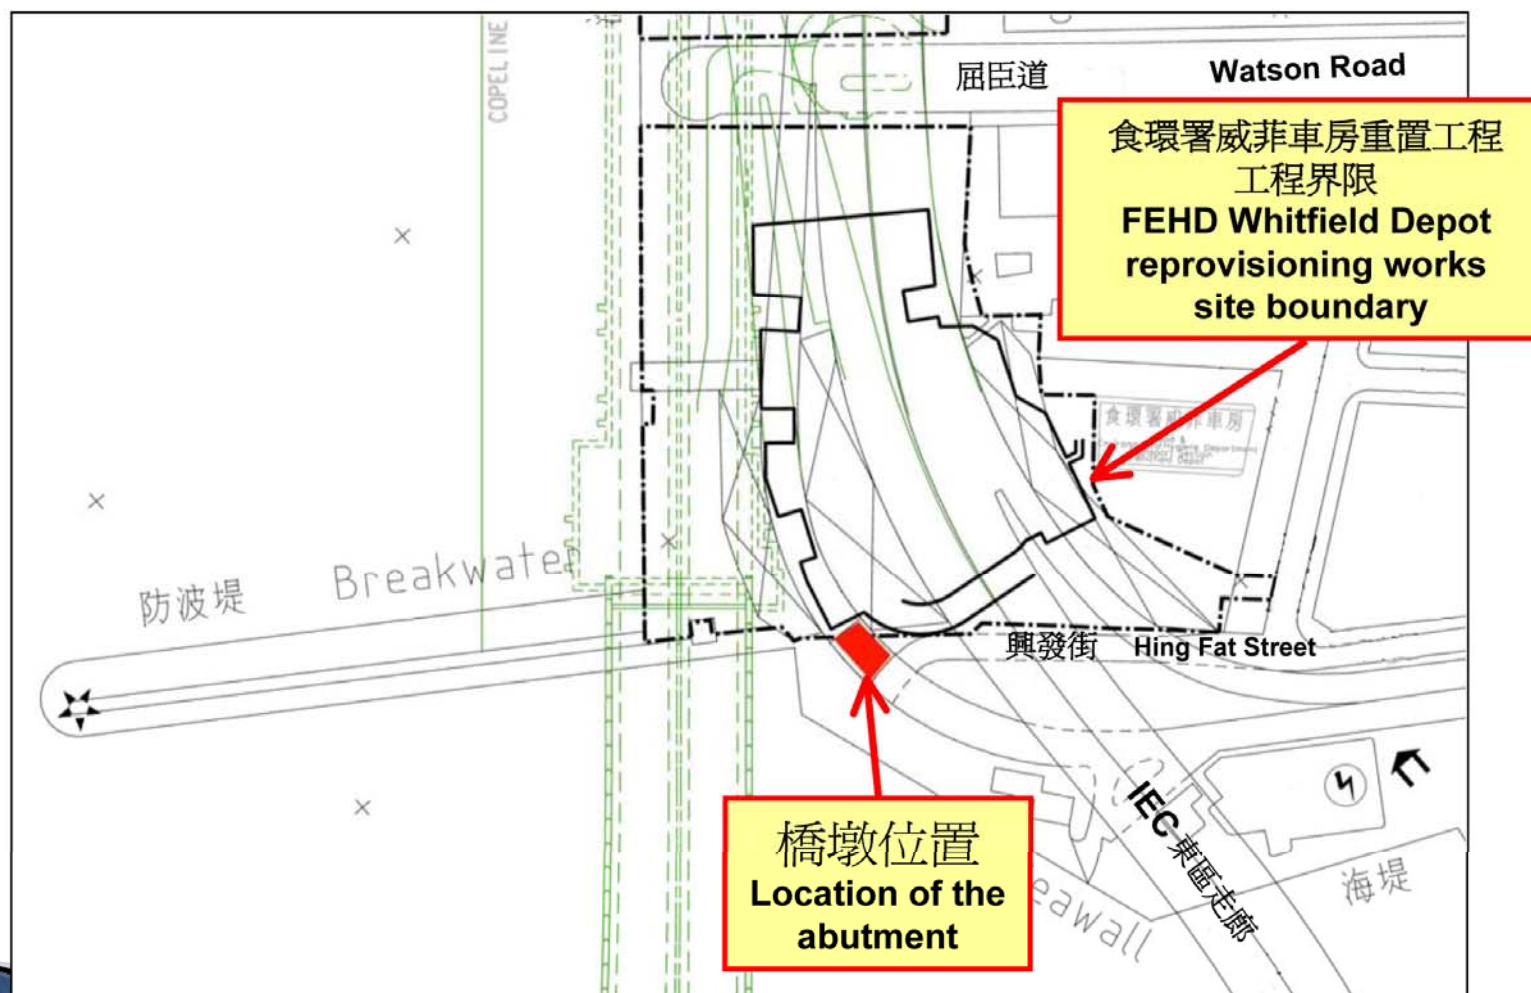
中環灣仔繞道  
食環署威菲車房重置工程

Central - Wan Chai Bypass — FEHD Whitfield Depot Reprovisioning Works

7. Funds for the CWB project were approved by the Legislative Council in July 2009 and the construction of CWB commenced by the end of the same year. The construction works being carried out in North Point include the following : North Point reclamation, the tunnel works at the Causeway Bay Typhoon Shelter, the reprovisioning works for the FEHD Whitfield Depot, the tunnel works at North Point and construction of the link to IEC.
