Public Works Subcommittee

List of issues requiring follow-up actions by the Administration

Item PWSC (2008-09)55

就東面和西面看台上蓋進行的可行性研究
FEASIBILITY STUDY OF ROOF COVER FOR EAST & WEST STANDS

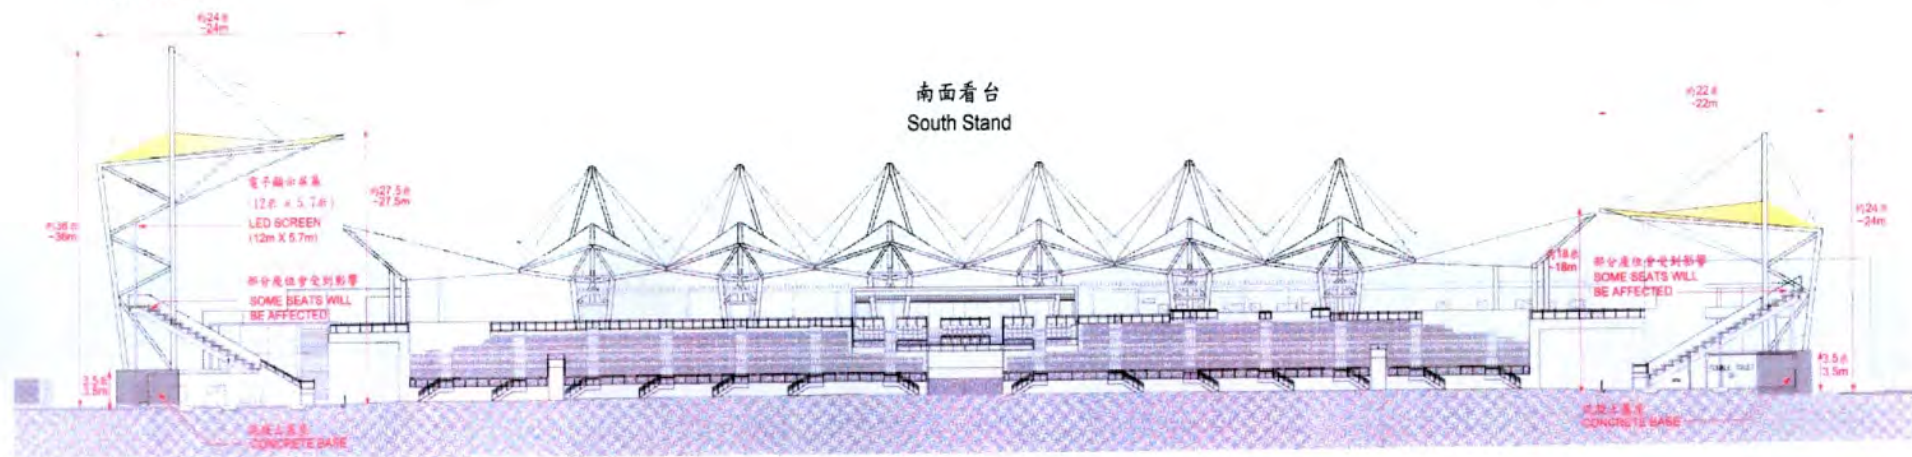
附件 2 ENCLOSURE 2

剖面圖(東面,南面和西面看台) SECTION (East, South & West Stand)

在東面加設的上蓋須豎設於電子顯示屏幕之上。這做法會令上蓋不能有效地為觀眾遮擋風雨和午間的陽光
Additional cover on the east side will have to be erected above the LED screen which cannot provide shelter for spectators against rain and sunshine in the afternoon effectively

西面看台上蓋的整體高度會超逾北面 and 南面看台上蓋的高度。這在外觀上並不理想，並會進一步引發附近居民對景觀和空氣流通的關注

Overall height of the west cover will be higher than the north and south covers. It is not desirable from aesthetic point of view and cause further visual and air circulation concern to the nearby residents

設於東面看台的高拉力纖維上蓋(電子顯示屏幕)
Tensile fabric cover at East Stand
(LED screen)

設於西面看台的高拉力纖維上蓋
Tensile fabric cover at West Stand

- (d) more rows of seats are provided on the West stand; therefore the overall height of the West cover would be higher than the North and South cover. This would be undesirable from an aesthetic point of view (Enclosure 2); and
- (e) any additional cover on the West side would be likely to cause further visual and air circulation concerns. We would need to consult local residents and the Yau Tsim Mong District Council again on the revised redevelopment proposal, which would lead to further delay in the redevelopment of the stadium.

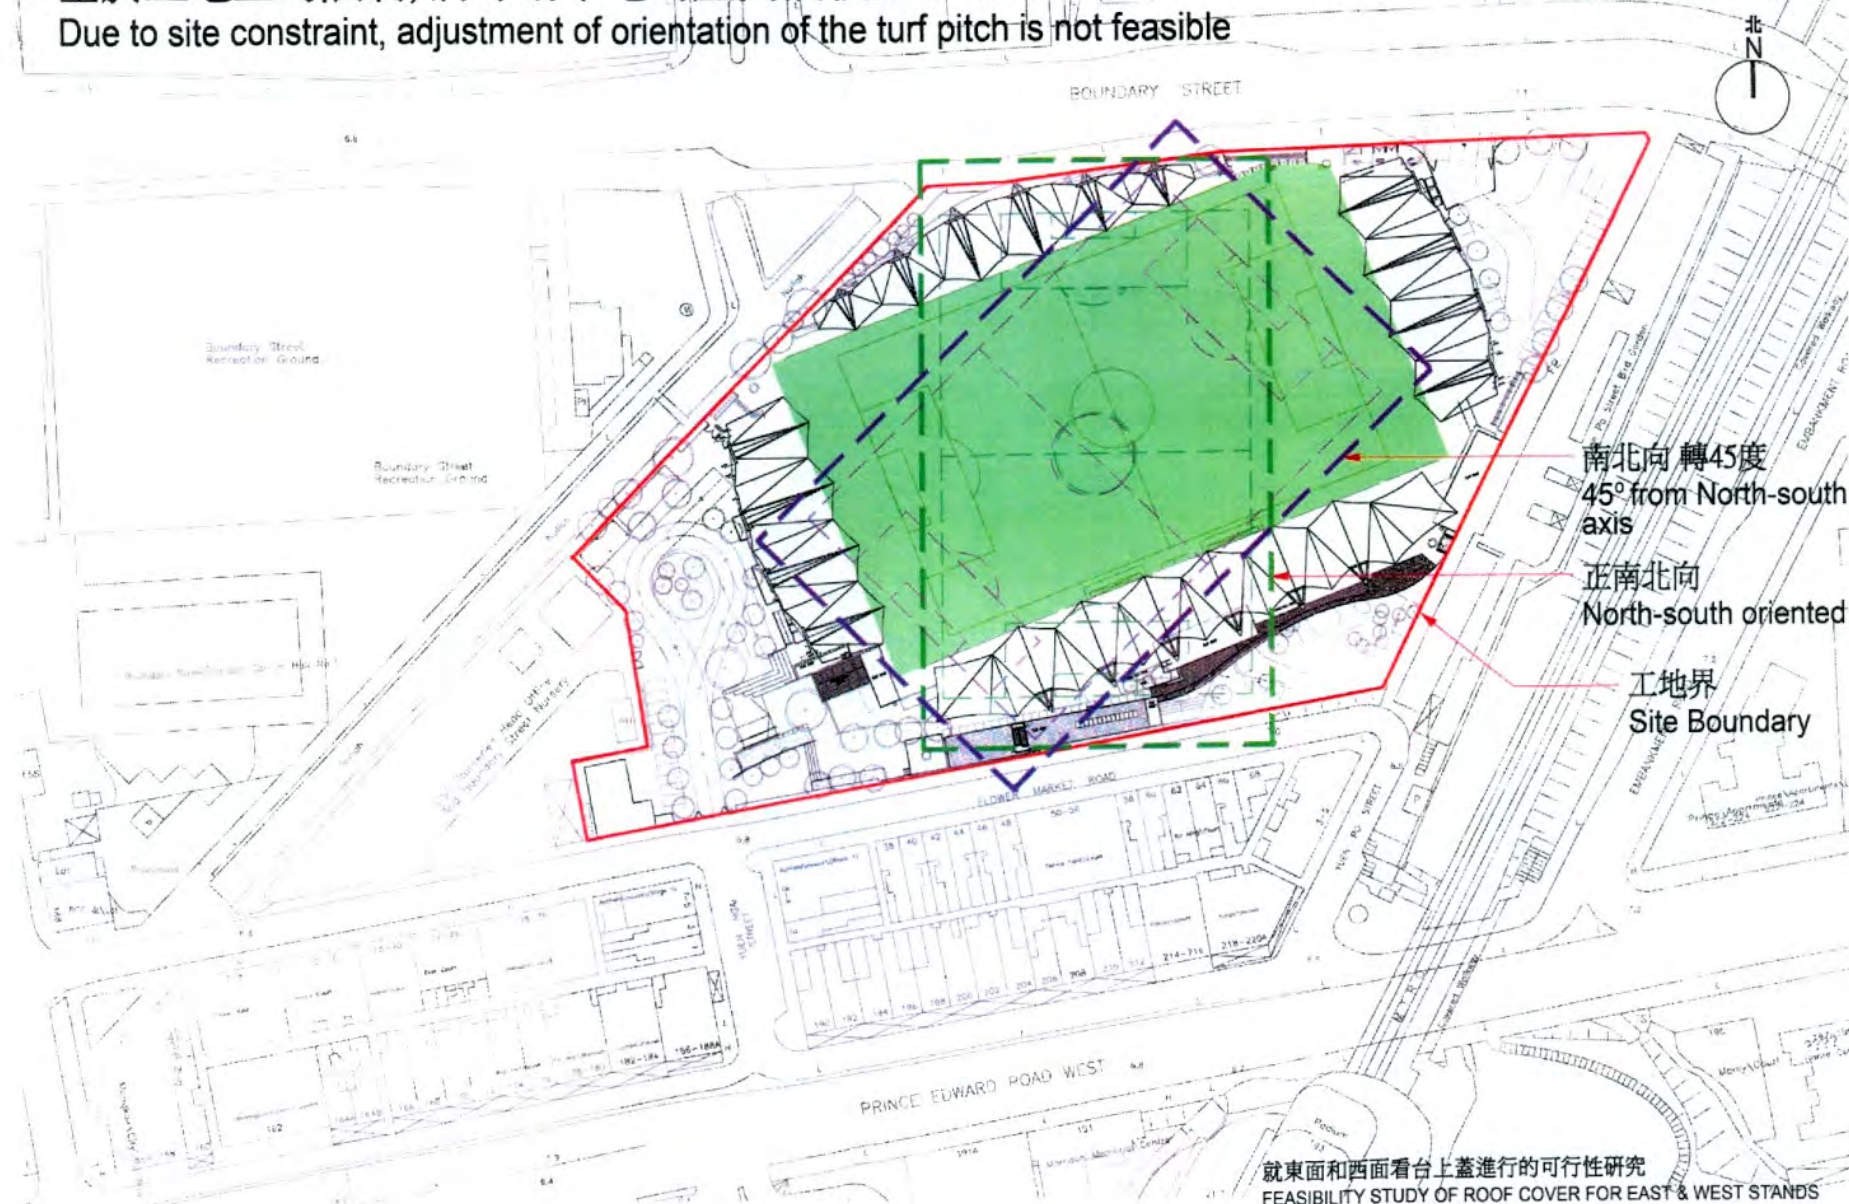
ENCLOSURE 8

Due to site constraint, adjustment of orientation of the turf pitch is not feasible

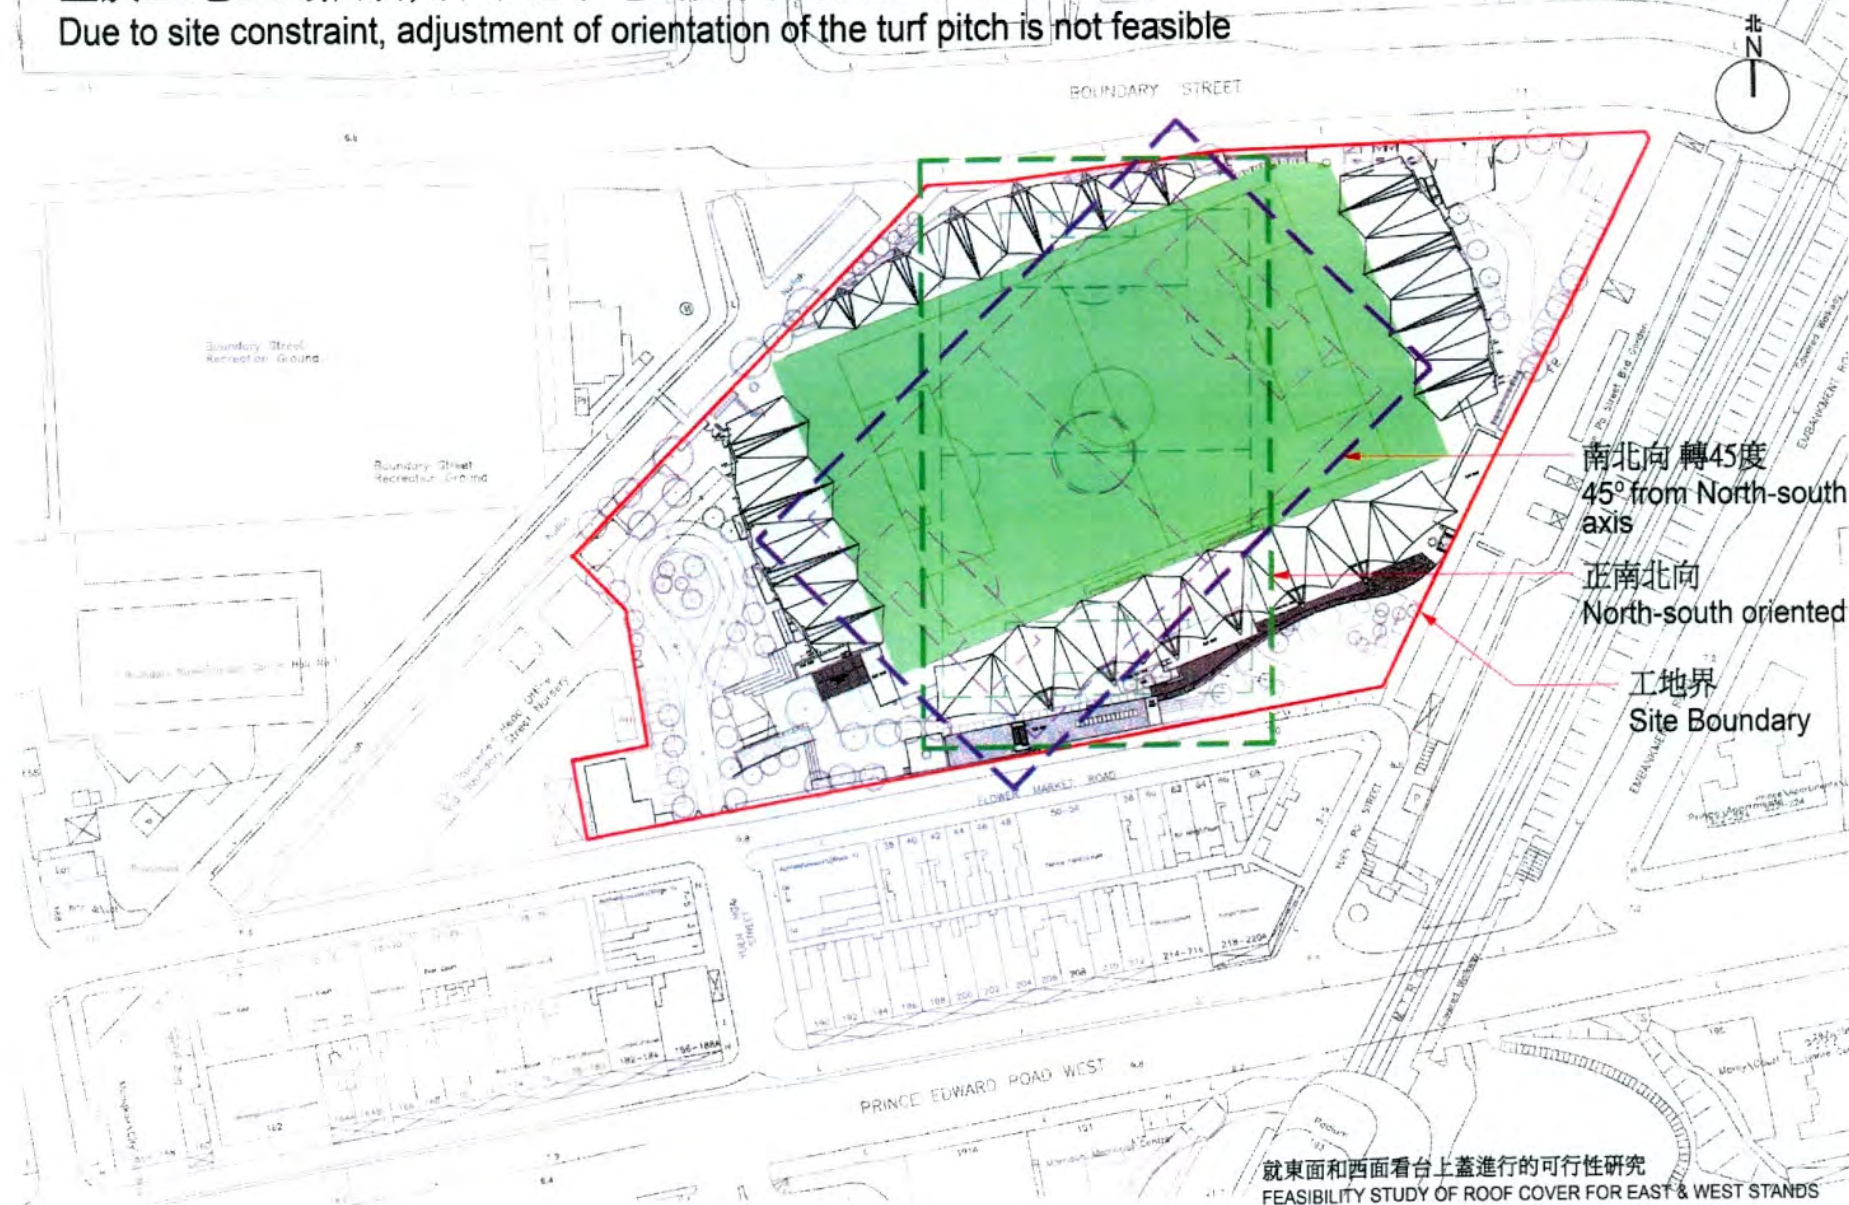
附件 8

Due to site constraint, adjustment of orientation of the turf pitch is not feasible
