Heritage Impact Assessment

The Former Legislative Council Building (Old Supreme Court Building)

Relocation of The Court of Final Appeal and the Development Office of The Judiciary to The Legislative Council Building

11 May 2012

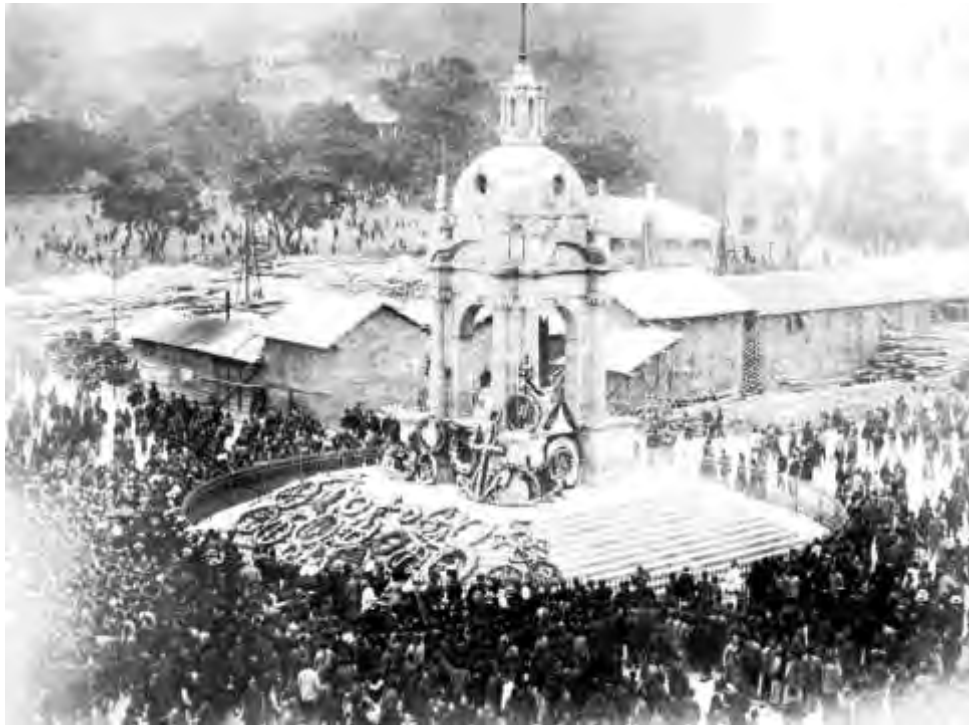
Fig.9 The condolence expression of Hong Kong citizens to the death of Queen Victoria in front of the Queen's Statue, 1901. Behind saw those straw sheds covering the foundation of the building with the pine tree trucks put beside which were ready for piling. (Source: Public Records Office, HKSAR)

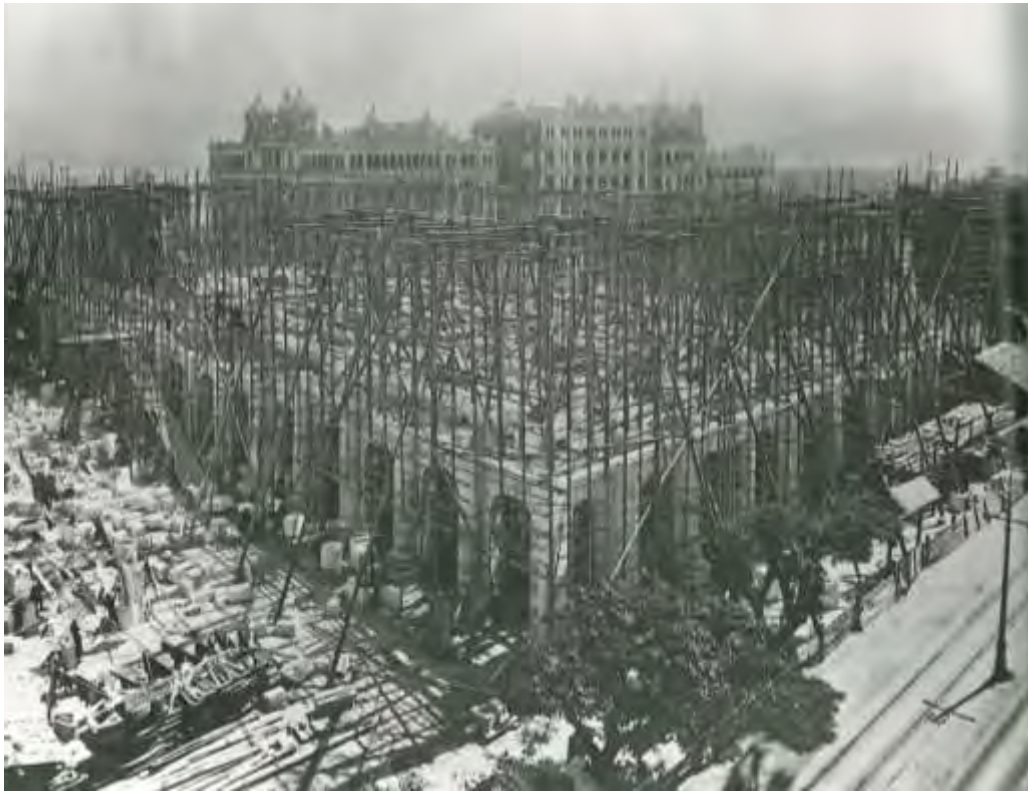
Fig. 10 The building of the superstructure, 1903 (Source: Hong Kong Museum of History)

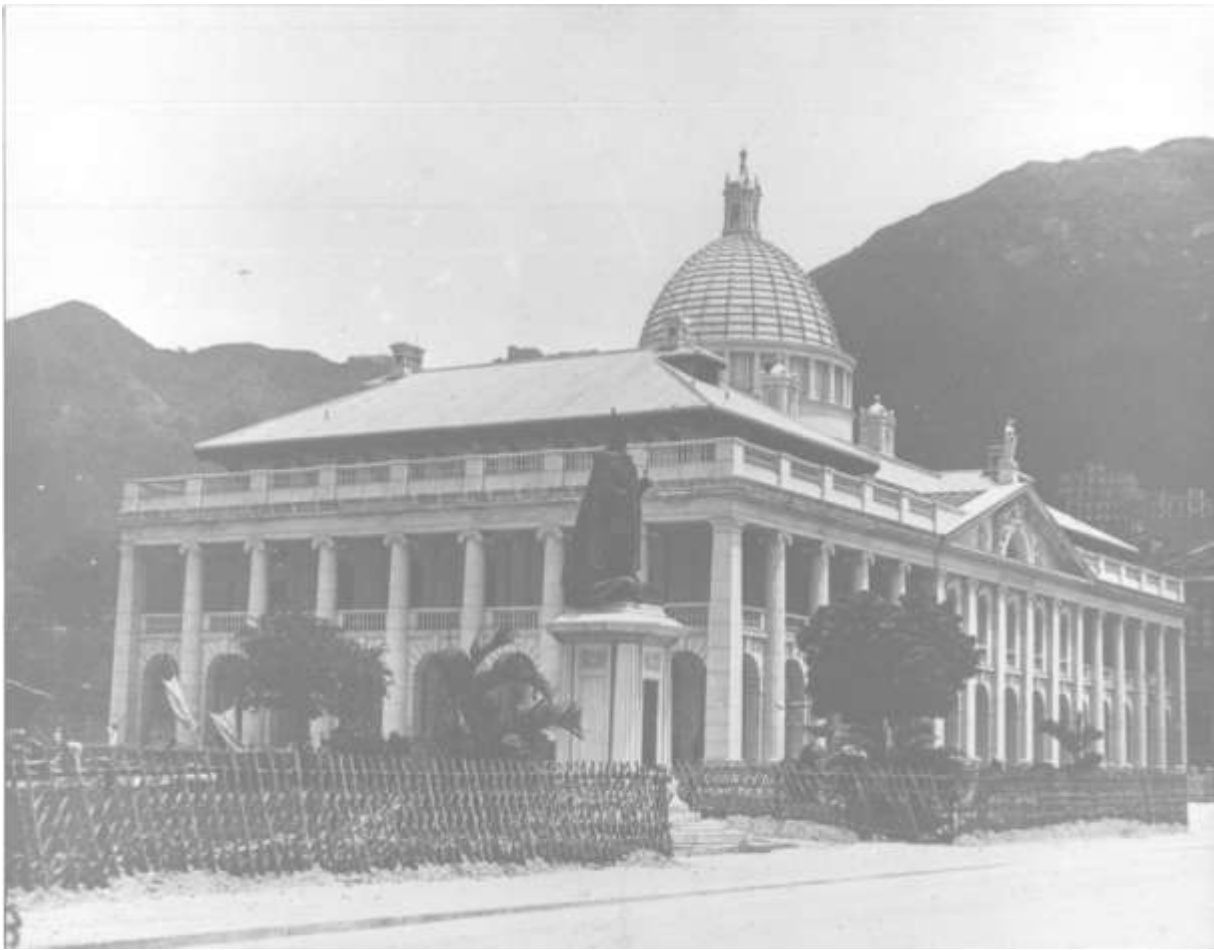
Fig. 12 The just-completed Supreme Court Building, 1912. The entire project had spent nearly 12 years to complete. The nearby gardening works were not completed and was bounded by bamboo fencing. This is the earliest photograph capturing the completed Supreme Court Building. (Source: Hong Kong Museum of History)

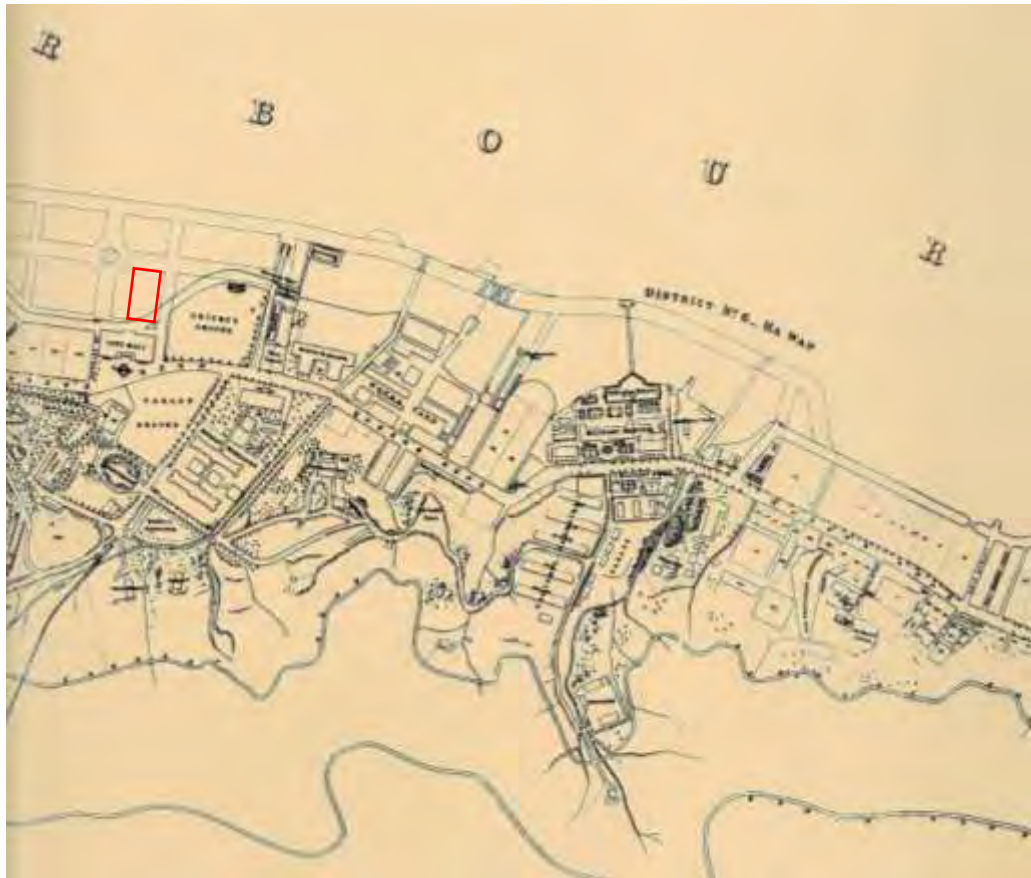
Fig. 15 Plan of The City of Victoria showing the proposed area of the Praya Reclamation Scheme of 1899 and the New Court site (red square), 1889 (Source: Mapping Hong Kong: A Historic Atlas)

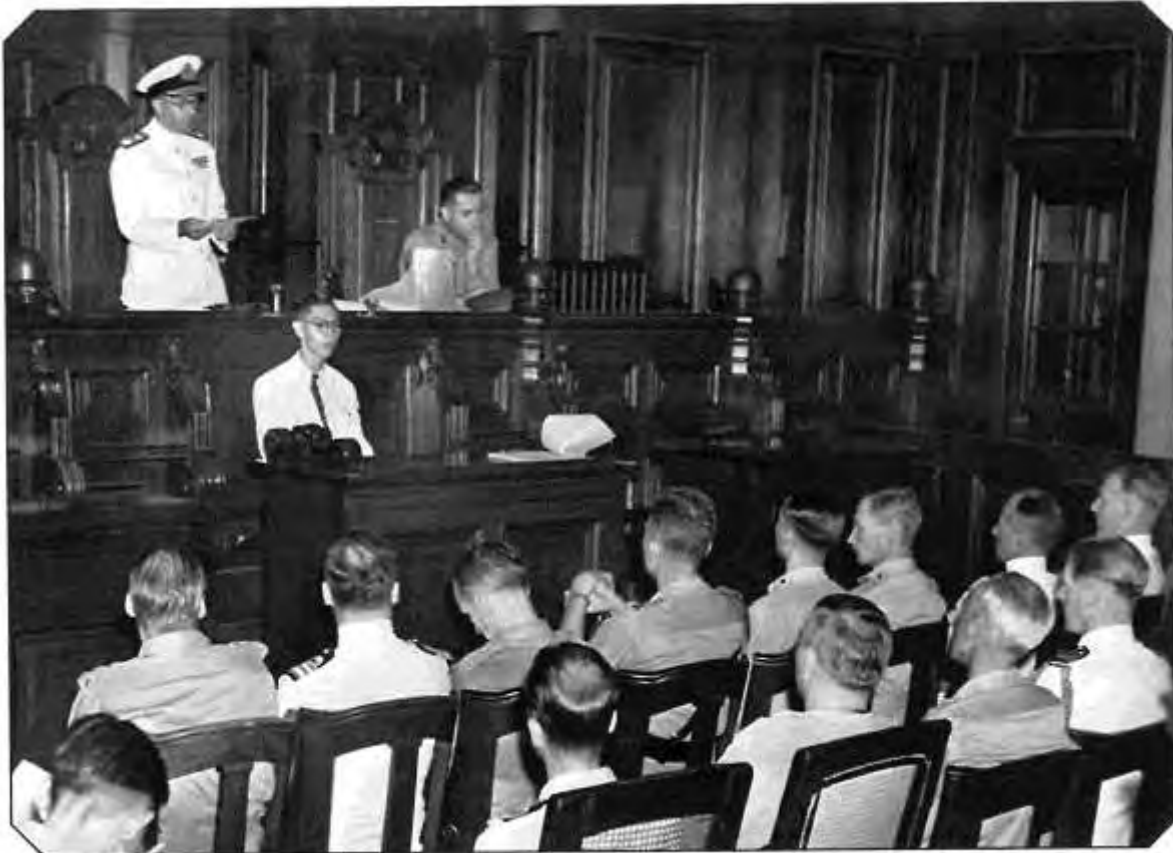
Fig. 22 The reconvention of Judiciary of Hong Kong by Admiral Harcourt in the Great Court of the building right after Japanese surrender on 15 Aug 1945.. This valuable piece has captured the interior design of the Great Chamber including the judges' bench, the wall panels and one of the door entrances. (Source: Hong Kong The Classic Age, FormAsia, 3rd publishing, 2011)

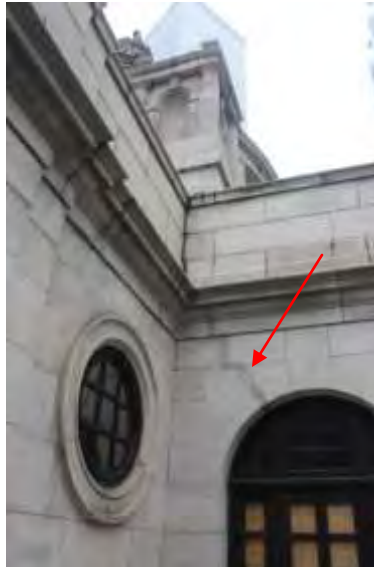
Fig. 23 Cracks developed on various locations on the building which led to the temporary closure of the entire building in 1978 for restoration. The photo shows one of the cracks located on the granite surface in 2/F under the central dome being repaired in 1980s. (Pointed)

In late 1970s, dewatering process in underground during construction of the Charter Station (now named Central Station) of Mass Transit Railway led to uneven ground settlement. Severe structural cracks found throughout the building and construction noise

had greatly affected the operation of the Supreme Court. In 1978, the Supreme Court was relocated to vacant the building for emergency repair.

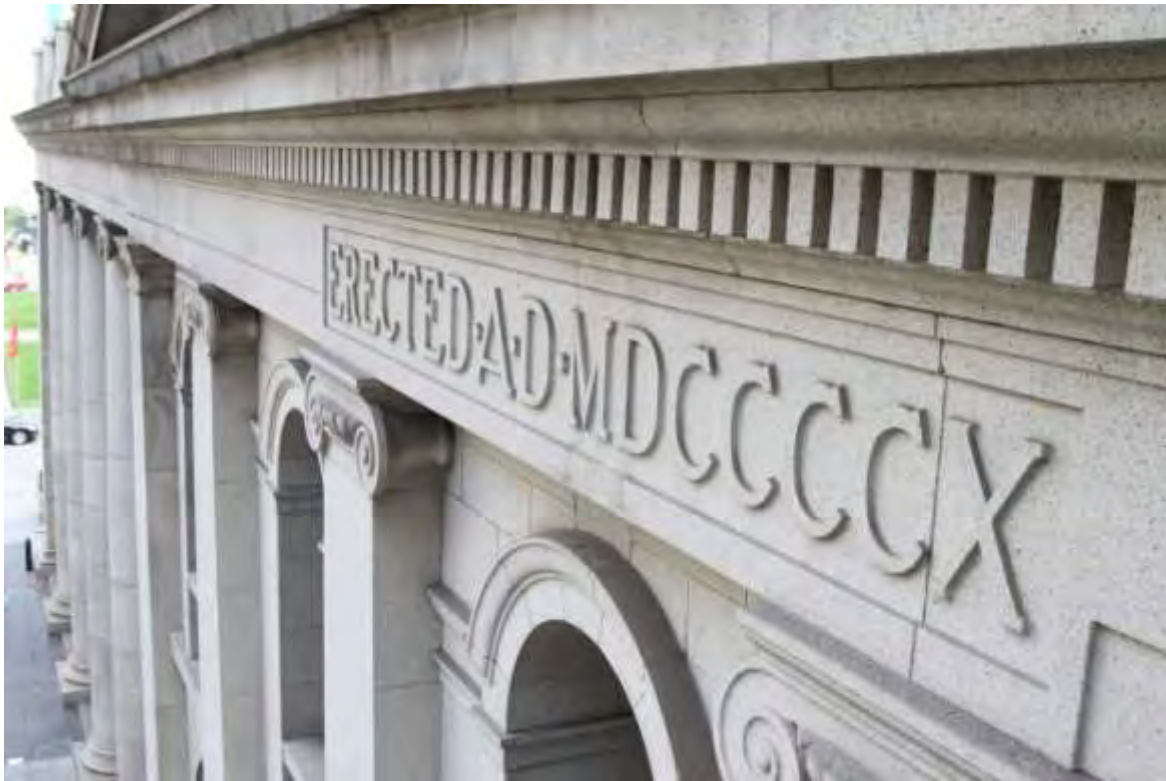
Fig. 30 The craft inspection ERECTED • A • D • MDCCCX meaning “erected in 1910” under the compact design pediment

Below pediment, the inscription “ERECTED AD MDCCCX” meaning “erected in 1910”.

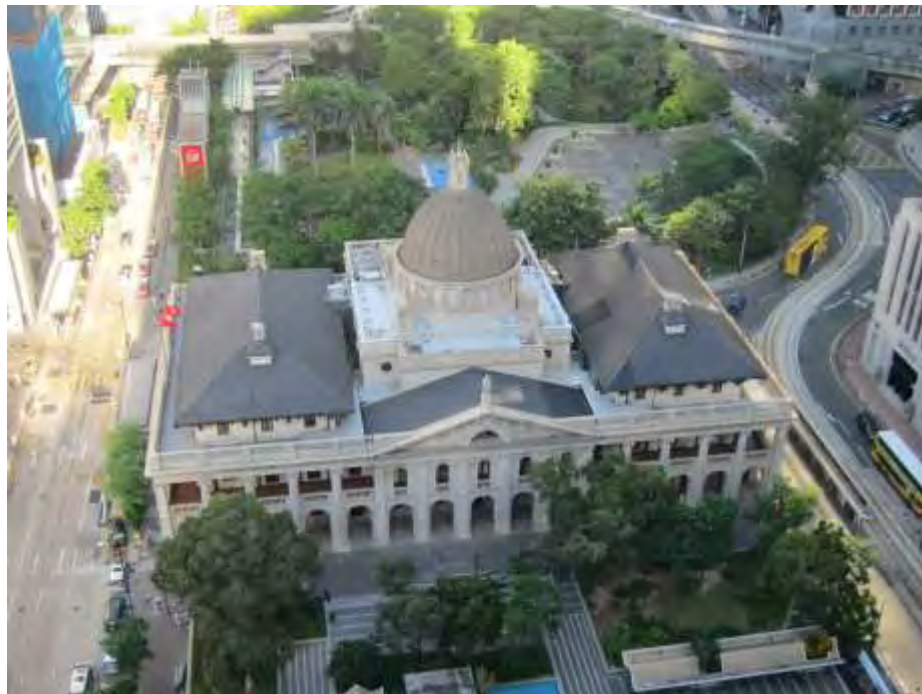
Fig. 35 Bird view of the roof level of the Old Supreme Court Building

On each side of the giant dome stands two pitched roofs covered with Chinese double pan and roll tiles with two granite chimneys. The use of double layer tiles is to further protect the roof from water leakage especially during heavy rain season. The whole roof is rest on timber brackets with iron T-bars inside and there are steel truss supporting the roof internally.

Behind the pediment sits a triangular pitched roof covering with granolithic roll slabs imported from London. Internally, it is supported by steel truss.

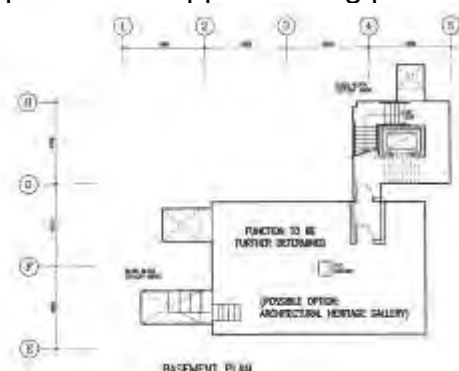
Fig. 36 (Left) The general layout of the basement area

There are no proper records found regarding the basement floor in historic plans. According to historic record, this area is designed locally by Public Works Department to house the heating apparatus.

Currently, the whole floor is used as E&M rooms. Large machineries are housing inside. Walls and top ceiling are packed with cushions. The northwest corner is partitioned and leveled up as the office and control room.

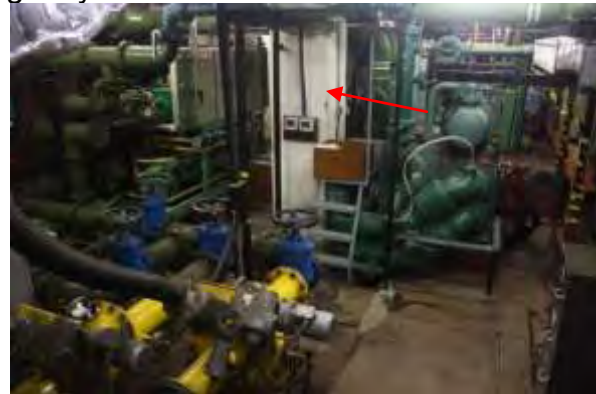
Fig. 37 (Right) The general view of the existing basement used as the plant room. A load bearing column constructed at the centre supporting the entire floor

At the centre stands a square load bearing column supporting the upper ceiling. According to historic report, the wall should be in brickwork. The supporting arches leading to the skylights and also the entrance are in granite. The ceiling is in extraordinary design with segmental small arches pattern that are hardly seen in other parts of the building. This segmental arch design is useful by increasing its strength to cope with the upper loading pressure bought by the above structure.

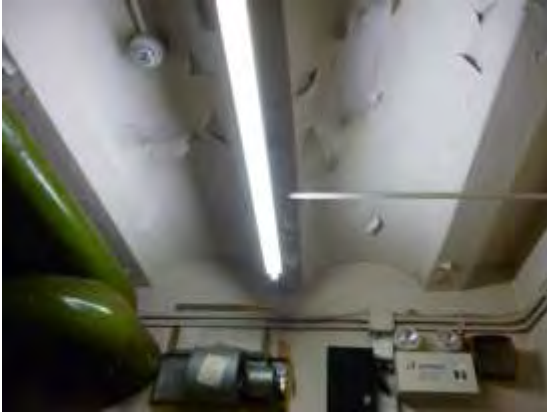
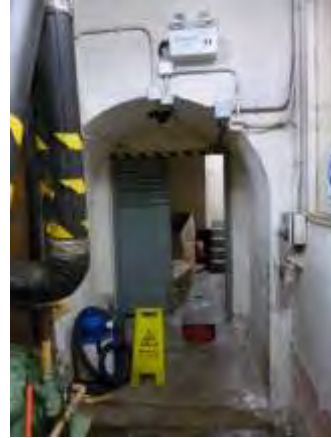
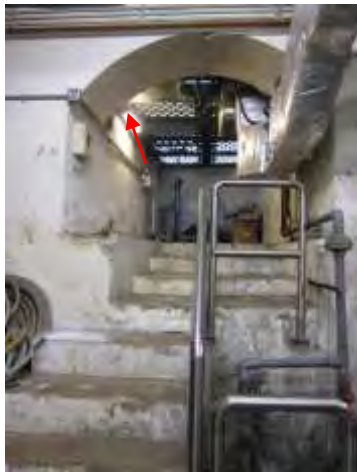
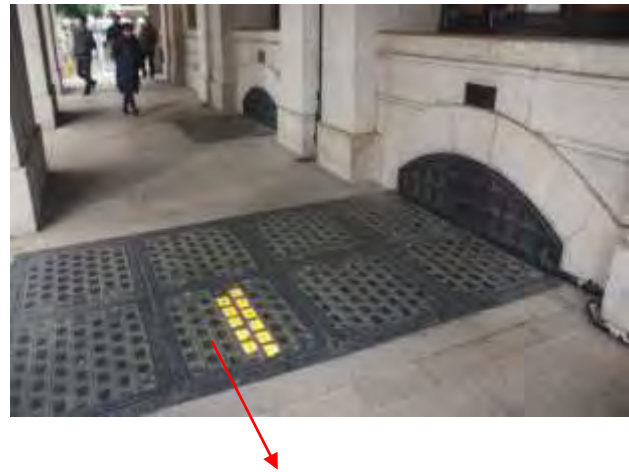
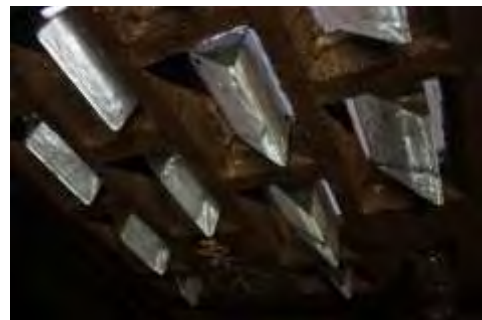
Fig. 38-42 (Top to bottom, left to right)
The building features within the area including the segmental arches ceiling (Fig. 38), the arched doorway (Fig. 39), skylight openings with granite supporting arches (pointed) (Fig. 40), its cast iron openings leading to G/F (Fig. 41) and a close-up to their inserted glass prism rods (Fig. 42)

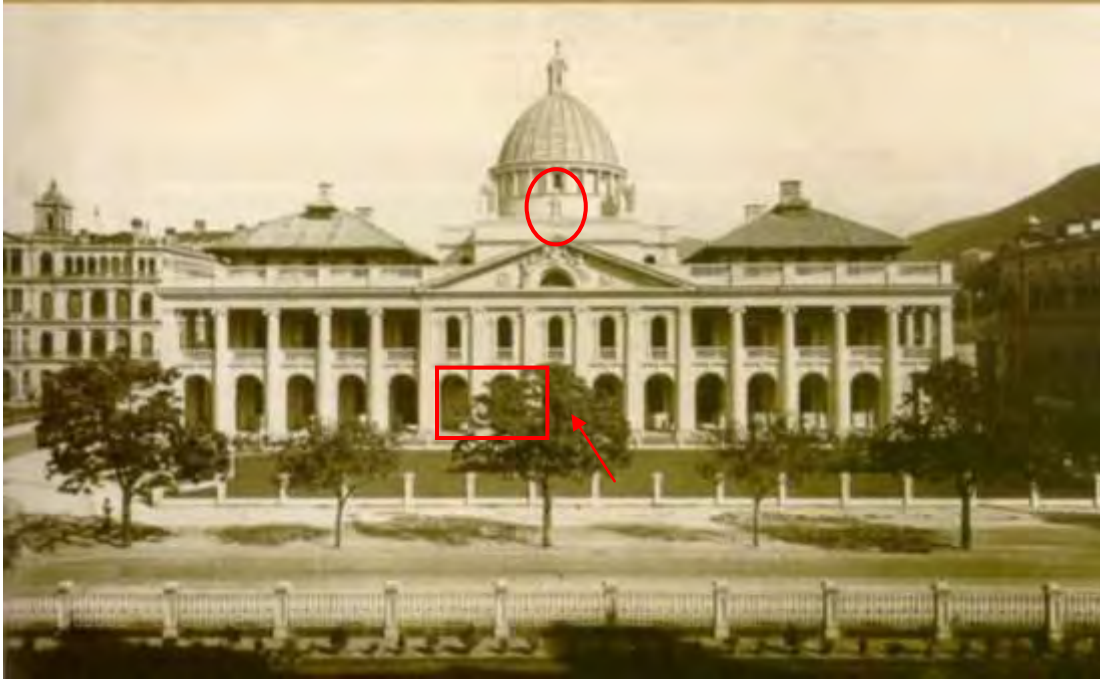
Fig. 43 The main elevation of the Old Supreme Court in 1915. The main entrance (pointed red) locating under the Statue of Justice (circled) signifies that all people are equally treated no matter what classes of these people are. The external windows of the cells (enclosed with rectangle) were originally designed with filled granite walls for security reasons which was matching with the details with 1899 design drawing. (Fig.44)

This area was specially designed to receive and hold prisoners before going upstairs to the court room in 1/F. It was located right behind the main entrance on the central axis on the west elevation. Historic records reviewed that this area consisted of a main entrance area, 2 holding cells and a prisoners' receiving room with two staircases leading to the central large court room and the aside second court.

The location of the entrance below the Statue of Justice has its significant meaning. It signifies that all people are equally treated under the law and order.

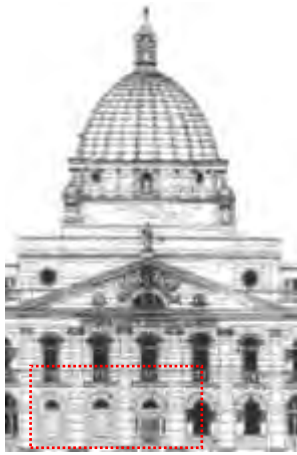
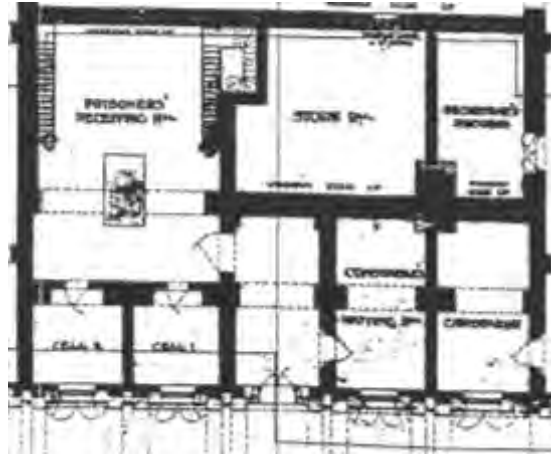
Fig. 44 (left) The 1899 design drawing showing two window-filled cells design in the prisoners' receiving area and Fig. 45 (right) the detailed layout inside including the two "Bridge of Sights" .

It was recorded that the entrance area was covered with ceramic tiles. Two cells were built locating left of the entrance and their arched openings are still existing. They were separated rooms however they are now interconnected with a new opening. There were two stairs which were built to connect this area with the main court and second court called "Bridge of Sights". The bridges were used for transferring prisoners' into the court through a secured path.

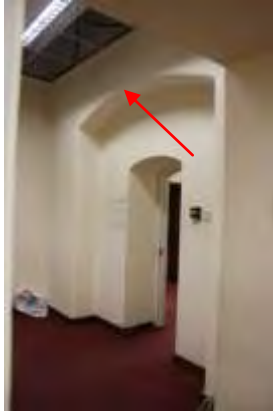
The original segmental arched opening of one of the cells (pointed)

The door openings of the two cells have preserved its original segmental arched openings. However, existing openings are diminished with new brickworks and the two cells are interconnected with new rectangular opening.

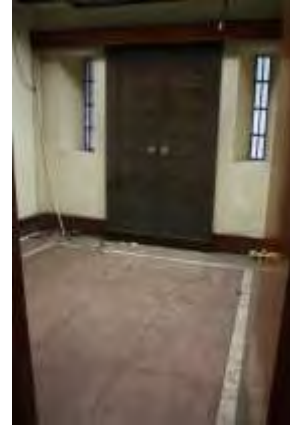
The prisoners' receiving entrance area with terrazzo floor finish

Existing condition reviewed that this area was later altered which are different from the historic description. The existing main entrance door and the security window and iron bars aside the door are believed to be intact and have matching pattern compared with the design drawing. The existing floor finishes of the entrance area is red terrazzo finish with white girdle surrounding its edge. This is a common decorative finish found in building constructed between 1950s and 1970s.

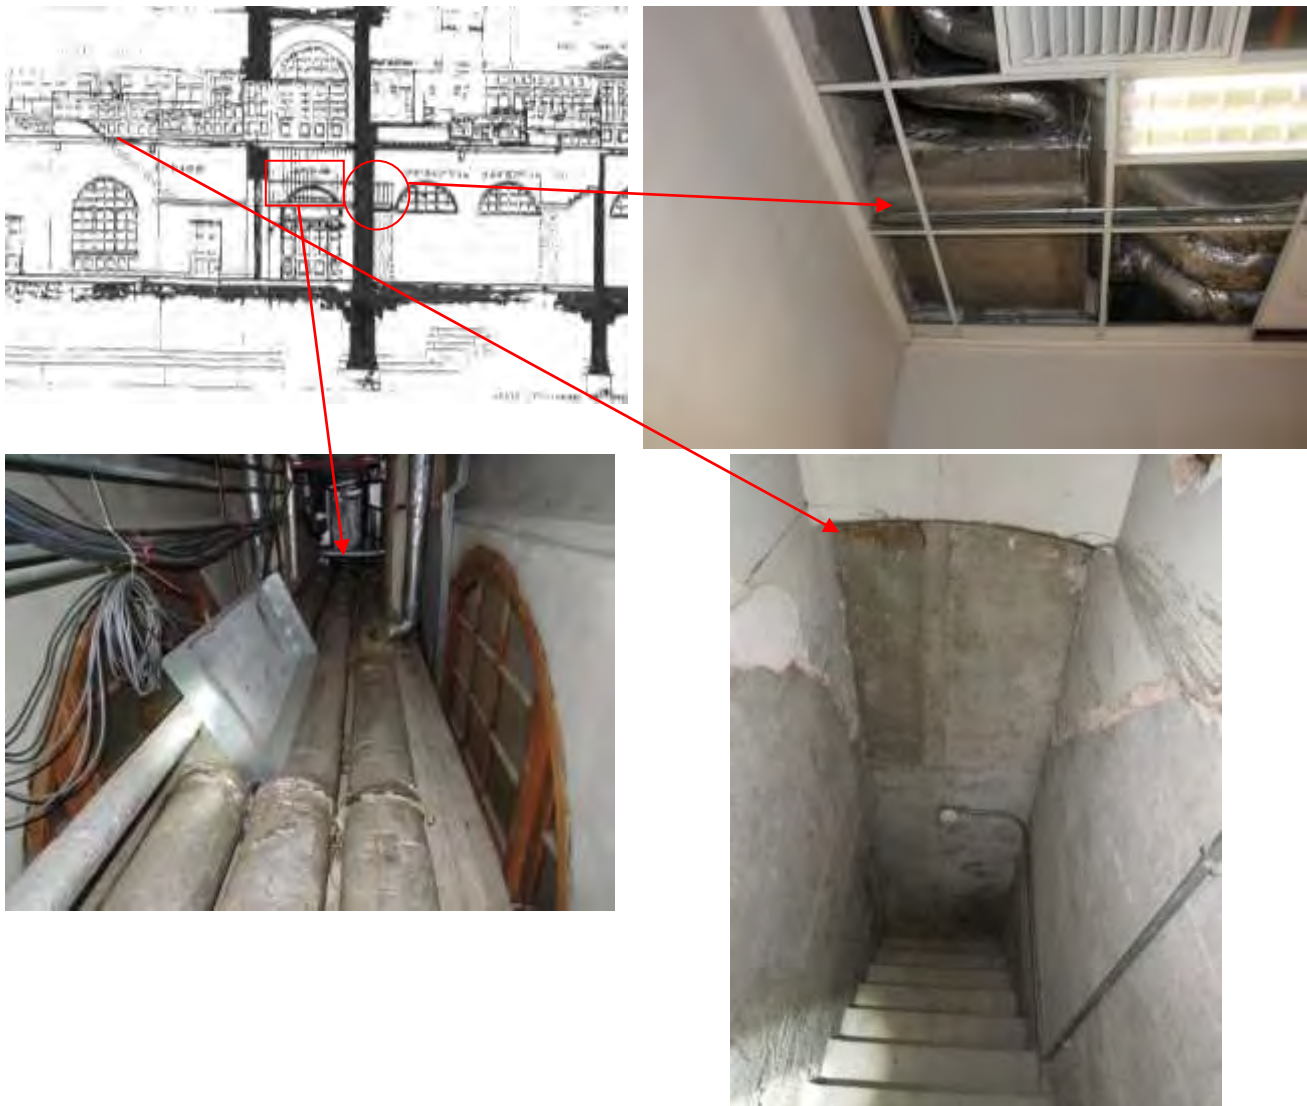
Fig. 48 (upper left) Section drawing showing the two Bridge of Sighs leading to the upper courts

Fig. 49 (upper right) shows the existing staircase landing found after removal of false ceiling

The two bridges were constructed with granite. Existing condition reviewed that most of these structures were disappeared except the part of bridge on mezzanine level to the second court. The landing of the bridge is only visible after dismantling the false ceiling of Room 010 of LegCo. It is found that this bridge is running on top of the existing middle timber doorway partition locating on the north corridor. Many building services is now occupying the bridge area and there is no metal railing observed flanking the staircase. Careful examination of the bridge is essential after removal of the occupying services

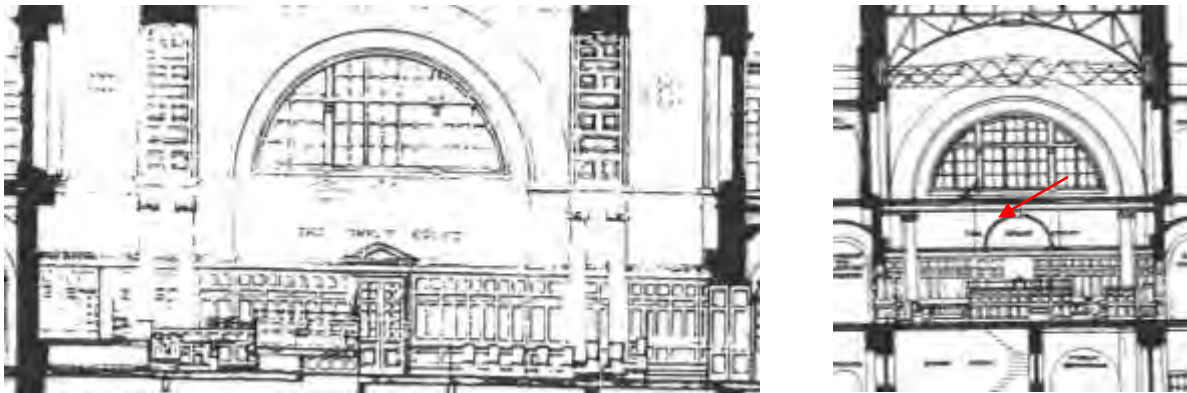
Fig. 52 (left) A cross section plan showing the internal layout of the court, the decorative patterns of the wall panels and the elaborated door surrounds from 1899.

Fig. 53 (right) Another cross section showing the design of the judges' bench including the arched moulding at the back (pointed)

The large court room was originally located in 1/F under the central dome. The court is in double volume high. The central dome is supported by 2 giant barrel vaults crafted with coffered patterns resting on 4 granite double-column bases. The court was oriented in north-south setting. Judges' bench was put on north side of the room facing south. Side entrance is built on each side of judges' bench. The back wall of judges' seat was decorated with a big arched moulding. Other than that, the prisoners' dock was located on the central part of the court linking with the prisoners' receiving area in G/F by the "Bridge of Sighs". The public seats were located at south part of the room. Three main entrances were built on the central portion of the wall on east, west and north side. The internal walls were fit with teak panels for a height of 12' 0". Each main door entrance were flanked with elaborated timber surround with triangular pediment placed on top of them. The floor of the court was covered with teakwood strips nailed to fillets embedded in the concrete.

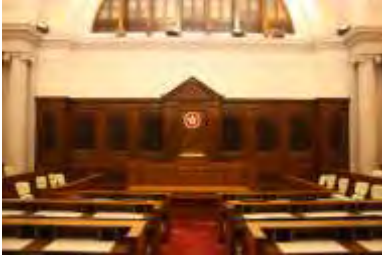
Overview of chamber showing the current chamber seat and existing timber wall panel.

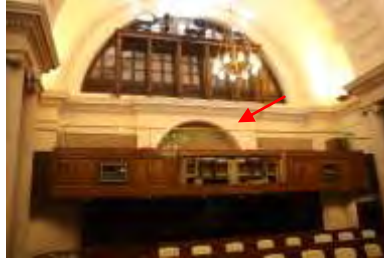
The north public gallery later added. The original arched moulding is still visible

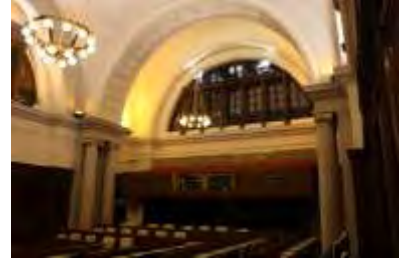
The barrel vault and granite double column bases are still intact

Beside internal fitting, the existing room structure including the double height domed ceiling, the semi-circular window openings and timber surrounds, 2 supporting barrel vaults and the four double-column bases and the ceiling moulding and dentils are greatly intact.

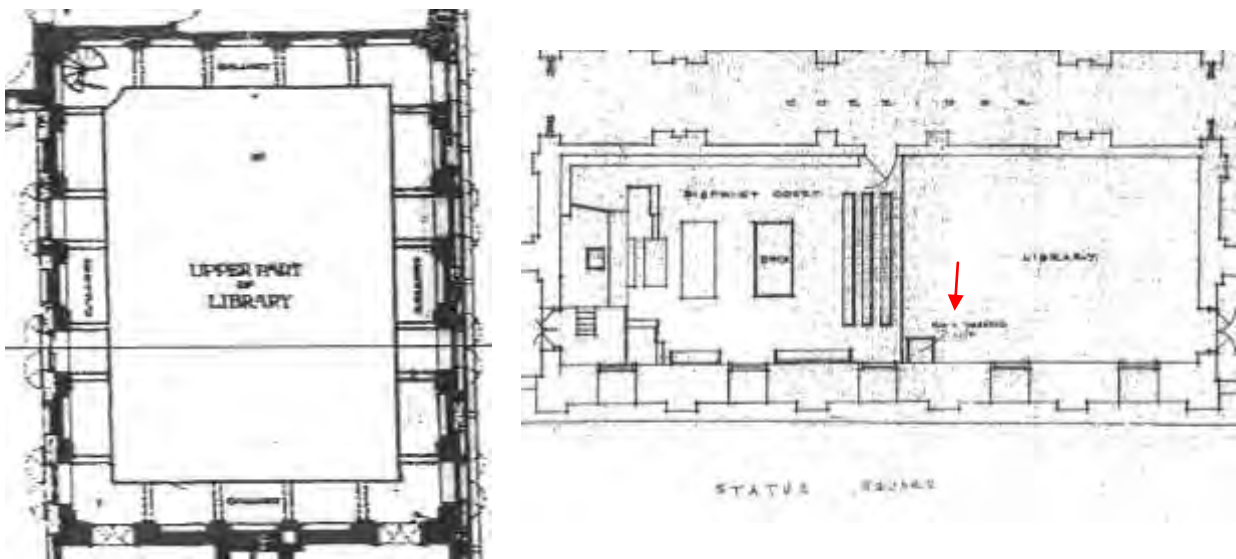
Fig. 61 (Left) The original design layout of the Library preliminary located at south side of the building
Fig. 62 (Right) The Library locating at west side in 1953 with a man operated lift going to the upper gallery was recorded (pointed)

In 1953 drawing, it showed that the library occupied only part of this space, the other part was shared with the District Court. A man operated lift was seen instead of a spiral staircase connecting to the upper deck.

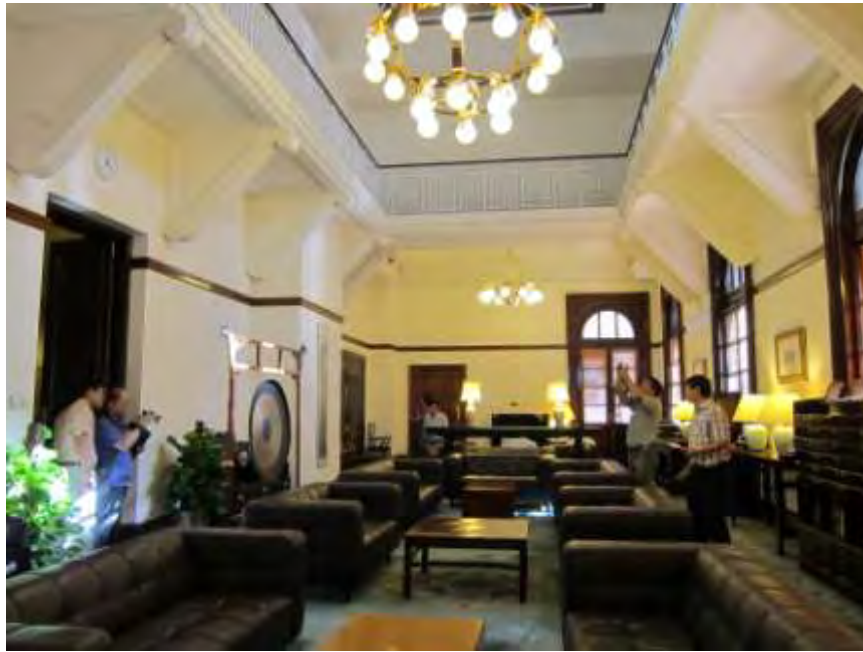
Fig. 63 The existing Ante Chamber nowadays

In 1985 conversion work, this area was renovated to form the Ante Chamber of the LegCo. The upper gallery with a central void setting was restored. Existing condition shows that the upper gallery is located on the mezzanine level with a central void. The gallery is decorated with fine designed iron balustrades. The timber flooring are believed to be re-laid again in 1985 with embedded plug openings. However there is no staircase accessible to the upper gallery. The guidebook of LegCo issued in 1985 formal opening reported that "*the original spiral staircase was restored*" but the captioned pictures in this booklet showing the restored central void of the gallery did not show any staircase inside.

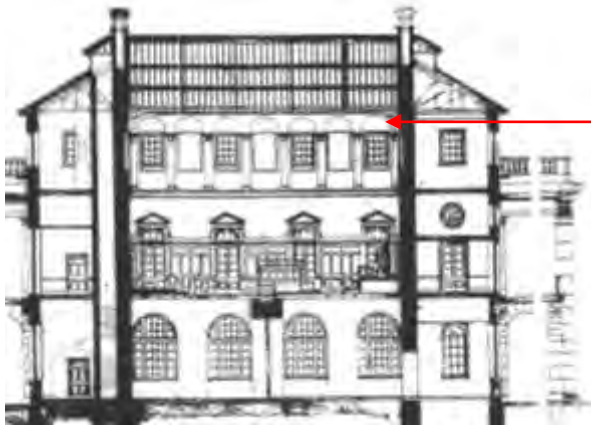
The 1899 design drawing showing the decorative wall moulding on the window level in 2/F

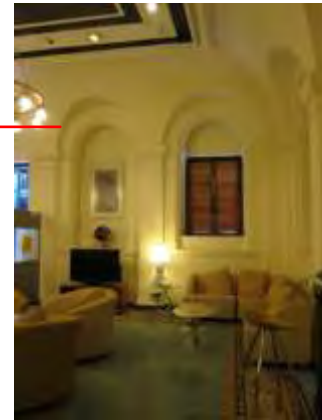
The Dining Room with original arch and pilaster moulding features still existing in 2/F

Existing condition showed that arch and pilaster moulding are found throughout the walls of these 2 rooms. Those arches are supported with Doric pilasters slightly decorated with some vegetal design. These features are largely preserved in the Dining Room but those in the conference room were covered by modern panel works in 1985.

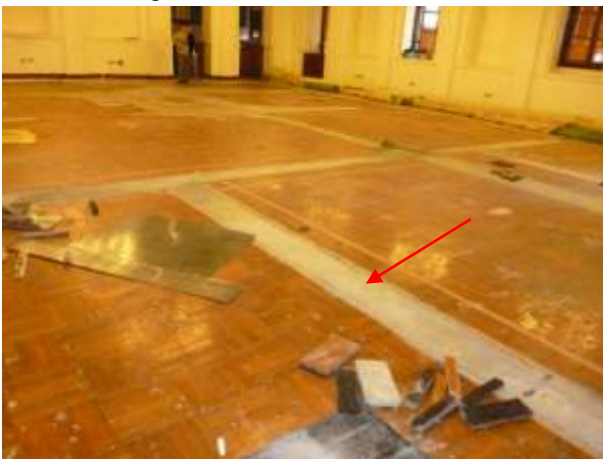
The square-patterned timber strip flooring finish reviewed after the removal of carpets. Trunk damages are discovered. (pointed)

In 1985 conversion work, the south room was converted into Conference Room A and the north room was converted into Dining Hall. The Existing condition of the Conference Room A is covered with modern wall panels and is stood on a raised platform, it is necessary to dismantle the current fitting in order to examine the condition of the above captioned building features. The removal of carpets in the Dining Hall showed that the flooring is covered with square-patterned timber strips. Part of the original floor is destroyed by modern trunk works.

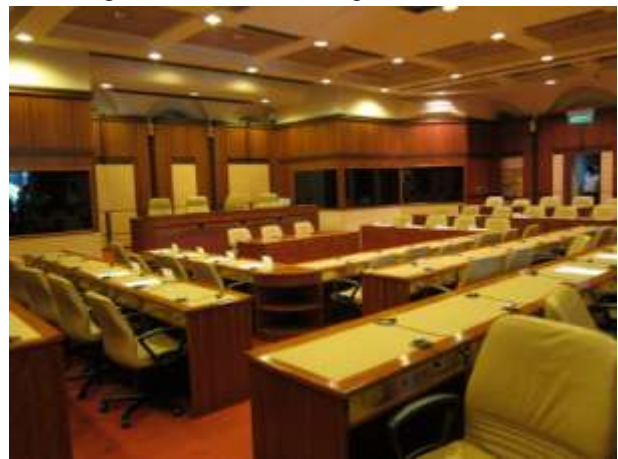
The renovated Conference Room A is extensively renovated which all walls are currently hidden by modern fittings

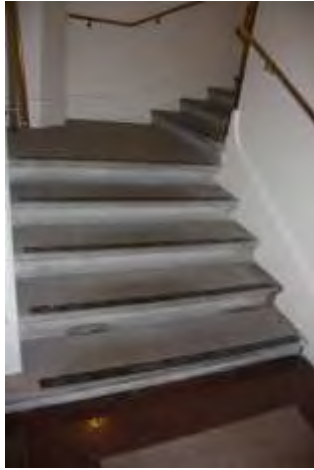
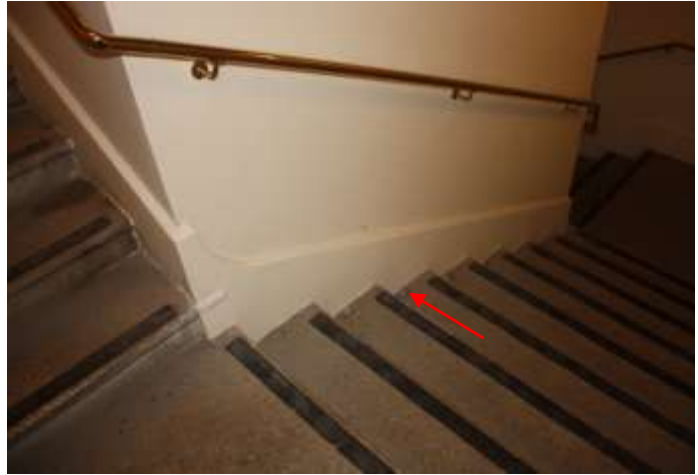
Fig.69 (left) and Fig. 70 (right) The preserved original granite staircase including the exposed granite steps and the footings with traces of original footing of the handrails (pointed).

The entire original staircase is constructed with dressed granite steps. The footing and also the upper ceiling part of the whole staircase is of exposed granite surface. The historic record reviewed that the wall surface of the staircase, corridor and lavatories are covered for a height of from 9' 6" to 4' 0" with ivory white glazed tiles with green skirting, band and capping mould. However, current inspection doesn't discover any wall tiles existing within the staircase area. Removal of covering plaster is then necessary to see whether any tile works are still existing inside.

The original handrail has been replaced with modern handrail design and traces of original handrail footing can still be visible on the edges of the granite steps. Other

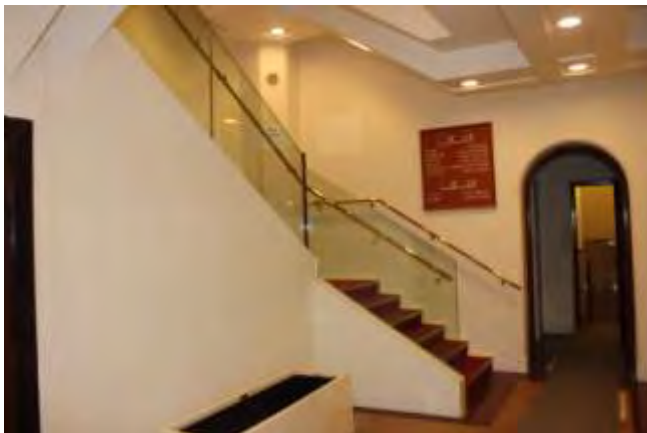
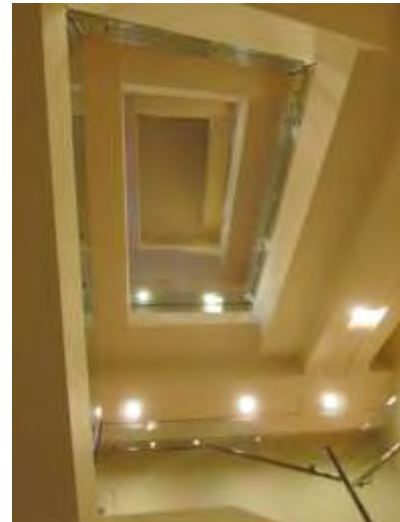
Fig. 71 (left) and Fig. 72 (right) One of the typical layout of the two reconstructed staircases done in 1985 conversion work. The staircase is constructed with concrete with glass panels balustrades spiraling around the central well to 2/F.

The 1985 conversion work only preserved the original staircase located at the northeast corner while the others were rebuilt by concrete. All the two lifts were reconstructed with an additional lift added to the southeast corner. A dump waiter was added in the pantry locating at the northeast corner to serve the dining hall in 2/F.

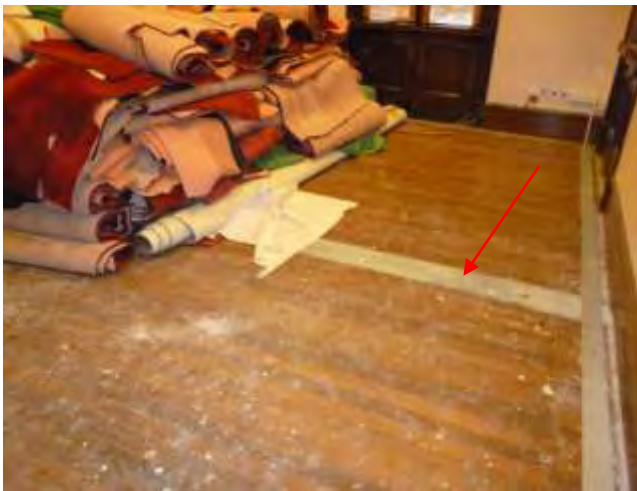
Fig. 73 (left) Pictures showing a room with original timber strip flooring. The floor was damaged by trunk work (pointed)

Most of the timber strip flooring is found within the office area and court spaces. The timber strips according to historic record are made of teak and they are in average of about 9cm width. The timber strips are fixed on the cement floor using iron nails. A thin layer of protective wax is still visible on some of the timber strip surfaces.

The general condition of the timber strip floors is poor in general. Those discovered are found rotted and destroyed by modern service trunks. There are no any rooms preserve undamaged original timber strip flooring. The best floor condition being discovered is inside the Ante Chamber. It is believed to be re-laid in 1985 and was covered with a thick layer of crystal wax.

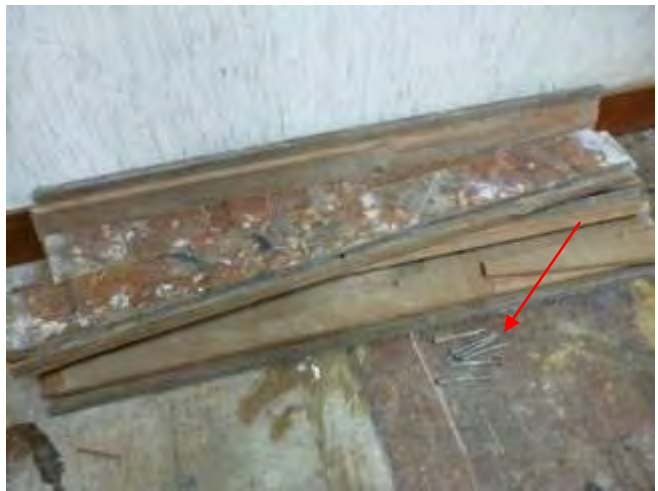
Fig. 74 (right) Some of the salvaged timber strip with moderate condition and the original fixing iron nails (pointed)

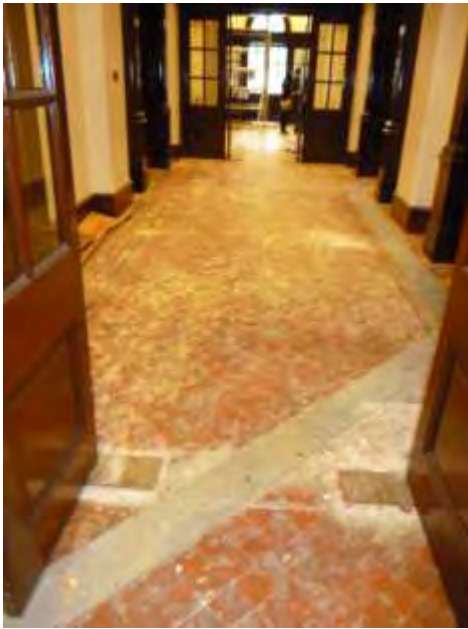
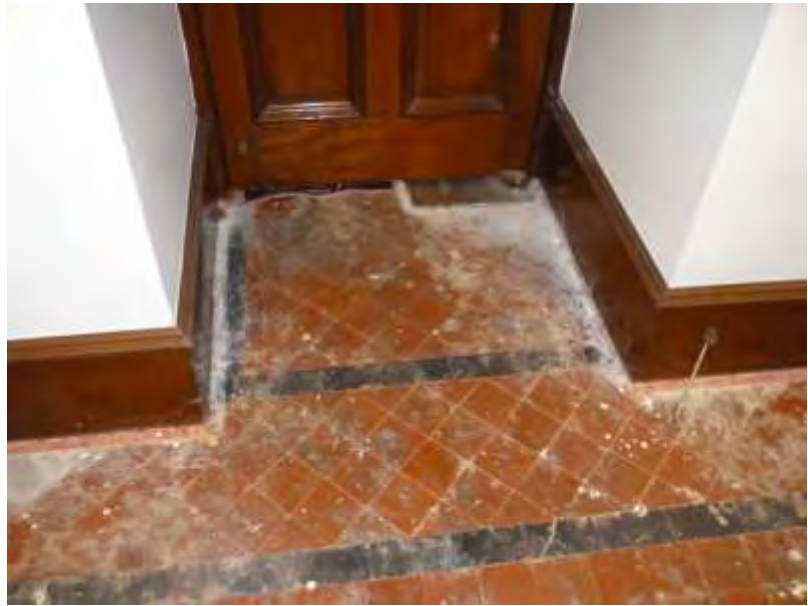
Fig. 78 (left) and Fig. 79 (right) Pictures showing the discovered original floor tiles (Fig. 78) with its detailed patterns (Fig. 79) found in the corridor areas located in 1/F and G/F respectively.

Most of the ceramic tiles are discovered in public area such as corridors, verandahs and inside some E&M rooms in 1/F. The existing condition of ceramic tile flooring is in poor condition. Most of them are heavily damaged by service trunks and covered with cement. In some areas such as the two vertical running corridor between Statue Square and Jackson Road, the entire floor has been replaced with modern stone works which no traces of original tile finish are found. One finding is the discovery of the original horizontal connecting corridor in between the two vertical running corridors in G/F which was shown in 1953 drawings but enclosed in 1985.

The ceramic tiles are mostly square-shape and in red colour. Blue rectangular tiles are used in the skirting and in front of the door openings.

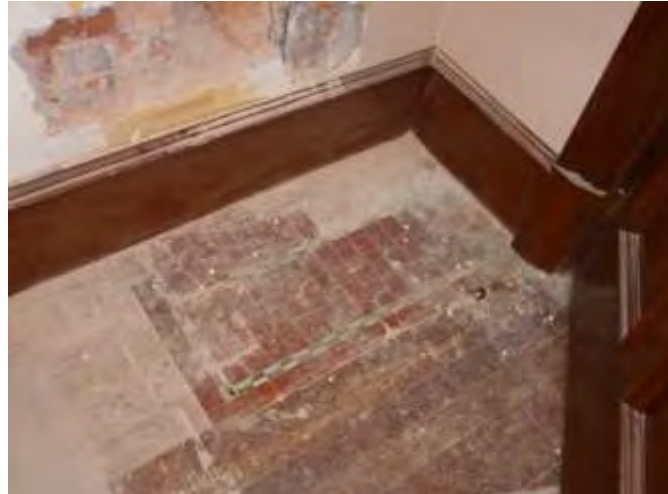
Fig. 81 (right) The ceramic tile surround at the original location of the fireplace are discovered in Room 109 & 112 in 1/F of the building

There are currently no fireplaces discovered inside the building. However, their ceramic floor tiles surround are discovered in some office areas (2 in office areas in 1/F) which are treated as the only remains of the fireplaces.

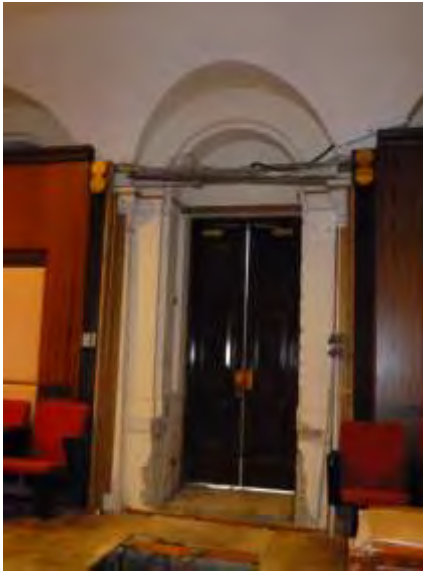
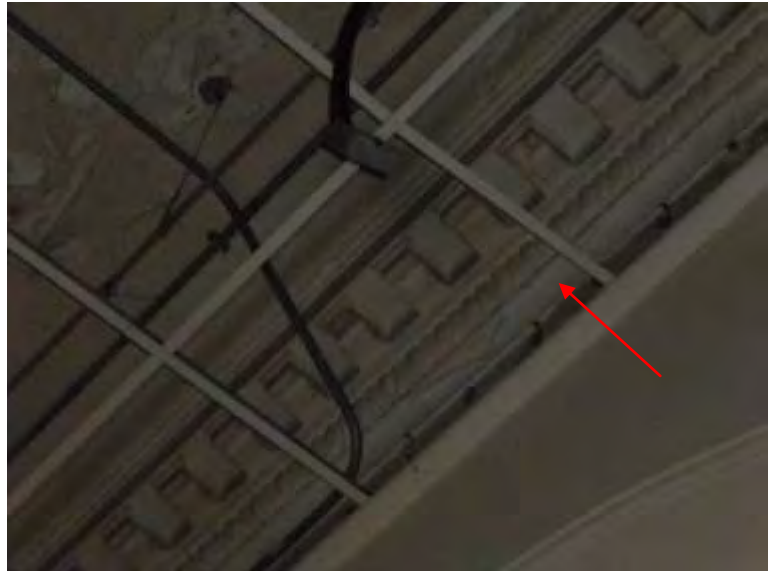
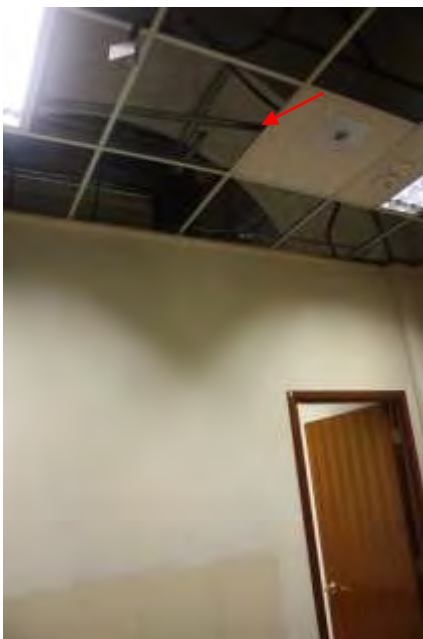
Fig. 85-87 (left to right, top to bottom)

Some of the original building features discovered after partial removal of modern fitting including the wall moulding (2/F Conference Room A, Fig. 85), dentil moulding on ceiling (discovered in G/F & 2/F ceiling, Fig. 86) and original arched doorway (mostly in G/F, Fig. 87)

- Dentil moulding on ceiling cornice (G/F and 2/F)
- Arched Doorway or window openings (G/F)
- Geometric pattern moulding (1/F corridor ceiling)

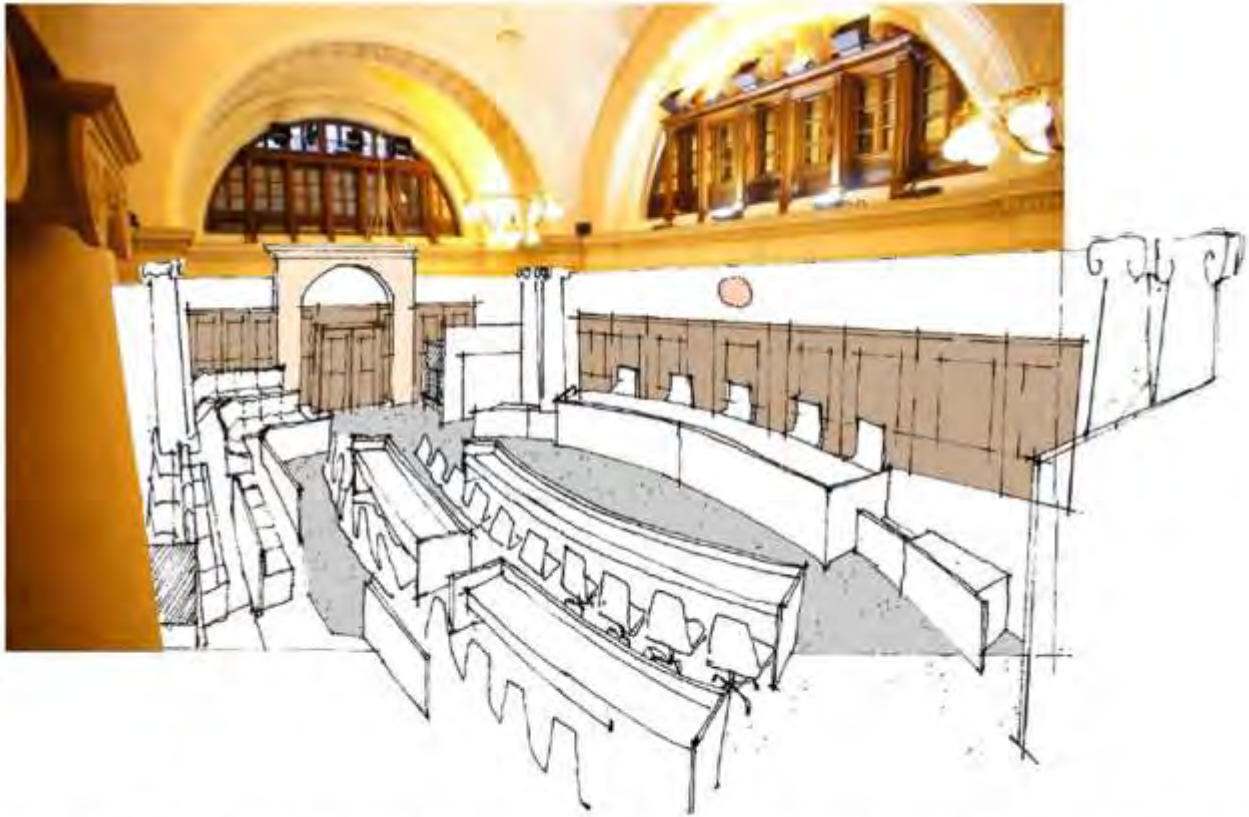
Image of the Large Court Room of the Court of Final Appeal converted from existing Chamber of the former Legislative Council

Fig. 88 A rough sketch of the future layout of the large court to be housed inside the Main Chamber of the Former Legislative Council (provided by ArchSD)
