Heritage Impact Assessment

The Former Legislative Council Building (Old Supreme Court Building)

Relocation of The Court of Final Appeal and the Development Office of The Judiciary to The Legislative Council Building

11 May 2012

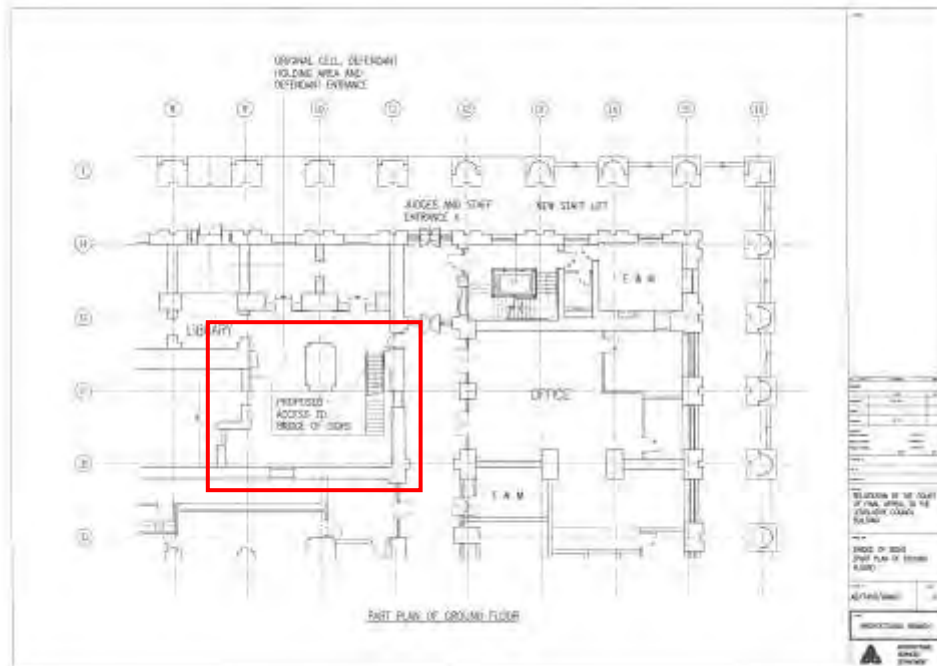
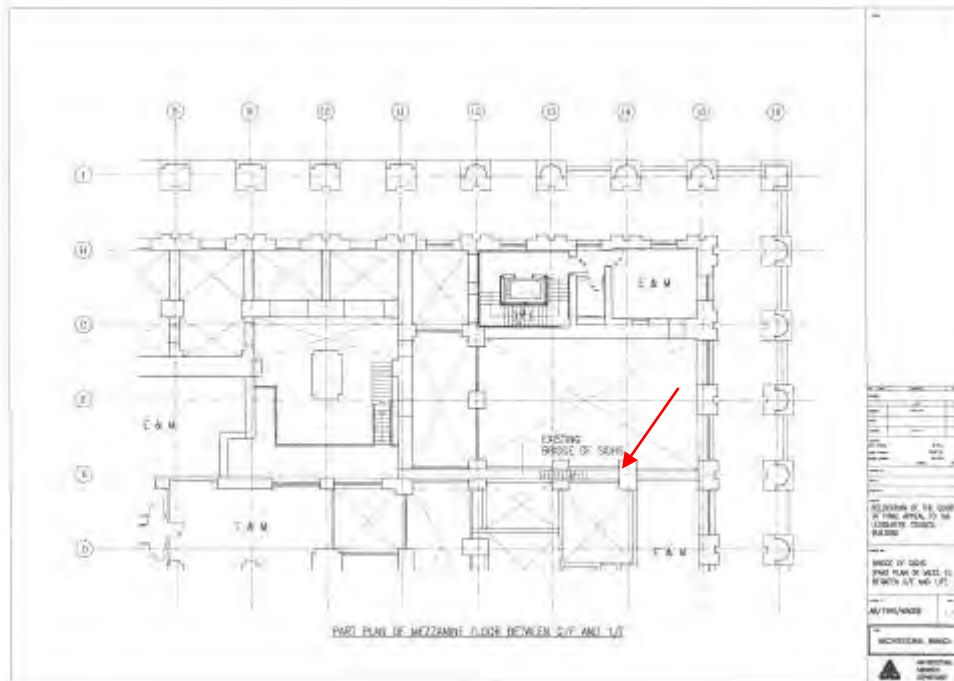
Fig. 89 (Up) & Fig. 90 (Down) showing the proposed additional mezzanine level (red squared) and a staircase added to connect the existing section of “Bridge of Sighs” (pointed red) on mezzanine level

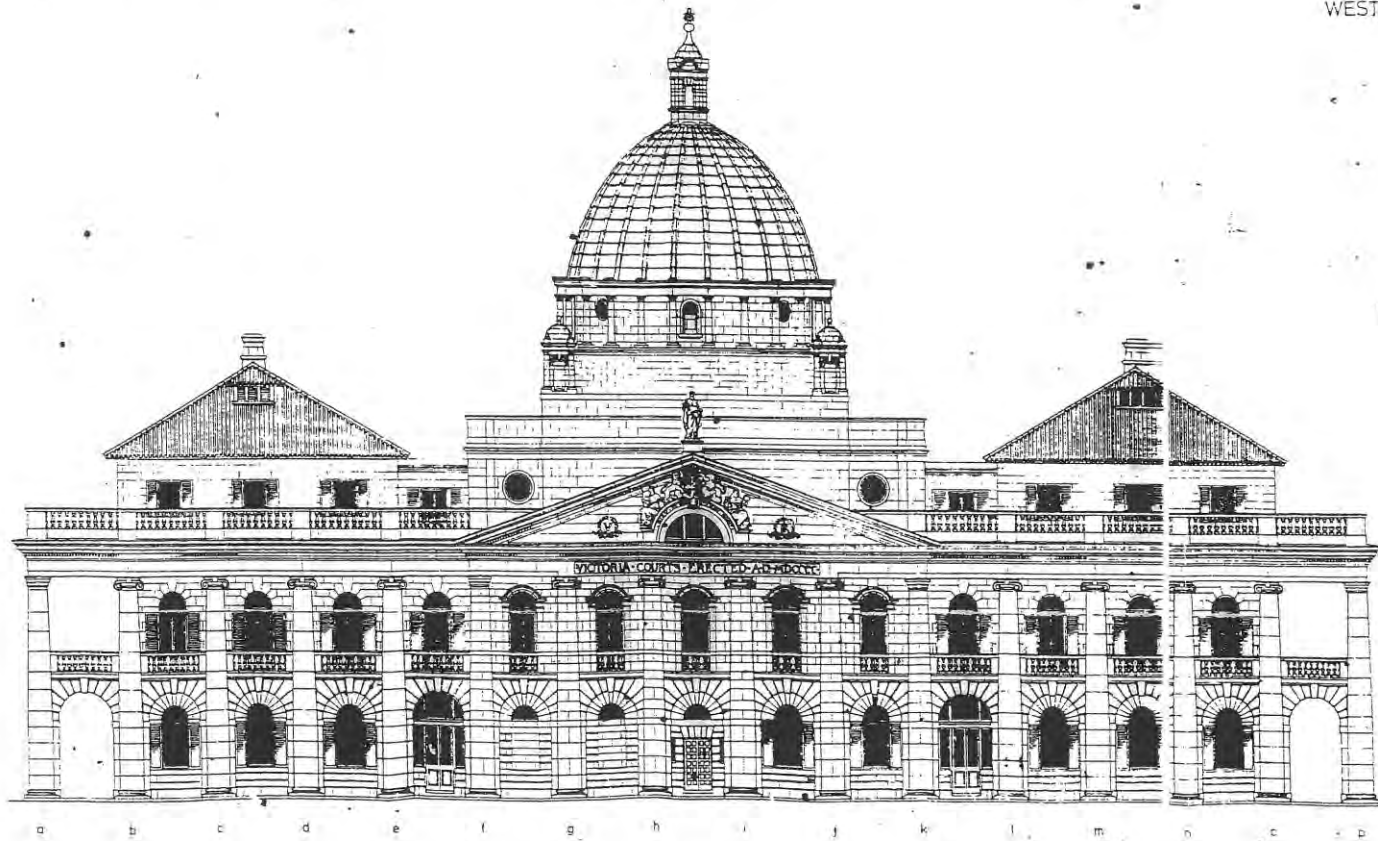
FIGURE 5

Drawing reduced from
Architects' design drawing
dated September 1899

ARCHITECTS' DESIGN
EAST ELEVATION
BUILT (WITH MINOR CHANGES) AS
WEST ELEVATION

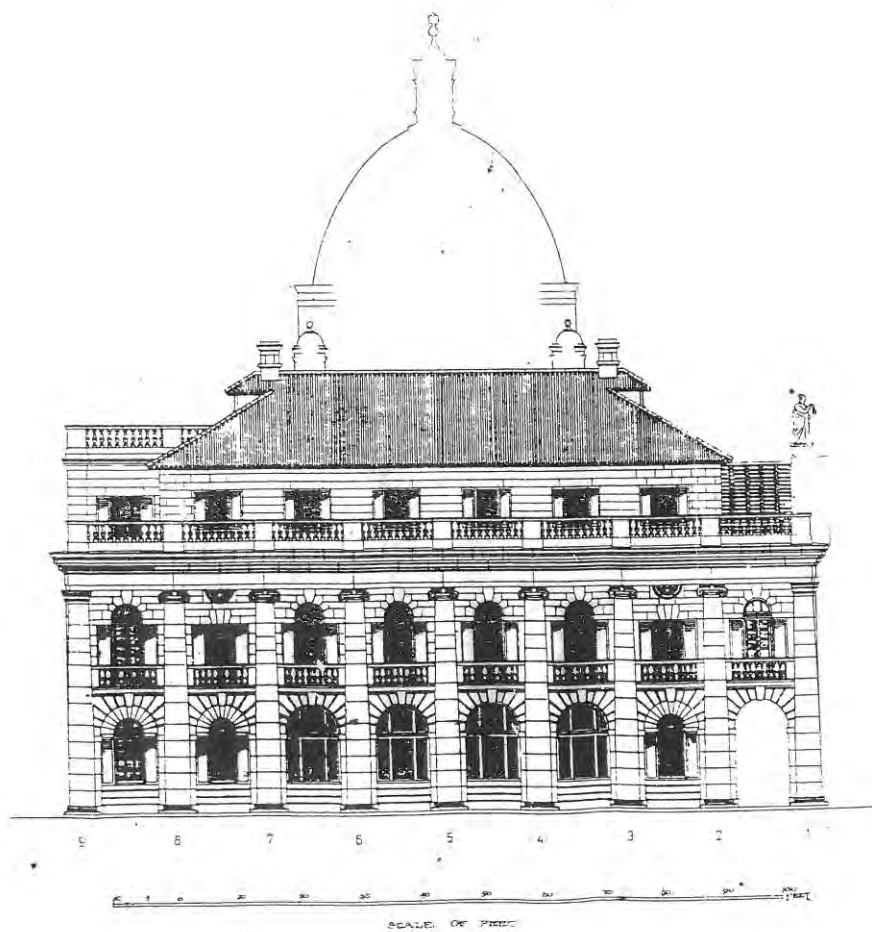
FIGURE 7

is reduced from
original design drawing
of September 1895
References added

ARCHITECTS' DESIGN
SOUTH ELEVATION
BUILT (WITH MINOR CHANGES) AS
NORTH ELEVATION

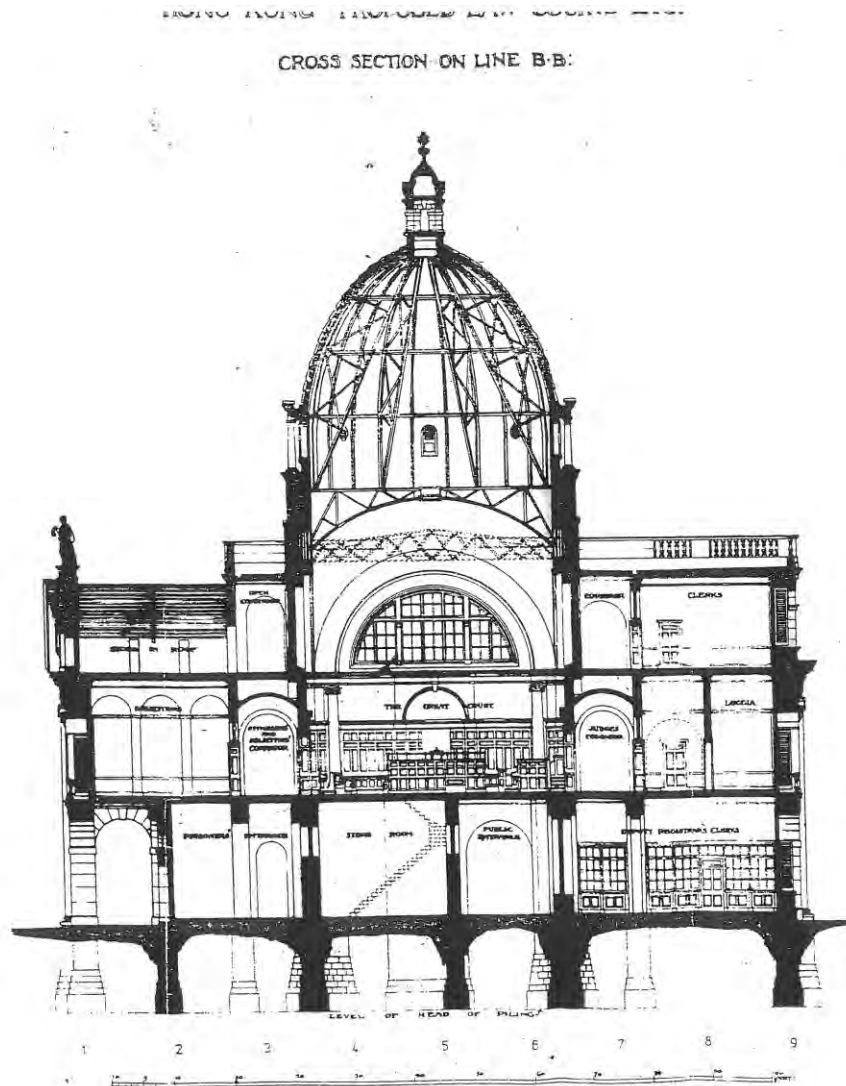
FIGURE 9

Being reduced from
 Architects' design drawing
 dated September 1899
 references added

No 9
 ARCHITECTS' DESIGN
 CROSS SECTION B - B

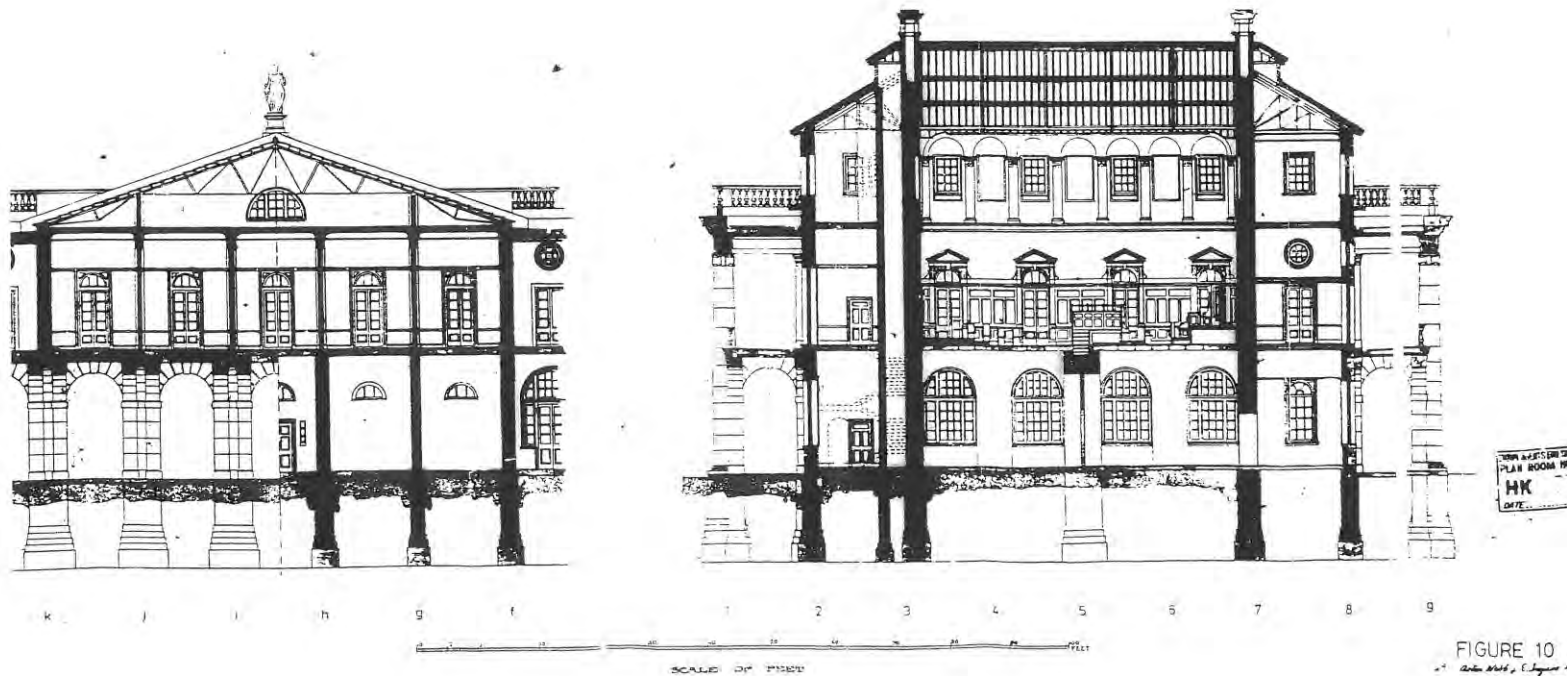
FIGURE 10
Architects' Design
Sections C-C & D-D

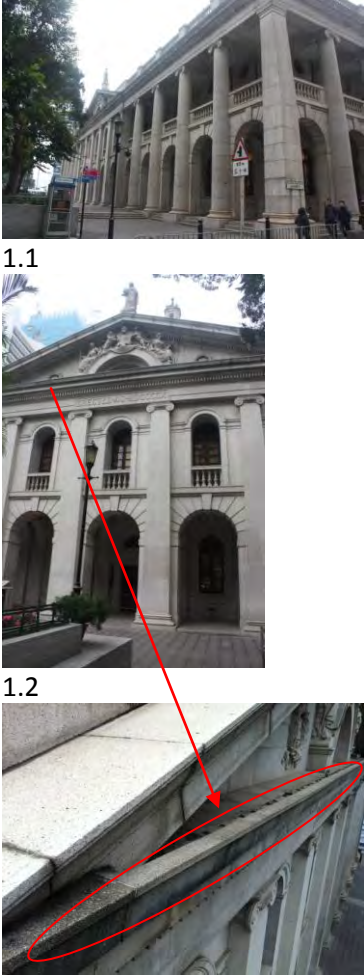
<p>1.1</p> <p>1.2</p> <p>1.3</p>	Exceptional	<ul style="list-style-type: none"> Preserve in-situ the entire external wall and retain the openness of the 1/F verandah and G/F colonnade. No painting will be applied on the granite surface. General cleaning to the granite surface will be carried out by accredited methods causing no damage to the granite. Repairing works will only be carried out if crack is discovered. Mortar mix with granite chips matching adjacent granite surface will be used for repairing. Later-added precast concrete fins in dilapidated condition are identified at the base of the pediment. Study will be carried out to confirm whether those fins are post-war construction before taking any action to the fins. Further proposal will be submitted to the AMO for approval. (1.3) 	Beneficial

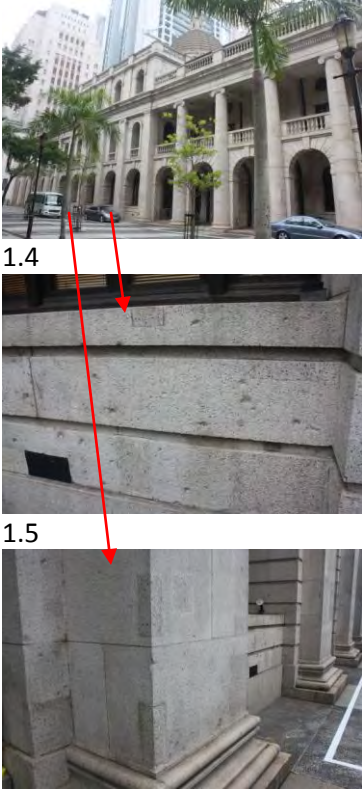
<p>1.4</p> <p>1.5</p> <p>1.6</p>	Exceptional	<ul style="list-style-type: none"> • Preserve in-situ the entire external wall and retain the openness of the 1/F verandah and G/F colonnade • No painting will be applied on the granite surface • General cleaning to the granite surface will be carried out by accredited methods causing no damage to the granite. • Repairing works will only be carried out if crack is discovered. Mortar mix with granite chips matching adjacent granite surface will be used for repairing. • Traces of damages on the granite surface, which are believed to have been caused by bullets during the World War II, are identified. Some of them were repaired in previous maintenance works. The damages and the previous repairing are considered part of the history of the building. No work will therefore be proposed to those damaged areas. (1.5 & 1.6) 	N.A.

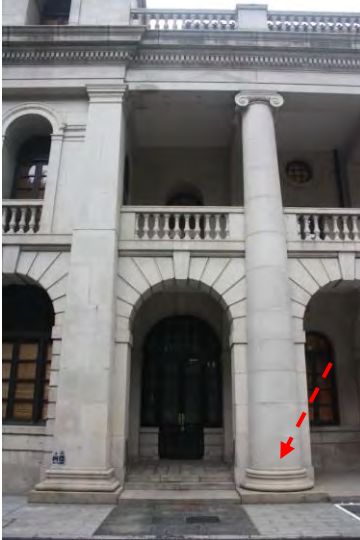
<p>1.7</p>	Exceptional	(cont'd) <ul style="list-style-type: none"> The existing ramps were constructed in the 1980s by modifying the level of the original granite floor. The gradient of the ramps could not meet current statutory requirement on barrier free access. Exemption for not complying current standard will be applied to relevant authorities, as persons with disability could be assisted by management staff. (1.7) If exemption could not be granted, the gradient of the ramp at the right entrance on this façade will be modified by adding a ramp of demountable materials on top of the existing one, so that no irreversible damage will be caused to the granite elements. (1.8) 	Acceptable with mitigation measures

<p>1.8</p>			
	<ul style="list-style-type: none"> Propose to modify existing ramp next to the rear right entrance from Jackson Road to fulfill the current barrier free access standard, if exemption could not be granted. 				
	Site Location				
<p>Statue Square</p>

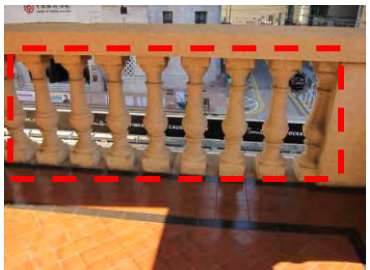
<p>1.13</p>	Exceptional	(cont'd) <ul style="list-style-type: none"> The new metal gates will be supported by free standing posts without being fixed onto the granite surface. During installation, minor portion of the existing floor tiles will be temporarily opened up and reinstated upon completion. Details will be further confirmed with AMO. The existing gaps between the vase-shaped balusters are only slightly wider than the allowable width under current statutory requirement. Exemption for not complying current standard will be applied to relevant authorities, so as to retain the original appearance of the balusters. If exemption could not be granted, transparent barrier could be installed to the balustrade at the public accessible verandah, by being clamped onto the balusters (1.13) without damaging the granite surface. 	Acceptable impact with mitigation measures

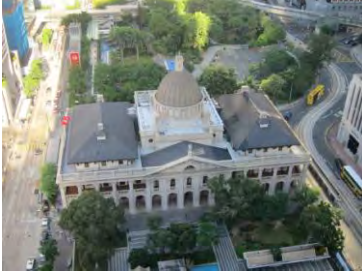
Item No	Identified Elements / Materials	Photo and Ref.	Level of Significance	Recommended Treatment/ Justification/ Mitigation Measures	Impact Level
1.6	Roof Level

<p data-bbox="674 483 730 506">1.15</p>	Exceptional	<ul style="list-style-type: none"> • Preserve the central dome, two Chinese pitched roofs and the triangular pitched roof behind the pediment. • Conduct structural assessment on the internal original steel supporting structures for different roofs. Preserve all the structures. Restore and strengthen the structures where necessary. • Preserve all the exposed features including columns, walls, arches, steps, openings and balustrades. • No painting will be applied on the granite surface. • General cleaning to the granite surface will be carried out by accredited methods causing no damage to the granite. • Repairing works will only be carried out if crack is discovered. Mortar mix with granite chips matching adjacent granite surface will be used for repairing. • Modern facilities, such as mechanical plants and external lighting system, will be located properly so as to minimize their visual impact to the building. • Inspect the roof drainage, waterproofing and lightning protection systems. Improve the systems where necessary. 	N.A.

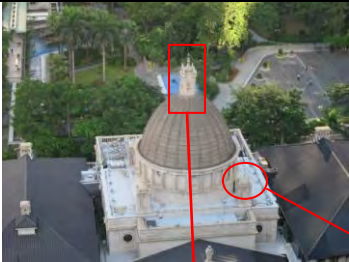
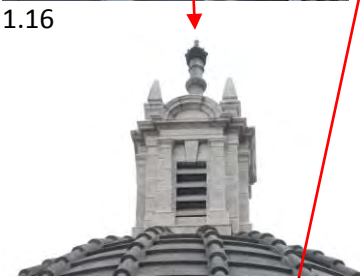
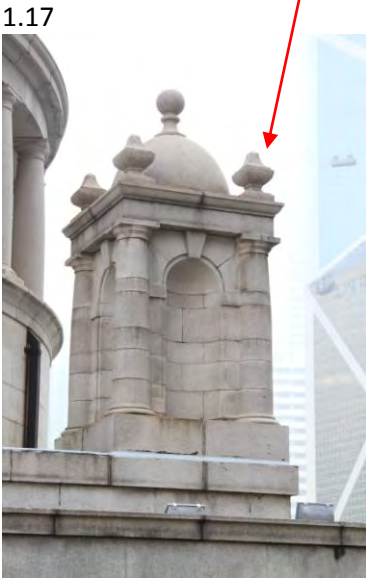
Item No	Identified Elements / Materials	Photo and Ref.	Level of Significance	Recommended Treatment/ Justification/ Mitigation Measures	Impact Level
1.7	Central Dome Area

<p>1.18</p>	Exceptional	<ul style="list-style-type: none"> • Preserve the dome structure including the granite drum, top lantern with bronze Tudor Crown, square base with four corner pinnacles, all surrounding balustrade and granolithic slabs covering of the roof. • No painting will be applied on the granite surface. • General cleaning to the granite surface will be carried out by accredited methods causing no damage to the granite. • Repairing works will only be carried out if crack is discovered. Mortar mix with granite chips matching adjacent granite surface will be used for repairing. • Modern facilities will be located properly so as to minimize their visual impact to the building. • Inspect the roof drainage, waterproofing and lightning protection systems. Improve the systems where necessary. 	N.A.

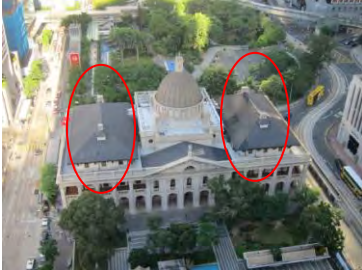
<p>1.19</p>

Item No	Identified Elements / Materials	Photo and Ref.	Level of Significance	Recommended Treatment/ Justification/ Mitigation Measures	Impact Level
1.8	Timber Pitched Roof Area

<p>1.21</p>	Exceptional	<ul style="list-style-type: none"> • Preserve the existing pitched roof. • Preserve all the exposed granite features including the four chimneys and the cast iron lightning rods. • No painting will be applied on the granite surface. • General cleaning to the granite surface will be carried out by accredited methods causing no damage to the granite. • Preserve the existing timber joist, brackets and Chinese double surface pan and roll tiles. • Test the waterproofing system, and carry out upgrading works where necessary. • Replace only defective, rotten or broken timber joist and roof tiles by similar materials matching existing. • Any new timber materials replacing the existing ones, should have undergone anti-termite treatment. • Rearrange the location of external lighting to minimize its visual impact to the building. 	N.A.

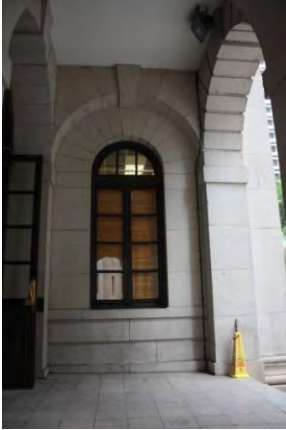
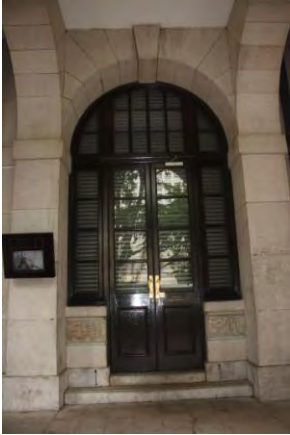
Item No	Identified Elements / Materials	Photo and Ref.	Level of Significance	Recommended Treatment/ Justification/ Mitigation Measures	Impact Level
1.10	Exterior window and door openings

High	<ul style="list-style-type: none"> • Preserve, clean, restore and make good all external windows, doors and their ironmongeries. • Replace only those timber elements which are rotten or beyond repair. Traditional style and similar materials will be used for repairing. • Apply termite treatment to all timber elements. • The external louvers at the semi-circular windows at high level of the large courtroom are later additions. The louvers will be taken down in order to allow natural light into the internal space. • Replace some of the glass panels by louvers for fresh air intake for the mechanical ventilation system. • The taken down timber elements and ironmongeries will be salvaged, numbered and recorded carefully for future reuse where appropriate. • The exact locations and method statement for replacement or modification of windows and doors will be submitted to AMO for approval once confirmed. • Any security measures, such as intrusion sensors, will be installed at the inner side of the windows and doors causing no visual impact to the building. • Security films will be transparent and applied to the inner side of the windows and doors causing no visual impact to the building. 	Acceptable impact with mitigation measures

<ul style="list-style-type: none"> • Remove the external louvers at the semi-circular windows at high level of the large courtroom in order to allow natural light into the internal space. • Replace some of the glass panels by louvers for fresh air intake for the mechanical ventilation system. • Apply transparent security films to the inner side of external windows and doors to enhance security. 	<p>1.24</p>

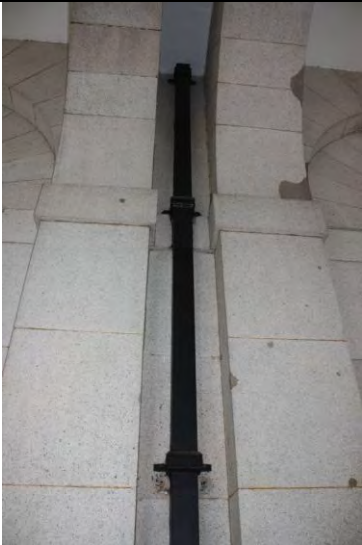
<p>1.26</p>

Item No	Identified Elements / Materials	Photo and Ref.	Level of Significance	Recommended Treatment/ Justification/ Mitigation Measures	Impact Level
1.11	Cast Iron rainwater downpipe and vent covers

<p>1.28</p>	High	<ul style="list-style-type: none"> • Preserve in-situ • Retain, repair and restore all the existing cast iron components throughout the exterior of the building. • Remove rust, mould, plant on the cast iron components. Repaint and apply anti-rust treatment where necessary. 	N.A.

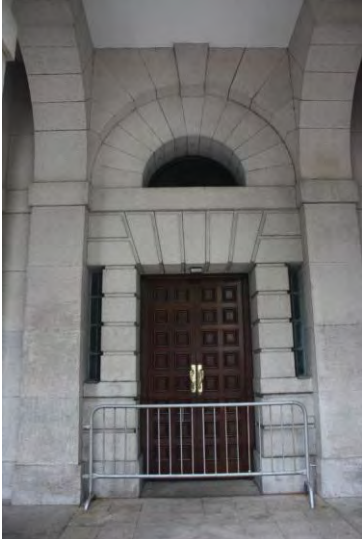
<p>1.32</p>

Item No	Identified Elements / Materials	Photo and Ref.	Level of Significance	Recommended Treatment/ Justification/ Mitigation Measures	Impact Level
1.13	Main Entrance Area

<p>1.34</p>	Exceptional	<ul style="list-style-type: none"> • Preserve in-situ • Preserve and repair the main entrance timber door, metal window frames on each side and the surrounding wall openings. • Preserve both the foundation stone of the Old Supreme Court Building, and the commemorative plaque for the opening of the Legislative Council on the columns on each side of the main entrance. • General cleaning to the granite surface and bronze plaque will be carried out by accredited methods causing no damage to the surfaces 	N.A.

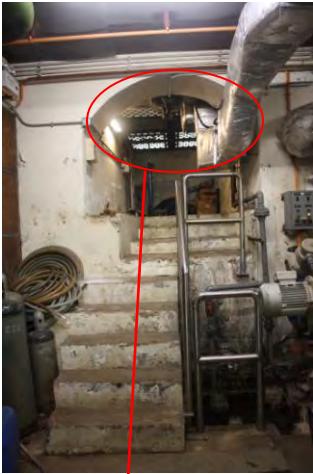
Site Location	<p>2.02</p>

Item No	Identified Elements / Materials	Photo and Ref.	Level of Significance	Recommended Treatment/ Justification/ Mitigation Measures	Impact Level
2.1	Basement Area

Moderate	<ul style="list-style-type: none"> • Preserve and repair the central load-bearing column. • Preserve and retain the three vent openings to ground level. • Preserve the general layout of the basement. • Exposed the segmental arched ceiling soffit and the granite arches. • General cleaning, disinfecting and waterproofing works will be conducted. • Raised metal grating system will be added to the basement to avoid damage to the original finishes and exhibits. 	Beneficial
	Proposed Use / Alteration	<p>2.01</p>

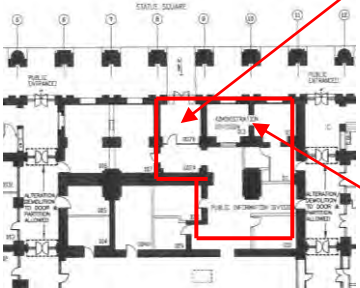
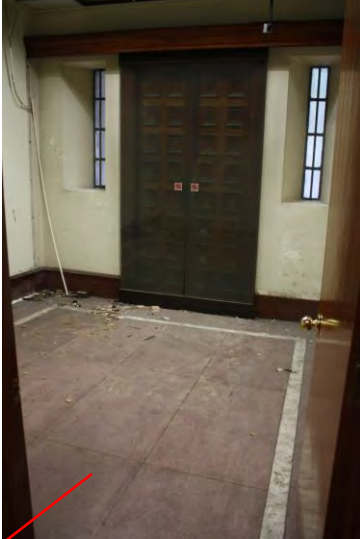
Item No	Identified Elements / Materials	Photo and Ref.	Level of Significance	Recommended Treatment/ Justification/ Mitigation Measures	Impact Level
2.2	<p data-bbox="296 250 644 418"><u>G/F</u> Old prisoners' receiving room (main entrance), holding cells and constable's waiting room</p> <p data-bbox="296 516 611 542">Proposed Use / Alteration</p> <ul data-bbox="296 574 632 704" style="list-style-type: none"> Proposed to convert the area into a reading corner inside future library <p data-bbox="296 721 453 743">Site Location</p>

<p data-bbox="296 1117 604 1175">Magnified old prisoners' receiving area in G/F plan</p>

<p data-bbox="674 1360 730 1386">2.06</p>	High	<ul data-bbox="1241 250 1696 818" style="list-style-type: none"> Preserve and repair the prisoners' entrance timber door, the side security windows and the metal bars. The door will be used as a secondary ceremonial entrance to the future library. Preserve and conduct general cleaning to the original terrazzo floor finish. Repair using similar materials by skilled tradesmen where necessary. (2.05) Retain the two original prisoners' cells and restore their original arch openings. (2.06) Metal gates with reference to cell gates of that period will be restored to the openings. 	Beneficial

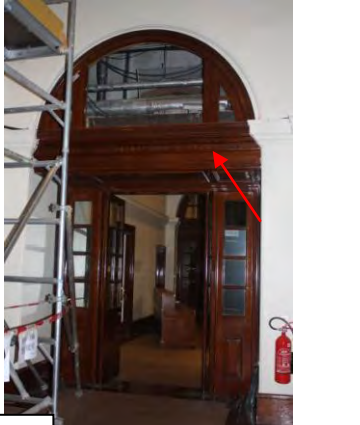
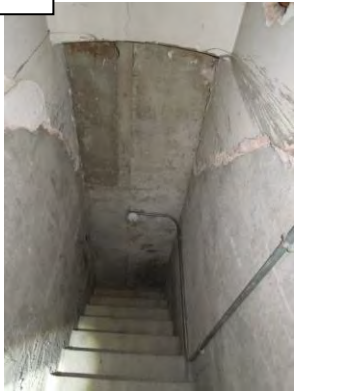
Item No	Identified Elements / Materials	Photo and Ref.	Level of Significance	Recommended Treatment/ Justification/ Mitigation Measures	Impact Level
2.3	<p data-bbox="294 308 651 438"><u>G/E</u> "Bridge of Sighs" in the original Prisoners' Receiving Room</p> <p data-bbox="294 568 651 609">Proposed Use / Alteration</p> <ul data-bbox="294 625 651 690" style="list-style-type: none"> Proposed to convert to be part of Library <p data-bbox="294 698 651 738">Site Location</p> <p data-bbox="388 771 556 803">Statue Square</p>

<p data-bbox="672 1429 724 1461">2.09</p>	High	<ul style="list-style-type: none"> Section of the Bridge of Sighs on mezzanine level (2.07) and stairs leading to original second court on 1/F (2.08) are discovered after taking away the suspended false ceiling and the glass panels of a doorway. Further examination on the condition of the Bridge will be conducted upon removal of all existing building services ductworks. The Bridge will be exposed as one of the important features of the building for public appreciation. Restore the Bridge after careful study on its condition, and reinstate its original features with reference to old photos and plans if found. A new staircase and cockloft connecting the Bridge with the future library is proposed. The new staircase facilitates public access to the Bridge for appreciation of this historic element. All new construction will be in compatible design and distinguishable with the original building structures. 	Beneficial

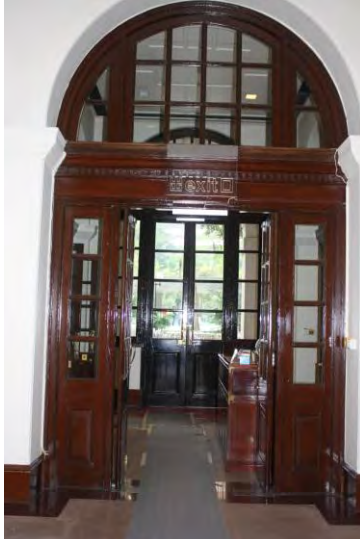
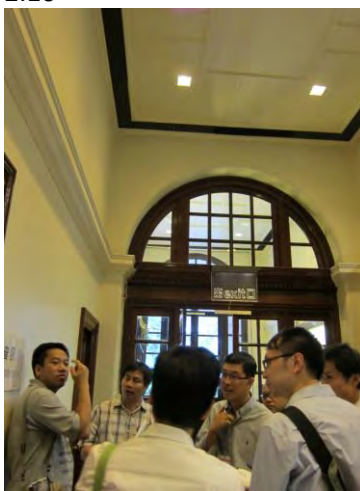
Item No	Identified Elements / Materials	Photo and Ref.	Level of Significance	Recommended Treatment/ Justification/ Mitigation Measures	Impact Level
2.4	<p><u>G/E</u> 2 corridors passing through East and West Elevations</p>

<p>2.10</p>	<p>Layout (High) Timber doorways (moderate)</p>	<ul style="list-style-type: none"> • Retain the general open layout of the corridor. • It is believed that all internal arch doorways and door panels were altered in the conversion works in the 1980s or relocated to present location from somewhere else. • Preserve the doorways in situ if they do not affect future uses. • If removal is necessary, the dismantled timber members and ironmongeries will be salvaged and recorded carefully, and kept for relocation or future restoration. • Any new doors and partitions to be added should be in harmony with the existing building. The existing transparent setting should be maintained as far as possible. • New security and safety measures, such as exit signs and sensors, should be designed and located appropriately to minimize visual impact to the heritage elements. • The locations of the timber elements that will be affected by the works, will be submitted to AMO for approval before alterations once confirmed. • A building survey is being carried out to identify the pre-1985 timber elements. The result will be submitted to AMO for record. 	<p>Acceptable with mitigation measures</p>

<p>Proposed Use / Alteration</p>				
	<ul style="list-style-type: none"> • Remain its corridor function 				
	<p>Site Location</p>

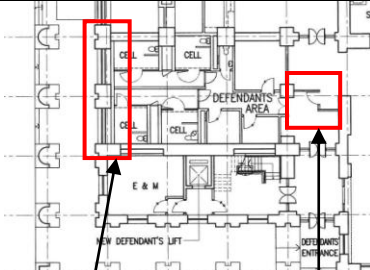
Item No	Identified Elements / Materials	Photo and Ref.	Level of Significance	Recommended Treatment/ Justification/ Mitigation Measures	Impact Level
2.5	<p>G/E New Defendant Area</p>

Low	<ul style="list-style-type: none"> • The new brickwork wall will not be attached to the external wall, so that the external wall and windows will not be affected. The finishes of the brickwork wall facing the street will be carefully designed in order not to cause visual impact to the exterior of the building. • Bricks salvaged on site will be used for construction of the brickwork wall where practical, so as to maintain the authenticity of the heritage building. • The new security wall is necessary to separate the defendant walkway from the public corridor. • The new wall will be constructed in reversible method, and could be taken down without damaging the existing building structure if necessary in future. 	Low

Proposed Use / Alteration	2.12			
	<ul style="list-style-type: none"> • To construct a new brickwork wall between the cells and the inner side of the external window. • To erect a new security wall to separate the defendant walkway from the public corridor. 	<div style="display: flex; justify-content: space-around;"> <div style="border: 1px solid black; padding: 5px;">New brickwork wall</div> <div style="border: 1px solid black; padding: 5px;">New security gate</div> </div>			
	Site Location

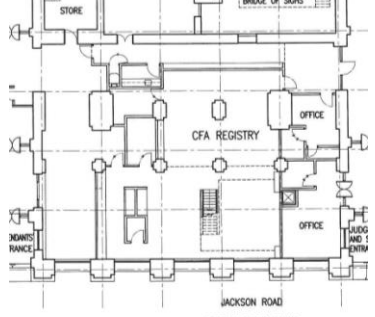
Item No	Identified Elements / Materials	Photo and Ref.	Level of Significance	Recommended Treatment/ Justification/ Mitigation Measures	Impact Level
2.6	<p><u>G/E</u> New mezzanine floor in new CFA registry area</p>

Low	<ul style="list-style-type: none"> • The location of the proposed mezzanine floor is less prominent and possesses less historic significance. • The structure of the mezzanine floor will be light in weight, independent and distinguishable from the existing structure. No additional loading will be exerted on the existing structure. • The mezzanine floor will be constructed in reversible method, and could be taken down without damaging the existing building structure if necessary in future. • The mezzanine floor also enables appreciation of the preserved moulding on the ceiling in a closer distance. 	Low
	Proposed Use / Alteration	<p>2.13 (G/F)</p>

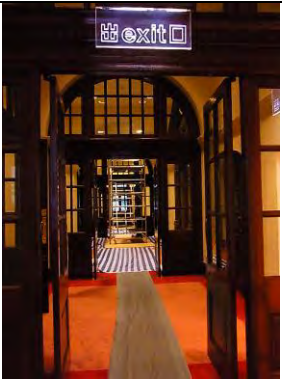
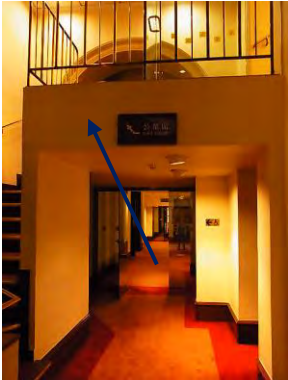
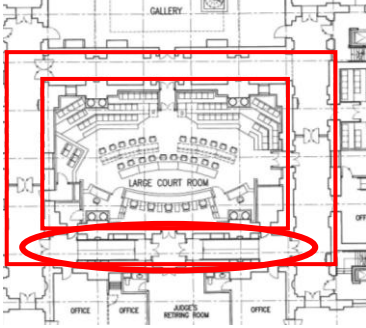
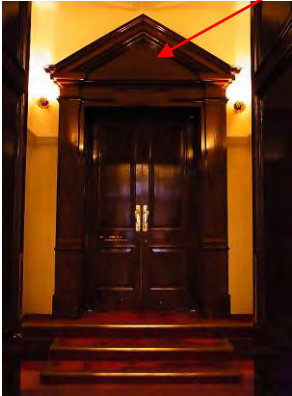
Item No	Identified Elements / Materials	Photo and Ref.	Level of Significance	Recommended Treatment/ Justification/ Mitigation Measures	Impact Level
2.7	<p><u>1/F</u> Corridors surrounding the Big Chamber</p>

<p>Layout (High) Timber doorways and door surrounds (moderate)</p>	<ul style="list-style-type: none"> • Retain the general open layout of the corridor. • It is believed that all internal arch doorways and door panels were altered in the conversion works in the 1980s or relocated to present location from somewhere else. • Preserve the doorways in situ if they do not affect future uses. • If removal is necessary, the dismantled timber members and ironmongeries will be salvaged and recorded carefully, and kept for relocation or future restoration. • Any new doors and partitions to be added should be in harmony with the existing building. The existing transparent setting should be maintained as far as possible. • Preserve and repair the four timber portals surrounding the four main entrances to the Big Chamber. (2.17) • A proposed two-sided ramp (circled on plan) will be constructed at the corridor outside the judges' retiring room to match the future level of the judges' platform inside the Large Courtroom. The ramp will be constructed in reversible method and demountable materials. • The later-added mezzanine floor at the corridor near Statue Square will be removed to reinstate the original high headroom setting. (2.16) • New security and safety measures, such as exit signs and sensors, should be designed and located appropriately to minimize visual impact to the heritage elements. • The locations of the timber elements that will be affected by the works, will be submitted to AMO for approval before alterations once confirmed. • A building survey is being carried out to identify the pre-1985 timber elements. The result will be submitted to AMO for record. • It is intended to reinstate the tile floor finishes at the corridor in front of the public entrance of future large courtroom with the salvaged tiles from other parts of the building, to restore the authentic building style of the space. 	<p>Acceptable Impact with mitigation measures</p>

<p>Proposed Use / Alteration</p>				
	<ul style="list-style-type: none"> • Remain its corridor function • Taken down the later added mezzanine floor(2.16) • Build a two-sided ramp to facilitate access to the raised entrance (circled on plan) 	<p>2.15</p>

<p>Chater Road Magnified 1/F Plan showing the circulating corridor</p>	<p>2.16</p>

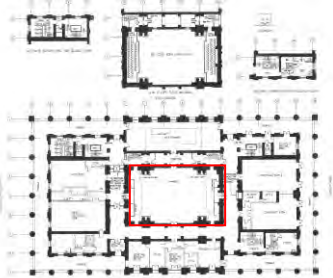
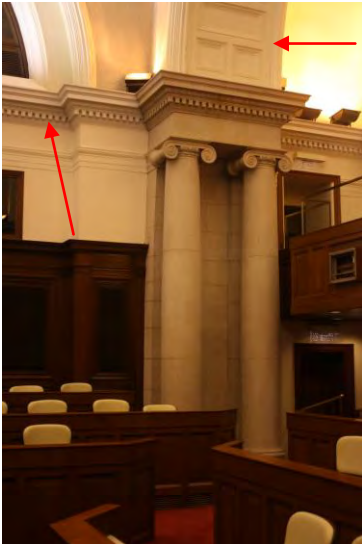
Item No	Identified Elements / Materials	Photo and Ref.	Level of Significance	Recommended Treatment/ Justification/ Mitigation Measures	Impact Level
2.8	<p>1/F Big Chamber</p> <p>(Structural Features)</p>

<p>2.18</p>	Exceptional	<ul style="list-style-type: none"> • Preserve the double height dome-shaped ceiling • Repair the plastering works with similar materials and colour matching existing. • Preserve the four granite double ionic columns supporting the two big arches on both sides of the Chamber. • No painting will be applied on the granite surface. • General cleaning to the granite surface will be carried out by accredited methods causing no damage to the granite. • Repairing works will only be carried out if crack is discovered. Mortar mix with granite chips matching adjacent granite surface will be used for repairing. • Retain and repair the decorative moulding on the supporting arches and cornice. (2.16) Mortars with colour matching existing will be used for repairing. 	N.A.

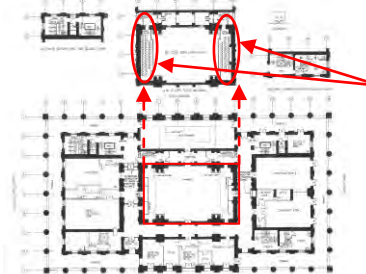
<p data-bbox="373 1089 569 1122">Existing 1/F Plan</p>

Item No	Identified Elements / Materials	Photo and Ref.	Level of Significance	Recommended Treatment/ Justification/ Mitigation Measures	Impact Level
2.9	<p data-bbox="296 305 520 407"><u>1/F</u> Big Chamber (Internal Features)</p> <p data-bbox="296 418 611 451">Proposed Use / Alteration</p> <ul data-bbox="296 477 632 683" style="list-style-type: none"> • Reinstatement to court room function • Redesign the internal fitting to accommodate the 5 judges setting of CFA requirement <p data-bbox="296 695 453 727">Site Location</p>

<p data-bbox="674 1097 1020 1300">2.23 (the piece showing the later added structure to be taken down, the upper galleries (pointed above) and the glazed control room (pointed below))</p>	Moderate	<ul data-bbox="1262 305 1692 1382" style="list-style-type: none"> • Preserve the remaining timber wall panels and door openings on the sides towards Statue Square and Jackson Road. • All furniture and fittings (tables, seats, benches for all councilors, officials and chairman, and the timber backdrop behind the chairman) are later added, and can be modified or removed subject to new functional needs. • There will be alteration to the internal fittings to meet the functional need of accommodating five judges at the judges' bench, and a number of counsels at the counsels' benches. (see new floor plan) • The two mezzanine public galleries and the control rooms below will be removed to reinstate the original setting of the chamber. The original arch wall decorations behind one of the galleries will be exposed and preserved. • Restore the missing timber wall panels after removing the mezzanine structures with panels of similar pattern and colour. • Remove the existing elevated platform to review the condition of the flooring. Preserve original materials such as tiles or timber flooring if discovered. • The timber windows and inner column-like decorations will be preserved and repaired according to the methods mentioned in the section for timber and window fittings. 	Beneficial

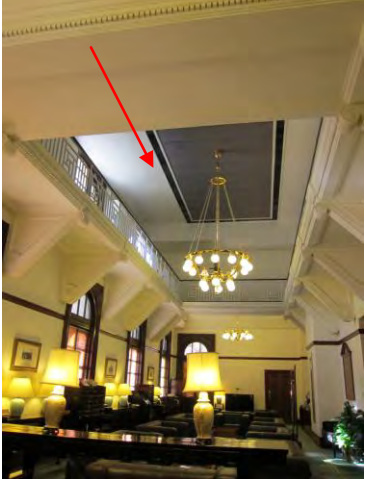
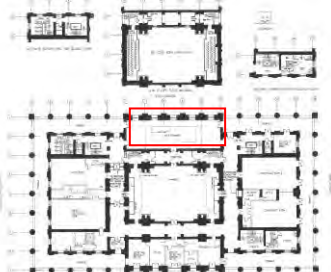
Item No	Identified Elements / Materials	Photo and Ref.	Level of Significance	Recommended Treatment/ Justification/ Mitigation Measures	Impact Level
2.10	1/F Ante Chamber

High	<ul style="list-style-type: none"> • Retain the central-open layout of the Ante Chamber. • Preserve the mezzanine level as book storage area. • Preserve and repair the metal railings, supporting brackets and line mouldings. If cracks are found on the brackets and mouldings, the cracks will be repaired by mortar and subsequently covered by plaster matching existing. • Restore the spiral staircase connecting the Ante Chamber with the mezzanine level. The spiral staircase will be designed with reference to available records and will be compatible with the surroundings. • The loading capacity of the mezzanine floor will be checked and verified. 	Beneficial
	Proposed Use / Alteration				
	<ul style="list-style-type: none"> • Proposed to convert into gallery

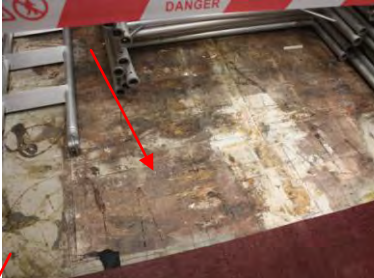
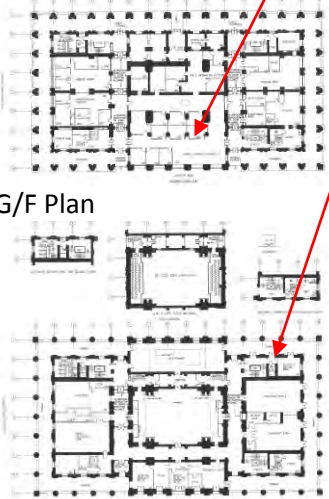
Item No	Identified Elements / Materials	Photo and Ref.	Level of Significance	Recommended Treatment/ Justification/ Mitigation Measures	Impact Level
2.11	Internal Flooring finishes (G/F to 2/F)

Moderate	<ul style="list-style-type: none"> • Carpets were removed, and some existing cement floor surface was chipped off at strategic locations, to review the conditions of the original floor finishes. • Timber flooring was found in existing offices and conference rooms, while tiles were found in existing corridors. • The timber flooring that are in good condition will be preserved, those that are rotten and beyond repair will be removed. • The tiles that are in good condition will be preserved and cleaned with non-destructive and neutral cleanser. • If in-situ preservation is not possible, the flooring will be salvaged for replacement in other areas and exposed for public appreciation where possible. Those that are not exposed will be covered without damaging. • The extent of preservation and method statement will be submitted to AMO for agreement in due course. • The traditional nailing technique will be adopted as far as practical during replacement of timber flooring. • Anti-termite treatment will be applied to the preserved timber flooring. 	Acceptable Impact with mitigation measures

Proposed Use / Alteration	2.26 (G/F, Room 025)			
	<ul style="list-style-type: none"> • Preserve and restore original fittings

<p data-bbox="296 927 401 951">G/F Plan</p> <p data-bbox="296 1252 401 1276">1/F Plan</p>	2.27 (1/F, Room 114A)

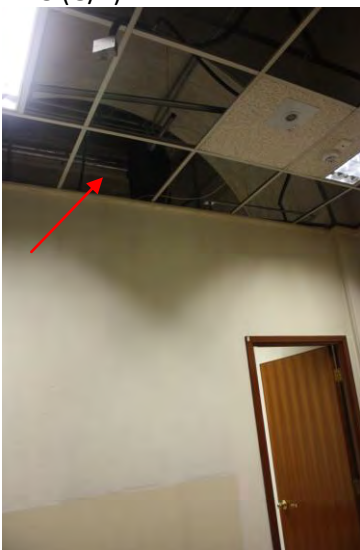
Item No	Identified Elements / Materials	Photo and Ref.	Level of Significance	Recommended Treatment/ Justification/ Mitigation Measures	Impact Level
2.12	Internal Ceiling Level (G/F to 2/F)

<p>2.28 (G/F)</p>	Moderate	<ul style="list-style-type: none"> • Retain and reinstate the high headroom spatial setting at locations where appropriate. • Repair mouldings with similar pattern and colour matching existing. • Expose some currently hidden ceiling features such as cornice mouldings, dentils and arch openings for public appreciation where appropriate. • Use existing openings on the structure for pipes and ducts as far as possible to minimize the need for new openings. • Repair existing openings for pipes and ducts if they will no longer be used. 	Beneficial
	Proposed Use / Alteration

<p>2.29 (G/F)</p>			
	<ul style="list-style-type: none"> • Propose to reopen part of the ceiling to expose those original features

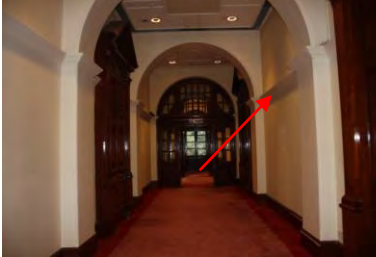
Item No	Identified Elements / Materials	Photo and Ref.	Level of Significance	Recommended Treatment/ Justification/ Mitigation Measures	Impact Level
2.13	Retain wall surface plaster and moulding (G/F to 2/F)

Moderate	<ul style="list-style-type: none"> • Retain all existing wall moulding along the corridors. (2.30) • Retain and repair the arch and pilaster decorative moulding around the internal wall of 2/F Dining Room and Conference Room. (2.31) Future partitions in the rooms will be aligned with the decorations, and details between new partitions and existing walls will be further confirmed with AMO, to ensure no damage will be caused to the wall decorations. • The decorative moulding will be exposed for appreciation as far as practical. 	Beneficial
	Proposed Use / Alteration	2.30 (along corridor)			
	<ul style="list-style-type: none"> • Preserve and repair wall moulding to reinstate the damaged decorative features in exposed locations

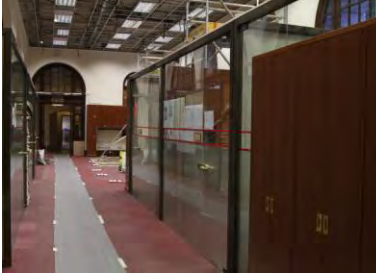
<p data-bbox="674 602 1047 667">2.33 (G/F Existing Office Partitioning)</p>	Low	<ul style="list-style-type: none"> • Preserve all original load bearing brickwork walls. • New partitions should be made of materials that could prevent sound transmission and meet fire separation and safety requirement. • Fixing points of new partitions to existing walls should be minimized where possible to minimize impact to the existing walls. • The joints between new partitions and existing walls should be carefully designed in order not to damage the identified CDEs and features with heritage value, such as wall moulding and cornice. • New partitions should be constructed in reversible method, and constructed by light weight structures as far as practical. 	Acceptable Impact with Mitigation Measures

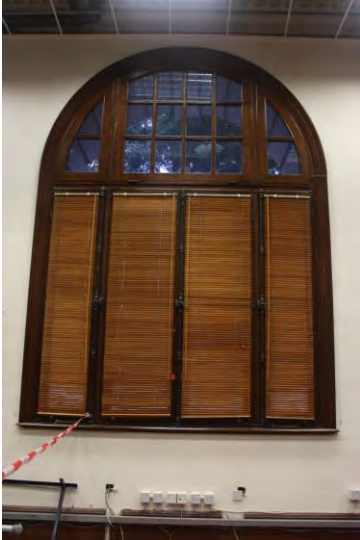
<p>2.34</p>

<p>2.35</p>	Moderate	<ul style="list-style-type: none"> • Most of the doors and windows opened to the exterior are original. • Preserve the doors and windows, and all elements on them such as timber frame, panels, ironmongeries, jambs and threshold, and timber security bars. (2.35) • Retain, clean, restore and make good all the timber doors, windows and their ironmongeries. • Replace only those timber elements which is rotten or beyond repair. Traditional style and similar materials will be used for repairing. • Apply termite treatment to all timber elements. • Any security measures, such as intrusion sensors, will be installed at the inner side of the windows and doors causing no visual impact to the building. • Adopt minimum intervention approach to minimize impact to the doors and windows. 	Acceptable Impact with Mitigation Measures

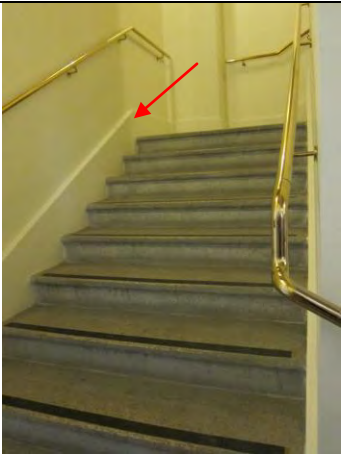
High	<ul style="list-style-type: none"> • Retain the entire flight of steps from G/F to 2/F. • No painting will be applied on the granite surface. • General cleaning to the granite surface will be carried out by accredited methods causing no damage to the granite. • Repairing works will only be carried out if crack is discovered. Mortar mix with granite chips matching adjacent granite surface will be used for repairing. • Preserve the base line moulding on the sidewall of the staircase. (2.36) 	N.A.
	Proposed Use / Alteration

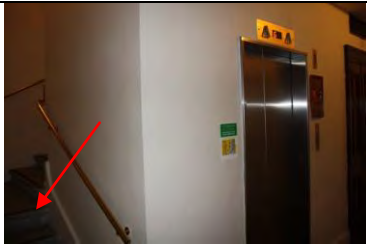
Proposed Use / Alteration	<p>2.38</p>

Moderate	<ul style="list-style-type: none"> The new lift provided in this area will be designated for judges. The original granite staircase is a CDE and will not be altered and damaged. There will be no structural alteration to the existing lift. The structural condition of the staircase will not be affected. The existing dump waster was built in the 1980s for the kitchen of the LegCo, and possesses little historic significance. The dump waster will be removed to allow space for installation of new lift for judges. New additions should be constructed in reversible method, and compatible and distinguishable with the existing building structure. Capacity of floor loading will be ascertain to ensure that the building structure will not be affected by the new facilities. 	Acceptable impact with mitigation measures

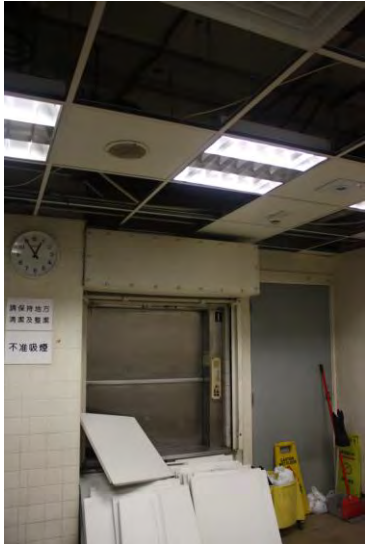
<ul style="list-style-type: none"> No alteration to the existing granite staircase and the lift in its central void will be done. The size and capacity of the existing lift is limited and does not meet future operational requirement and current standard of barrier free access. A new lift for judges will be provided near the existing location of the dumbwaiter in order to satisfy operational and statutory requirement. 	<p>2.39</p>

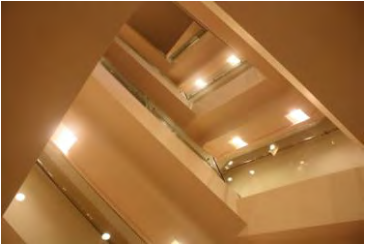
<p data-bbox="646 846 699 873">2.42</p>

Moderate	<ul style="list-style-type: none"> • The new lift provided in this area will be designated for public • The existing staircase was constructed in the 1980s and possesses no historic significance. • New additions should be constructed in reversible method, and compatible and distinguishable with the existing building structure. • Capacity of floor loading will be ascertain to ensure that the building structure will not be affected by the new facilities. 	Acceptable impact with mitigation measures
	<p data-bbox="254 521 569 548">Proposed Use / Alteration</p> <ul style="list-style-type: none"> • Provide a new disabled platform and modify existing staircase to facilitate public access to the basement, and comply with current statutory requirement. • A new lift for public will be provided near the existing location of the toilet in order to satisfy operational and statutory requirement. 	<p data-bbox="646 570 699 597">2.41</p>

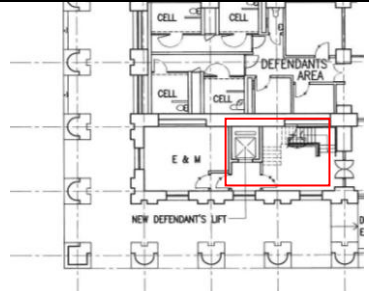
<p data-bbox="674 565 1033 597">2.43</p>	Moderate	<ul style="list-style-type: none"> • The new lift provided in this area will be designated for defendants. • The existing lift installed in the 1980s does not meet operational requirement and will be replaced. • New additions should be constructed in reversible method, and compatible and distinguishable with the existing building structure. • Capacity of floor loading will be ascertain to ensure that the building structure will not be affected by the new facilities. 	Acceptable impact with mitigation measures
	Proposed Use / Alteration				
	<ul style="list-style-type: none"> • A new lift for defendants will be provided near the location of the existing lift in order to satisfy operational and statutory requirement.
