## **LEGISLATIVE COUNCIL PANEL ON DEVELOPMENT**

### **Enhancing Safety of Aged Lifts**

## Seven Solutions for Enhancement of Older Lifts

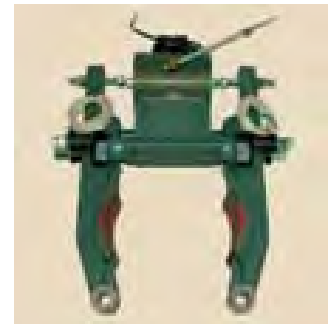
### ▶ **Solution 1: Install a Double Brake System**

Older lifts may be fitted with only one brake and so the failure of parts could cause a lift car to stop ineffectively. Installing a redundant braking system can enhance safety as it has all the main brake parts in two sets, so that in the event of one set of parts fails, the other set of parts will ensure the safe operation of the lift.

A modern double brake system has two independent braking systems, each of which is normally electrically monitored.

Enhancement Solution	Benefit
1.	Install a redundant brake system	Older lifts with one brake may lead to ineffective braking should the brake fail. If a redundant brake system is installed, the lift will be able to stop safely even if one set of the brake fails.

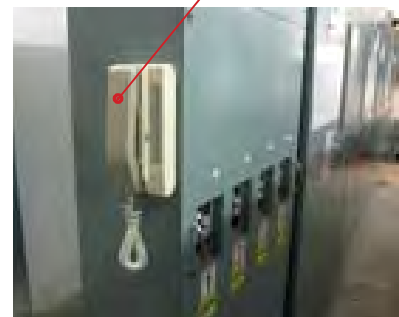
*Intercom*

If trapped in a lift, passengers can always press the alarm bell for help, but experience shows that it is not the best option. Installing an intercom system makes it possible for trapped passengers to communicate directly with management office staff who can take speedy action to call Fire Services Department and lift contractor. Some advanced intercom systems also allow passengers to directly contact a 24-hour call centre of the registered lift contractor for assistance.

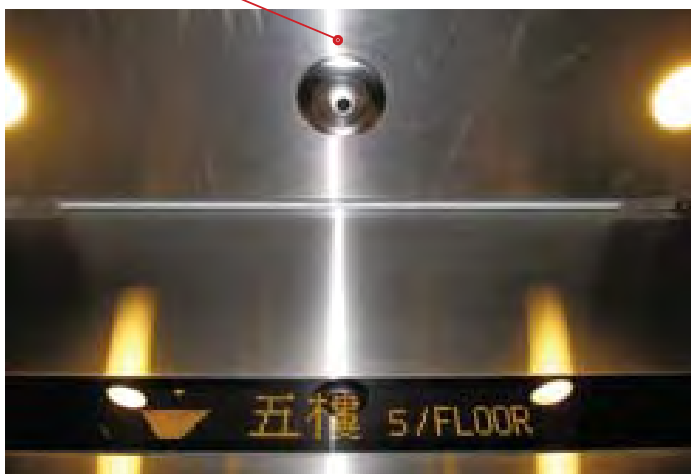
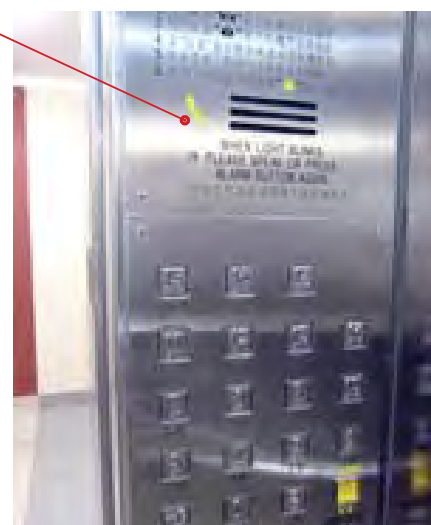
*CCTV system*

RPs may also consider installing a closed-circuit television (CCTV) system which comprises a camera in the lift car and an emergency alarm push button with buzzer (or alarm bell), all connected to the building management office. Management office staff can also monitor the CCTV video captured round the clock and take speedy action during emergency.

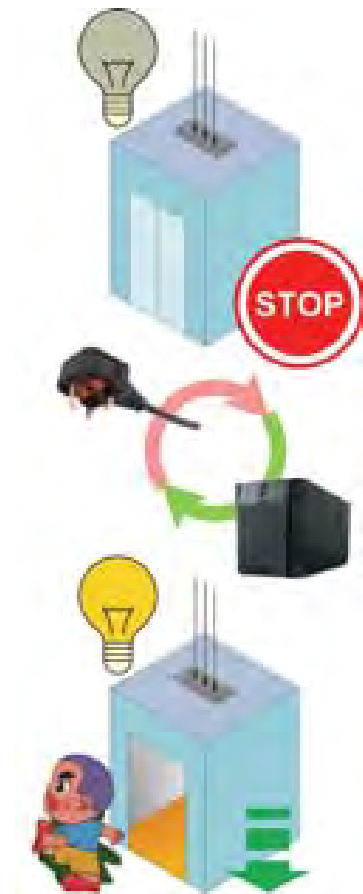
### **Solution 7: Add Automatic Rescue Devices**

Passengers may be trapped inside a lift car in case of power failure. If an advanced automatic rescue device is installed, it can maintain the lift in a momentary operation for the safe exit of passengers, and prevent them from being trapped. When normal power supply fails, the device detects the voltage dip, uses back-up battery power to move the lift to the nearest landing floor and opens the doors to release the passengers. The lift will then remain out of service until normal power supply is resumed.

7.	Add automatic rescue device	Prevent passengers from being trapped in case of power failure. Increased reliability of lift operation.
