Legislative Council Panel on Transport

**Investigation on
Prestressing Tendon Failure Incident at
Concrete Viaduct of Shenzhen Bay Bridge - Hong Kong Section**

**Transport and Housing Bureau
Highways Department
July 2019**

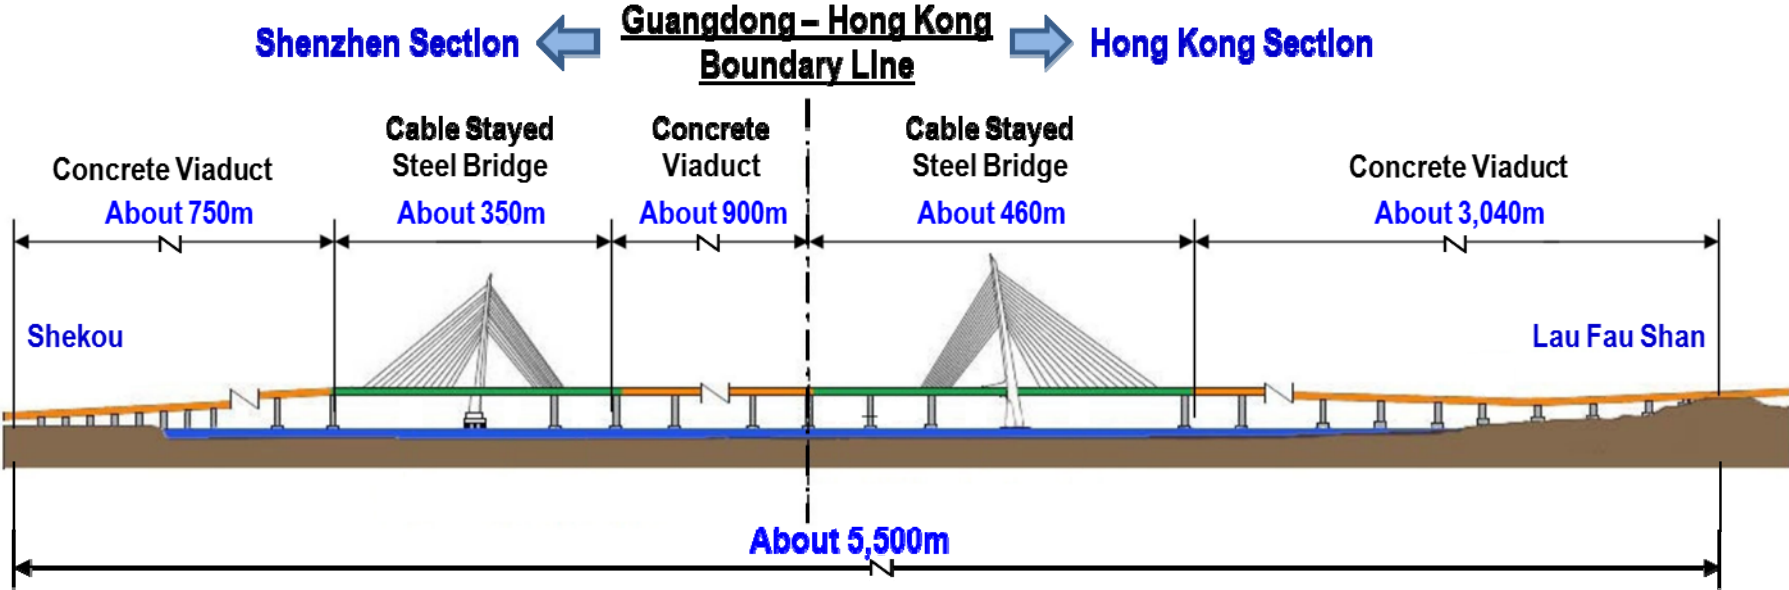
Annex - Elevation of Shenzhen Bay Bridge

2. The Shenzhen Bay Bridge, commissioned in 2007, carries a dual three-lane carriageway of about 5.5 kilometres (km) long and spans across Deep Bay between Lau Fau Shan of Hong Kong and Shekou of Shenzhen. The Shenzhen Bay Bridge is divided into two sections according to the Guangdong-Hong Kong boundary, namely the Hong Kong Section and the Shenzhen Section with a length of 3.5km and 2km respectively. The bridge consists of multi-span concrete viaducts and two cable-stayed steel bridges respectively spanning across the navigation channels of Hong Kong and Shenzhen (see **Annex**). The concrete viaduct of the SBB-HK was constructed by precast segmental method with the precast segments assembled by a number of internal and external prestressing tendons on the bridge piers. The Highways Department (HyD) is responsible for the maintenance of the SBB-HK, and professional staff have been employed to conduct routine inspections of bridge structures.
